Release Notification and Corrective Action

1RP-2689

Name of Company	Plains Pipeline, LP	Contact	Jason Henry
Address	2530 Hwy 214 - Denver City, Tx 79323	Telephone No.	(575) 441-1099
Facility Name	Jack B 15 4-inch Historical	Facility Type	Pipeline
Surface Owner	Bill Grobe	Mineral Owner	
		Lease No.

Prepared by: NOVA
Project Name: Jack B 15 4" Historical

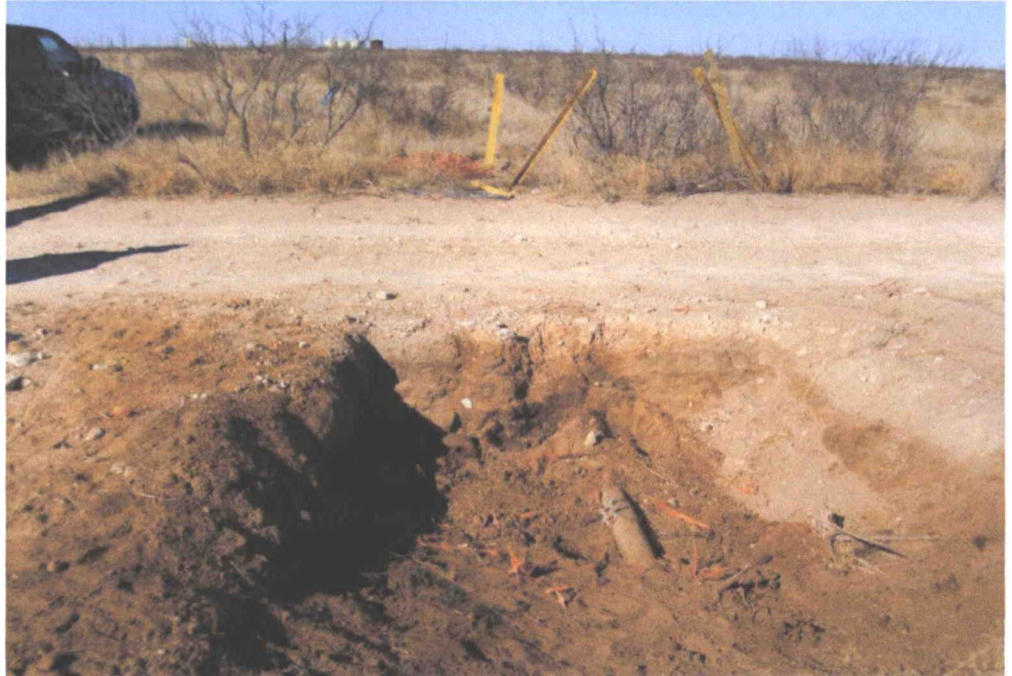
Direction:
View West

Description:
View of initial release.

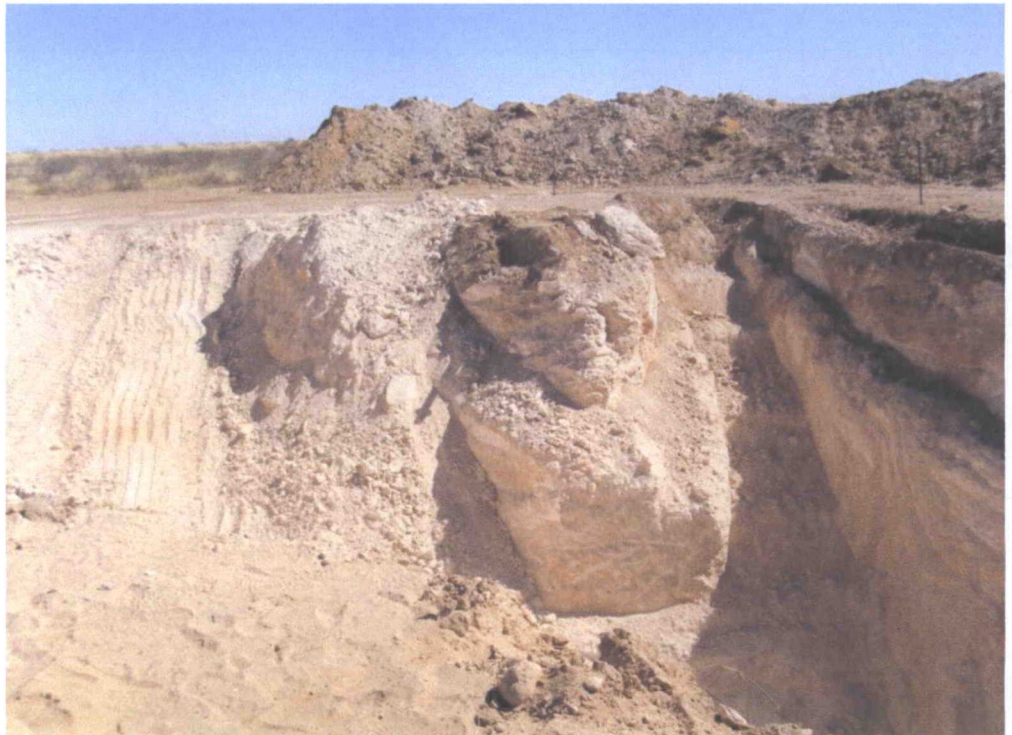
Photograph No. 2

Direction:
View East

Description:
View of excavation and ramp.

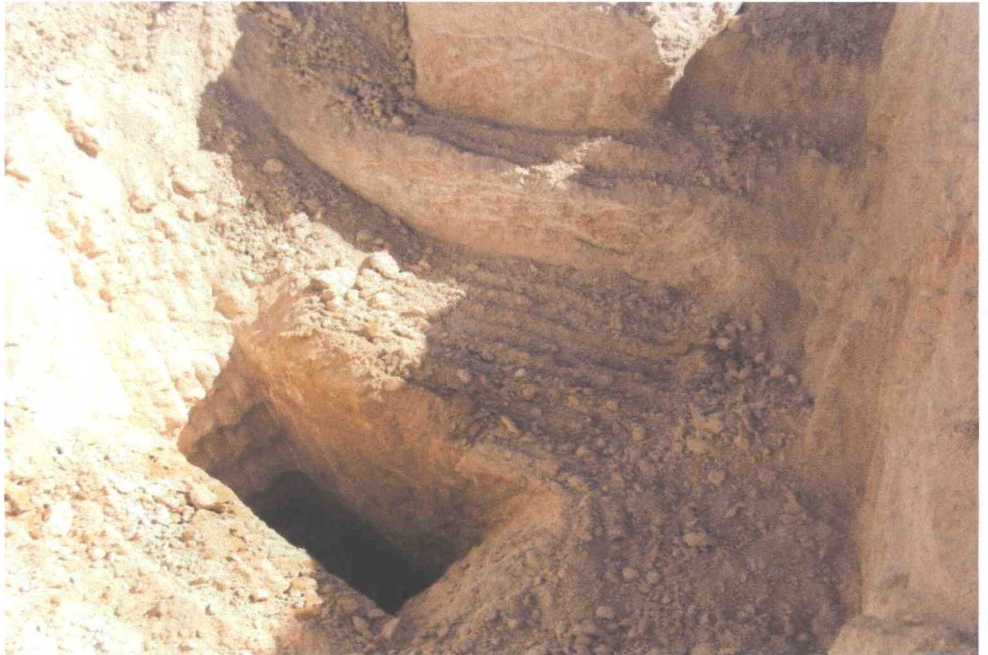
Direction:
View East

Description:
View of trench in floor of
excavation.

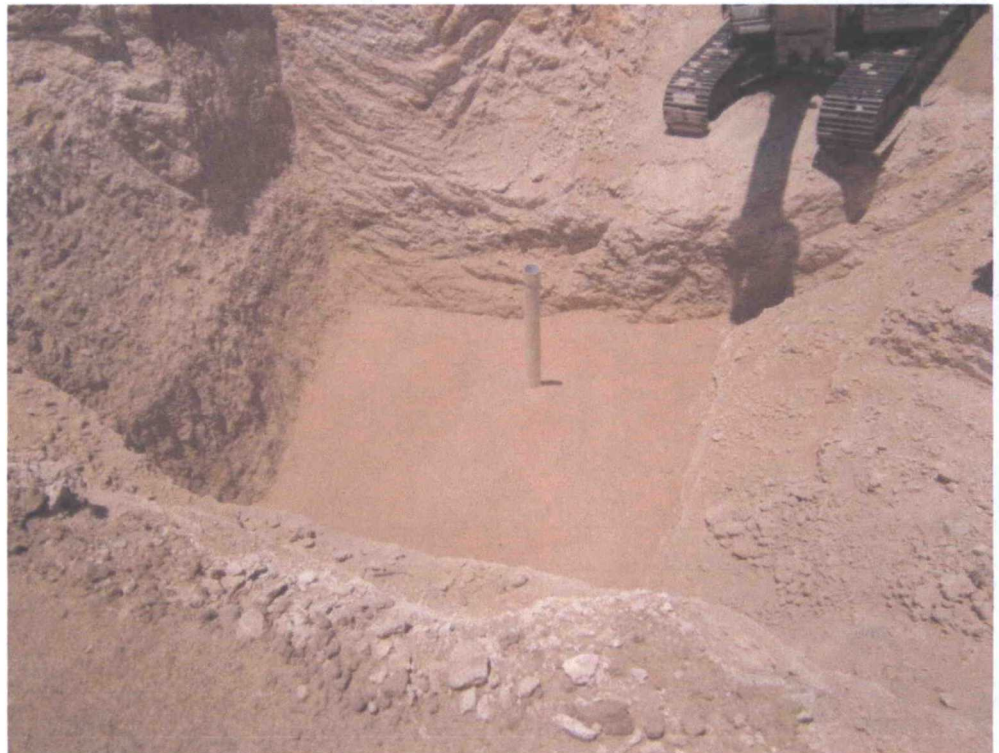
Photograph No. 6

Direction:
View North

Description:
View of backfilling
around PVC riser.

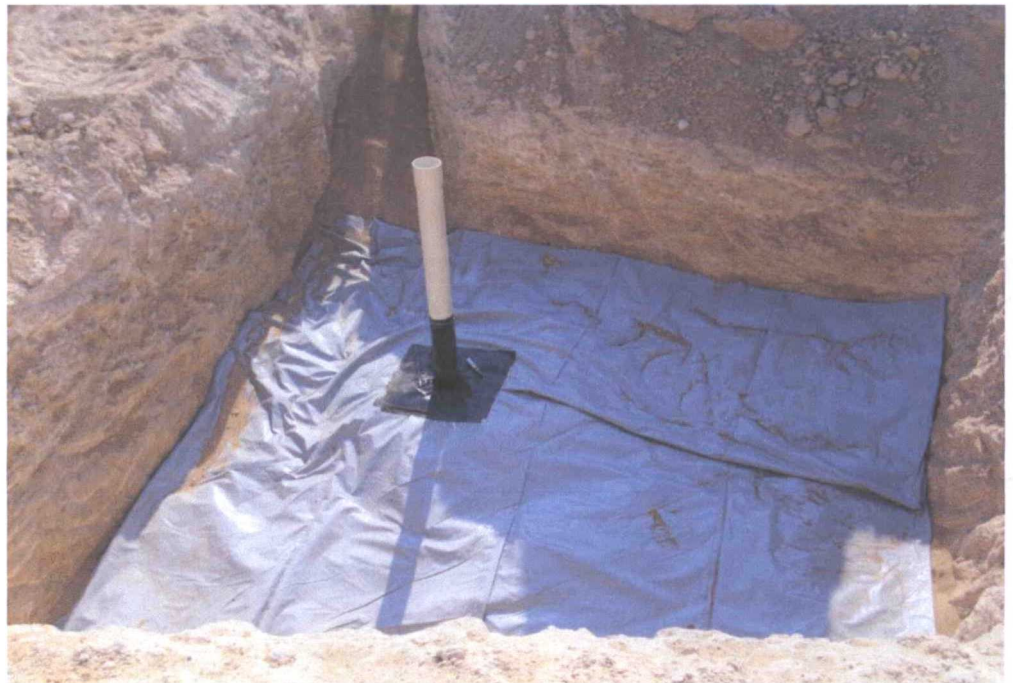
Direction:
View East

Description:
View of installation of
liner and boot around
PVC riser.

On June 14, 2011, a twenty (20) mil polyurethane liner was installed in the deeper portion of the excavation at approximately twenty (20) feet bgs (Figure 2). The eight (8) inch PVC riser, located within the excavation, was fitted with a forty (40) mil boot, which was chemically welded to the twenty (20) mil liner to protect the impermeability of the liner. The liner was cushioned by a six (6) inch layer of sand above and below the liner to protect the liner from damage during excavation backfilling activities. The excavation was backfilled with locally obtained non-impacted soil and water compacted. On completion of backfilling activities the impacted area was contoured to fit the surrounding topography. The site will be reseeded by the landowner.

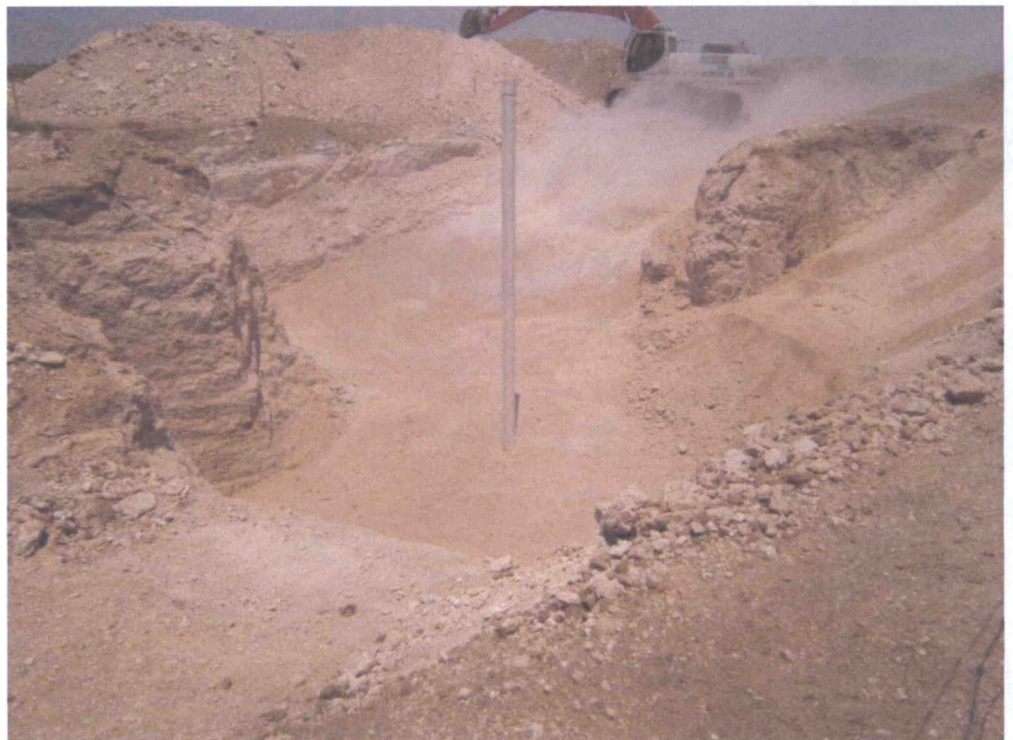
Photograph No. 8

Direction:
View Northeast

Description:
View of backfilling
activities.

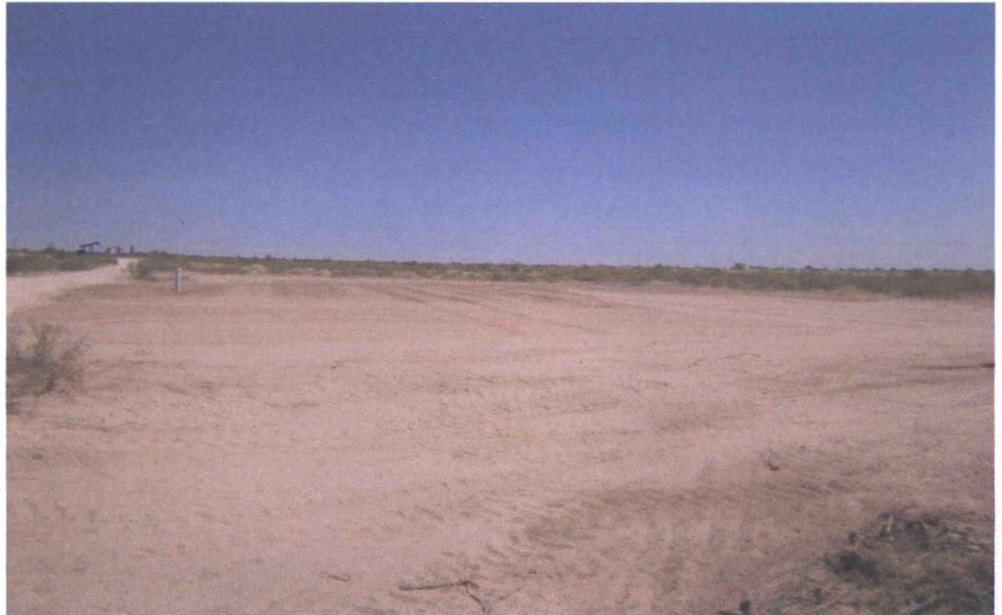
Direction:
View Northeast

Description:
View of site upon
completion of remediation
activities.

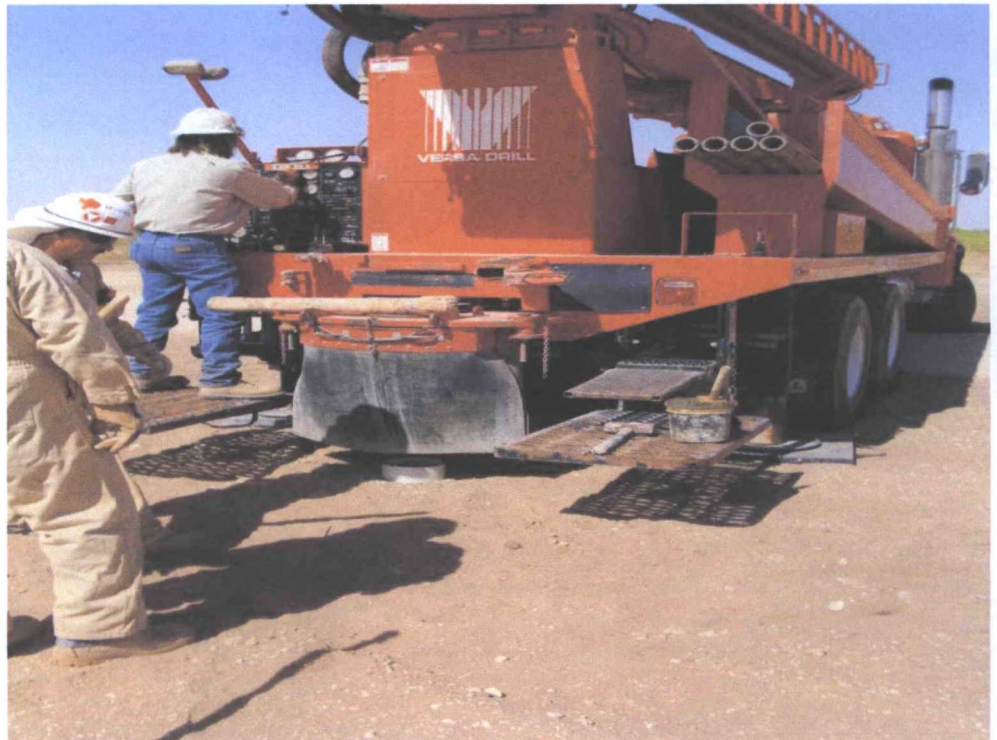
Photograph No. 10

Direction:
View West

Description:
View of advancement of
soil boring SB-1.
