East Hobbs San Andres Unit Main Battery

Closure Report

Release Date: January 9th, 2013

**RE: Termination Request
Linn Energy Resources
East Hobbs San Andres Unit Main Battery
UL/I sec. 30 T-18-S R-39-E**

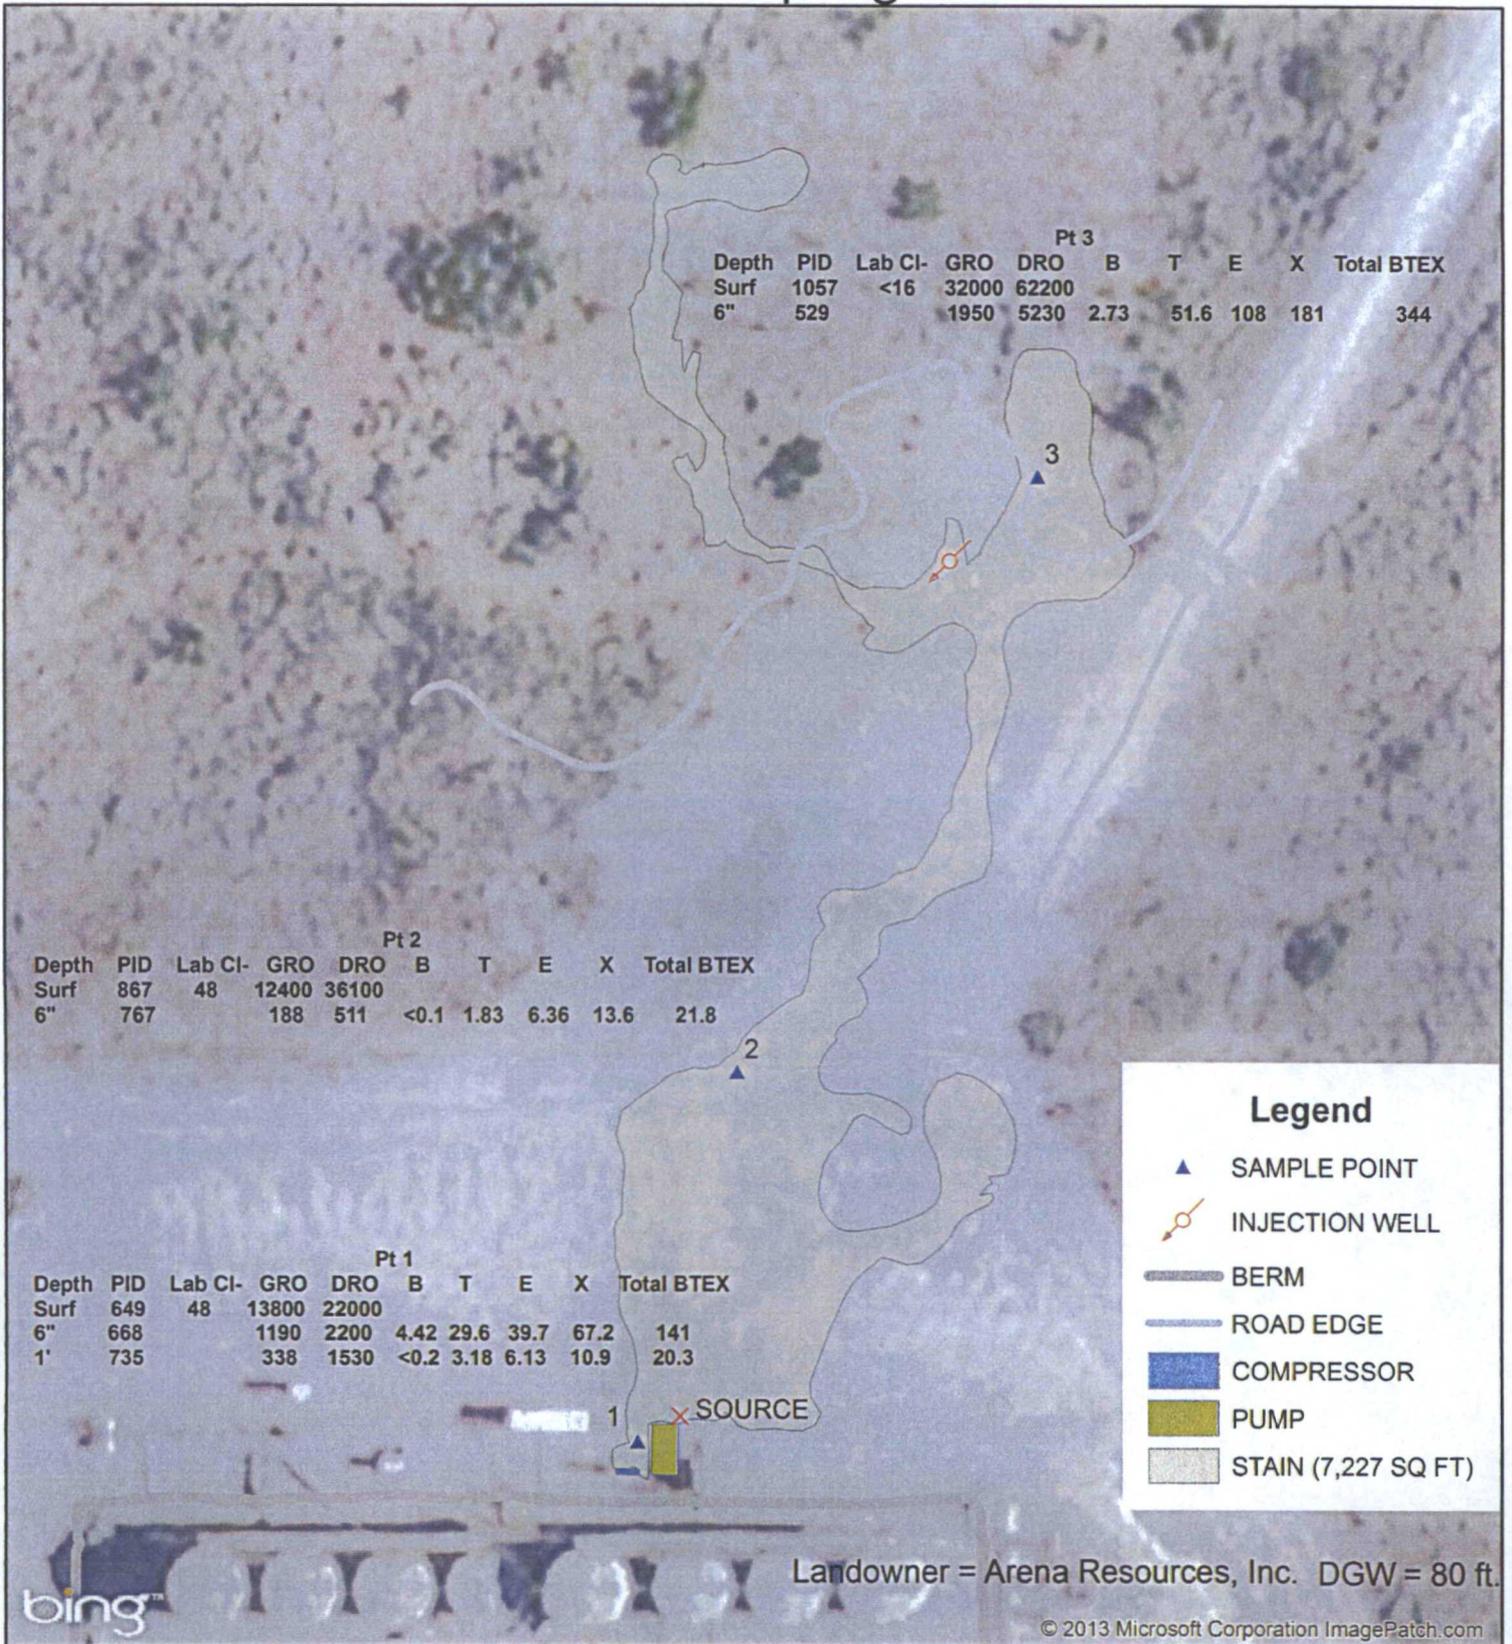
Figure 1

RECS personnel were on site to begin work at the East Hobbs San Andres Unit Main Battery on January 9th, 2013. Surface samples and samples at depth were taken throughout the site (Figure 1). The samples were taken to a commercial laboratory for analysis of chlorides, TPH and the samples at depth for BTEX (Appendix A). Throughout the site, the chloride values were low; however, TPH and BTEX levels were elevated but decreased with depth.

Initial Sampling Data

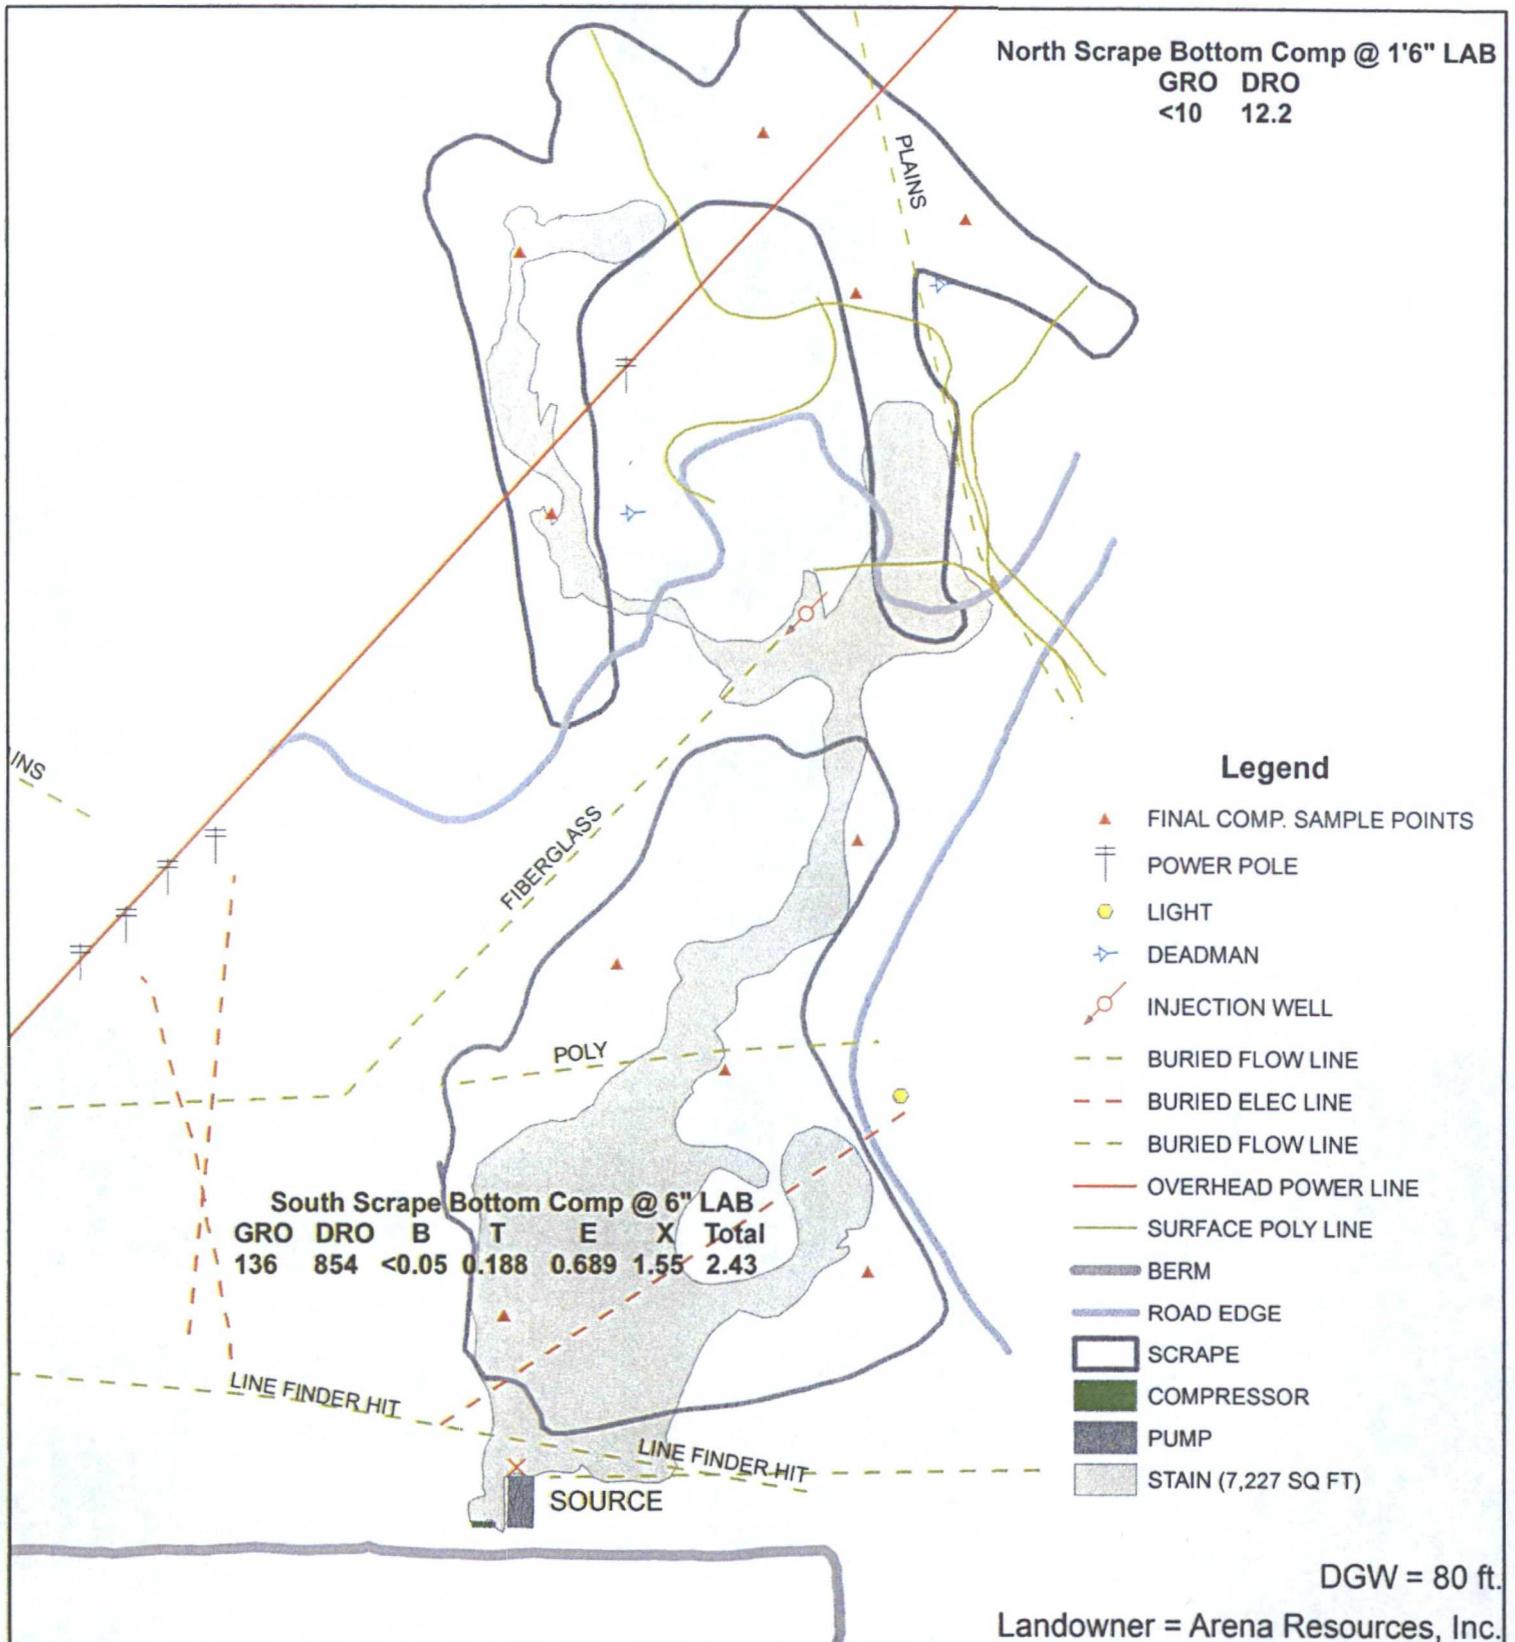
Figure 2

Based on the laboratory data, the area to the south, located on the pad, was scraped down 6 inches and the area to the north, located in the pasture, was excavated down 1.5 ft (Figure 2). The excavated soil was taken to a NMOCD approved facility for disposal. A bottom composite sample of both the scrape and the excavation were taken to a commercial laboratory for analysis of TPH and BTEX (Appendix B). The north excavation returned a TPH reading of 12.2 mg/kg. The south scrape returned a TPH reading of 990 mg/kg and a Total BTEX reading of 2.423 mg/kg.

Excavation Data

On May 2nd, 2013, NMOCD District 1 office verbally approved backfilling the pasture excavation. The north excavation was backfill with clean, imported top soil and the south scrape was backfilled with clean, imported caliche. Photo documentation of these activities can be found in Appendix C.

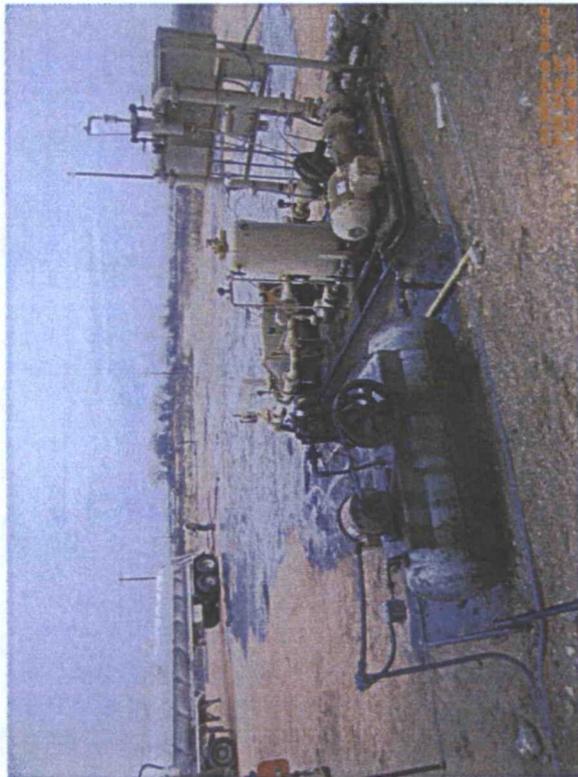
1/9/13

Initial release area, facing northeast

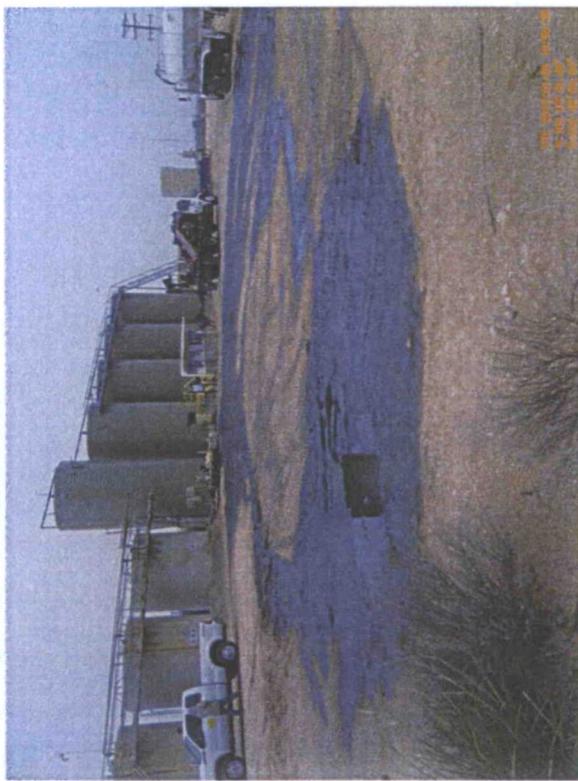
1/9/13

Initial release area, facing southwest

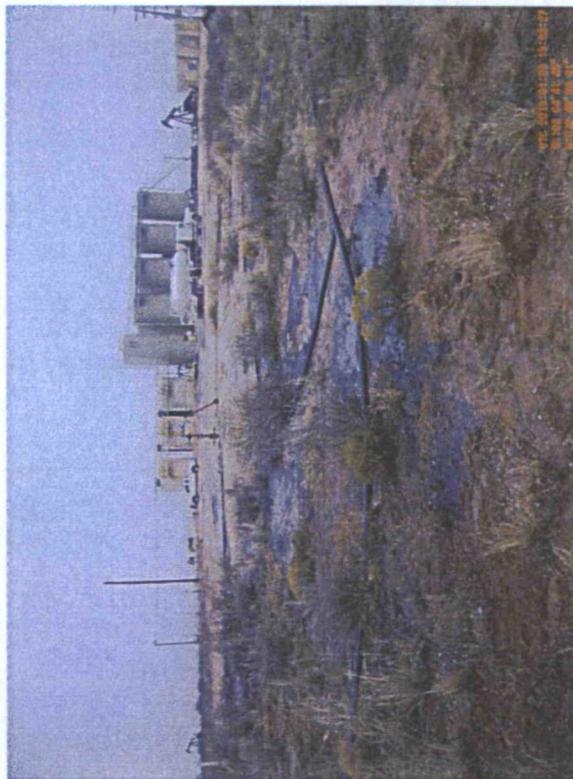
1/9/13

Initial release area, facing southwest

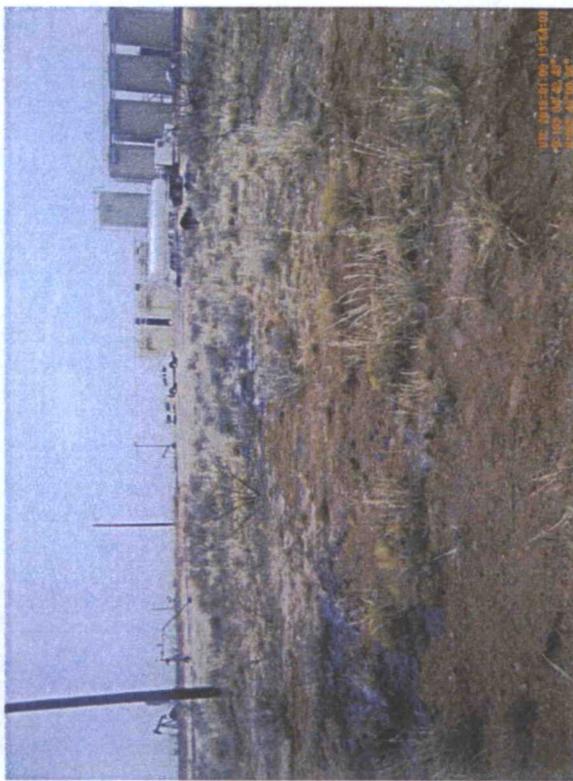
1/9/13

Initial release area, facing south

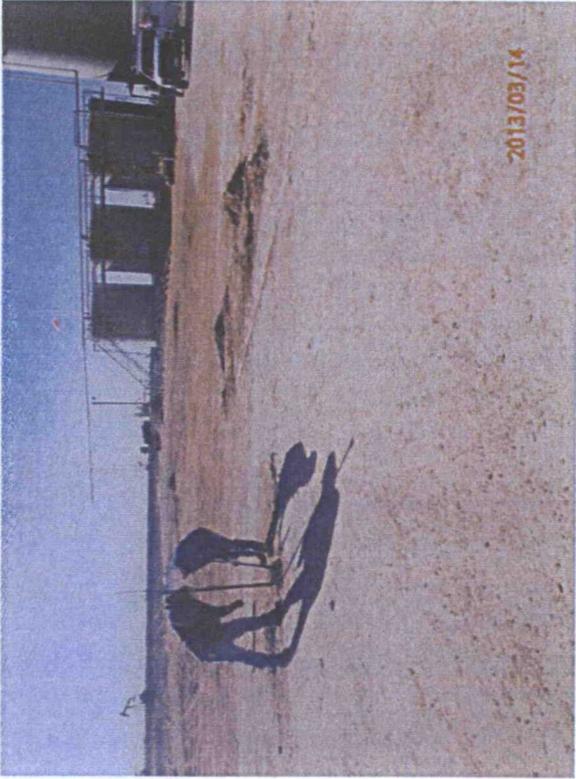
3/14/13

Spotting lines, facing southeast

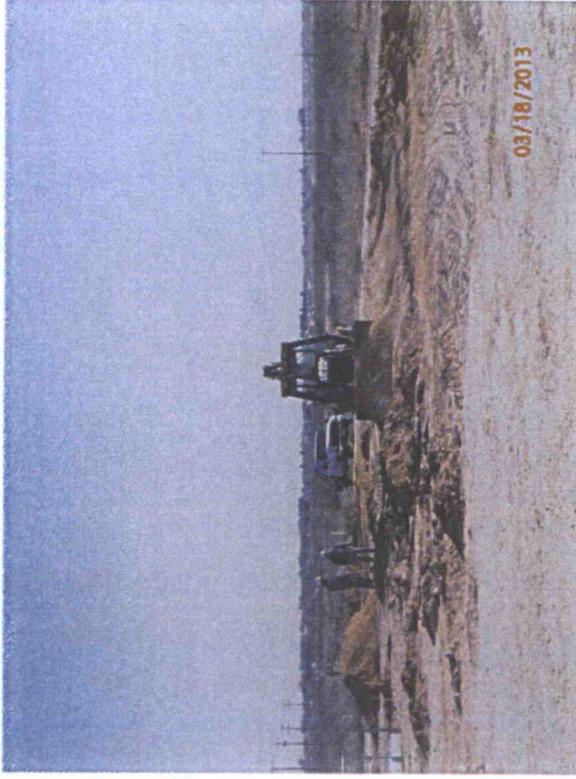
3/18/13

Scraping south area, facing northeast

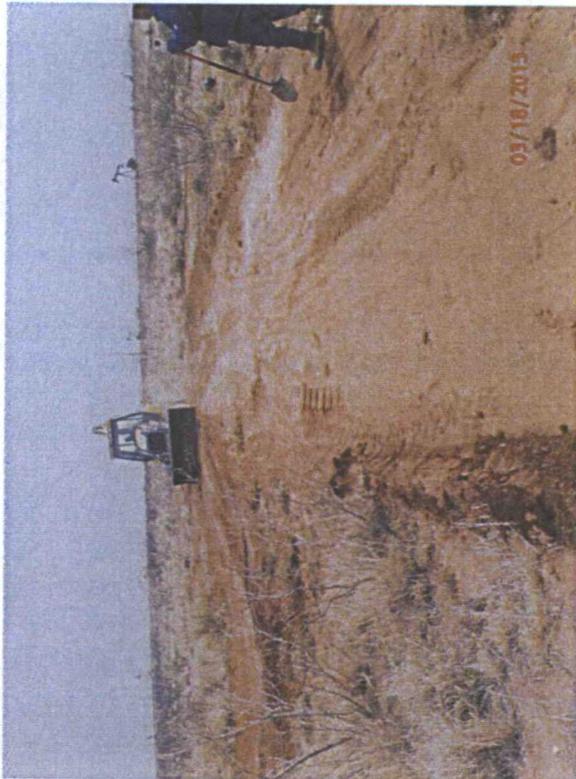
3/18/13

Scraping north area, facing east

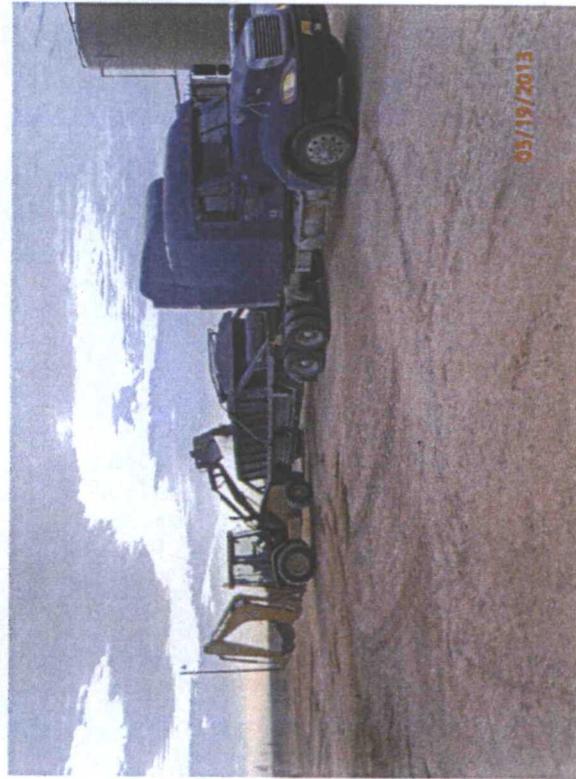
3/19/13

Exporting soil, facing northeast

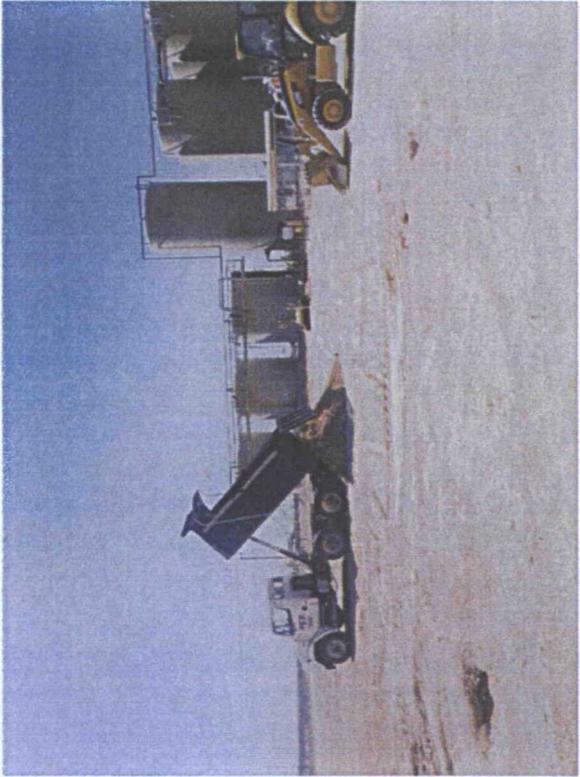
4/4/13

Importing soil, facing south

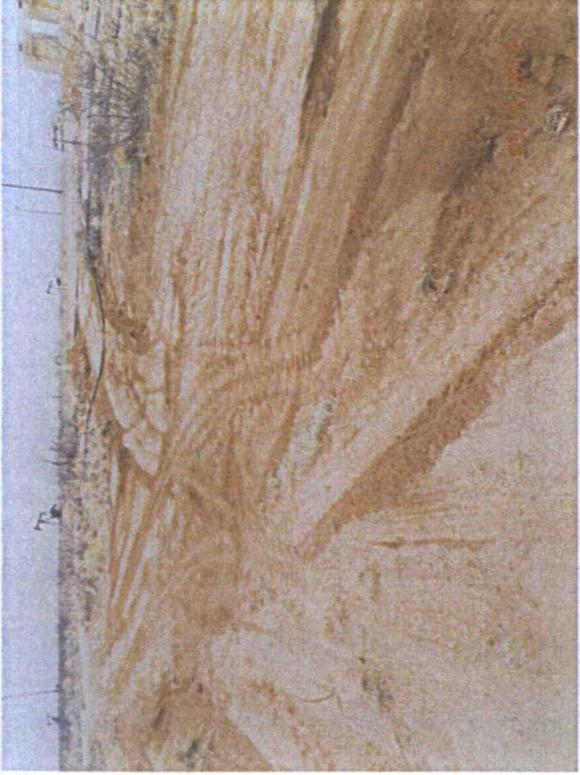
4/19/13

Scrape completed to 1', facing southeast

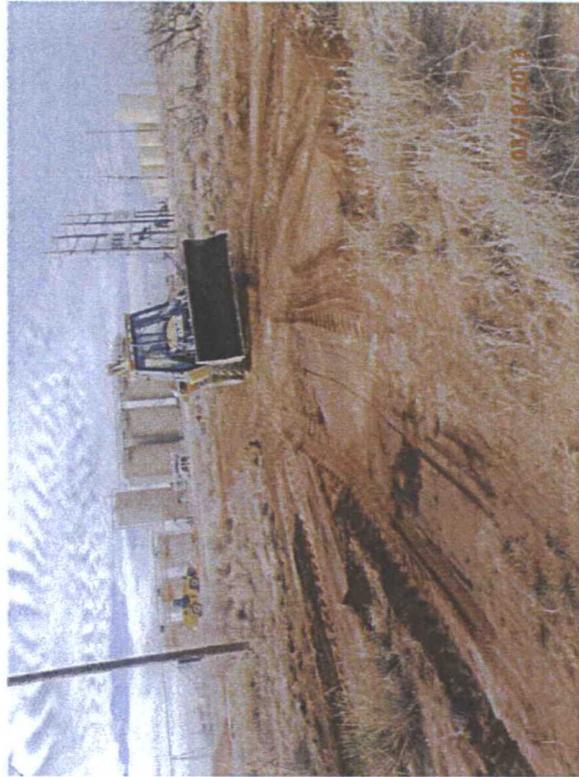
4/19/13

Scrape completed to 1', facing southeast

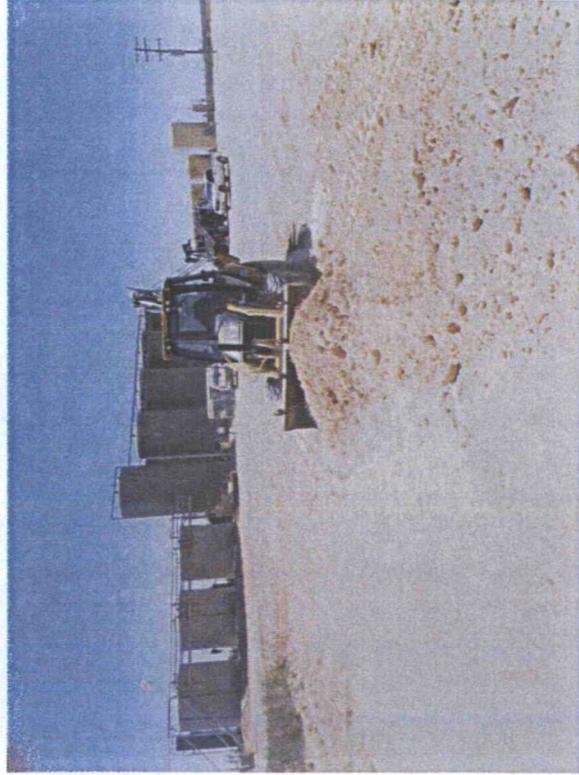
4/4/13

Backfilling pad, facing southwest

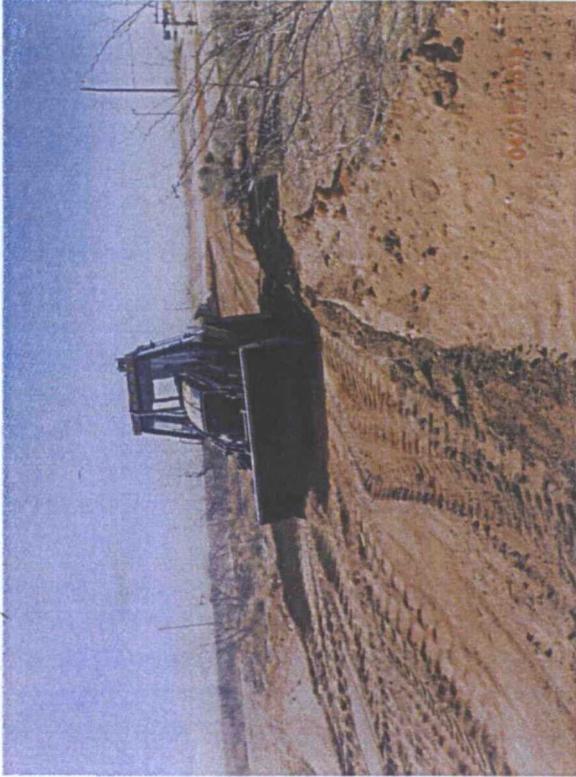
Excavating pasture 6 more inches, facing southeast
4/15/13

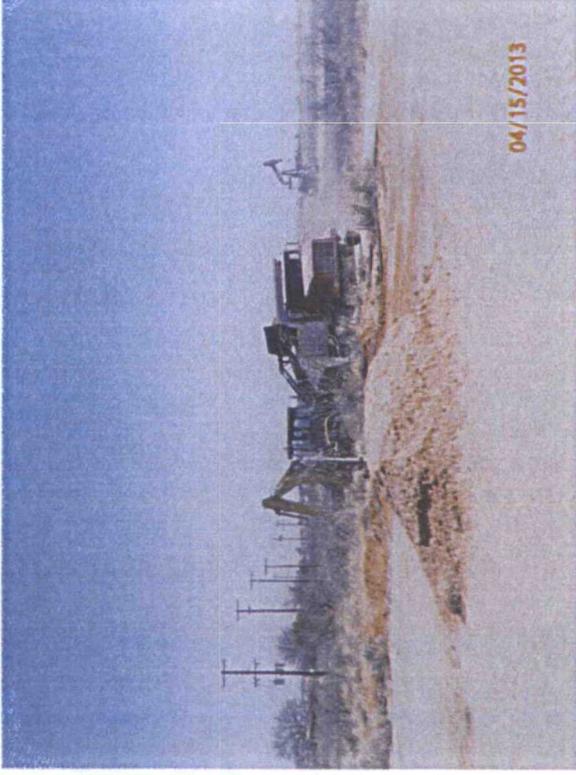
Exporting soil, facing northeast
4/15/13

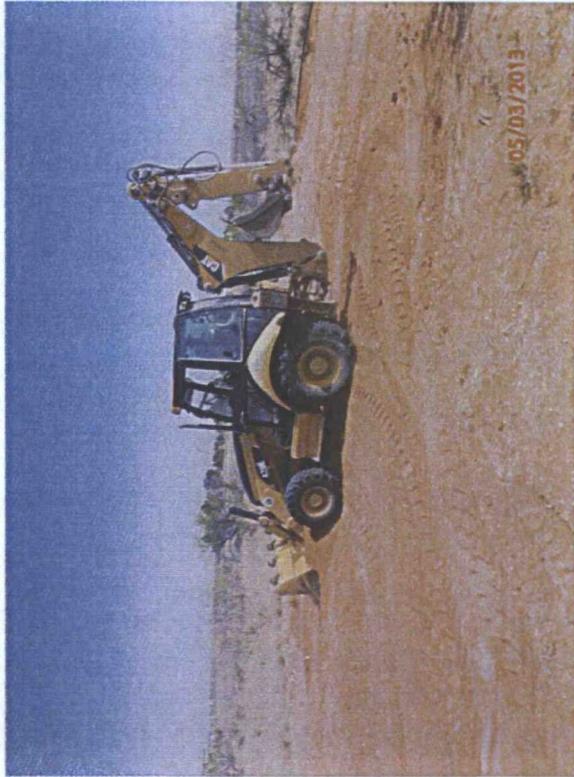
Backfilling site, facing west
5/3/13

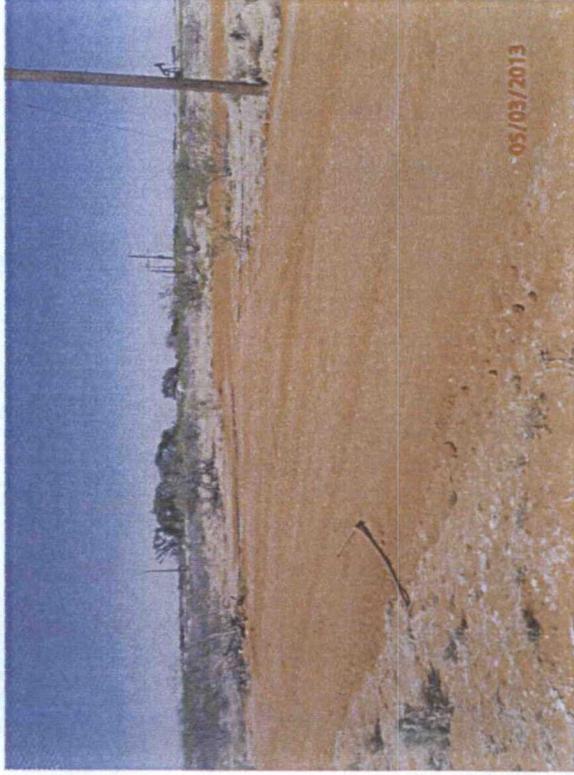
Site completed, facing southeast
5/3/13

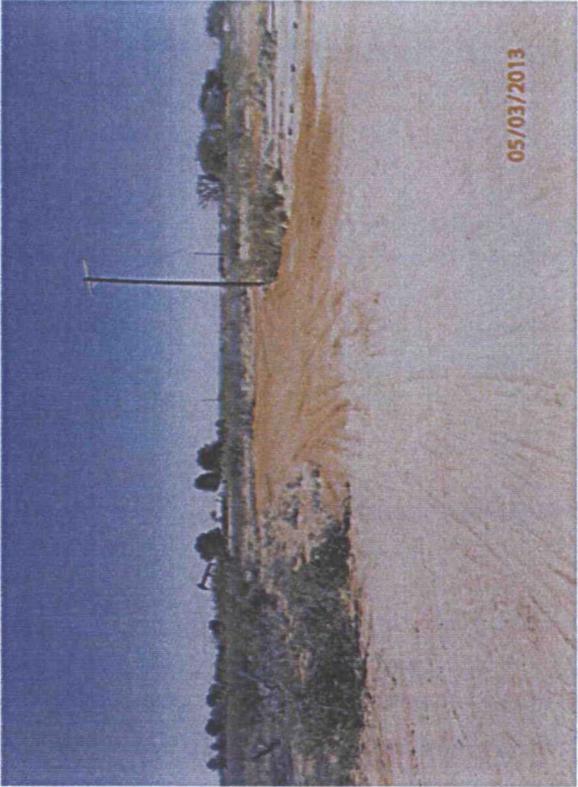
Excavation completed in north area, facing northwest
5/3/13

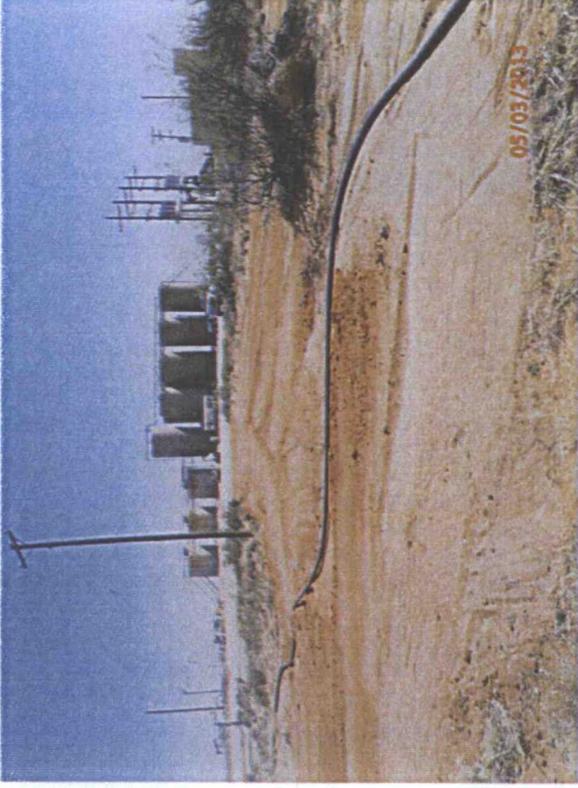
Site completed, facing southwest
5/3/13
