**Release Notification and Corrective Action**

## **M State Central Tank Battery** **Termination Request**

**RE: Termination Request**  
**Quantum Resources – M State Central Tank Battery**  
**UL/A sec. 30 T22S R37E**  
**API No. 30-025-38961**

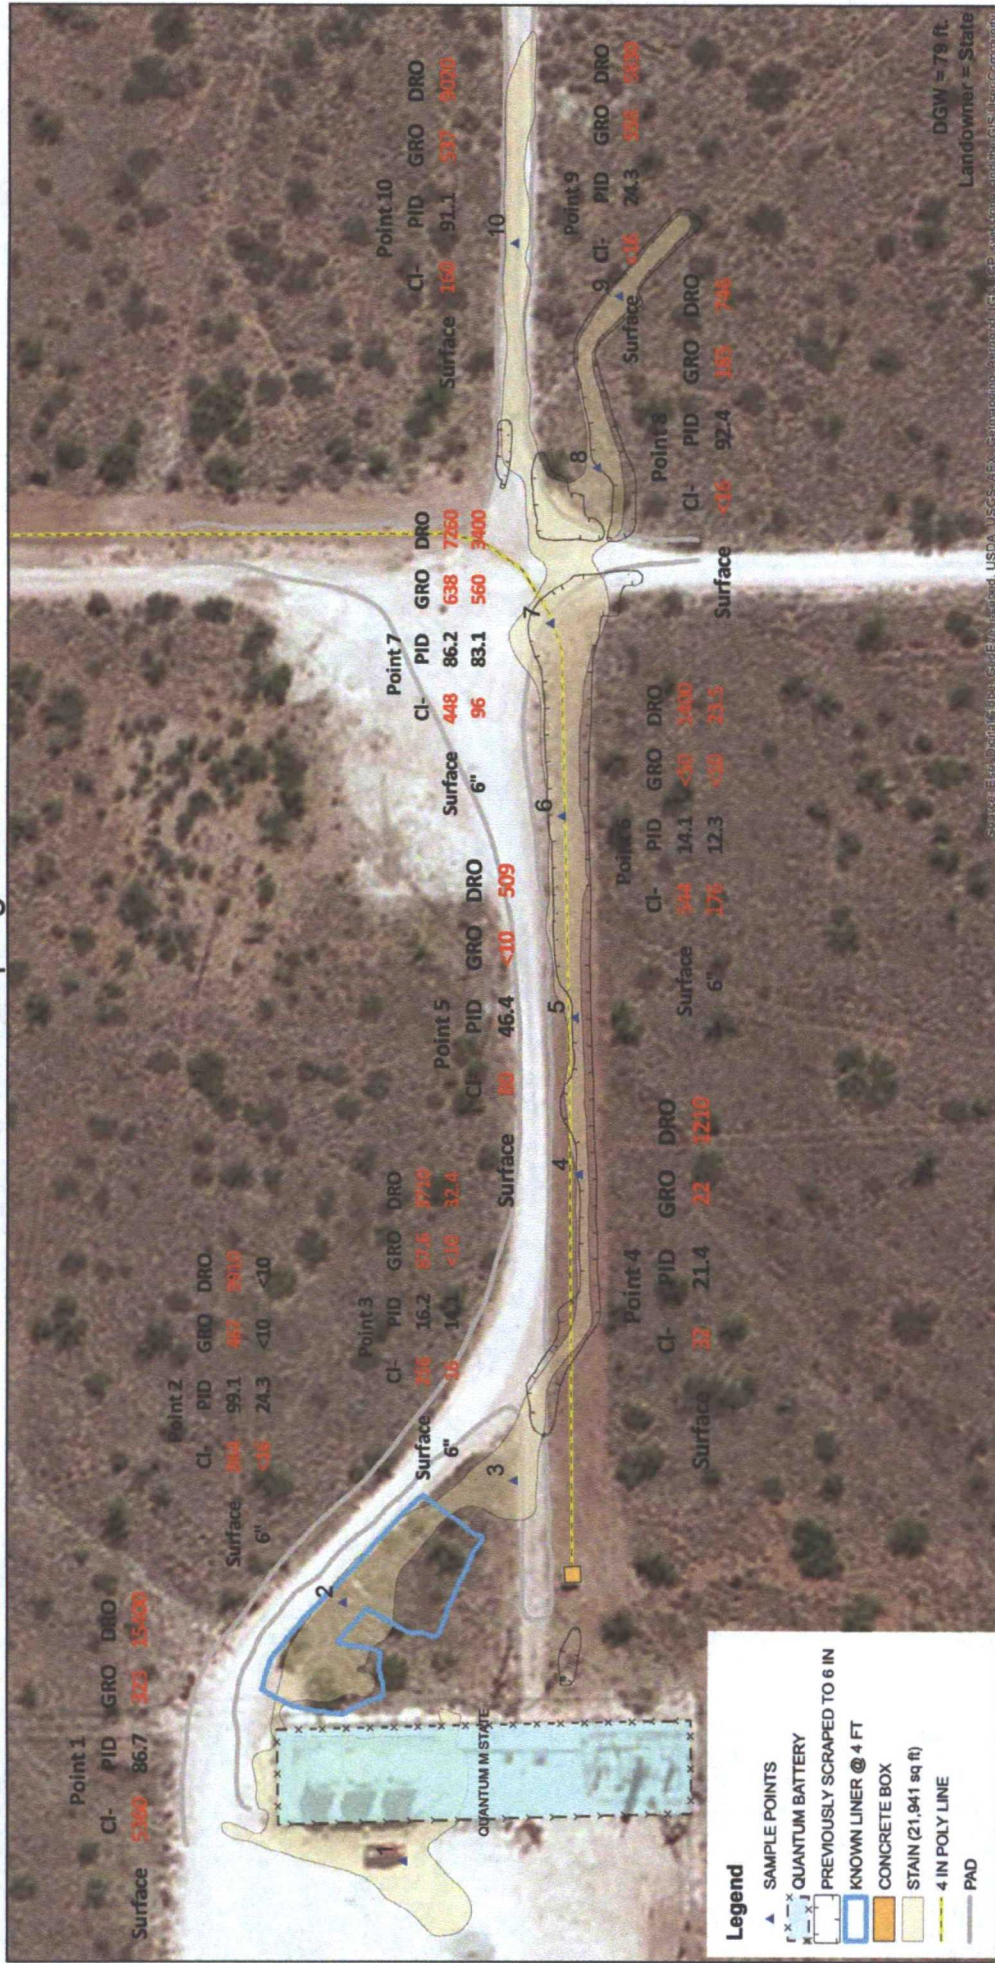
# Initial Sampling Data

Prior to RECS arriving at the site, parts of the release had been scraped down to a total of 8,161 square feet to remove the wet soil (Figure 1). RECS personnel arrived on site beginning on March 25<sup>th</sup>, 2014 to assess the release. Ten points within the release area were field sampled at the surface and four points were sampled with depth. The samples were field tested for chlorides and organic vapors and all samples were sent to a commercial laboratory for analysis (Appendix B).

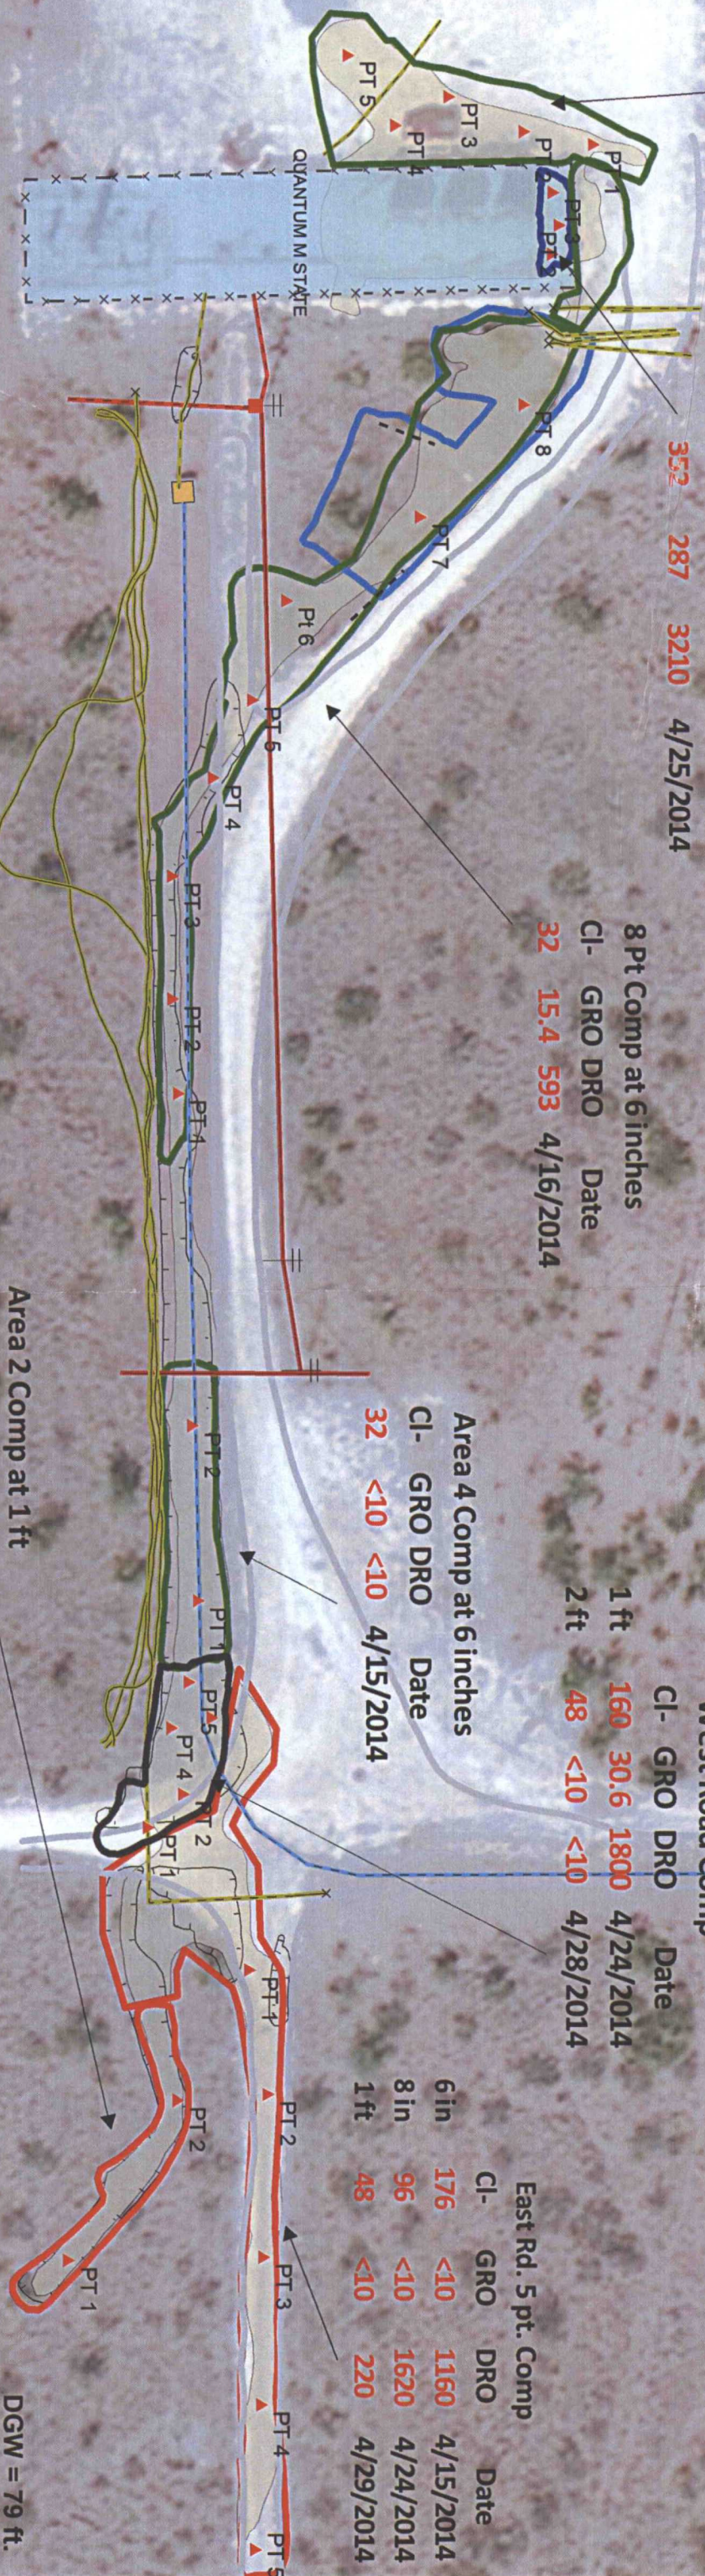
| 6" Scrape Comp | | | |

Battery 3 pt. Comp

| 8 Pt Comp at 6 inches | | | |

| Area 4 Comp at 6 inches | | | |

| West Road Comp | | | |

| East Rd. 5 pt. Comp | | | |

| Spoil Pile Comp. | | | |

| Area 2 Comp at 1 ft | | | |

approved for backfill w/ 1' of clay liner @ TB
