RELEASED
Release Notification and Corrective Action

Name of Company: Linn Operating	Contact: Gary Wink
Address: 2130 W. Bender Hobbs, NM 88240	Telephone No.: 575738-1739
Facility Name: CMU 266	Facility Type: oil

Release Notification and Corrective Action

The area was excavated and tested for Chlorides, TPH 8015m, and BTEX the excavation is an area of 75'x50'x4'. All the contaminated soil was hauled off and the excavation was backfilled using clean material. An Exploratory well was drilled for further delineation of the soil below ground surface.

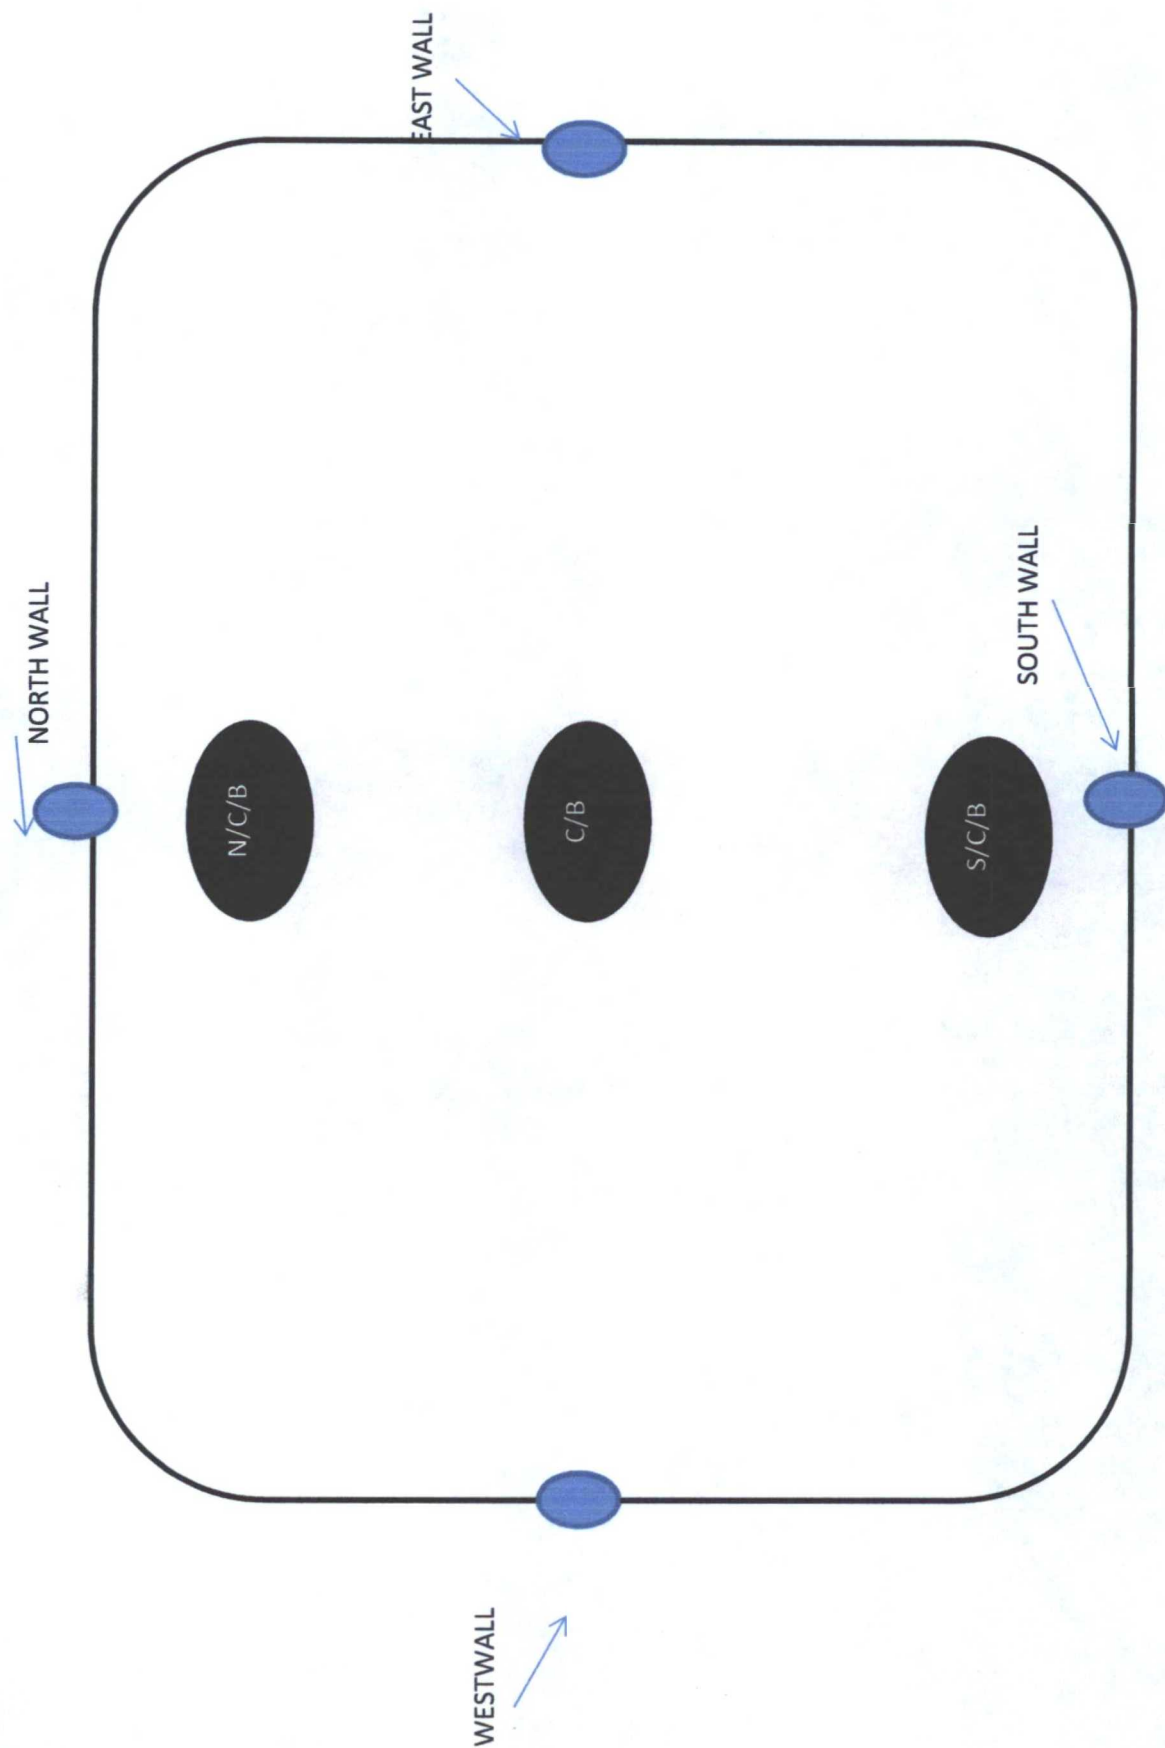
SOUTH EXCAVATION 350'X4'X2'

NORTH EXCAVATION@4'
