**SITE REMEDIATION AND
CLOSURE REPORT**

**ENDEAVOR ENERGY RESOURCES, LP
PETERSON "C" LEASE, WELL #1, API: 30-041-20362
ROOSEVELT COUNTY, NEW MEXICO**

Prepared By:
**SOUTH ENVIRONMENTAL SERVICES, INC.
2400 S. LOOP 250 WEST
MIDLAND, TEXAS 79703**

NOVEMBER 2009

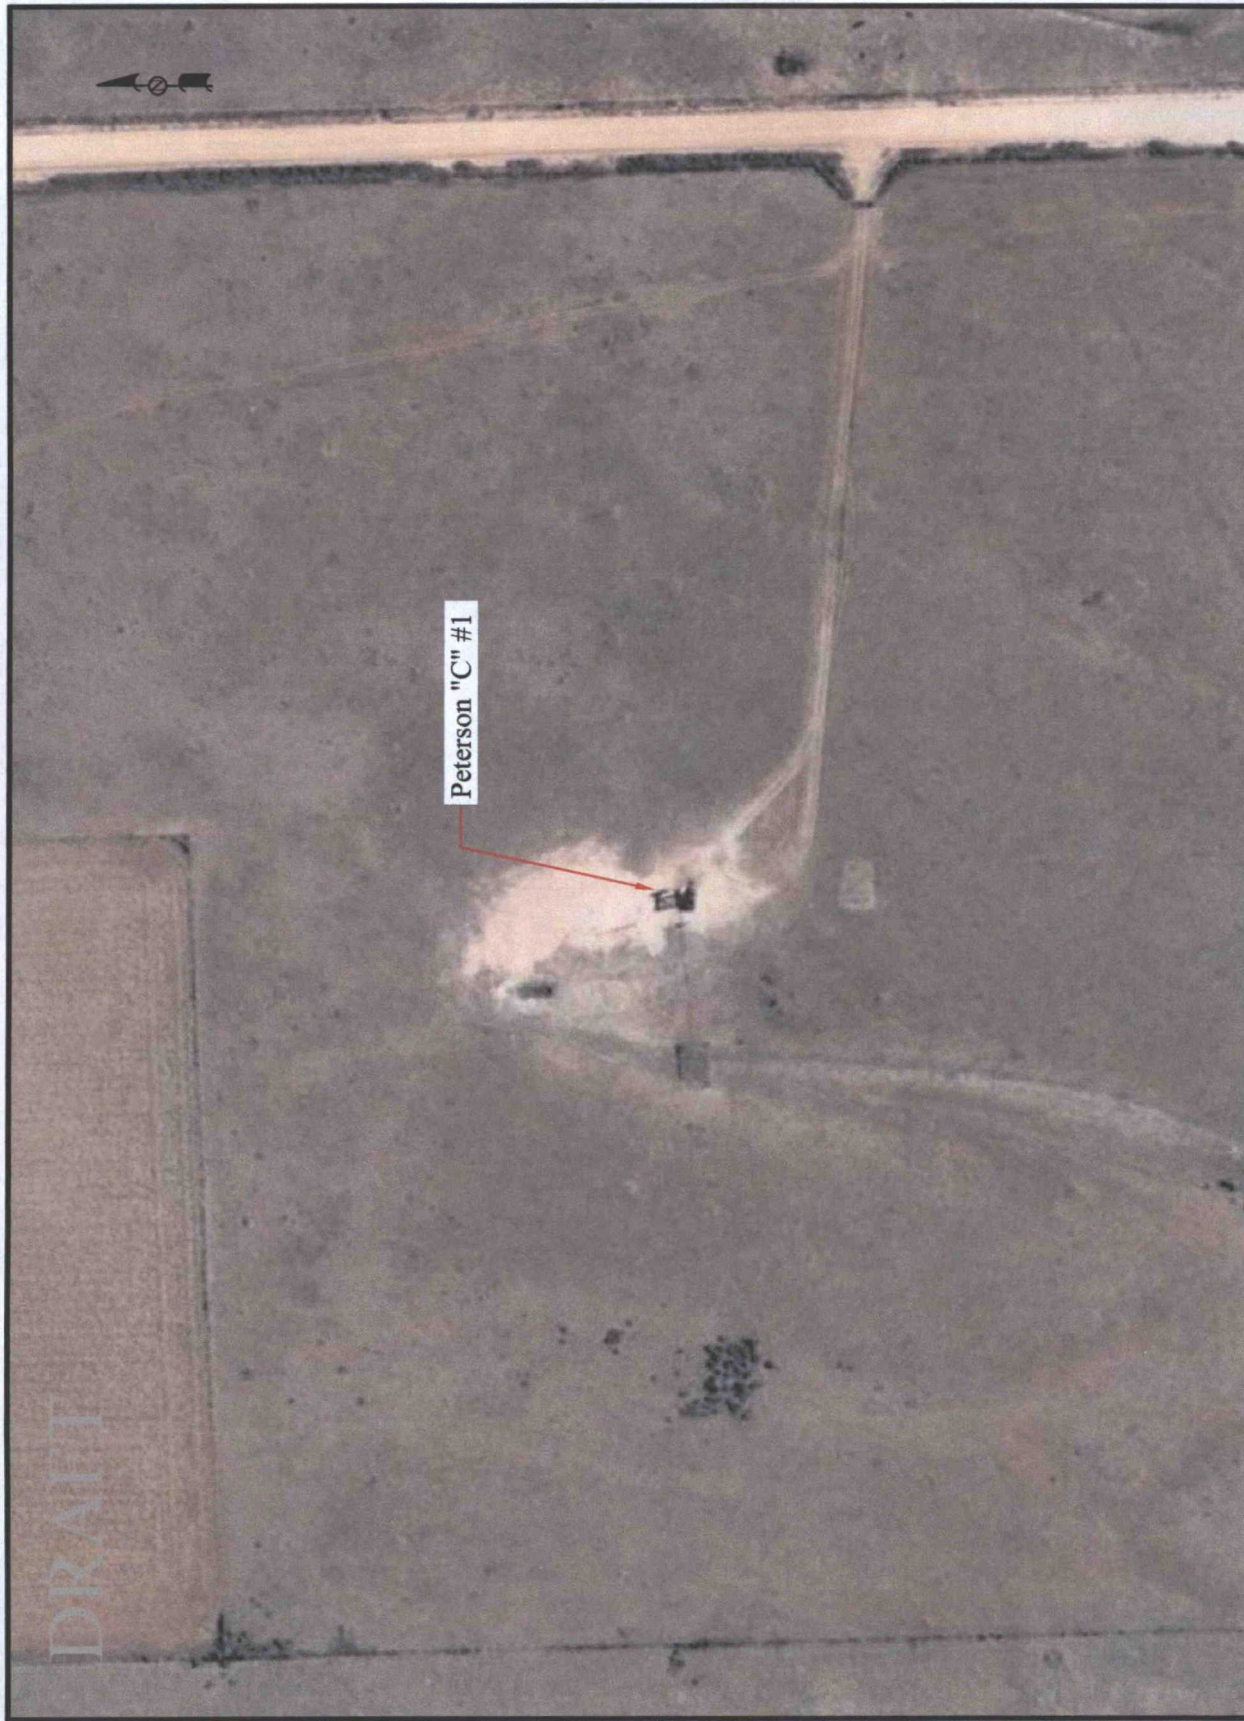
Figure 1 Aerial Photo	
		South Environmental Services, Inc.	
Peterson "C" #1		Endeavor Energy	
Drawn By: JDJ October 4, 2009		Rev: A-2 Scale: 1" = 160'

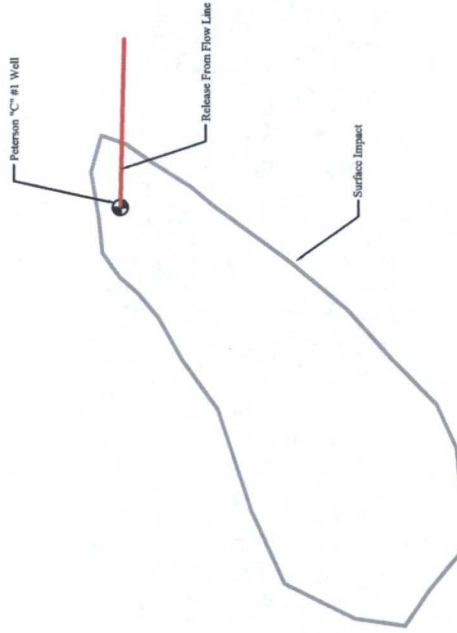
Figure 3 Site Map
Peterson 'C' #1		Endeavor Energy
Drawn By: JDJ October 4, 2009		Rev: A-2 Scale: 1" = 20'
		South Environmental Services, Inc.

Following excavation of impacted soil, confirmation soil samples were collected from the base of the excavation, based on a minimum of one (1) discrete sample for each 500 square feet of surface area. Following conformation sampling event(s), any area still exhibiting TPH concentrations >1,000 mg/kg, Chloride concentrations >500 mg/kg, or Benzene concentrations >50.0 mg/kg were over-excavated and re-sampled to confirm attainment of remedial goals. All samples were submitted for laboratory analysis for TPH, BTEX, and Chlorides as referenced above. Site photographs are included as Attachment 3.
