TORO OPERATING

Release Notification and Corrective Action

1.0 Introduction

This report addresses the site remediation at Toro Operating Hobbs Battery. Analytical results, C 141's, an overhead map, and a general scope of work performed are included in this document. The project manager for Hungry Horse, LLC was Oscar Frayre.

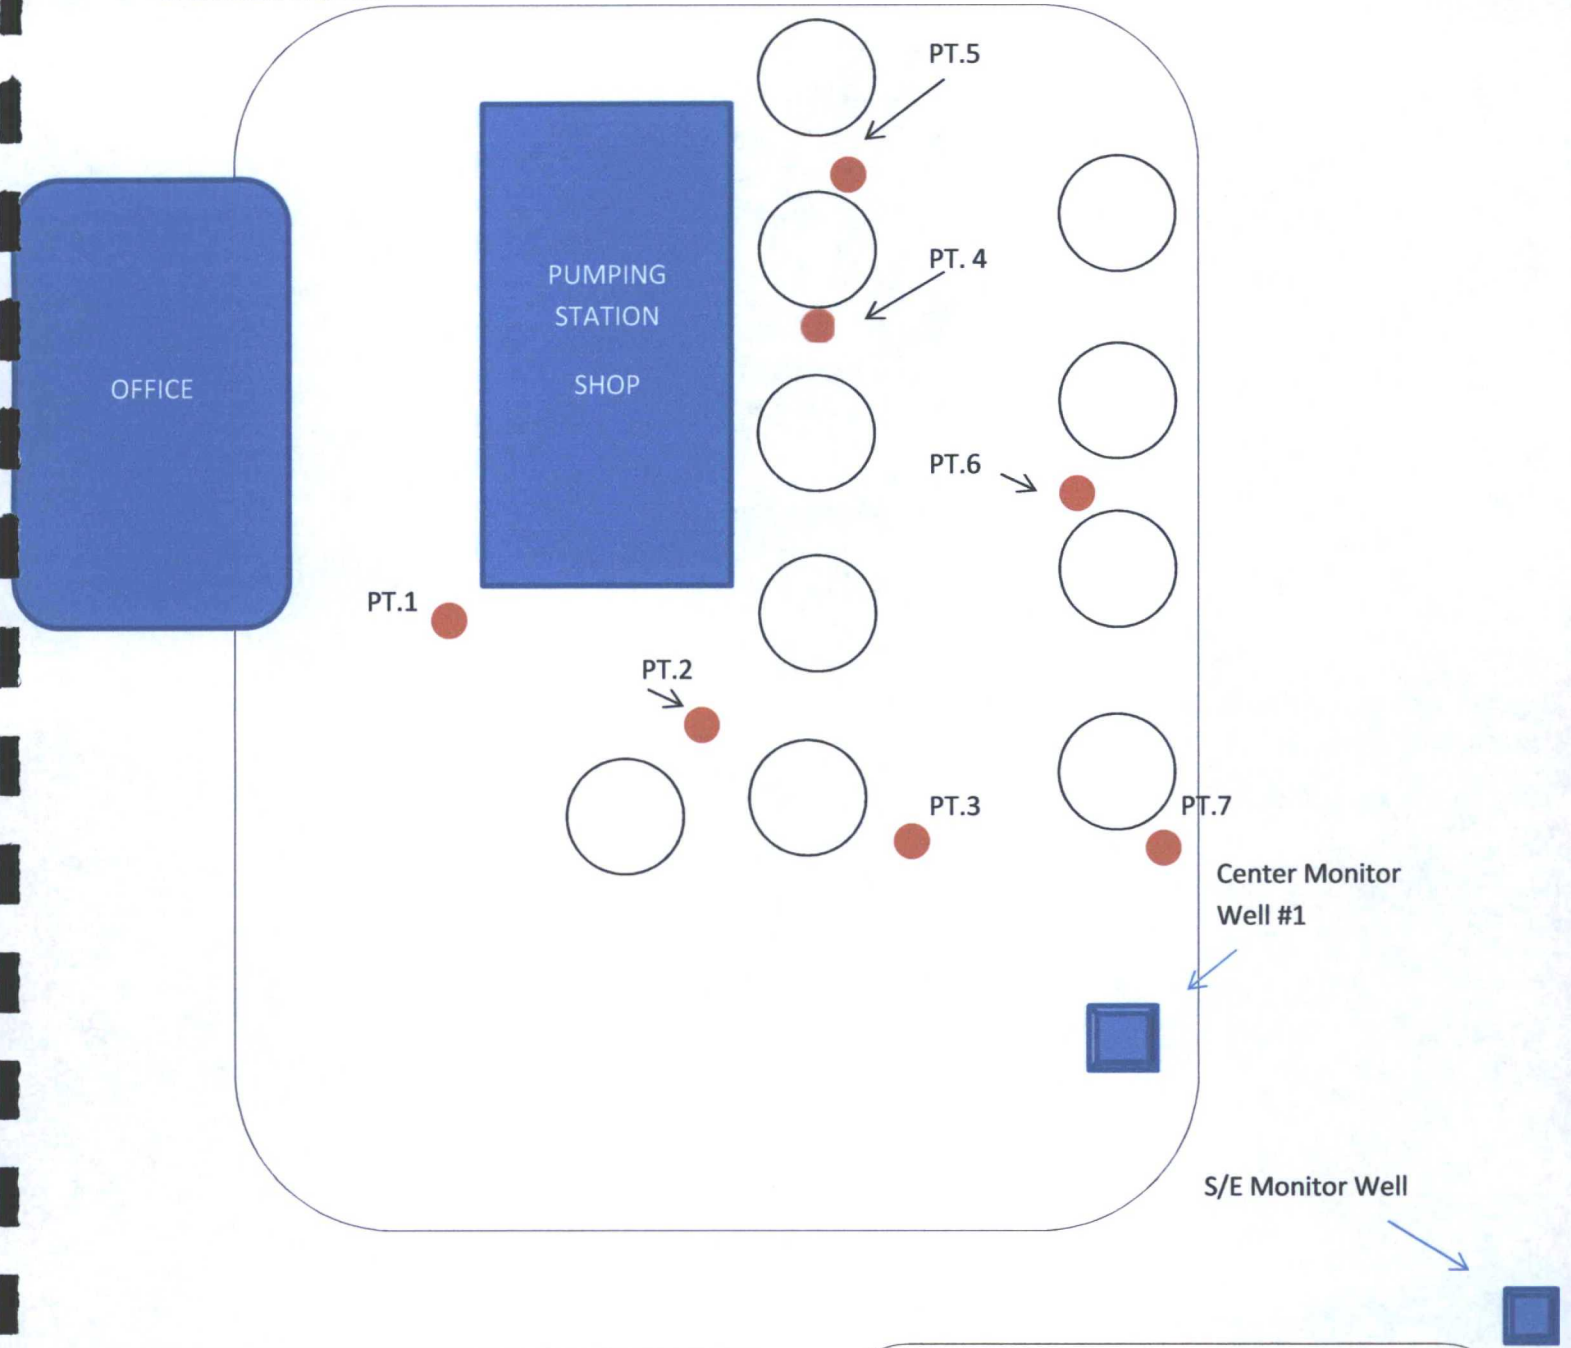
HOBBS BATTERY

THE MAIN BATTERY

S/W BATTERY

S/E BATTERY

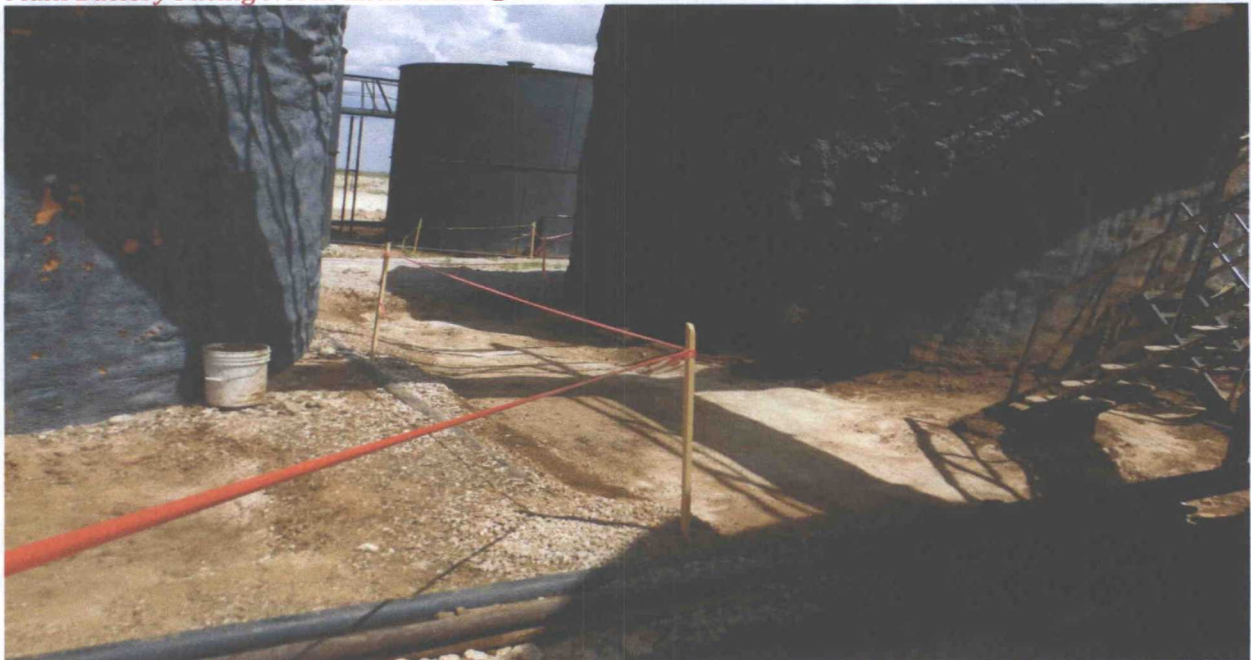
Main Battery Facing North Excavation @2'

Based upon the initial delineation results, the main battery in and around the tanks, was excavated by hand down to approximately 3' (BGS). At Approximately 3' (BGS) hard rock was encountered and further excavation using hand tool was not possible nor was it safe to continue digging due to the tanks. Soil samples were obtained and analyzed for CL, TPH and BTEX. Results were presented to NM OCD along with the explanation that further excavation was not possible. OCD recommendation was to conduct a soil boring inside the battery to determine the extent of the downward migration of contaminants.

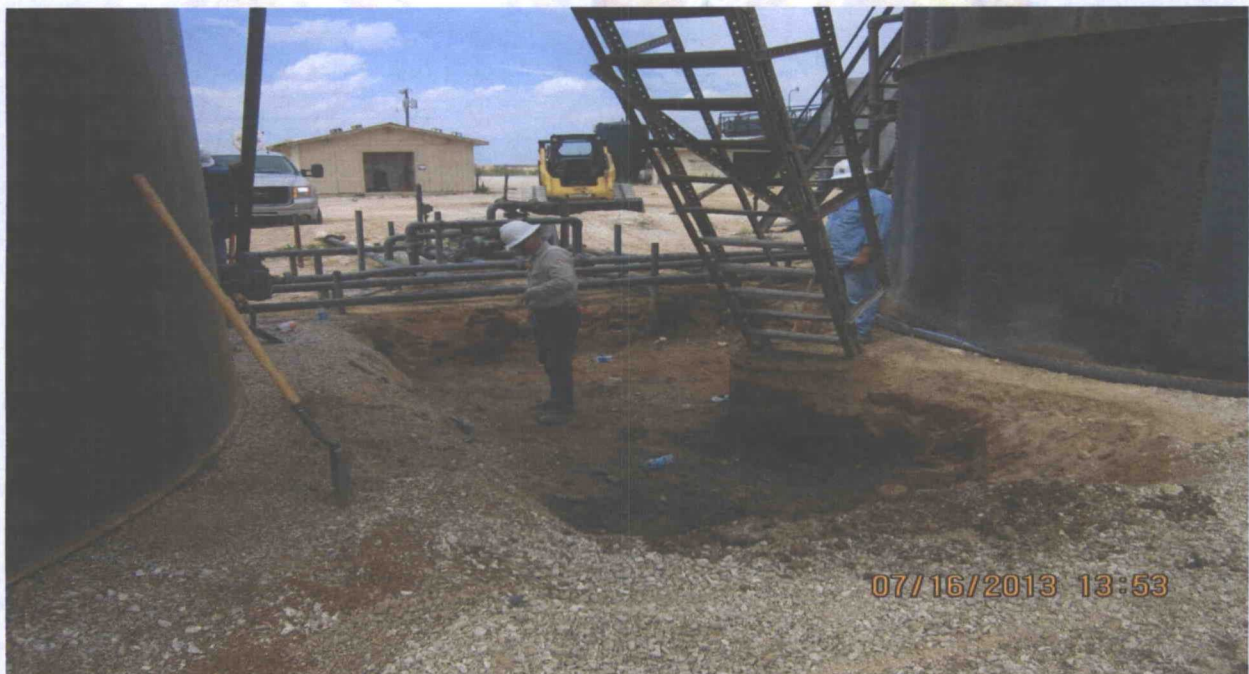
Main Battery Facing North Excavation @2'

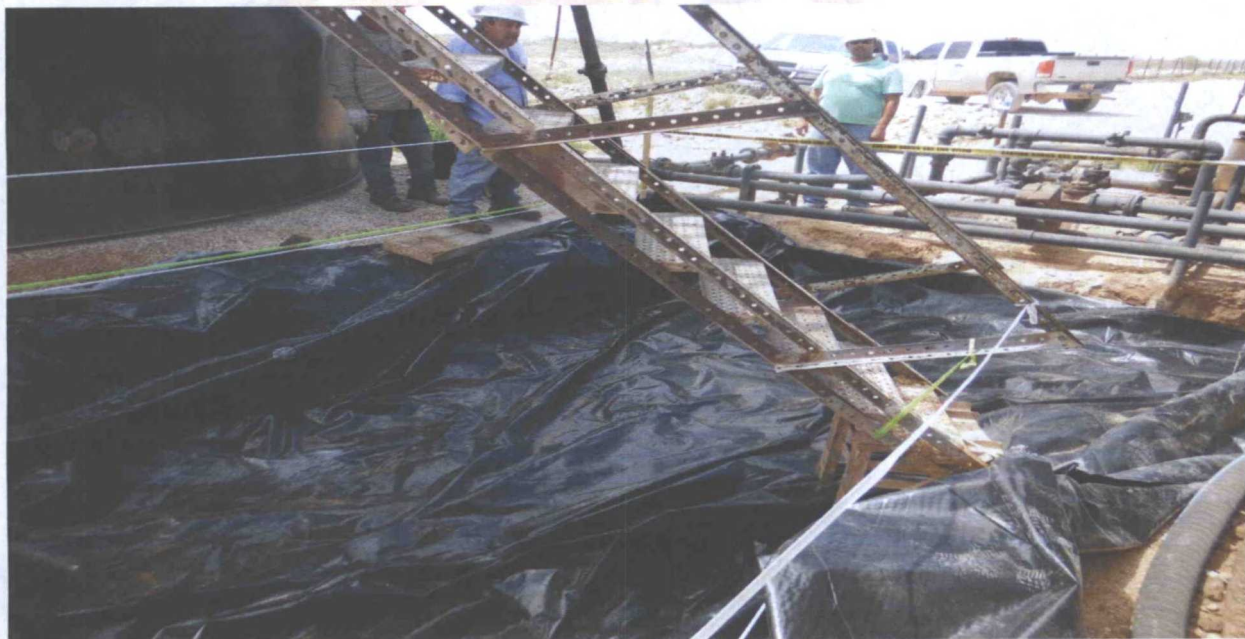
S/W Battery Plastic Liner at @3'BGS

Delineation results from the two tanks and from around the frac tank indicated elevated levels of (CL) and (TPH). This area was excavated by hand to approximately 3' (BGS) at which time it became unsafe to continue excavating due to the tanks tipping over. Solid rock was encountered and soil samples were obtained and analyzed, lab results were presented to NM OCD for guidance. It was recommended that we conducted a soil boring to determine the downward migration of contaminants. The soil boring was conducted obtaining samples and field test for (CL) at 5' increments. Lab analysis determine that chloride levels are under the NM OCD closure limits from 5'-131' (BGS). No ground water was encountered through the duration of the soil boring investigation. Selected samples were analyzed for (CL), (TPH 015M,) and (BTEX). These results along with field test results were presented to NM OCD for closure approval. Approval was given to install a 20 mil synthetic liner and backfill the affected area.
