Release Notification and Corrective Action

REMEDIATION SUMMARY & RISK-BASED SITE CLOSURE REQUEST

**FASKEN OIL & RANCH, LTD.
DENTON SWD HISTORICAL SITE #3
Lea County, New Mexico
Unit Letter "J" (NWSE), Section 11, Township 15 South, Range 37 East
Latitude 33.0298° North, Longitude 103.1688° West**

April 2012

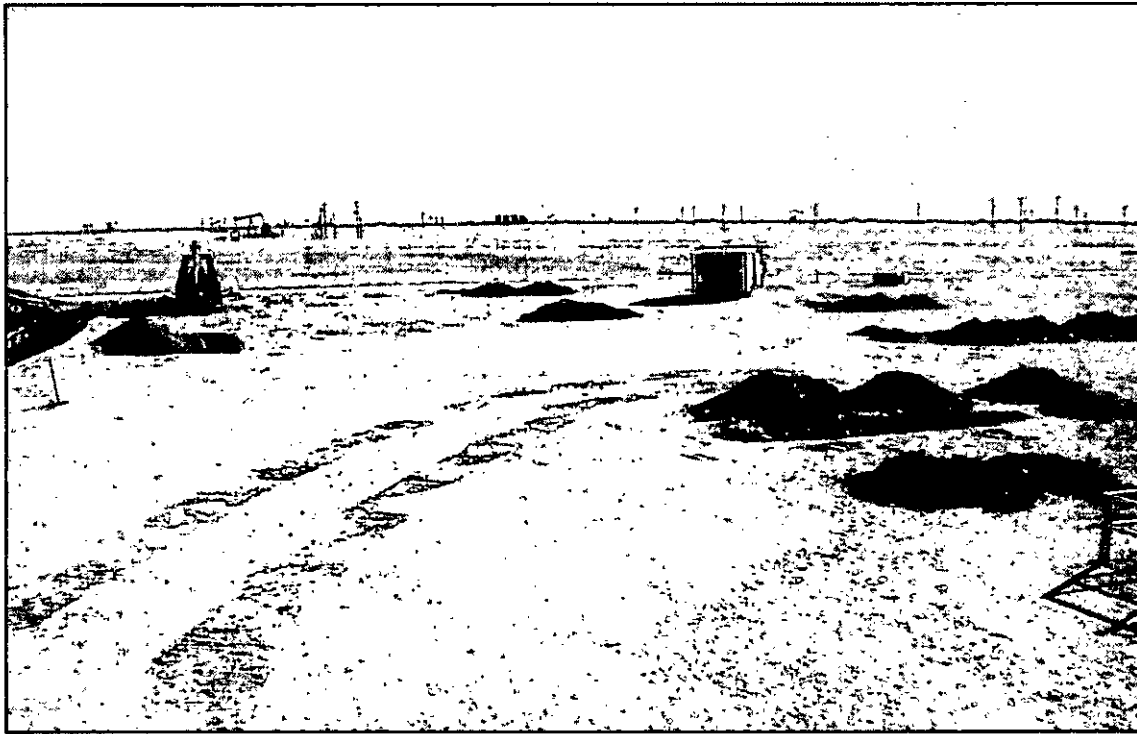
Denton SWD Historical Site #3 - Release Site (Delineation)

In July 2009, Fasken discovered a historical release along the Denton Salt Water Disposal (SWD) flowline. The release was attributed to failure of a section of an old steel flowline, which had been replaced with a fiberglass line several years prior to the discovery of the release. Failure of the steel flowline resulted in the release of an unknown volume of produced water. The historical release was reported to the New Mexico Oil Conservation Division (NMOCD) Hobbs District Office on July 31, 2009. General photographs of the release site are provided as Appendix A.

In July 2009, a previous consultant advanced two (2) soil borings at the release site to delineate the vertical extent of impacted soil.

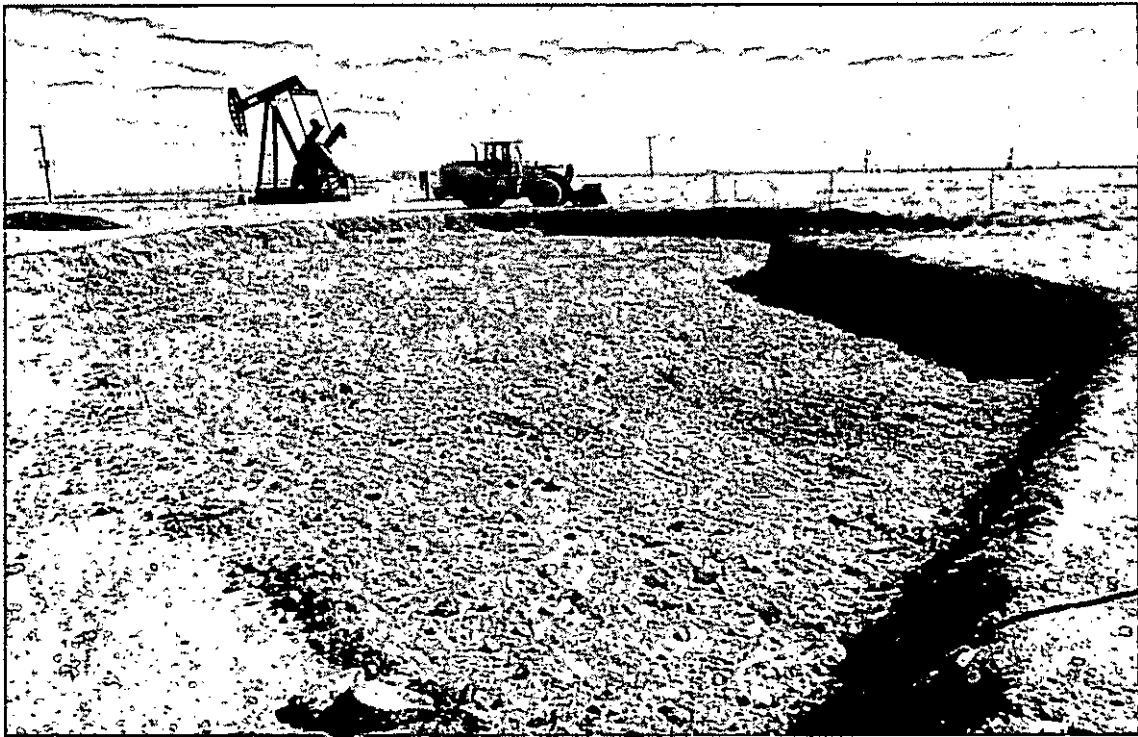
Denton SWD Historical Site #3 - Excavation, Section B (looking Northwest)

On March 9, 2012, one (1) soil sample (Section B - West Wall #1) was collected from the sidewall of Section B and submitted to the laboratory for analysis of chloride concentrations. The chloride concentration was 96.0 mg/Kg. Review of laboratory analytical results indicated the chloride concentration in soil sample Section B - West Wall #1 was less than the RRAL established for the site.
