## Release Notification and Corrective Action

**Range Operating New Mexico, Inc.  
Greenwood Battery  
Section 9, Township 22S, Range 37E  
Lea County, New Mexico**

**Closure Report**

**July 27, 2009**

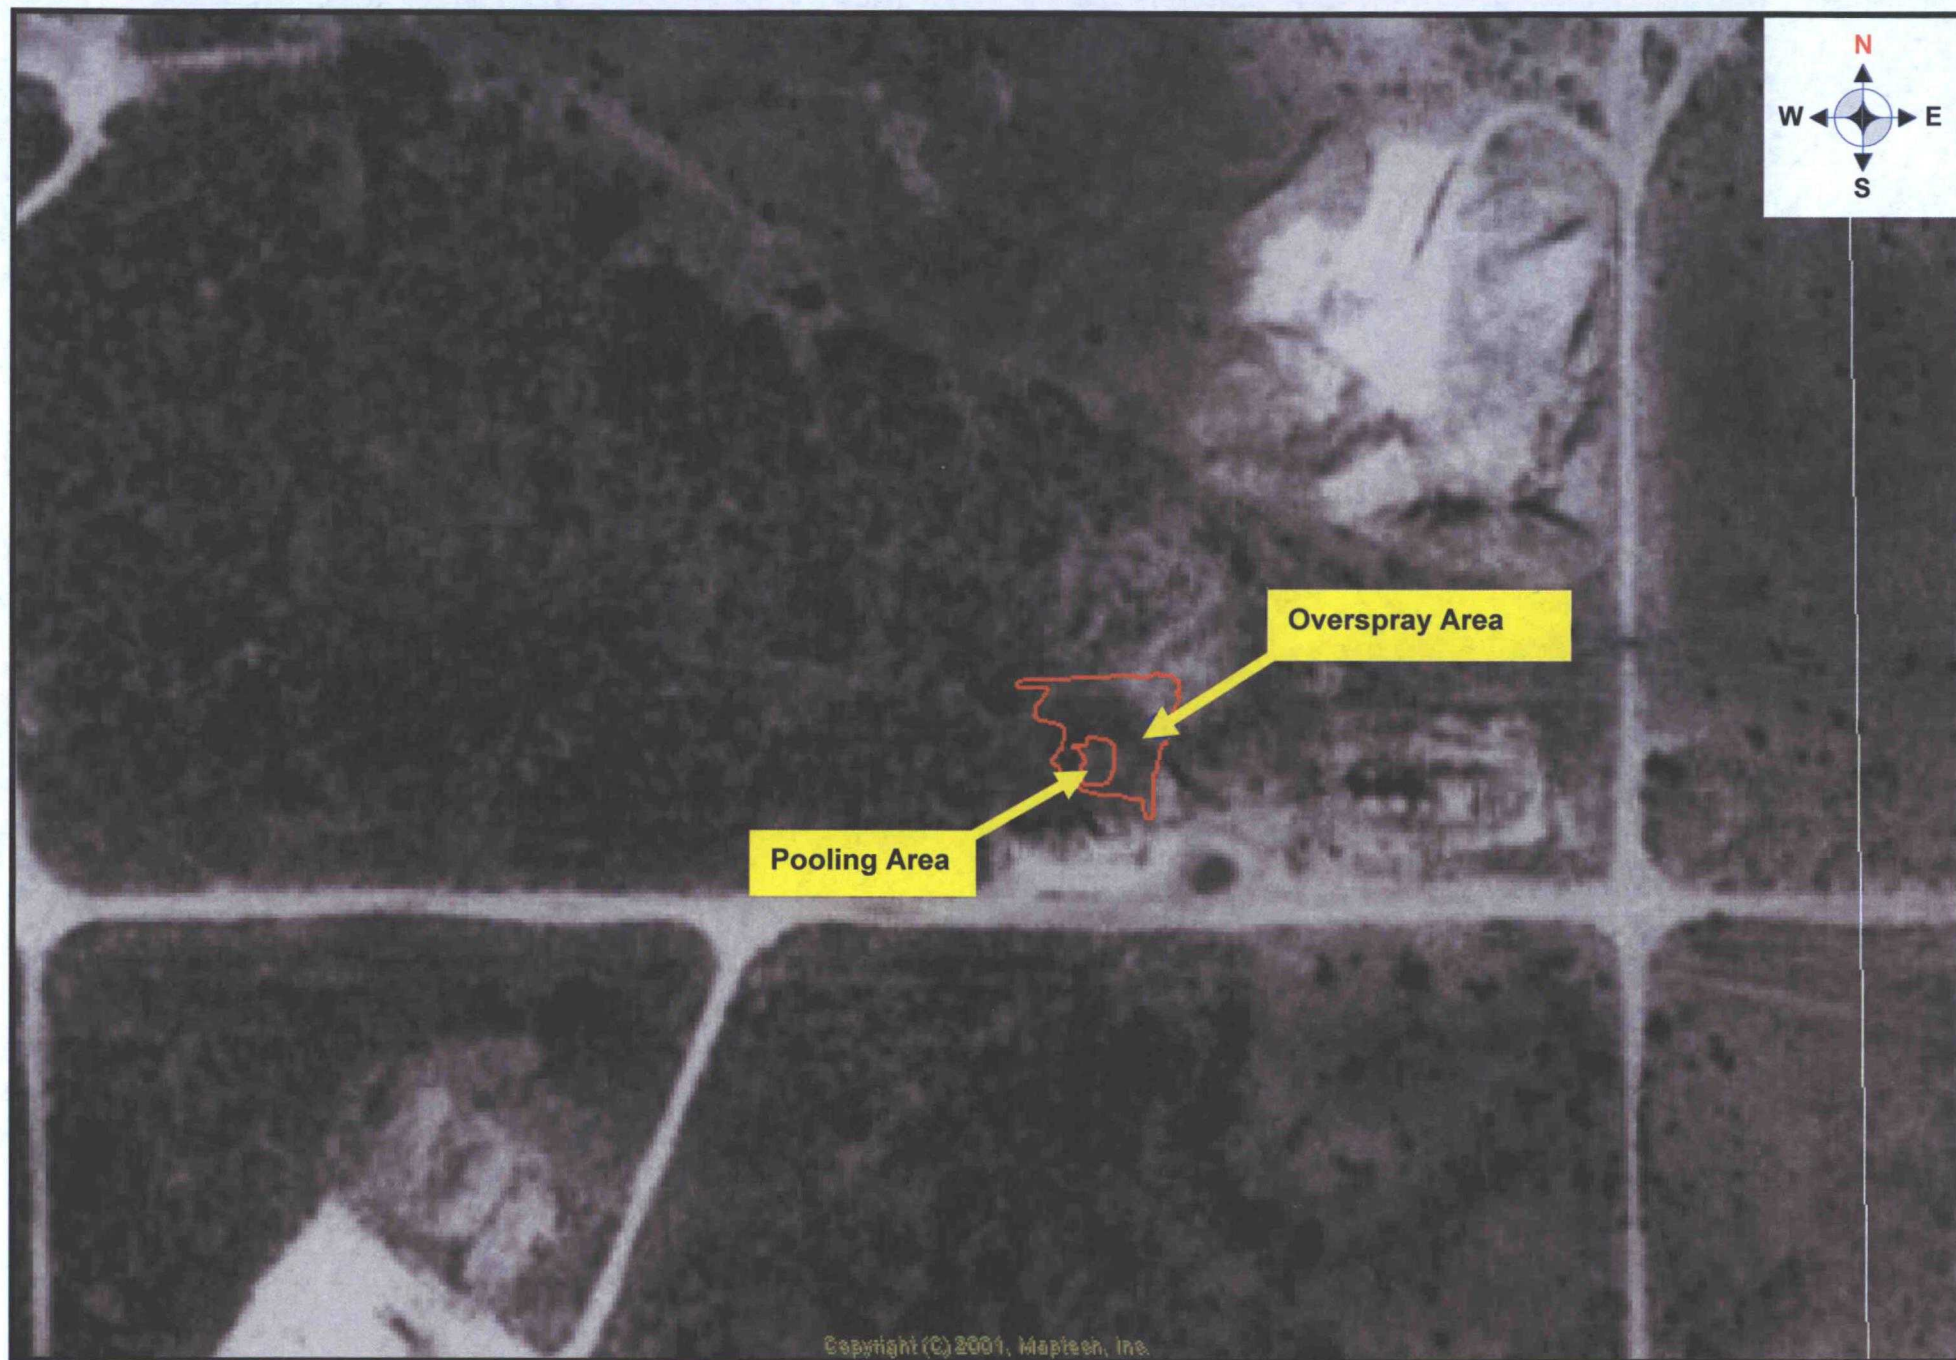
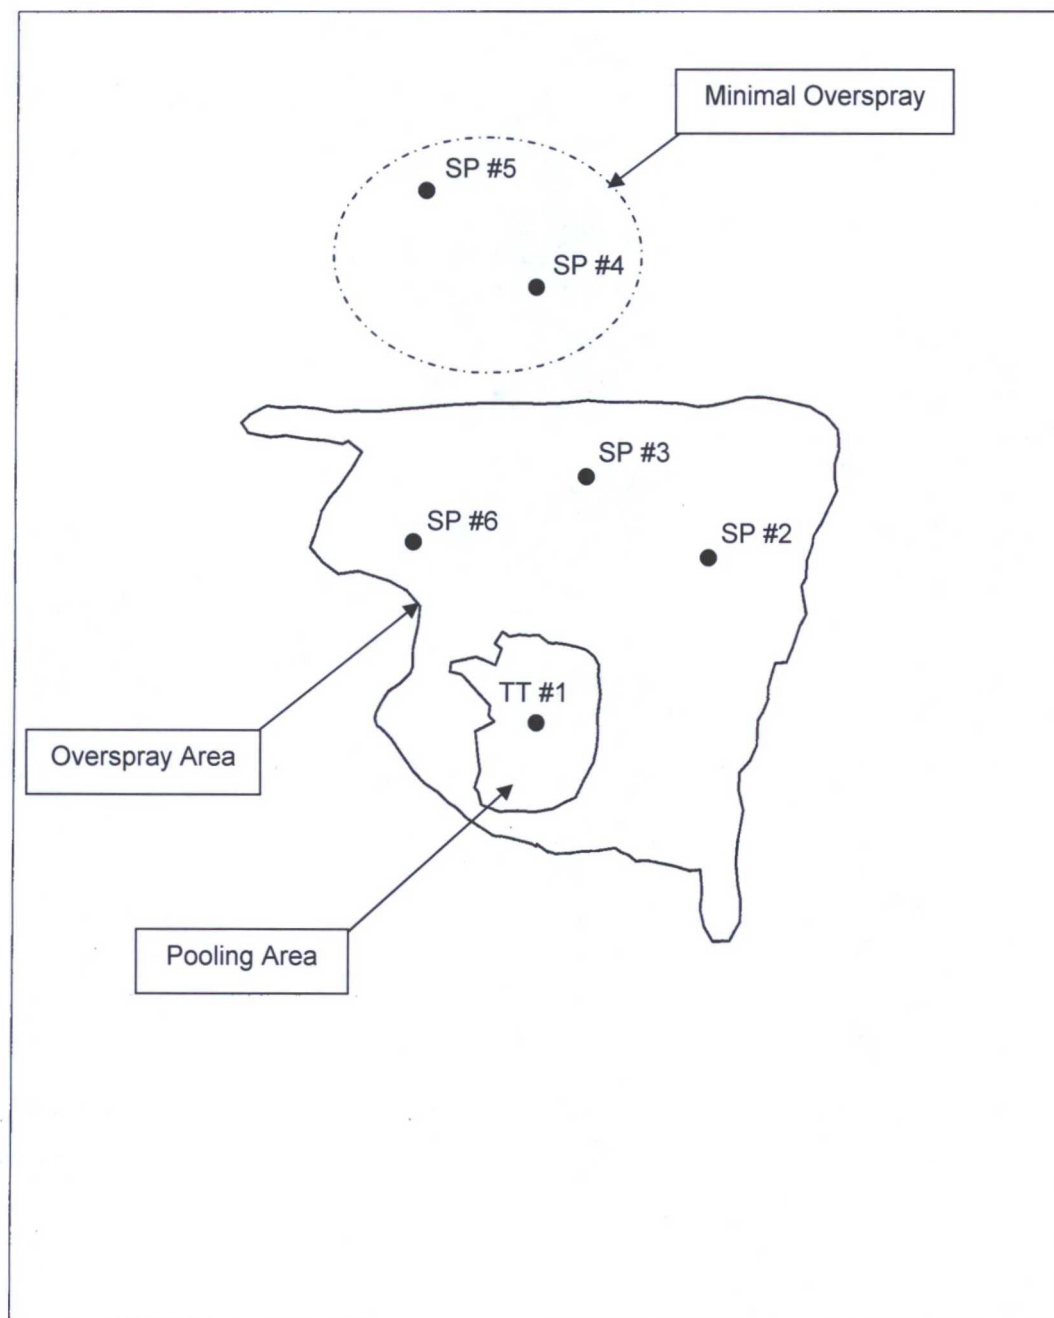
**Figure 2**  
**Site Plan**

On July 1, 2009, SESI was onsite with Environmental Plus Inc (EPI). A test trench was installed in the center of the pooling area, the release point (See Figure 2). Grab samples were collected at 1' intervals from within the trench and transported under chain of custody to Cardinal Laboratories of Hobbs, New Mexico for analysis. The samples were analyzed for Chlorides (EPA Method 4500-Cl<sup>-</sup>B).

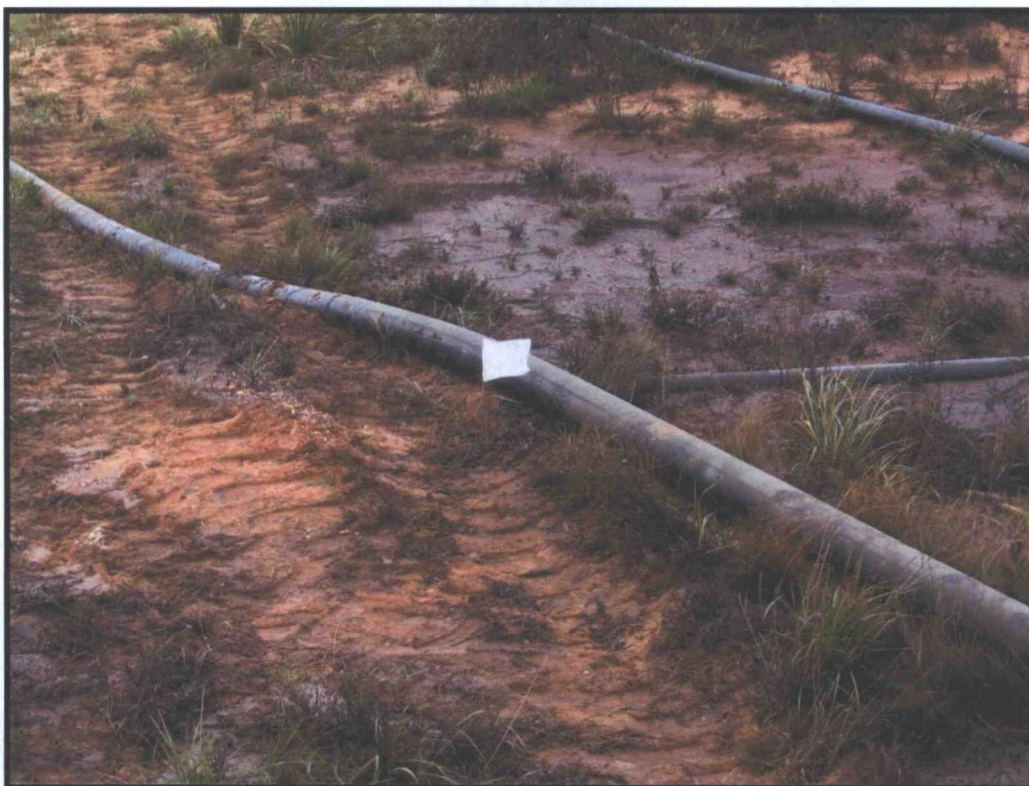
SESI utilized a hand auger to attempt to delineate the spill area at the release point. Auger refusal was encountered at a depth of 3'7" below ground level (bgl) due to the hard caliche layer. Grab samples were collected and transported under chain of custody to Cardinal Laboratories of Hobbs New Mexico, for analysis. In compliance to the New Mexico Oil Conservation Division (NMOCD) set of required sampling conditions, the samples were analyzed for Chlorides (EPA Method 4500-Cl<sup>-</sup>B), Total Petroleum Hydrocarbons (EPA Method 418.1), and Benzene, Toluene, Ethyl Benzene, and Xylenes (BTEX) (EPA Method SWA-846 8021 B).

Auger Hole #1 Facing West

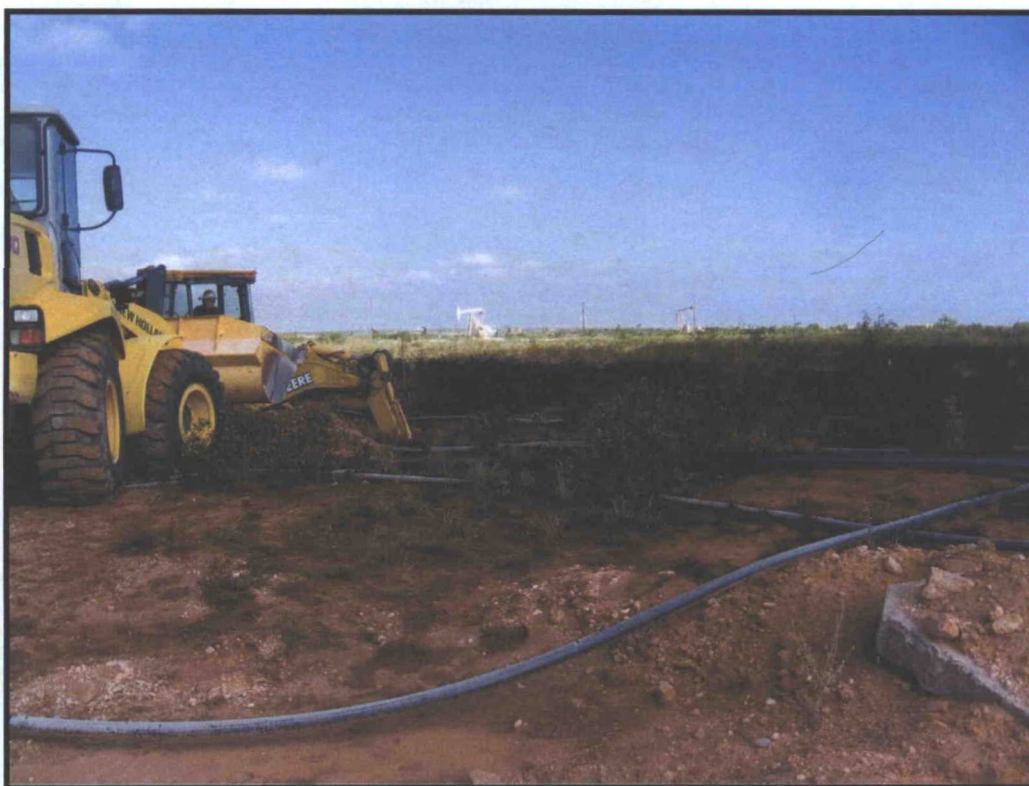
On June 26, 2009, SESI was onsite to map the affected area. The area was mapped using a Trimble Geo XM GPS. SESI observed overspray to the North of the battery with minor staining to vegetation and soil. Produced fluid ran off location and mixed with rain water on lease road. Two (2) vacuum trucks were utilized to recover 200 barrels of produced fluid, which included the standing rain water on the lease road.

Impacted Area Facing NW

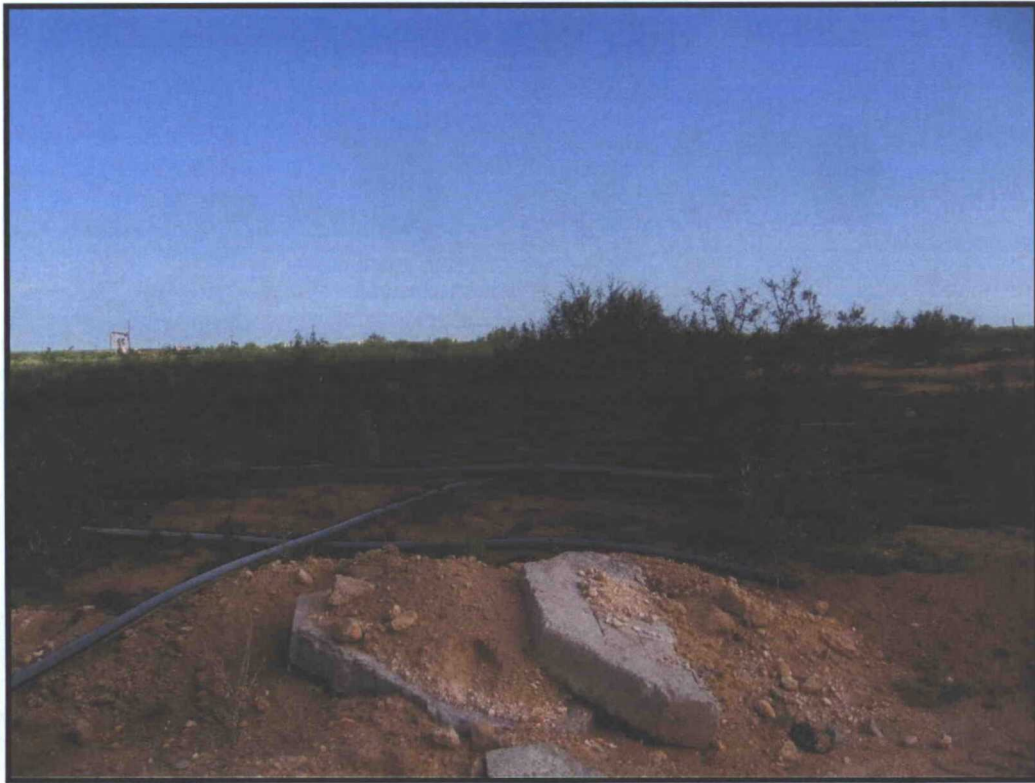
Impacted Area Facing North

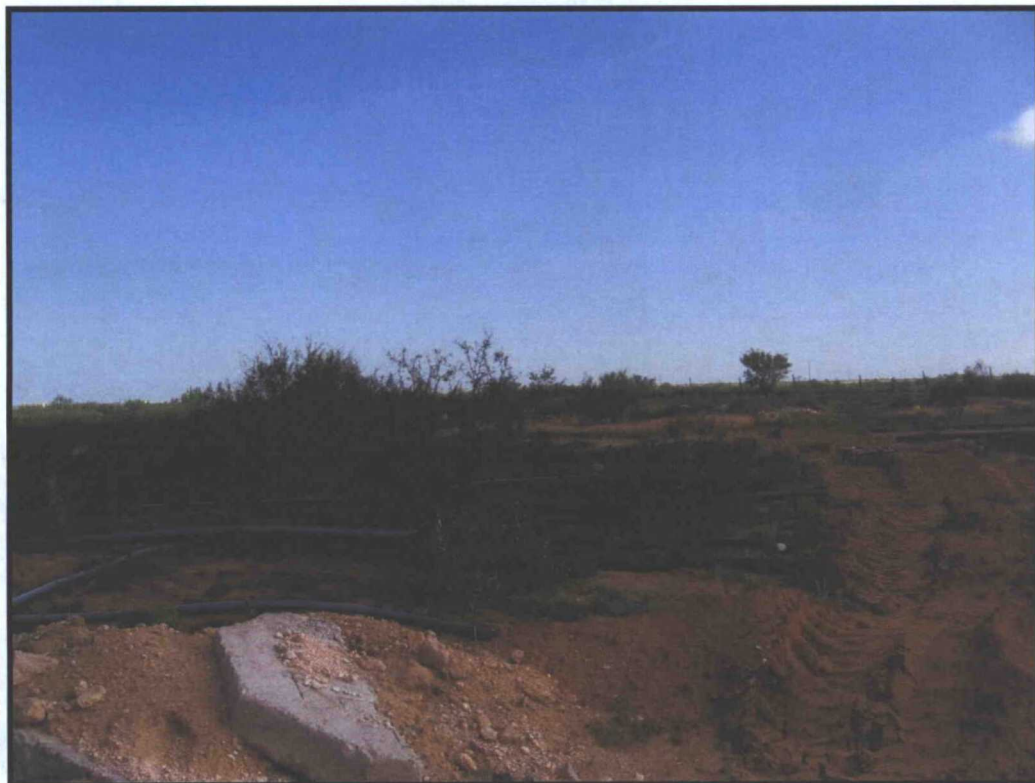
Impacted Area Facing North

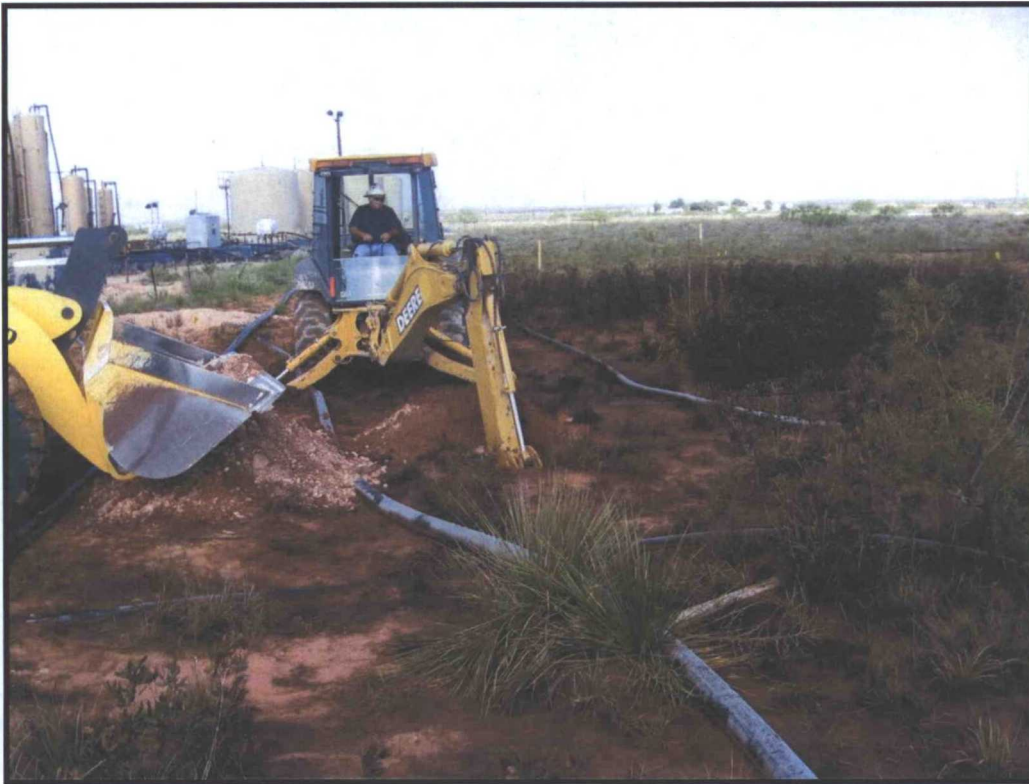
Excavating Test Trench Facing West

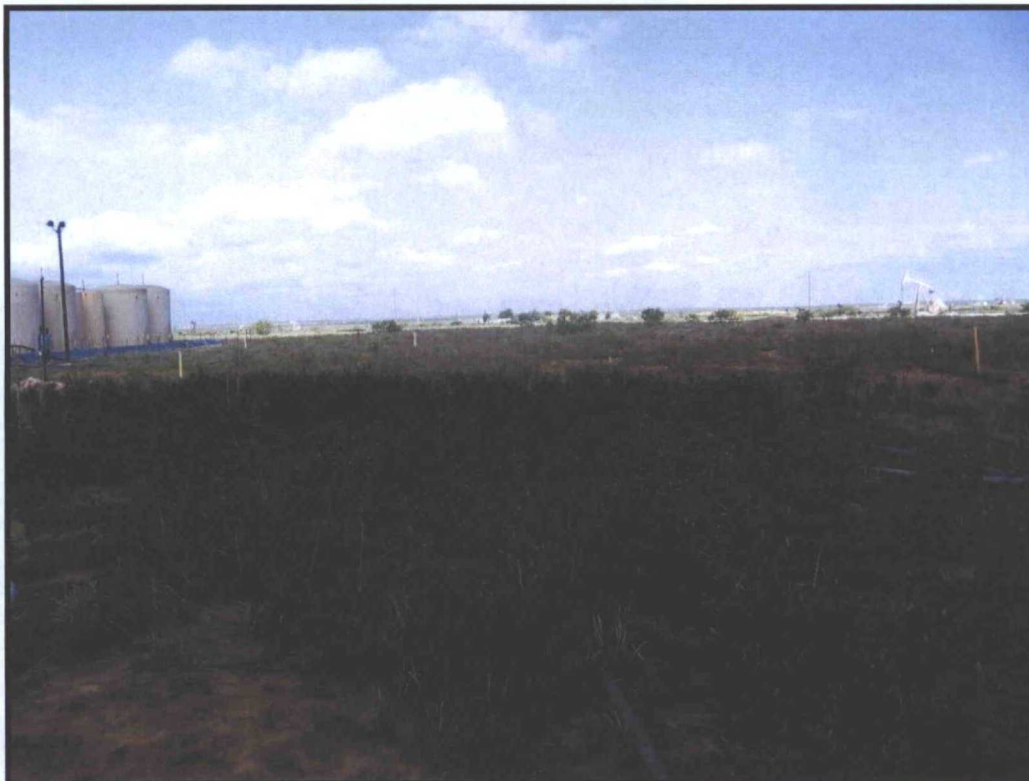
Impacted Area Facing West

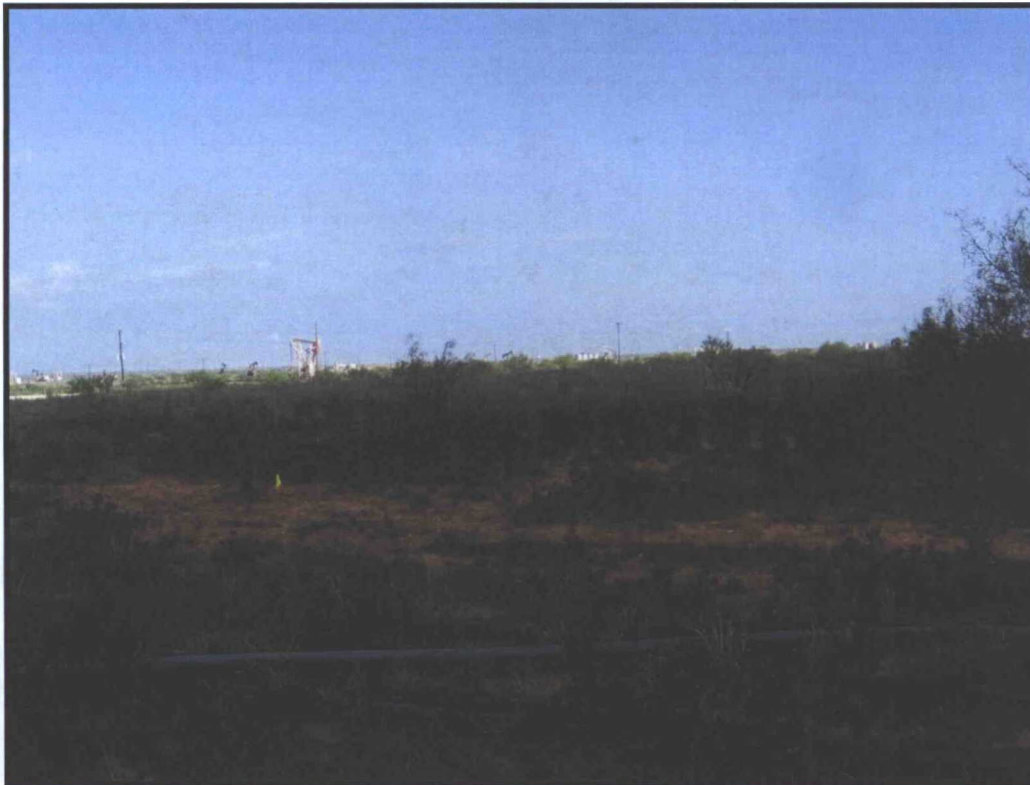
Impacted Area Facing NW

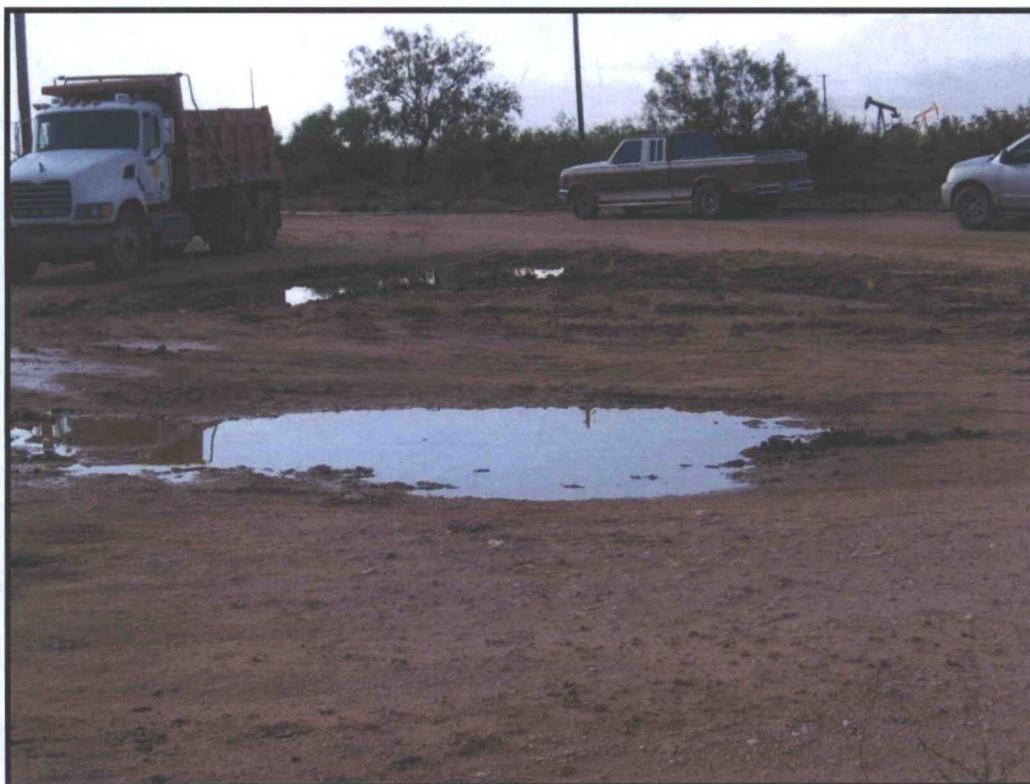
Run Off Area on Location Pad

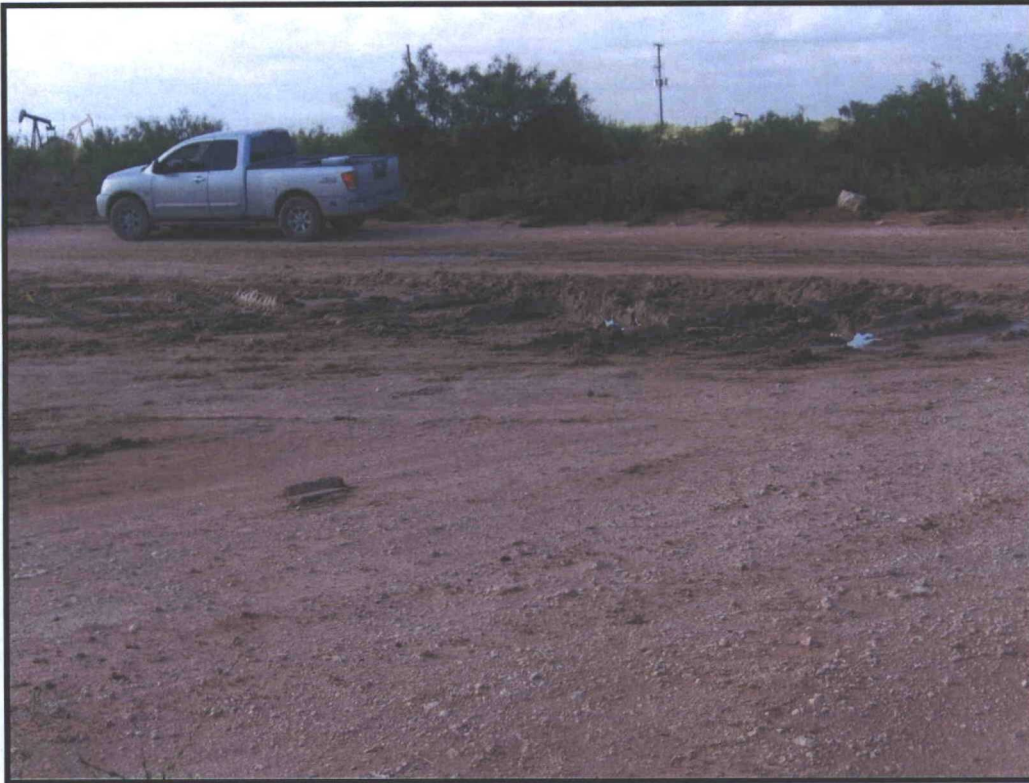
Run Off Area on Location Pad and Edge of Road

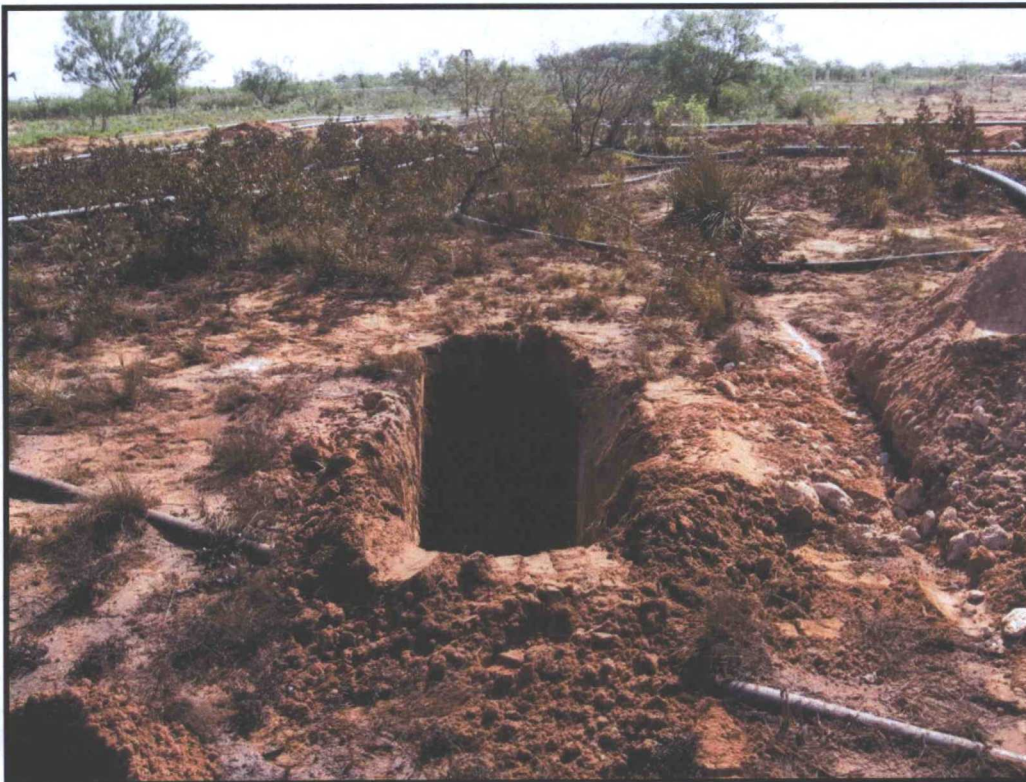
Sample ID	Chlorides (mg/kg)
TT#1 4' BGL	624
TT#1 5' BGL	352
TT#1 6' BGL	336
TT#1 7' BGL	48

Test Trench #1

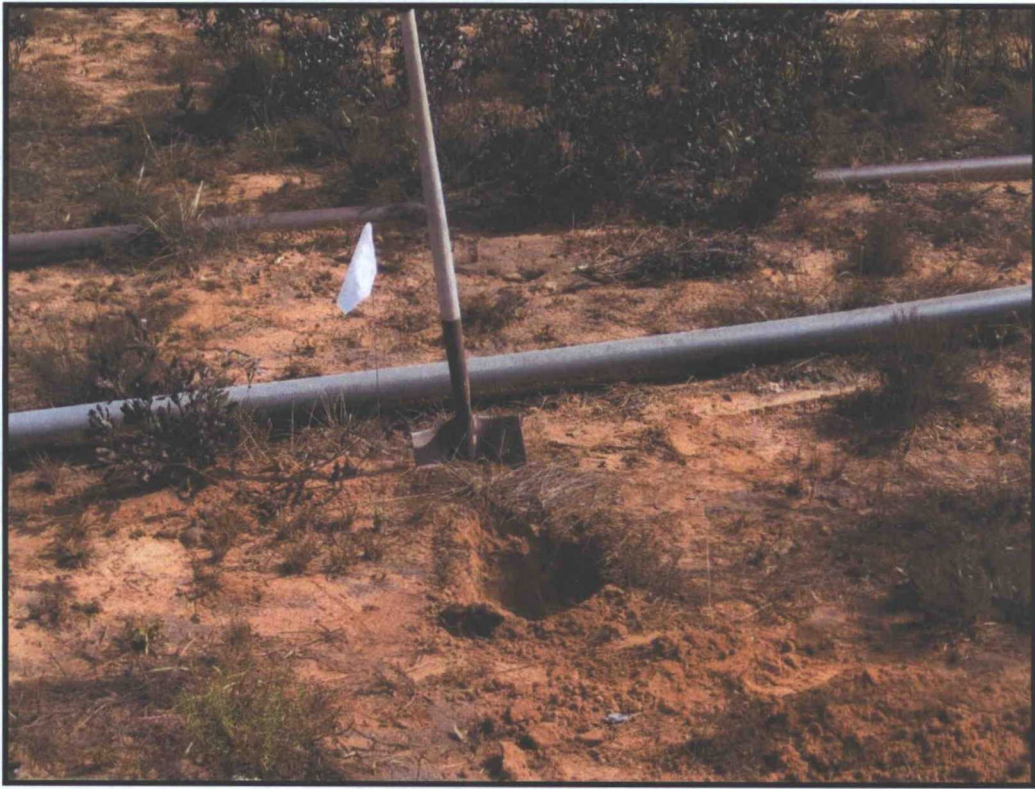
Sample Point #2

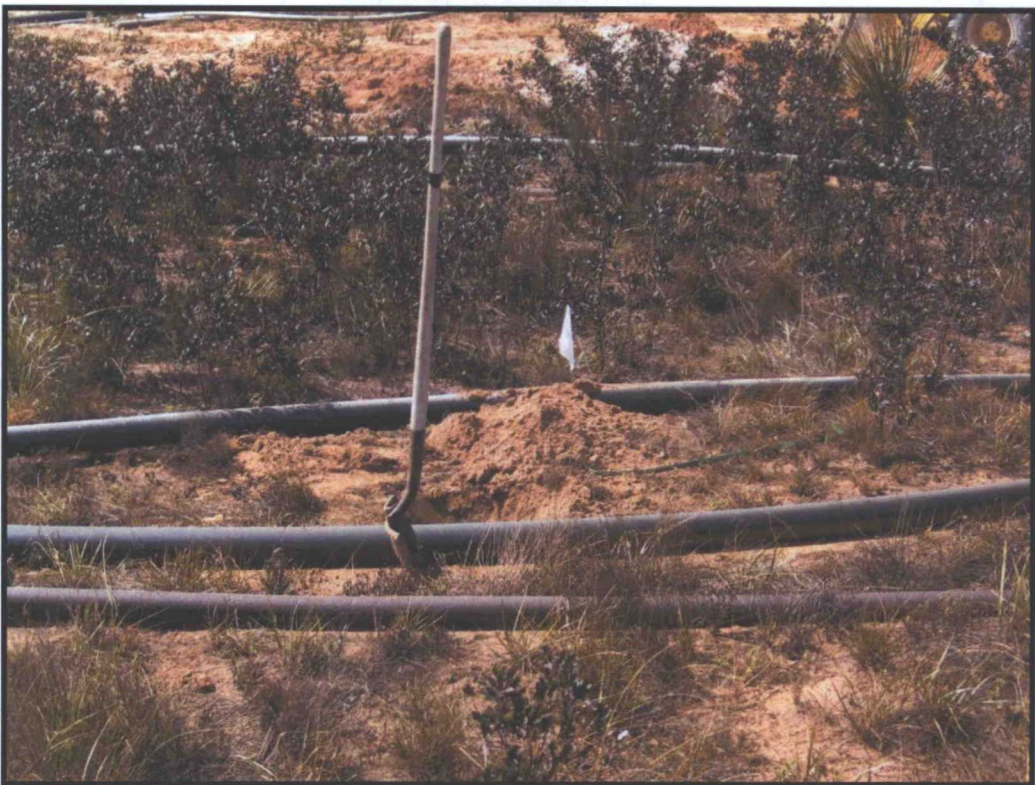
Sample Point #3

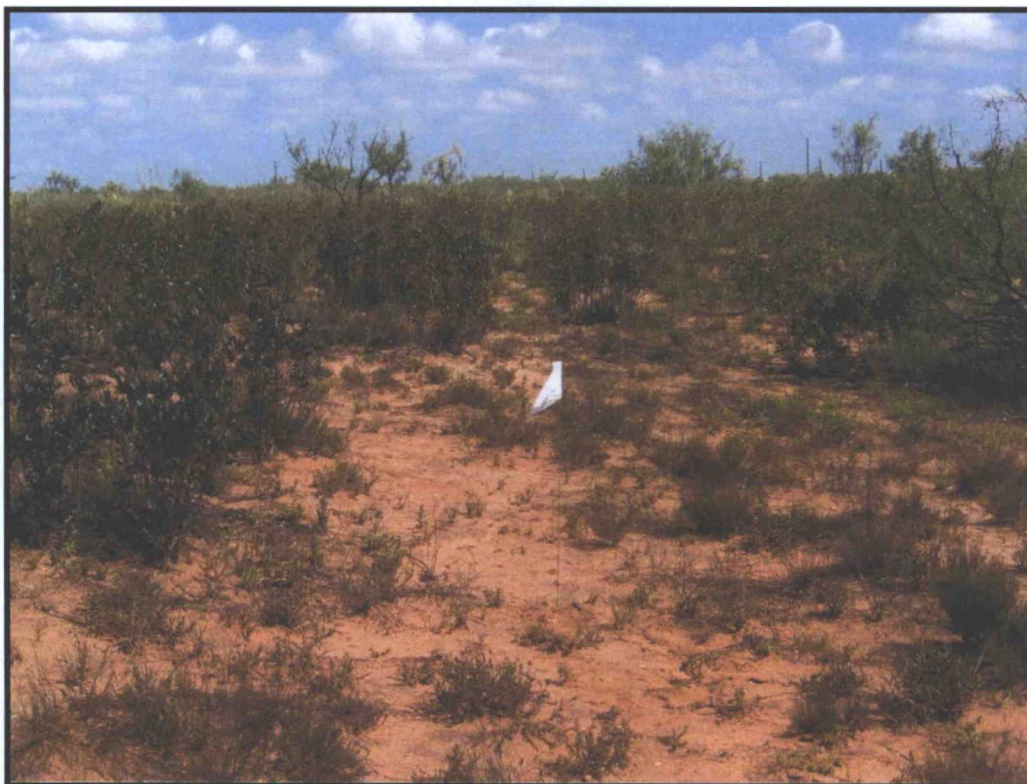
Sample Point #4

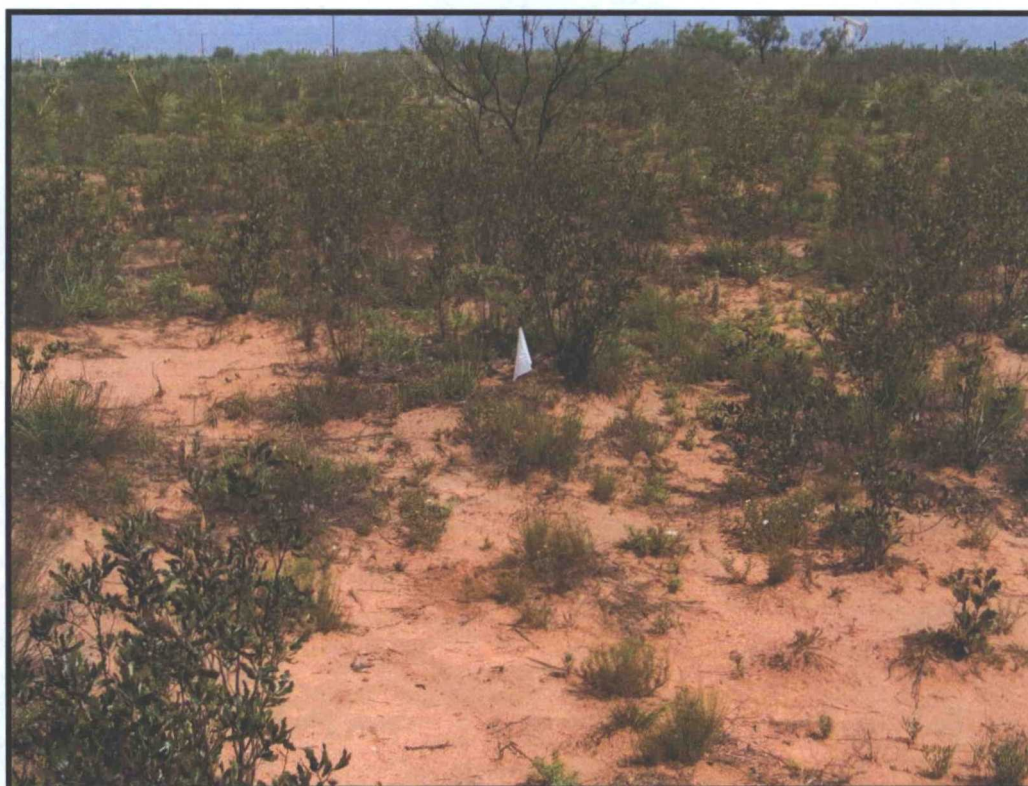
Sample Point #5

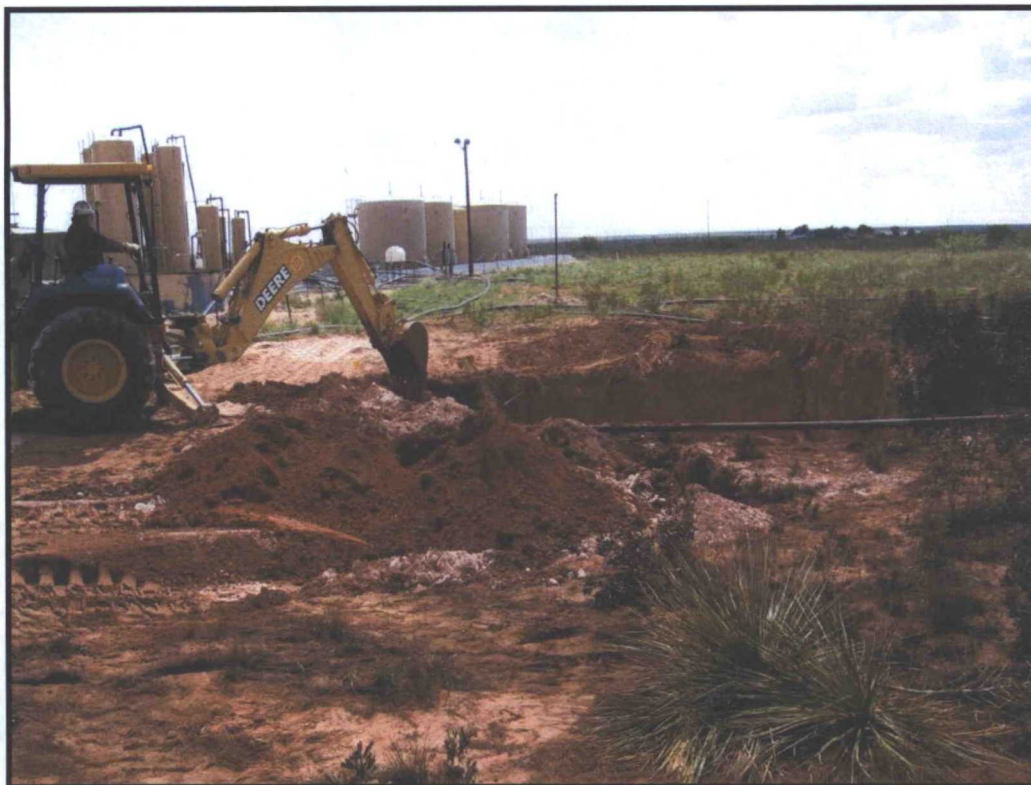
Excavating "Pooling Area" Facing West

Based upon the analytical results, the vertical extent of TPH contamination was determined at a depth of 7'. Therefore, the entire pooling area was excavated to a depth of 7' bgl.

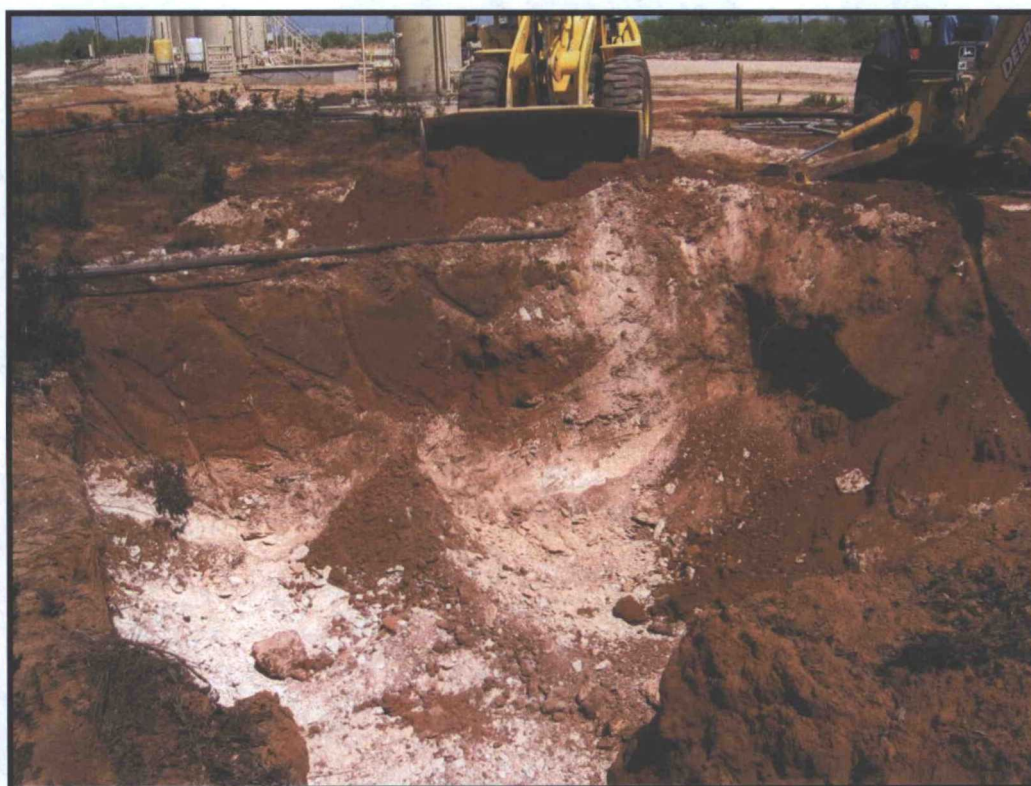
Excavating "Pooling Area" Facing East

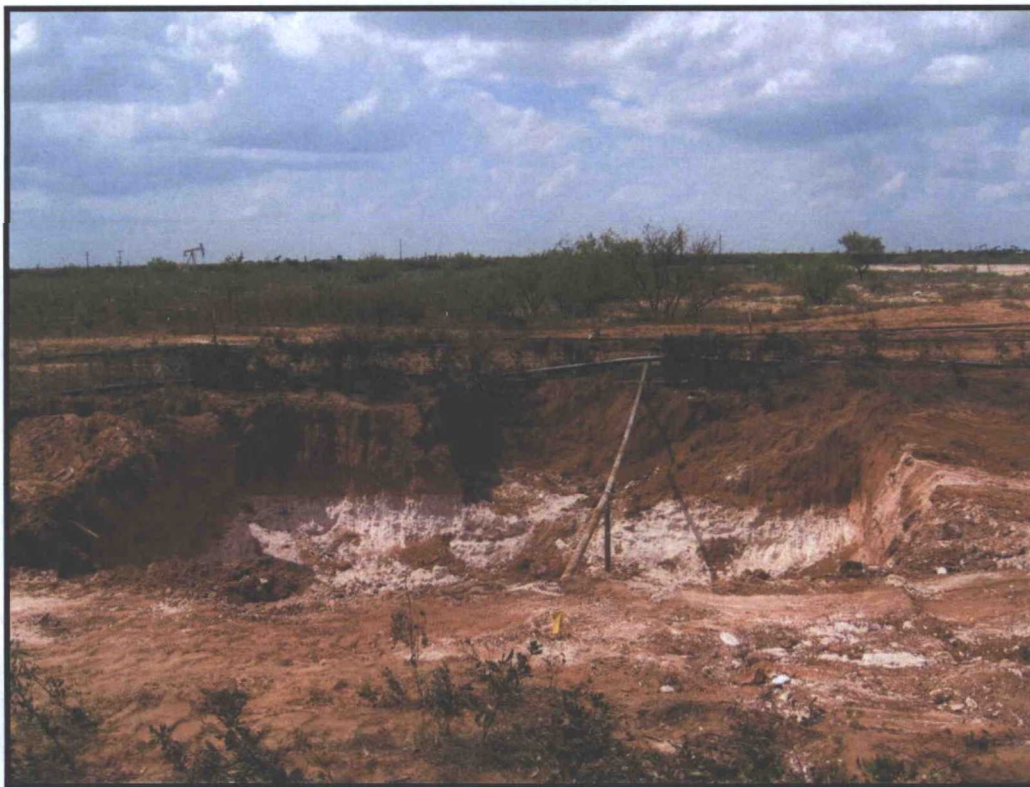
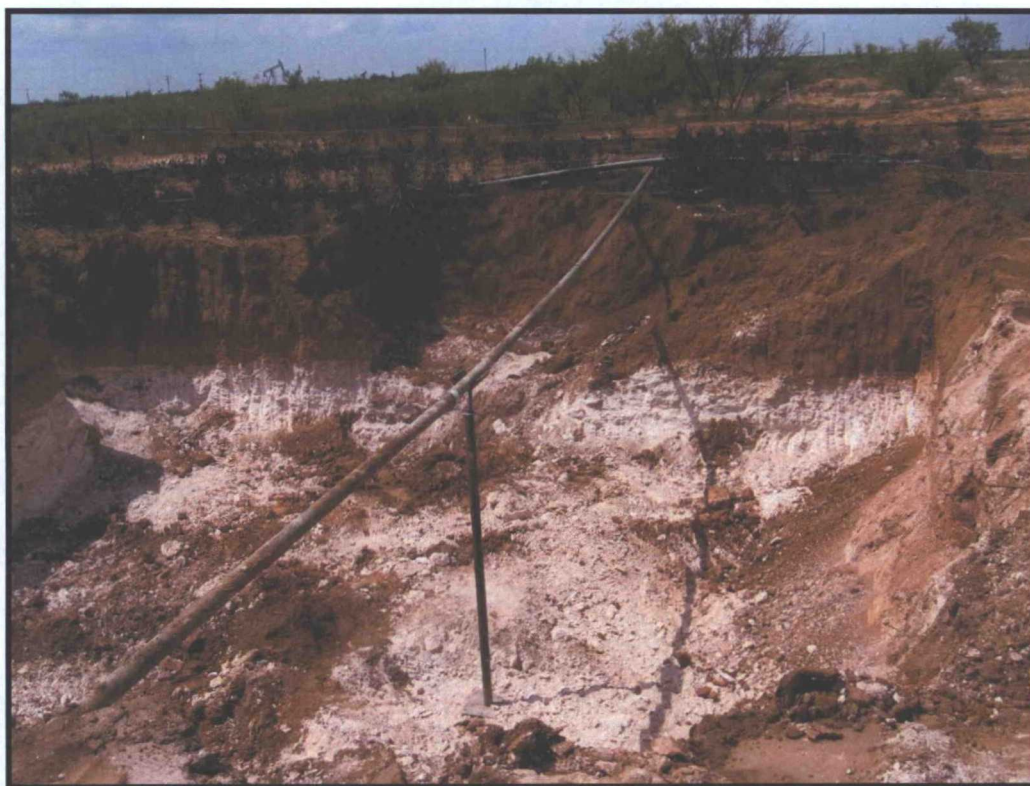
"Pooling Area" Excavated to 7' bgl Facing North

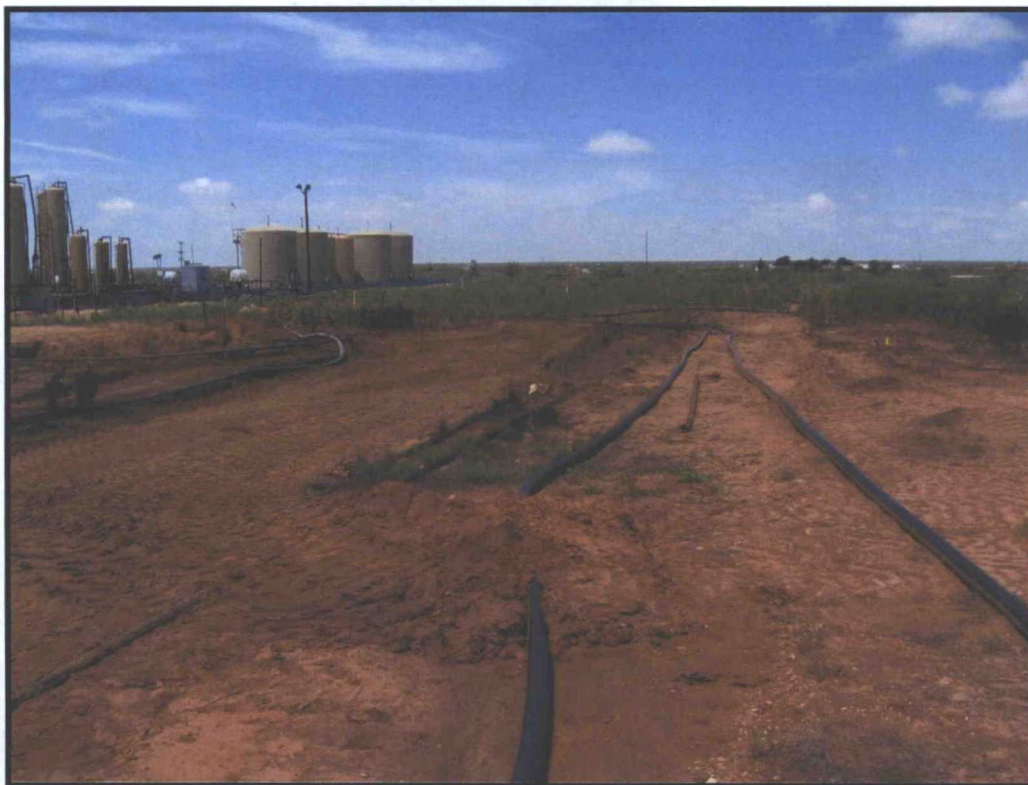
Excavated Area Facing West

The overspray area surrounding the pooling area was excavated from a depth of 6" to 12" bgl. Grab samples were collected from the excavated areas and transported under chain of custody to Cardinal Laboratories for analysis. The samples were analyzed for Chlorides (EPA Method 300.0), Total Petroleum Hydrocarbons (EPA Method 418.1), and BTEX (EPA Method SWA-846 8021B).

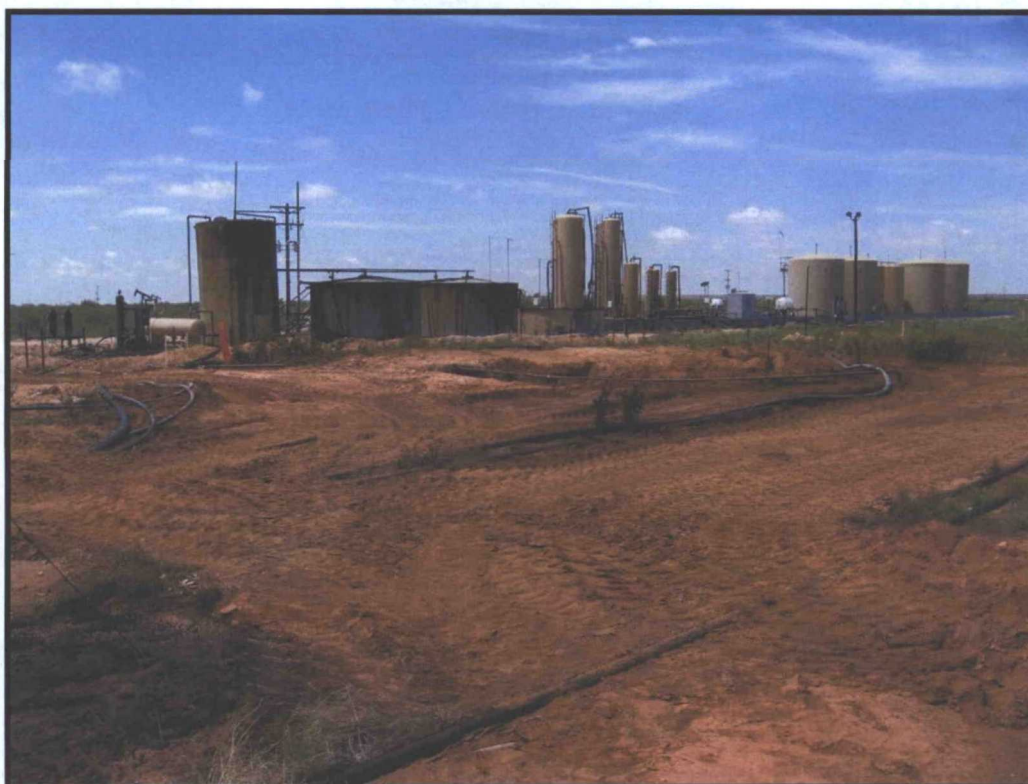
Excavated Area Facing SW

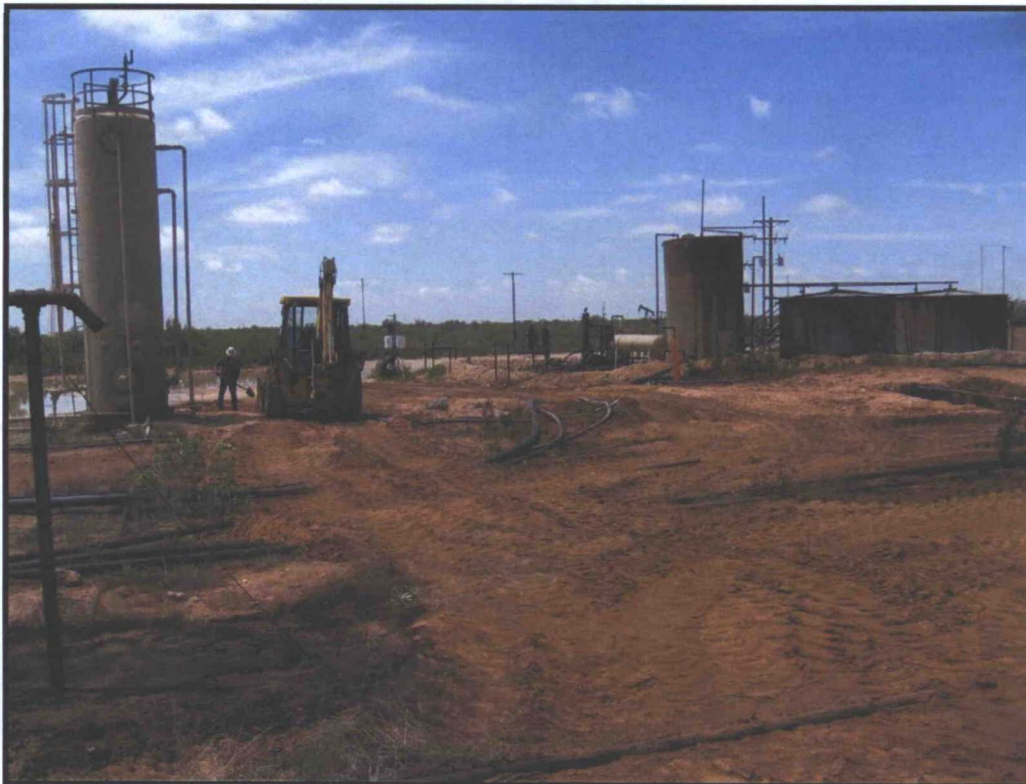
Excavated Area Facing South

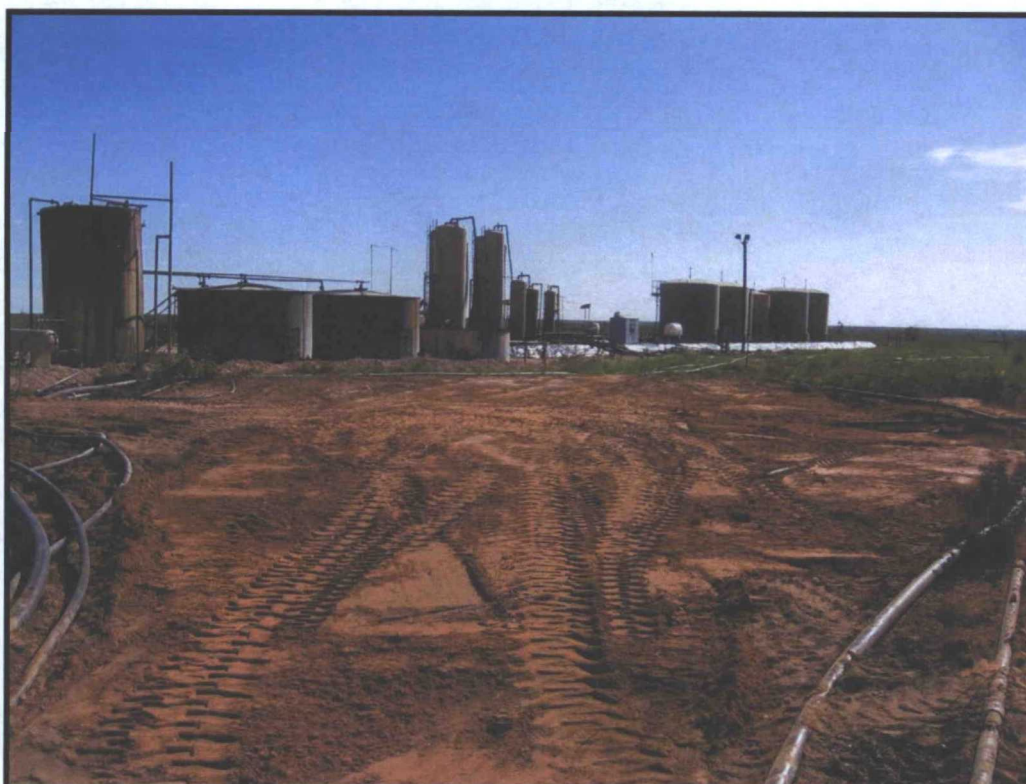
Backfilled Excavation Facing SW

On July 6-7, 2009, SESI was onsite with EPI. A total of 378 yards of contaminated soil was transported to Sundance Services, a New Mexico Oil Conservation Division (NMOCD) approved facility for disposal. The pooling area was then backfilled to 3' bgl with a total of 112 yards of caliche, then from 3' bgl to surface with 238 yards of topsoil. The excavated overspray areas were also backfilled with topsoil and contoured to grade.
