## Release Notification and Corrective Action

**Range Operating New Mexico, Inc.  
Greenwood Battery  
Section 9, Township 22S, Range 37E  
Lea County, New Mexico**

**Closure Report**

**July 27, 2009**

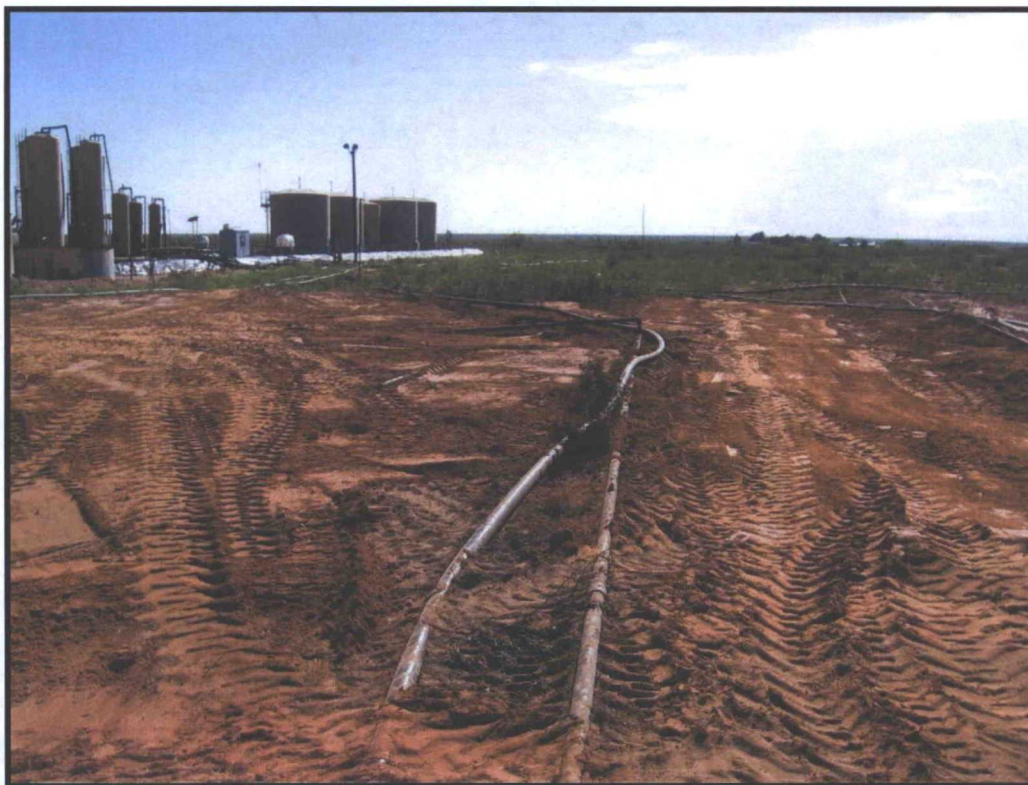
Backfilled Excavation Facing West

On July 6-7, 2009, SESI was onsite with EPI. A total of 378 yards of contaminated soil was transported to Sundance Services, a New Mexico Oil Conservation Division (NMOCD) approved facility for disposal. The pooling area was then backfilled to 3' bgl with a total of 112 yards of caliche, then from 3' bgl to surface with 238 yards of topsoil. The excavated overspray areas were also backfilled with topsoil and contoured to grade.

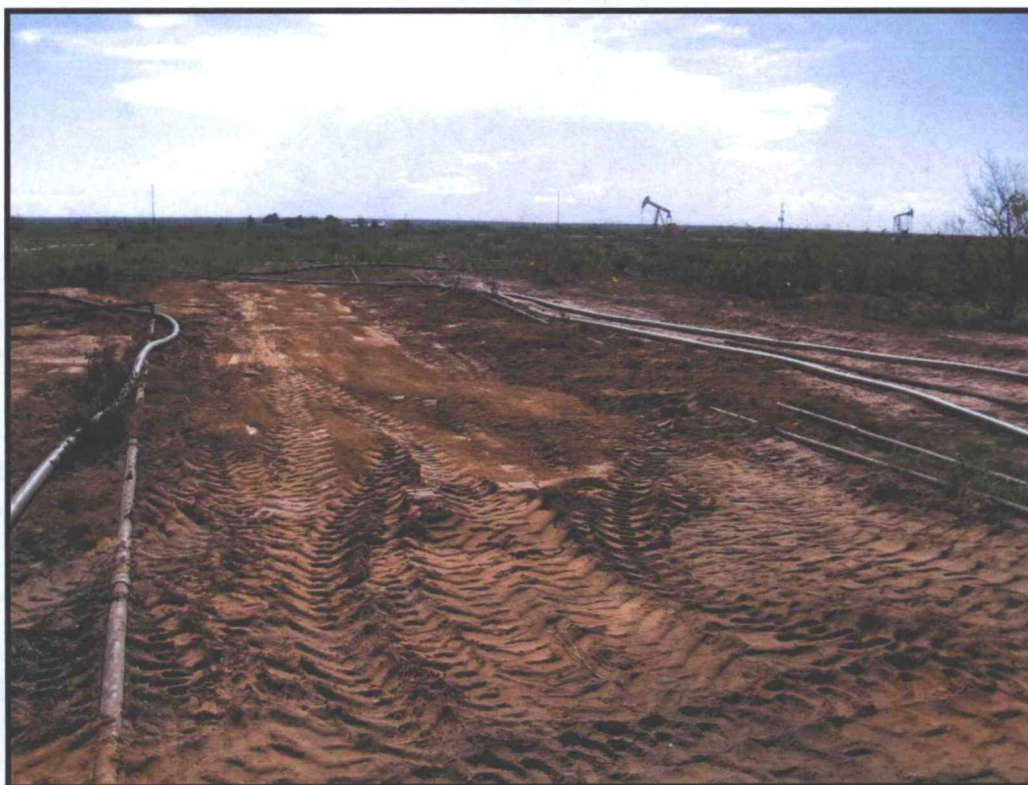
Backfilled Excavation Facing NW
