Whole Earth Environmental, Inc.

Reference: 1RP-2759

Enclosed, please find a copy of our remediation protocol for the Chaparral Energy WDSQU-Sat. #2 spill located in Unit Letter P, Section 30, Township 24S, Range 38E. Though the newly reported spill contained minimum volumes, it came atop previous events with significant vertical migration.

Executive Summary

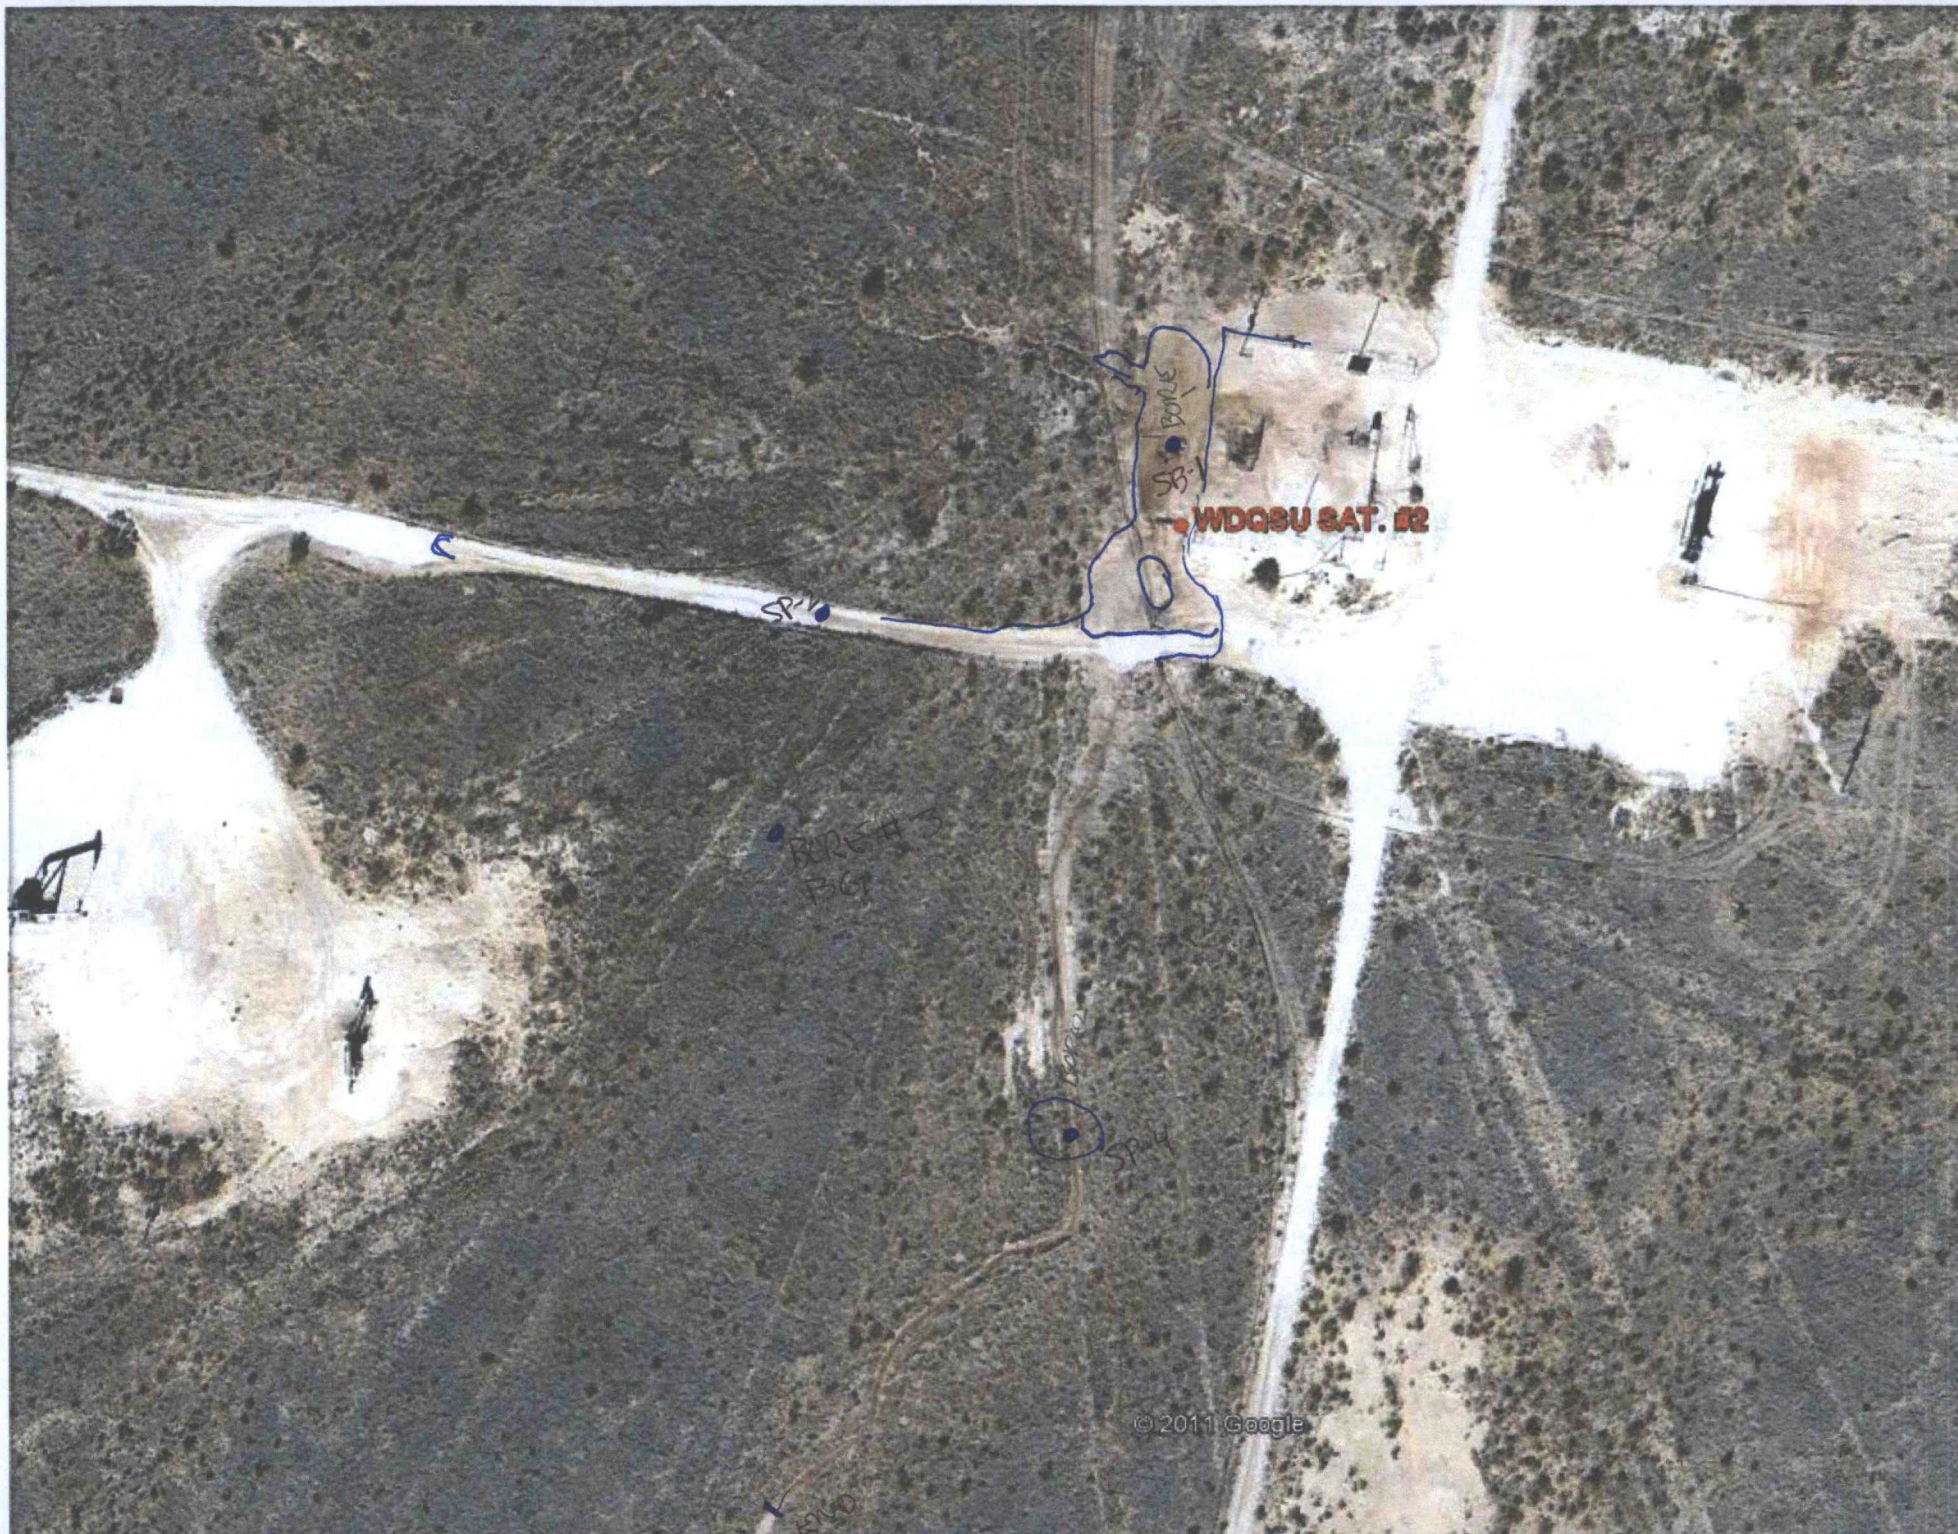
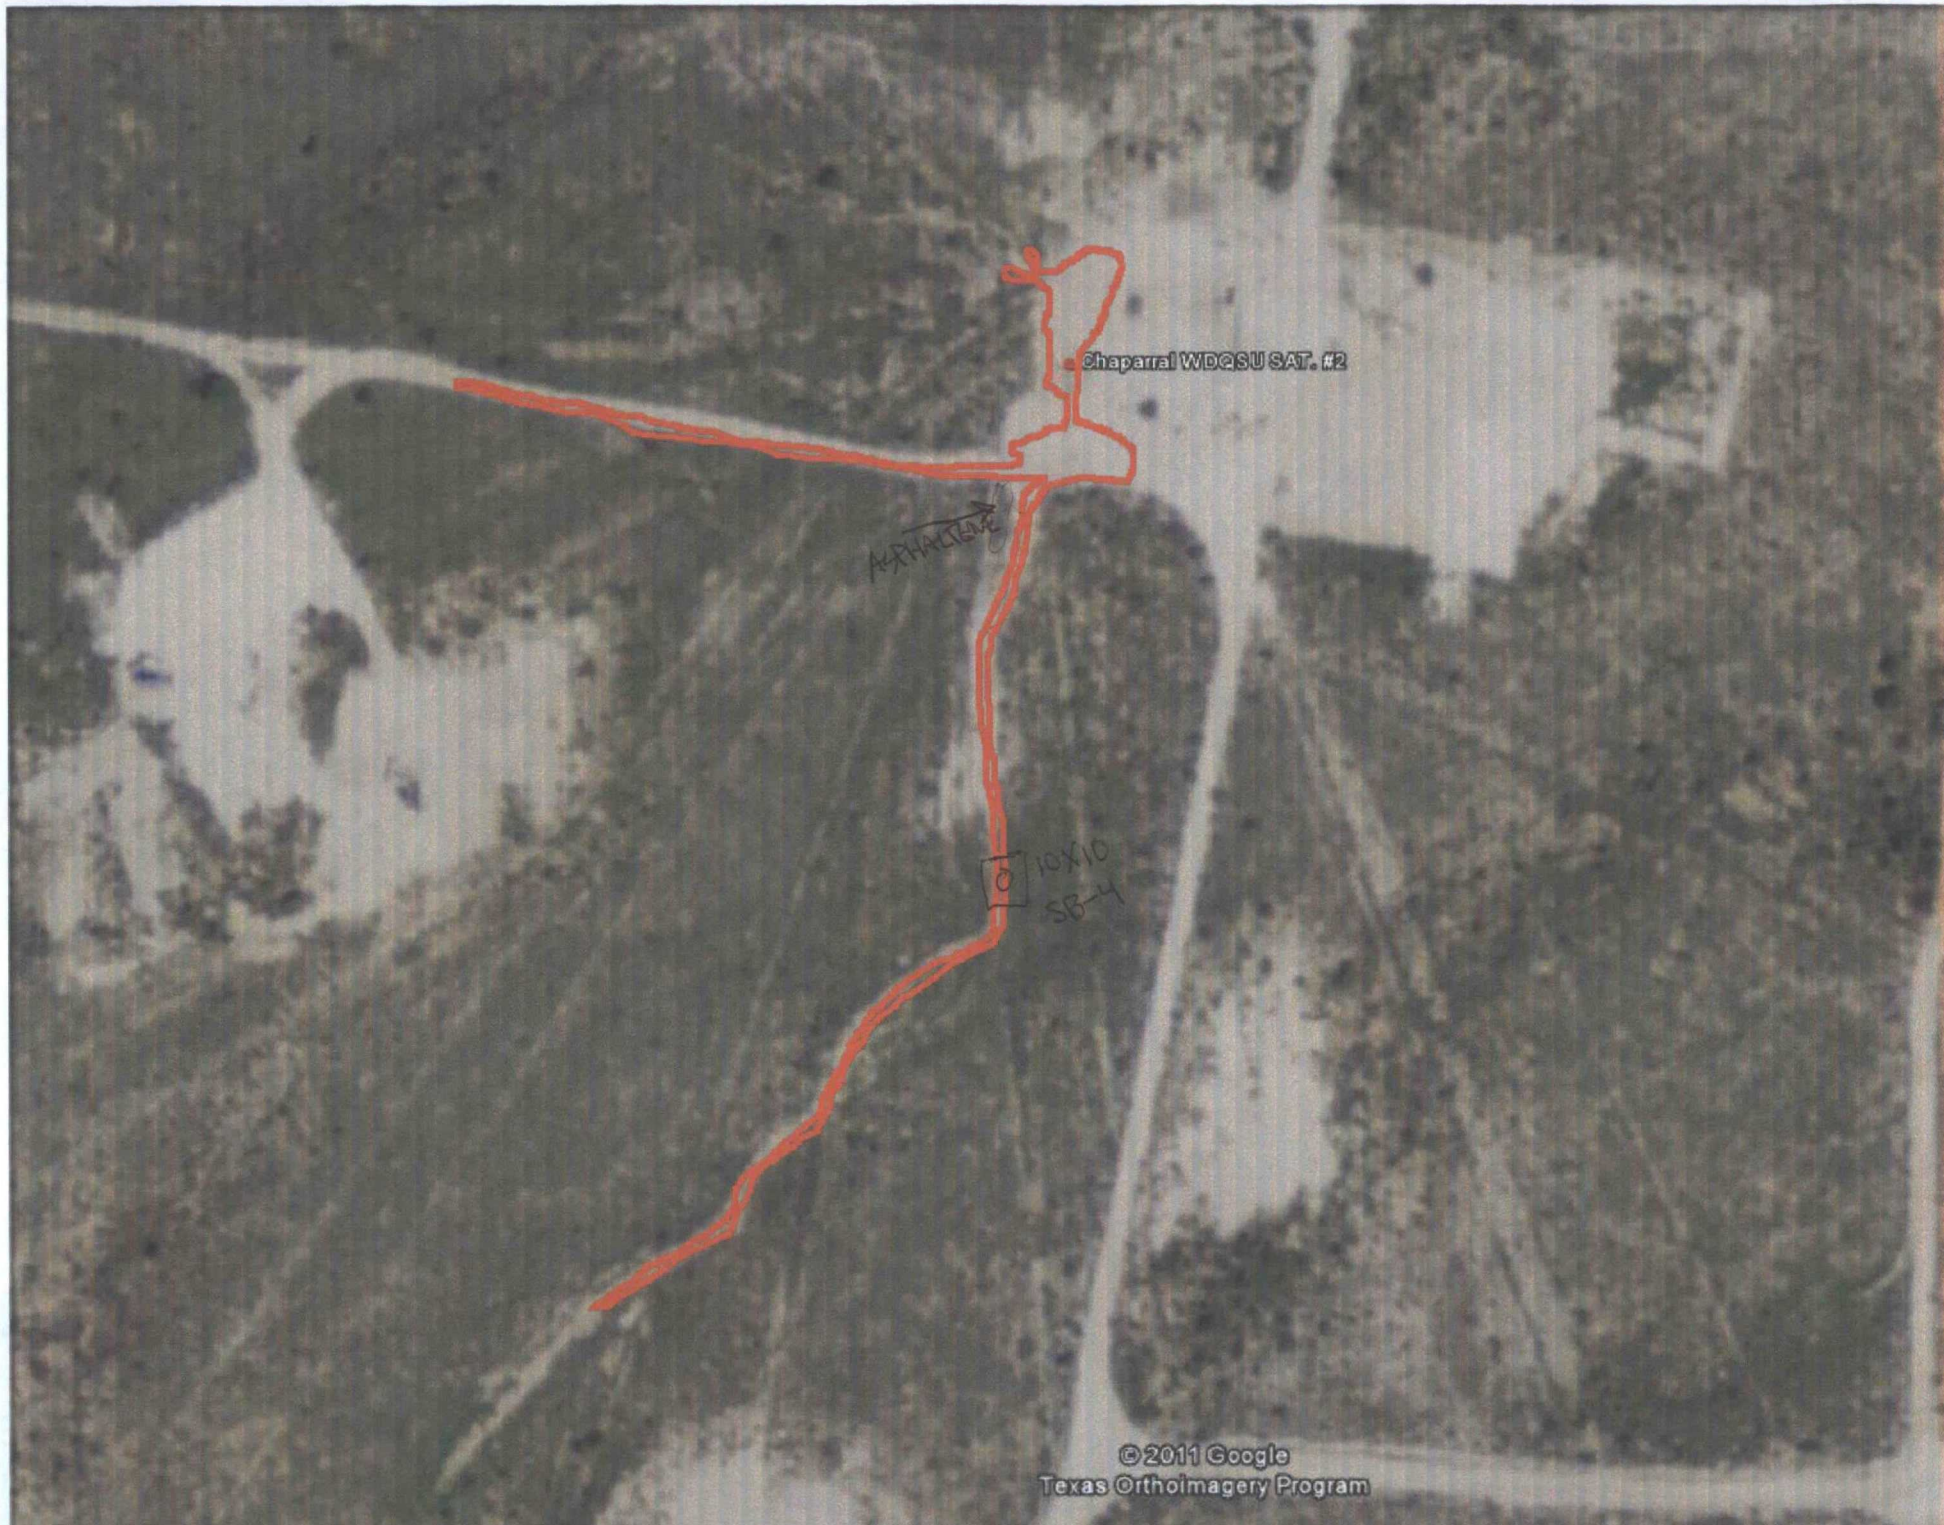
Chaparral
WDQSU SAT. #2 LEAK
UL/P SEC 30 - T24S - R38E
GPS N32.184706 / W103.093690
DRIVING DIRECTIONS: NE of Jal at intersections of Willis rd. & Dollarhide rd.
turn R. go 2.49mi, turn L. go 0.05mi (to first lease rd. on R.), turn R. staying on
main lease rd. go 0.63mi to Satellite #2. Leak is located on West side of header,
site is flagged and ided.
