Release Notification and Corrective Action

Name of Company	Murchison Oil & Gas, Inc.	Contact	Greg Boans
Address	1100 Mira Vista Blvd, Plano, TX 75093	Telephone No.	(575) 361-4962
Facility Name	Jackson Unit #8	Facility Type	Production Battery
Surface Owner	State of New Mexico	Mineral Owner	API No. 30-025-35328

RE: Jackson Unit #8 Release
Final C-141, Request for Closure

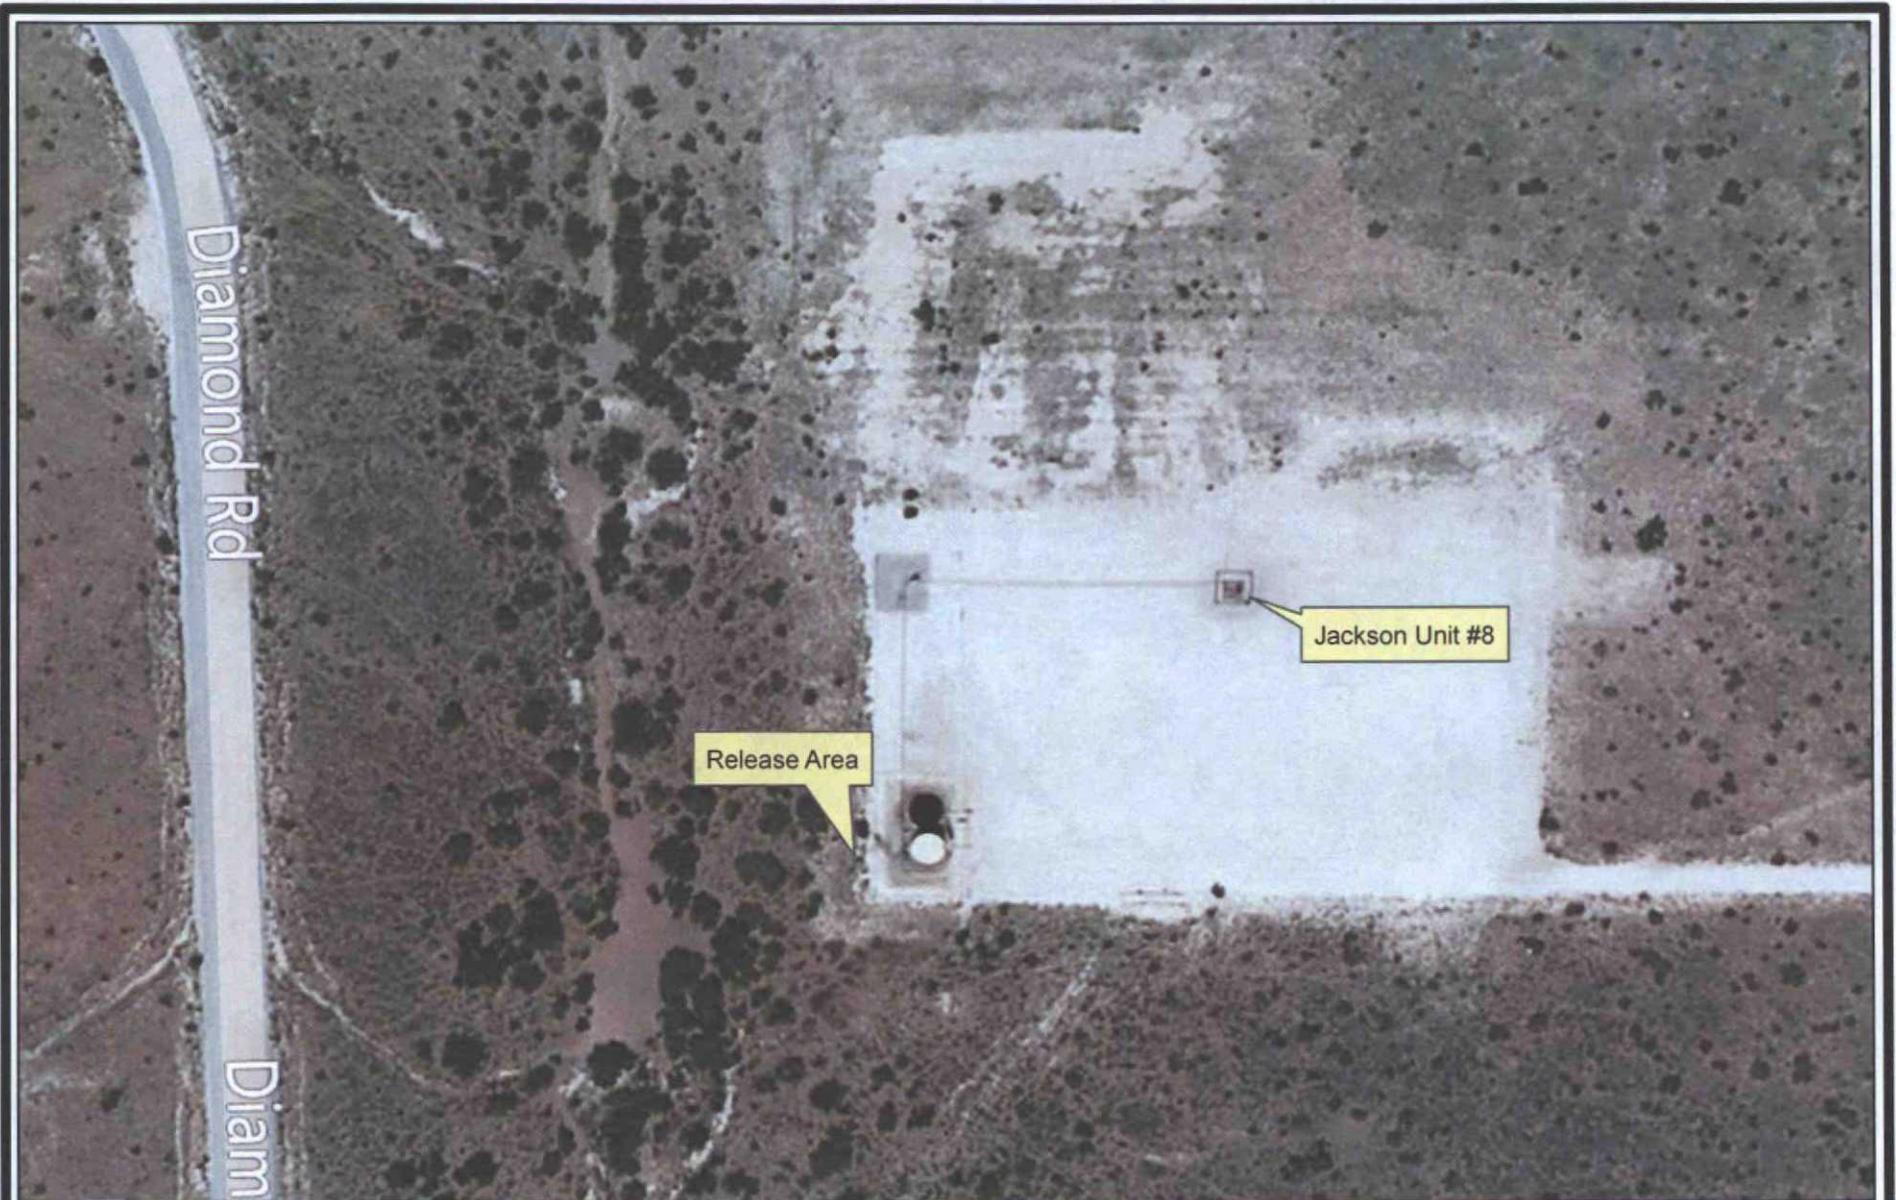
On behalf of Murchison Oil and Gas, R.T Hicks Consultants is pleased to submit the attached Final Report for the above-referenced release. Figure 1 shows the tank in the southwest corner of the location from which this release originated.

The ephemeral drainage channel described in the C-141 forms is considered a "watercourse" as defined by NMOCD Rules. However, this dry channel (visible in Figure 1) is not a surface water body or "significant watercourse" as it is neither a named drainage nor a first order tributary. Moreover, regulated constituent concentrations are too low to pose a threat to surface water.

Recent Air Photo of Location

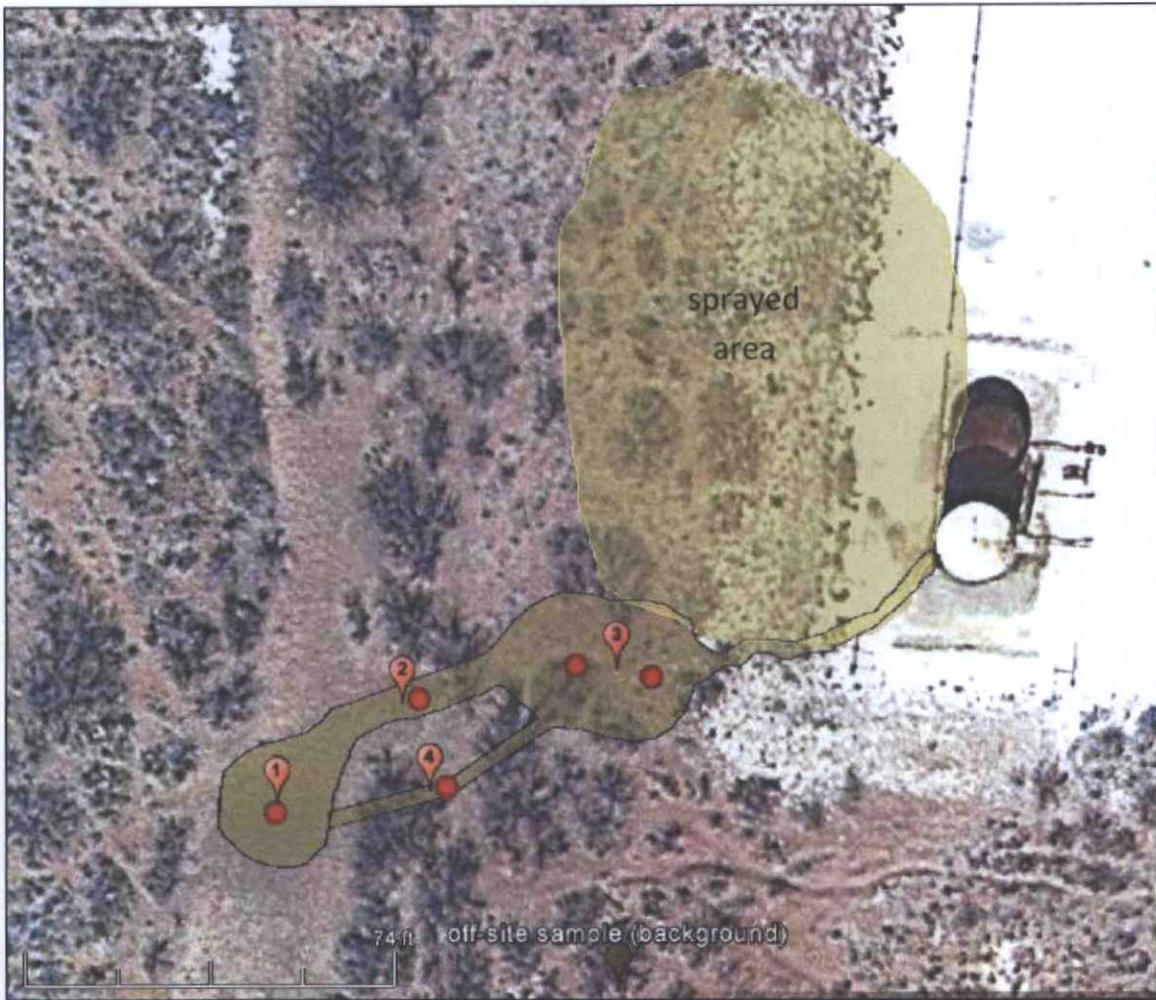
R.T. Hicks Consultants, Ltd 901 Rio Grande Blvd NW, Suite F-142 Albuquerque, NM 87104 505-266-5004	Release Area and Sample Locations - 1/21/2013	
	Murchison - Jackson Unit #8	Figure 2
	February 2013

Figure 2 shows the area impacted by the release, as described on the attached C-141. On 1/18/2013, Murchison removed the upper 4-inches of stained and saturated soil and placed this excavated material on a liner on location. We performed chloride field tests at four sample locations within the excavated footprint of the release: two of which included areas of obvious fluid pooling (sample numbers 1 and 3 on Figure 2). Chloride concentrations dissipated at 14 inches below ground surface. We returned on 1/21/2013 to collect laboratory confirmation samples. Laboratory analyses of a 5-point composite sample from the excavated surface yielded the results in the attached laboratory reports and shown in the Table below. Laboratory analysis of the excavated material showed a similar chloride concentration but lower concentrations of hydrocarbons. This result led us to conclude that simple aeration of the material could result in reduction of hydrocarbon concentrations over time.

Chloride Field Tests		
Sample Point	Depth (in. BGS)	Cl ⁻ (mg/kg)
1	4	563
	14	107
2	4	104
	14	58
3	4	654
	14	71
4	4	171
	14	62
off-site (background)	0	143
	4	119
	14	65
5-pt comp.	4	362
remed. comp.	4	320*

*2/19/2013 sample after remediation with disc harrow

Based upon these results, the release area was disc harrowed and contoured on two occasions in February in order to remediate residual hydrocarbons. On 2/19/2013, a second 5-point composite sample was collected from the harrowed surface for laboratory analysis. Results show that regulated hydrocarbons have declined to less than detectable limits, chloride remains unchanged as expected, and the long-chained hydrocarbons represented by TPH, GRO and DRO have also shown significant declines in concentration.

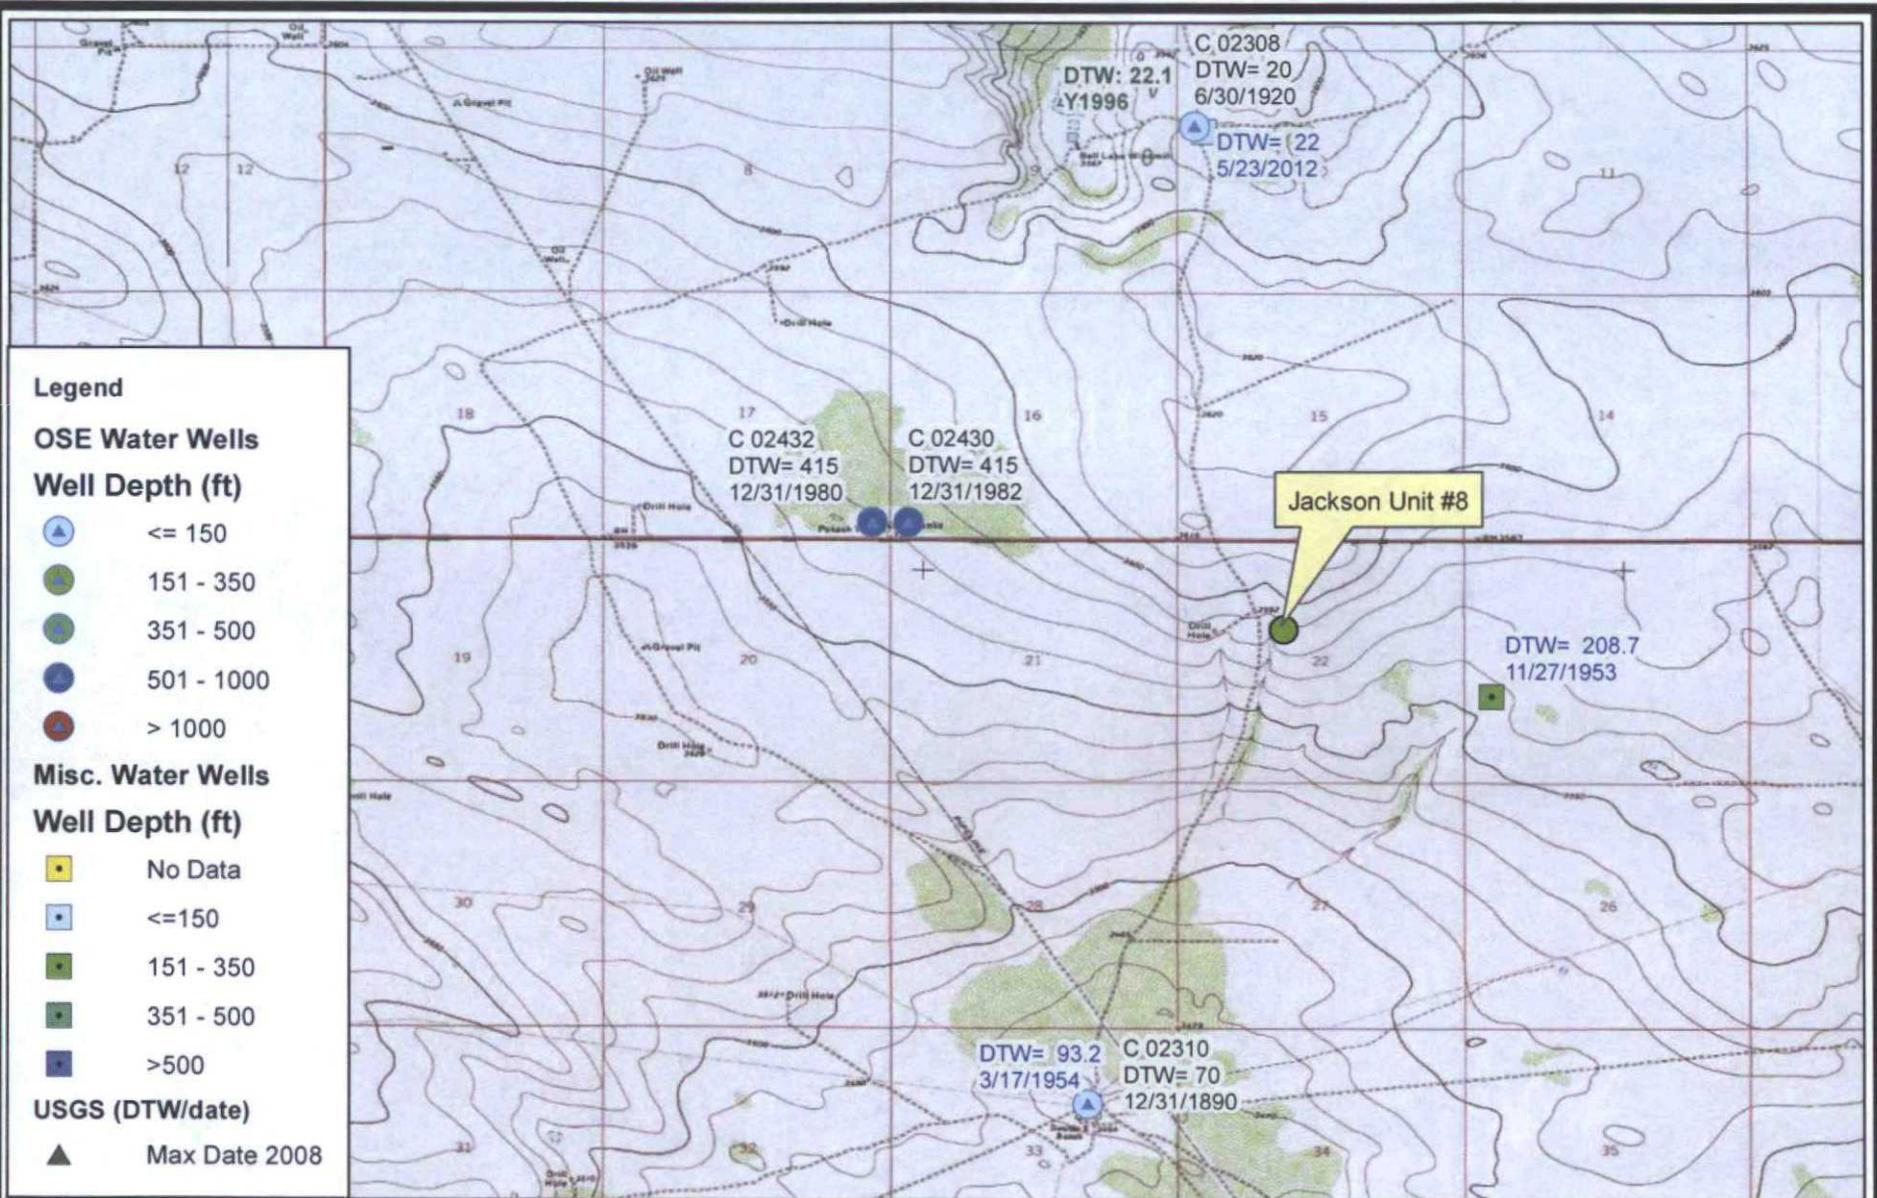
The nearest water well is approximately 5000 feet away, east-southeast. Data from this well and others shown in Figure 3 were employed to estimate groundwater depth at this site to be 287 feet below ground surface, or at an elevation of 3245 feet. Depth to water in the wells associated with the Bell Lake area on the north portion of the map were not used because they obviously tap a shallow water table associated with the ancient collapse feature. Our investigation (previously submitted to OCD) suggests that the shallow water table is localized to the Bell Lake area.

Depth to Groundwater
