Release Notification and Corrective Action

Name of Company	Southern Union Gas Services	Contact	Rose Slade
Address	P.O. Box 1226 Jal, New Mexico 88252	Telephone No.	432-940-5147
Facility Name	Trunk "O" - Fulfer	Facility Type	Natural Gas Pipeline
Surface Owner	Fulfer	Mineral Owner	API No 30-025-28822

**REMEDICATION SUMMARY
AND SITE
CLOSURE REQUEST**

Figure 2
 Site Details & Confirmation
 Soil Sample Locations
 Southern Union Gas Services
 Trunk O Fulfer
 Lea County, NM

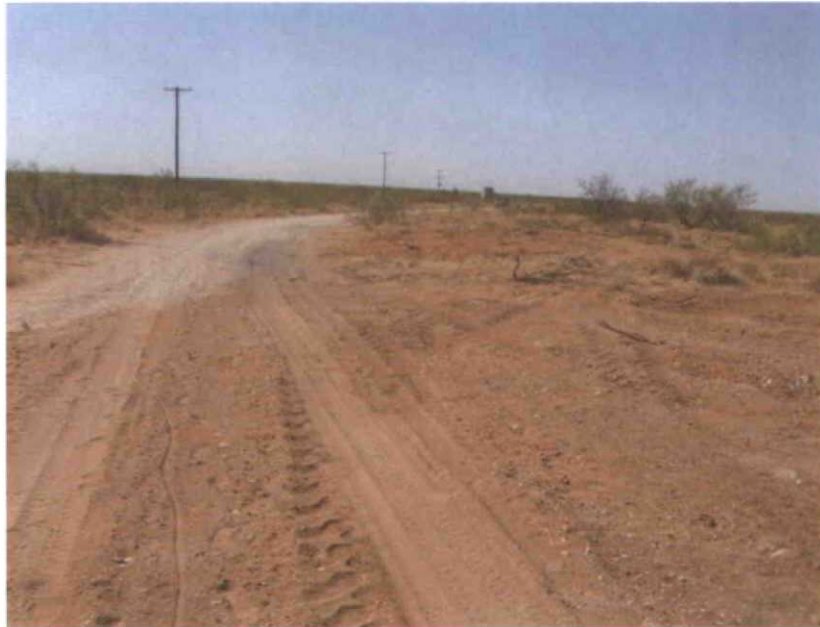
Direction:
Facing Southeast

Description:
View of the initial release.

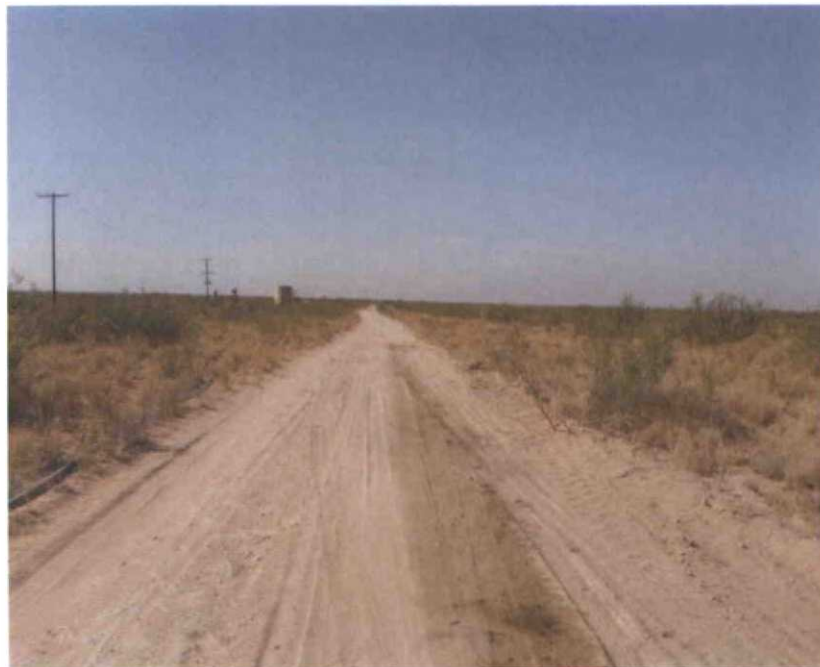
Photograph No. 2

Direction:
Facing South

Description:
View of the initial release.

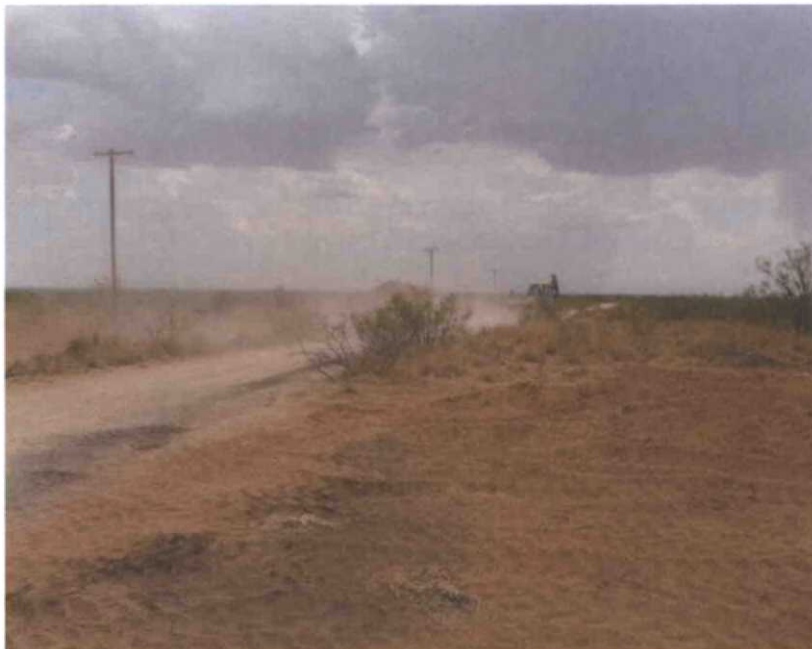
Direction:
Facing Southeast

Description:
View of excavation
activities along the flow
path.

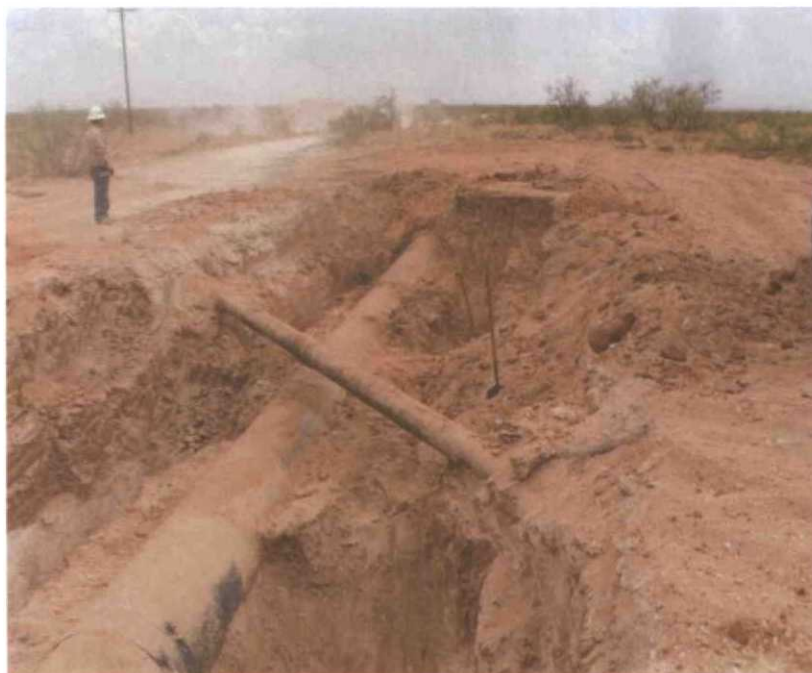
Photograph No. 4

Direction:
Facing Southeast

Description:
View of excavation
activities.

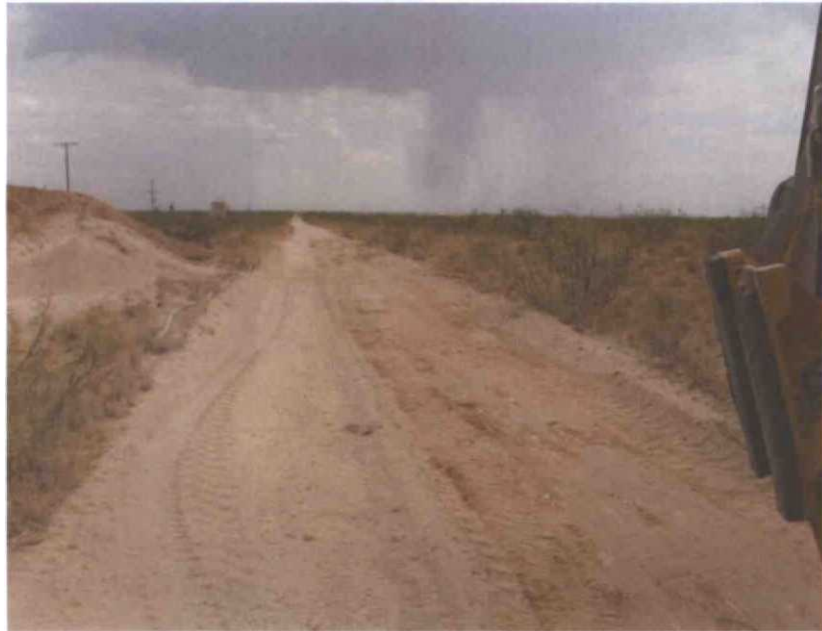
Direction:
Facing South

Description:
View of excavation
activities along the flow
path.

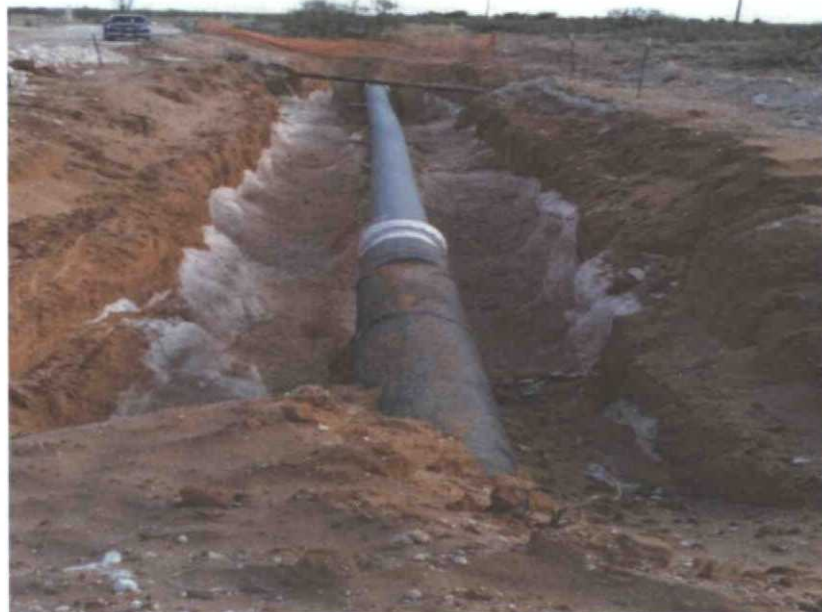
Photograph No. 6

Direction:
Facing North

Description:
View of excavation.

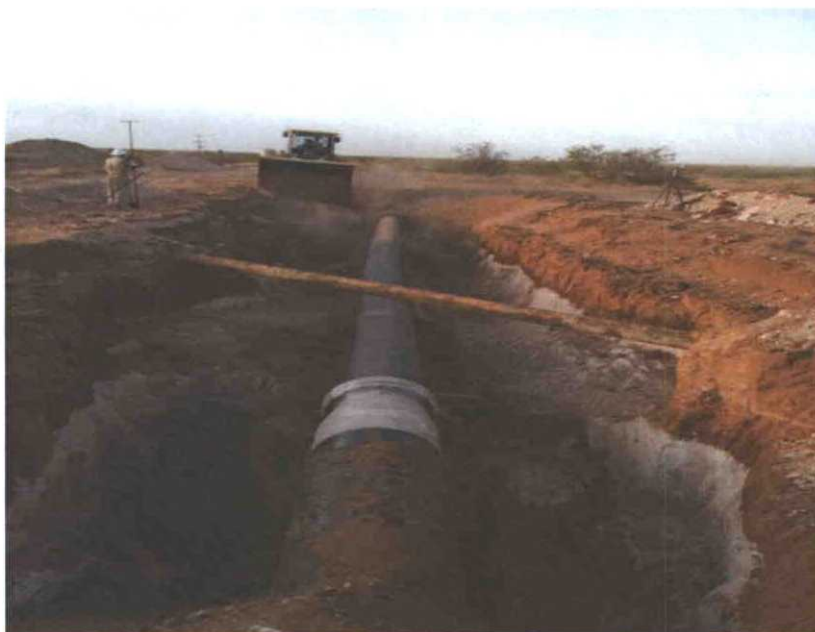
Direction:
Facing South

Description:
View of backfilling
activities.

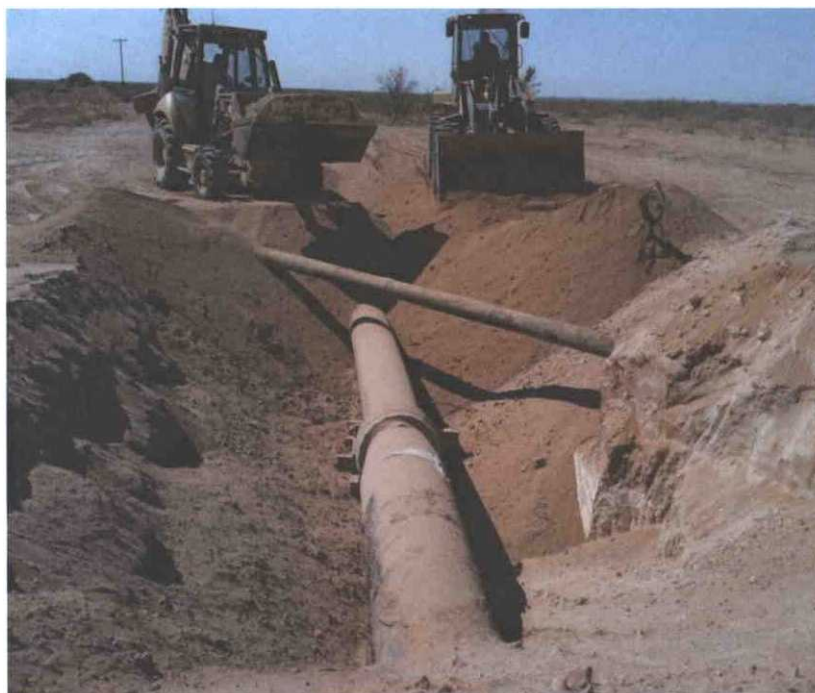
Photograph No. 8

Direction:
Facing South

Description:
View of backfilling
activities.

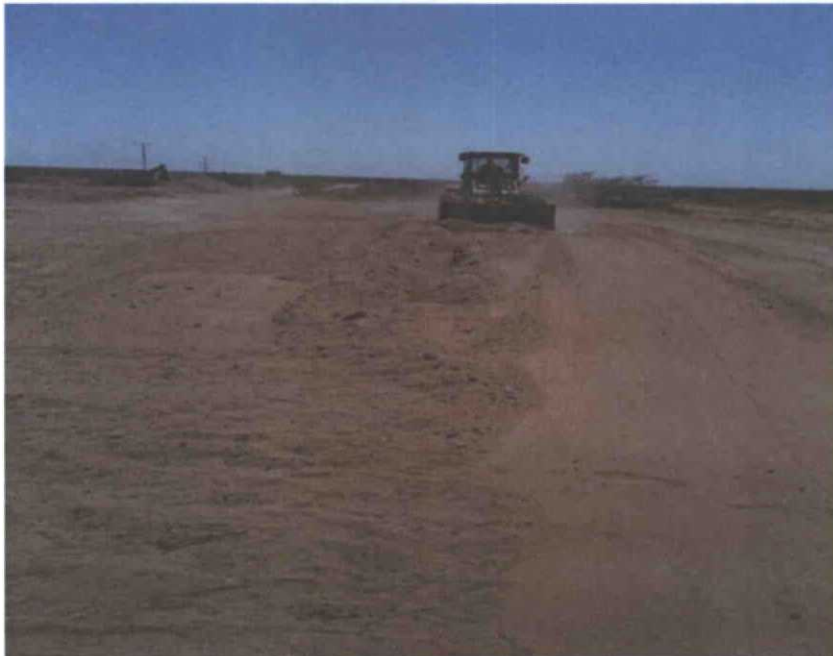
Direction:
Facing South.

Description:
View of site restoration
activities.

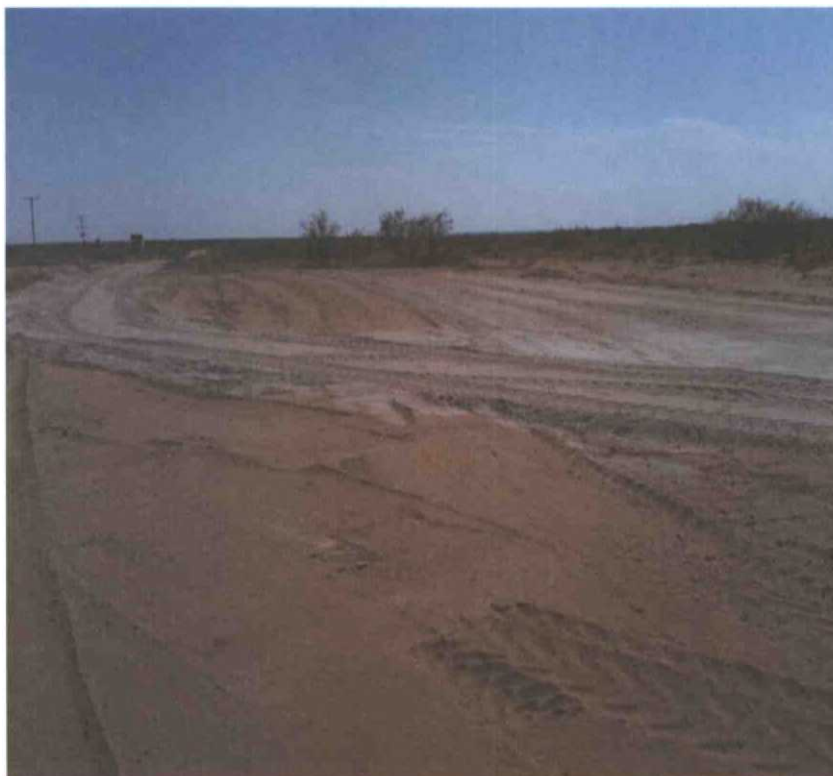
Photograph No. 10

Direction:
Facing South.

Description:
View of restored site.

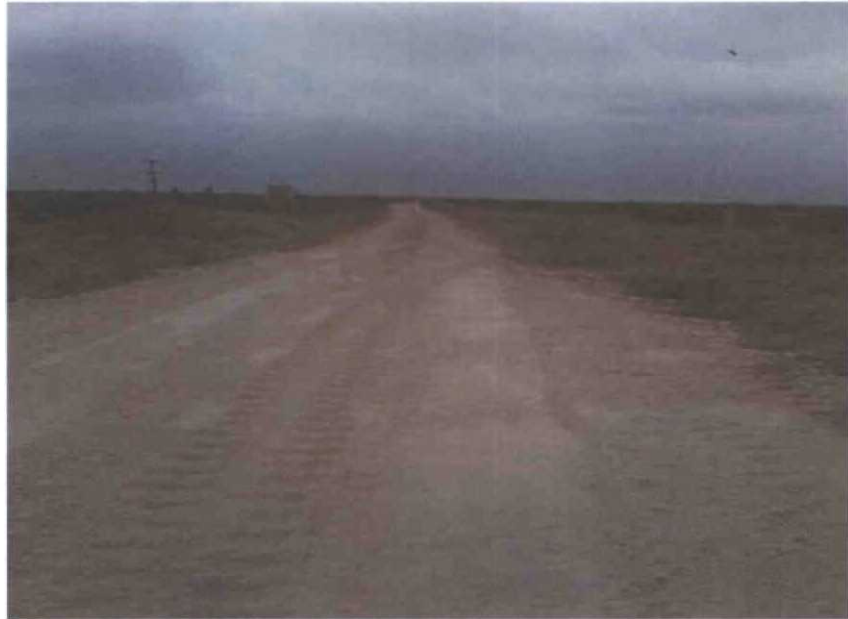
Direction:
Facing South

Description:
View of restored road.
