**Val Verde/ Blanco D
Turbine**

Release Notification and Corrective Action

Blanco Plant D-Turbine Lubrication Oil Release Report

July 11, 2016

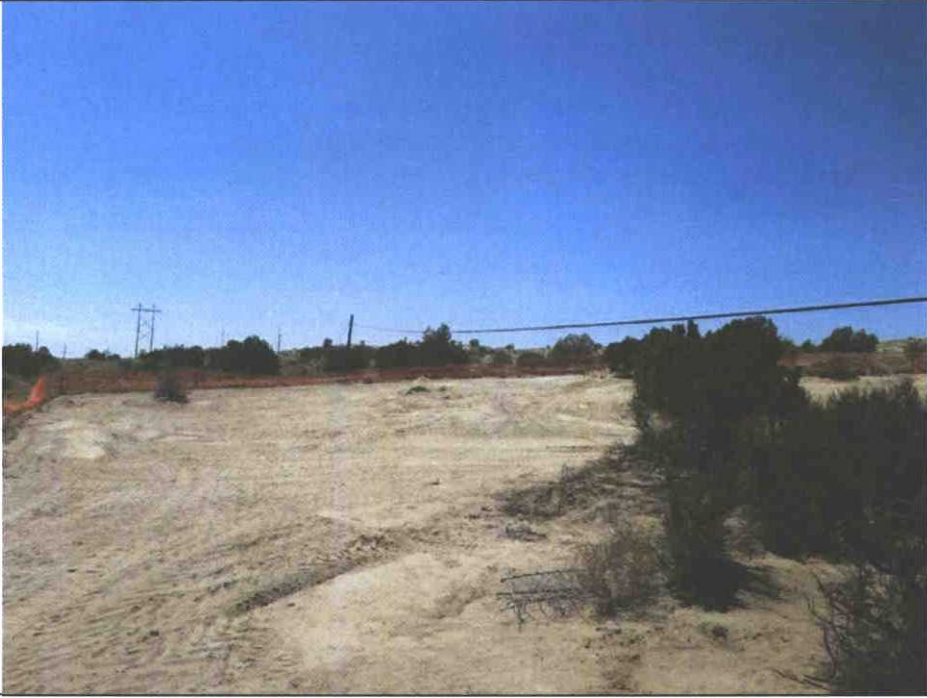
| Photograph #1 | |

| Photo Taken by: Thomas Long | Description: Facing northwest, view of the western portion of the final excavation. |
