Release Notification and Corrective Action

Name of Company Burlington Resources, a Wholly Owned Subsidiary of ConocoPhillips Company	Contact Bobby Spearman
Address 3401 East 30th St, Farmington, NM	Telephone No. (505) 320-3045
Facility Name: Hunsaker 1	Facility Type: Gas Well

Hunsaker #1 Release Report

Unit Letter N, Section 26, Township 31 North, Range 9 West
San Juan County, New Mexico

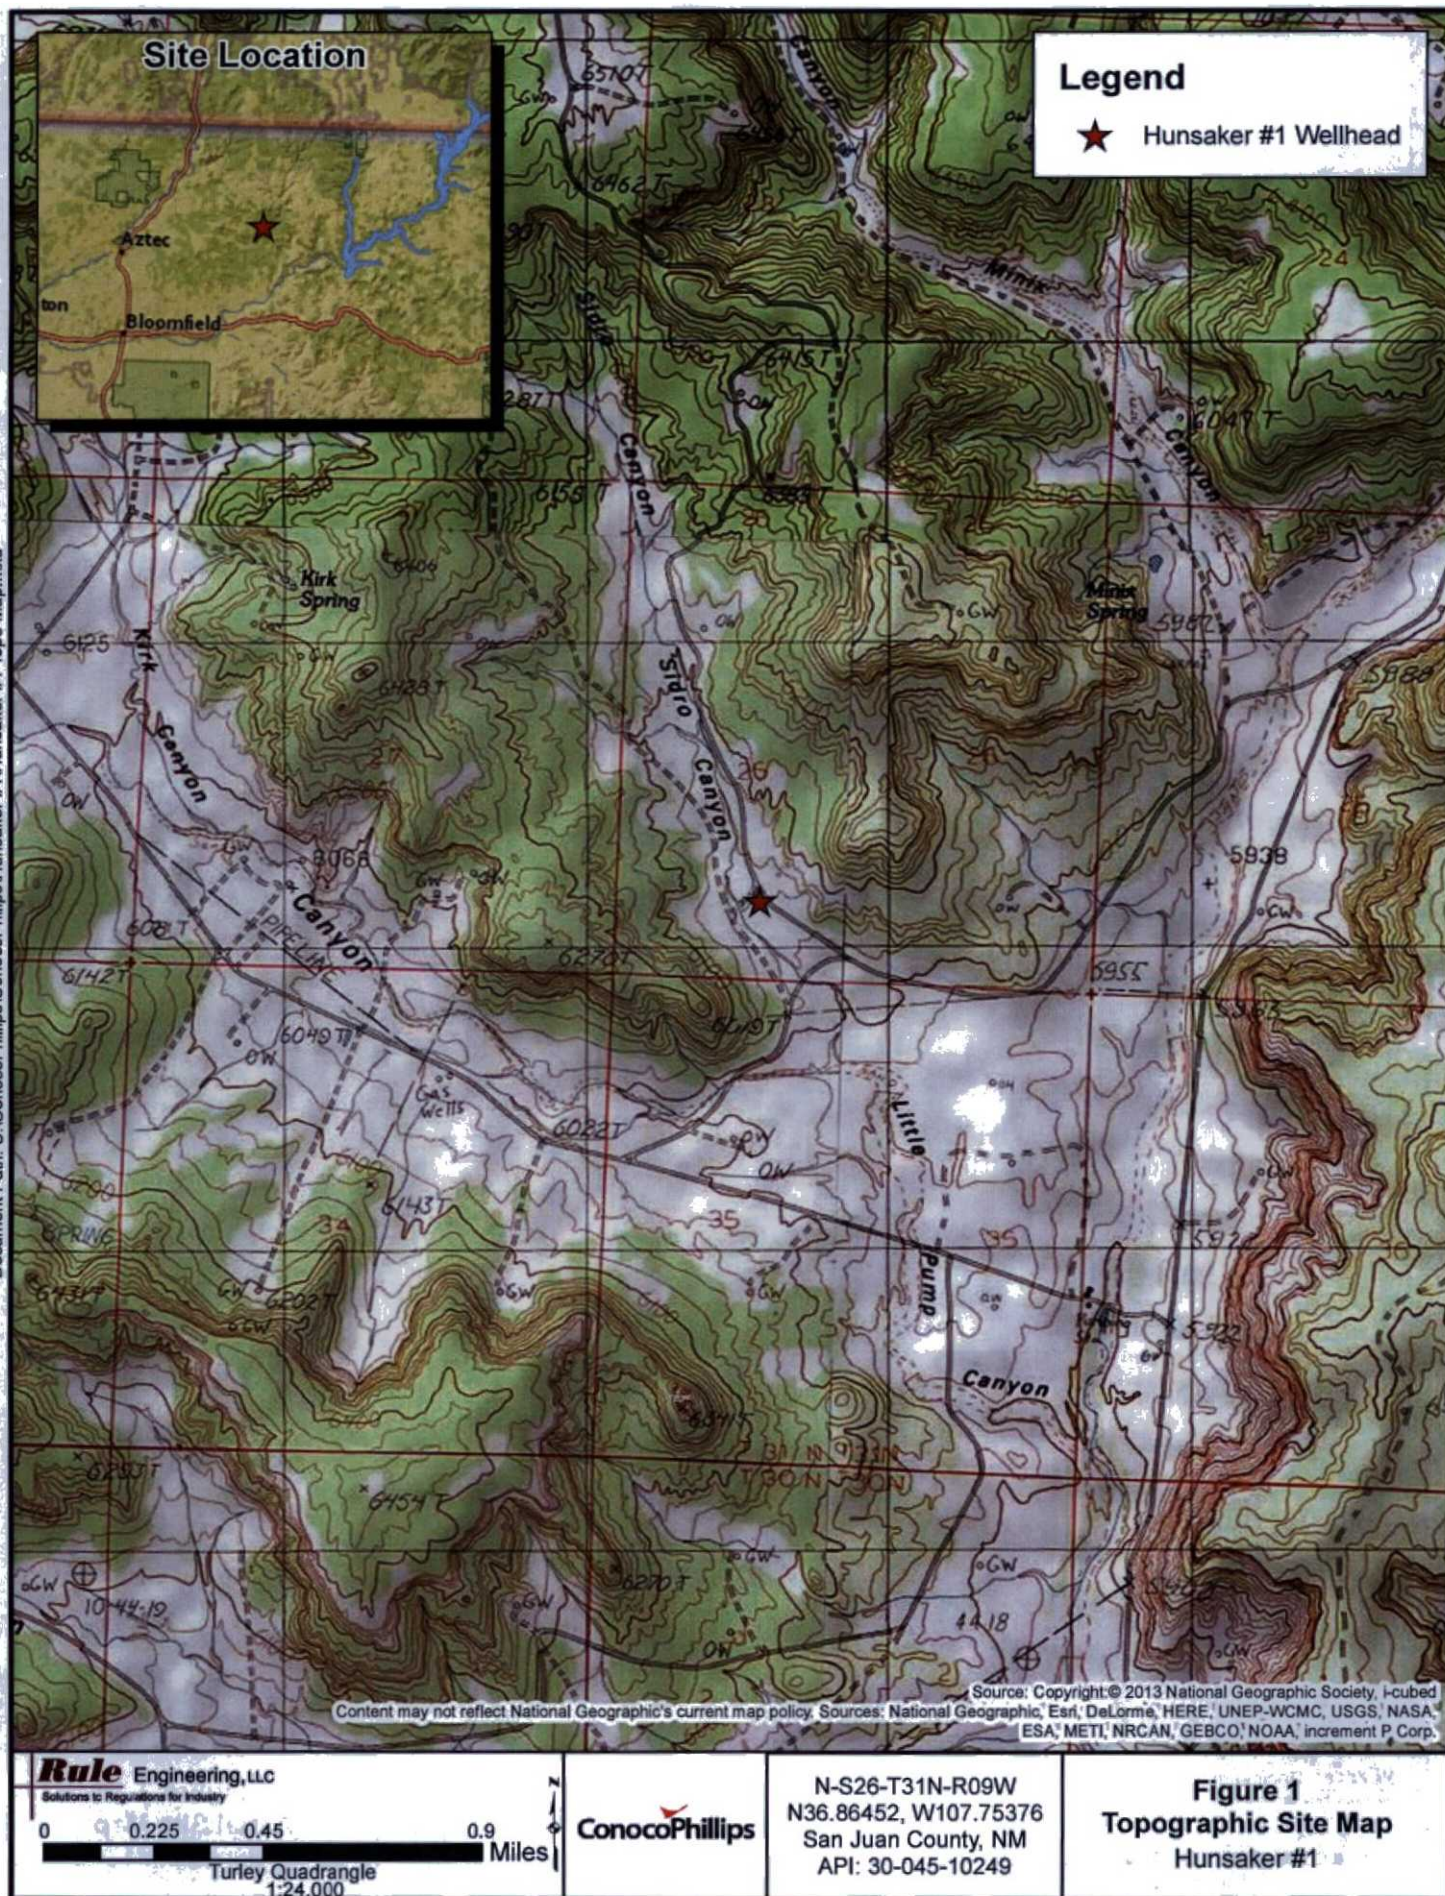
Figure 2
Aerial Site Map
Hunsaker #1

The maximum extent of the excavation measured approximately 16 feet by 16 feet by 7 to 8 feet in depth (3 to 4 feet below the original depth) in the BGT cellar area. The impacted soils were transported to the Envirotech Landfarm near Bloomfield, New Mexico for disposal/remediation and the excavation was backfilled with clean, imported material. A depiction of the final excavation with sample locations is included on Figure 2.

- ★ Hunsaker #1 Wellhead
- ◊ Composite Sample Locations
- ▭ Excavation
- ▭ Berm

Below Grade Tank
(Release Location)
GPS: N36.86454 W107.75341

A topographic map of the location reproduced from the United States Geological Society quadrangle map of the area is included as Figure 1 and an aerial site map is included as Figure 2.
