Release Notification and Corrective Action

CONFIRMATION SAMPLING REPORT

**LOCATED AT:
24" BARKER DOME PIPELINE LEAK
SECTION 27, TOWNSHIP 32N, RANGE 15W
SAN JUAN COUNTY, NEW MEXICO**

**PROJECT NUMBER 14038-0011
MAY 2015**

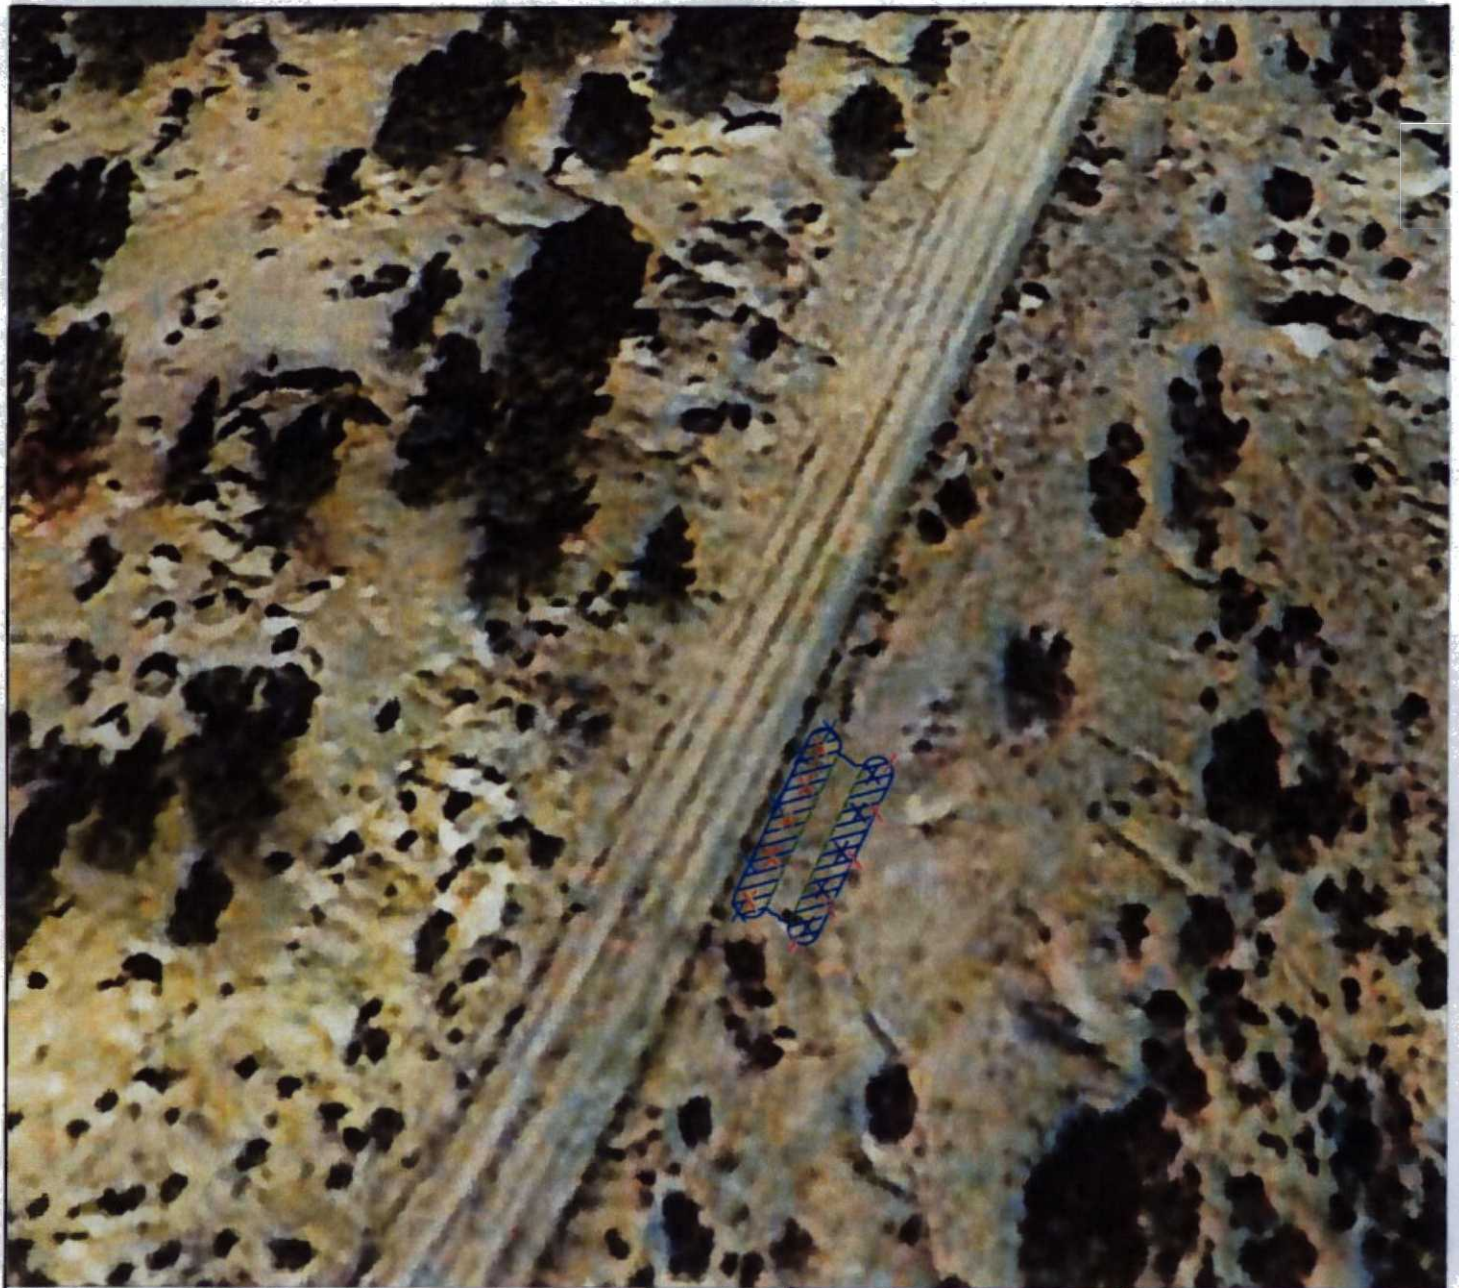
24" Barker Dome Pipeline Leak
SECTION 27, TWP 32 NORTH, RANGE 14 WEST
SAN JUAN COUNTY, NEW MEXICO

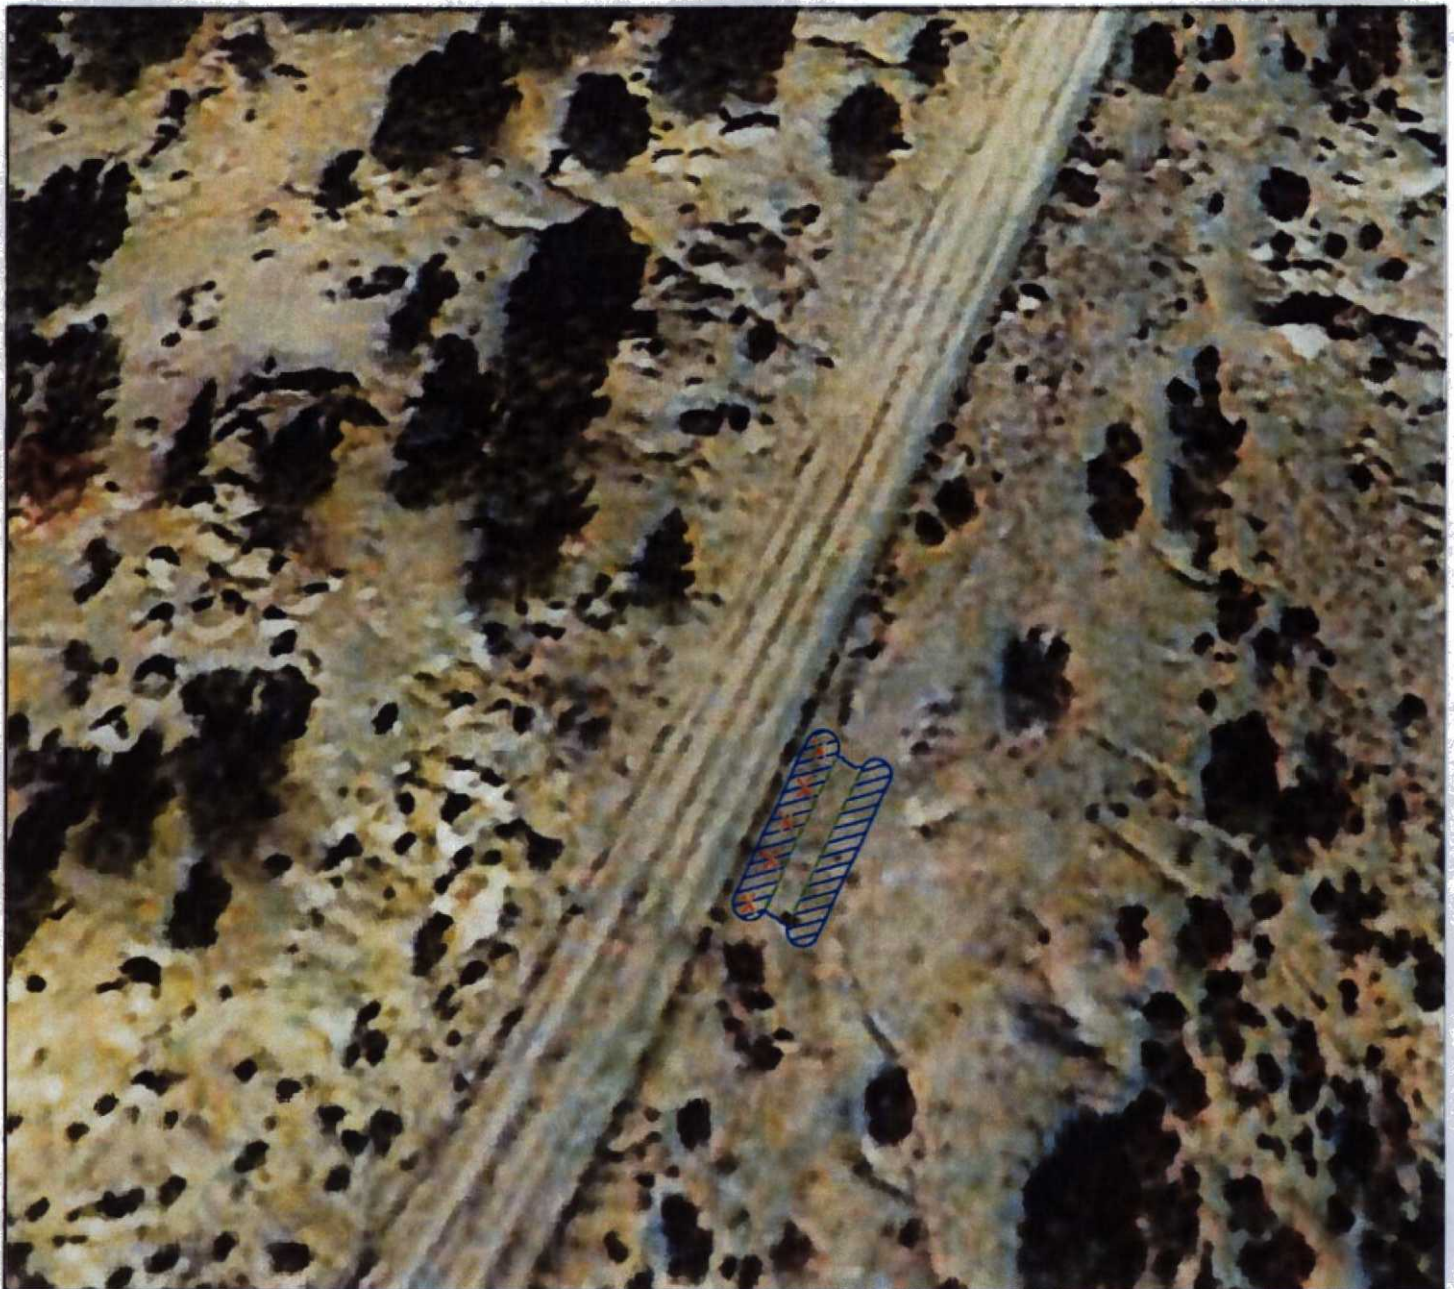
Figure 4, Site Map 3

24" Barker Dome Pipeline Leak

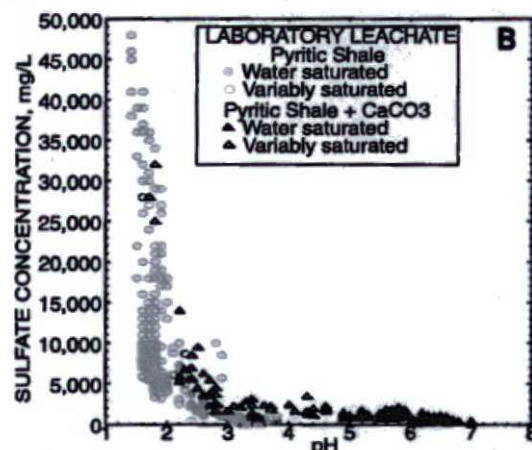
LABORATORY STUDY: COLUMN LEACHATE
 □ Pyritic shale, water saturated; N=59
 ▨ Pyritic shale, variably saturated; N=307
 ▩ Pyritic shale + CaCO₃, water saturated; N=40
 ▩ Pyritic shale + CaCO₃, variably saturated; N=100

Figure 5. Chemistry data for 606 leachate samples from pyritic shale. Data for each of four leaching scenarios, collected biweekly over 3 to 9 months (source: Cravotta, 1996). **A**, Frequency distribution of pH; data for each treatment weighted to represent 25% of the total. **B**, Relation between sulfate concentration and pH. **C**, Relation between sulfate concentration and calcium concentration.

abundance (near-neutral pH) of calcareous minerals necessary to buffer the pH (fig. 5A). Pyritic shale was subjected to leaching under continuously or variably saturated hydrologic conditions; calcite was added in different proportions to evaluate effects on the oxidation of pyrite and the transport of sulfate and metals (Cravotta, 1996). Without the addition of calcite, the leachate from the shale typically had pH 1.5 to 3.5 and high concentrations of sulfate and iron. However, with the addition of calcite, the leachate had pH 4.5 to 7 and lower concentrations of sulfate and iron. The dissolution of calcite not only neutralized acid but decreased pyrite oxidation rates, as indicated by higher pH and Ca^{2+} concentrations and lower SO_4^{2-} concentrations for leachate from shale with added calcite (figs. 5B and 5C). All the leachate samples were undersaturated with respect to gypsum; only leachate in continuously saturated columns with added calcite was saturated or supersaturated with respect to calcite.

The leaching tests also showed the hydrology of a mine has an important effect on pyrite oxidation. By maintaining stagnant, water-saturated conditions, which minimized the oxygen available for reactions, pyrite oxidation was minimized, as indicated by low SO_4^{2-} concentrations in leachate (figs. 5A and 5B). The leaching data can be summarized generally as follows:

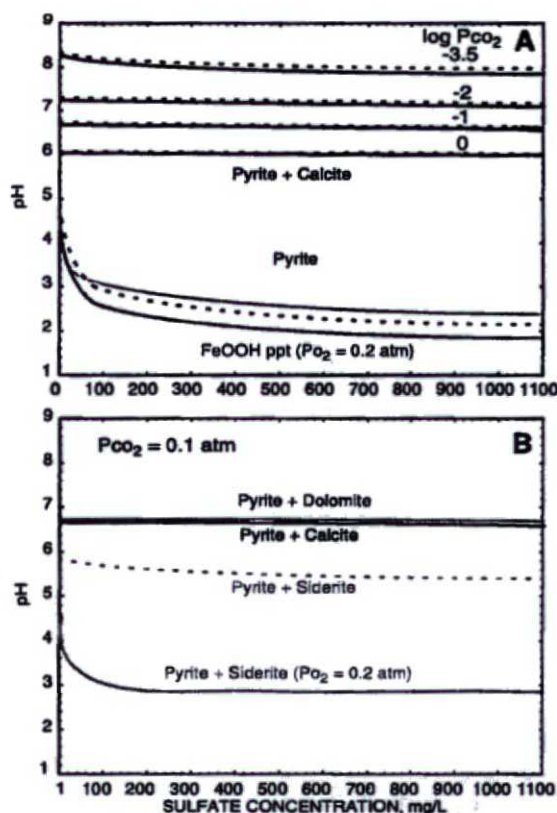
FIGURE 6. Simulated pH and sulfate concentration resulting from pyrite oxidation under different conditions (dashed line O_2 limited; solid line $\text{Po}_2=0.2$ atm). Simulations conducted using PHREEQC (Parkhurst, 1995); temperature = 10°C , $\text{Pco}_2 = 0.1$ atm, and amorphous $\text{Fe}(\text{OH})_3$ allowed to precipitate, unless specified. A, Effects of Po_2 and Pco_2 and equilibrium with calcite. B, Equilibrium with various carbonate minerals.

Firstly, the oxidation of pyrite, in the absence of calcite, is considered for different Pco_2 and Po_2 (fig. 6A). Except for depressing the pH of initially pure water, varying Pco_2 from $10^{-3.5}$ to 10^{-1} atm has little effect on the pH after pyrite oxidation has begun. In contrast, limiting the availability of oxygen has a significant effect on the pH as simulated for an "open system" (air equilibrium, $\text{Po}_2=0.2$ atm, for complete oxidation of S and Fe in FeS_2 by reactions 1 and 2) or a "closed system" (3.5 mol O_2 per mol FeS_2 for oxidation of only S by reaction 1). Starting with pure water in equilibrium with ambient Pco_2 , pH declines from 5.5 to 4 with the oxidation of only a small quantity of pyrite ($0.012 \text{ g}\cdot\text{L}^{-1}$ FeS_2 produces pH~4 and $20 \text{ mg}\cdot\text{L}^{-1}$ SO_4^{2-}); continued pyrite oxidation decreases pH to about 3 at the point where total SO_4 concentration is $100 \text{ mg}\cdot\text{L}^{-1}$. As SO_4 concentration increases from 100 to $1,200 \text{ mg}\cdot\text{L}^{-1}$ the pH declines asymptotically approaching 2. For an open system, where oxygen is unlimited, the oxidation of pyritic S and Fe^{2+} and the precipitation of amorphous $\text{Fe}(\text{OH})_3$ (reactions 1 and 2) results in pH about 0.3 units greater than that for the closed system where oxygen is limited to only the stoichiometric amount needed to produce SO_4^{2-} (reaction 1). The pH decreases about 0.5 units if a phase such as goethite (FeOOH) precipitates instead of higher solubility amorphous $\text{Fe}(\text{OH})_3$, resulting in pH under air equilibrium that is less than that under oxygen limited conditions (fig. 6A). The narrow range of pH results mainly from the logarithmic scale for pH, plus buffering by ionic complexation $\text{Fe}(\text{OH})^{2+}/\text{Fe}^{3+}$ and $\text{SO}_4^{2-}/\text{HSO}_4^-$
