**Range Operating New Mexico, Inc.  
SCB 23-19 Injection Facility  
Section 23, Township 23 South, Range 28 East  
Eddy County, New Mexico**

**Closure Report**

**September 28, 2010**

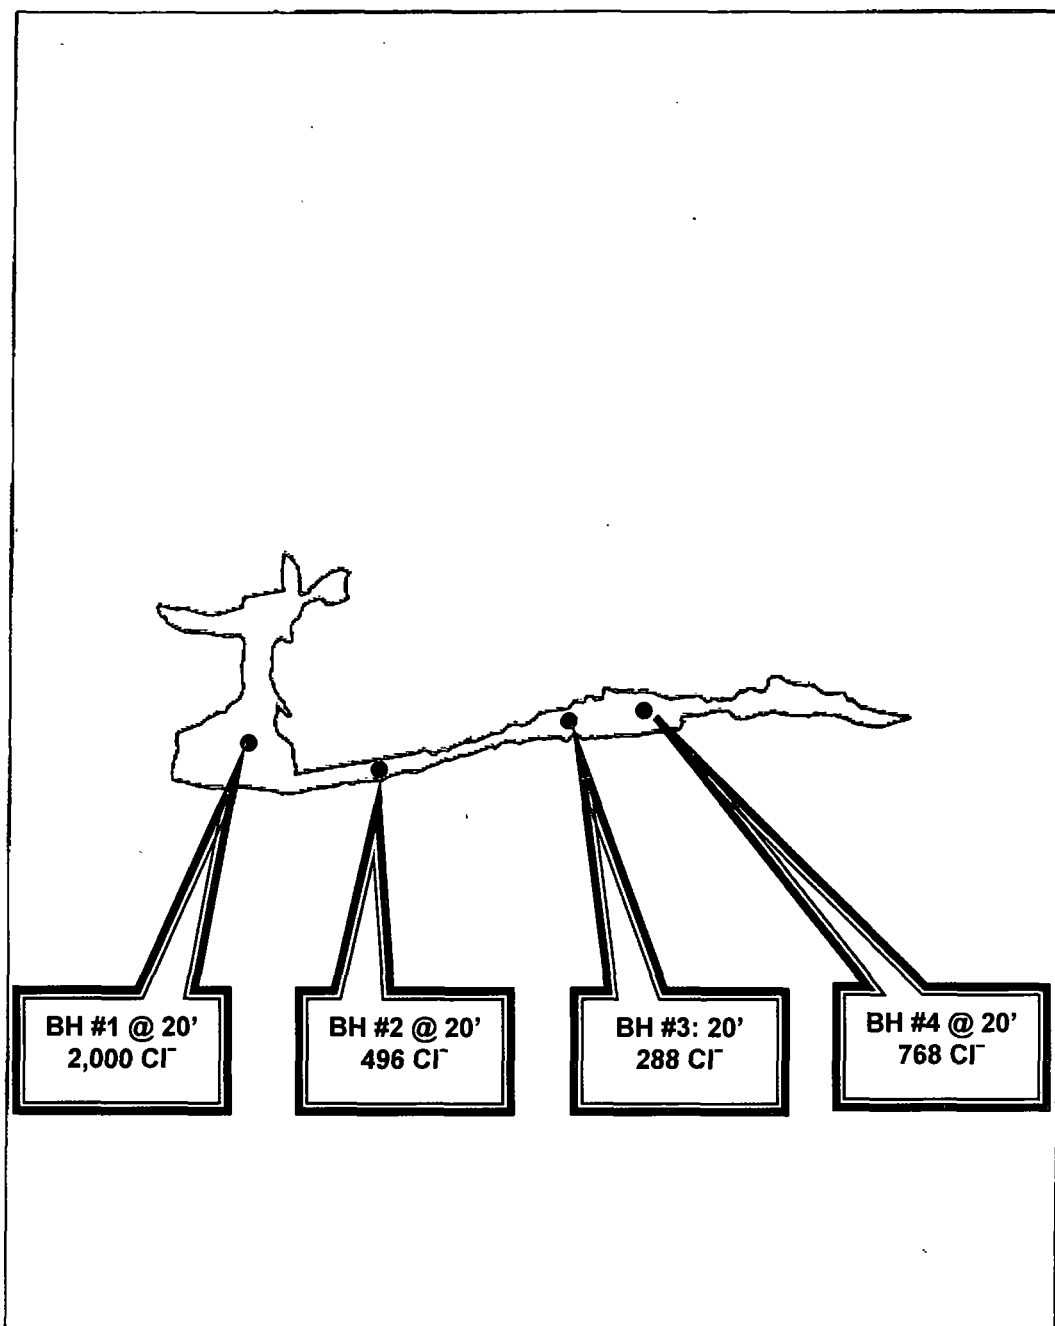
**Figure 2**  
**Site Plan**

## SCB 23-19 Injection Facility

On August 17, 2009, SESI was onsite to assess the affected area. The area was mapped using a Trimble Geo XM GPS. SESI observed that the release had runoff into the lined firewalls of the tank battery. The fluid had overflow onto the location on the north end then traveling approximately 200 yards to the east. A hand auger was utilized to attempt to delineate the spill area. A total of eight (8) auger holes were selected all resulting in auger refusal from 6" to 10" bgl.

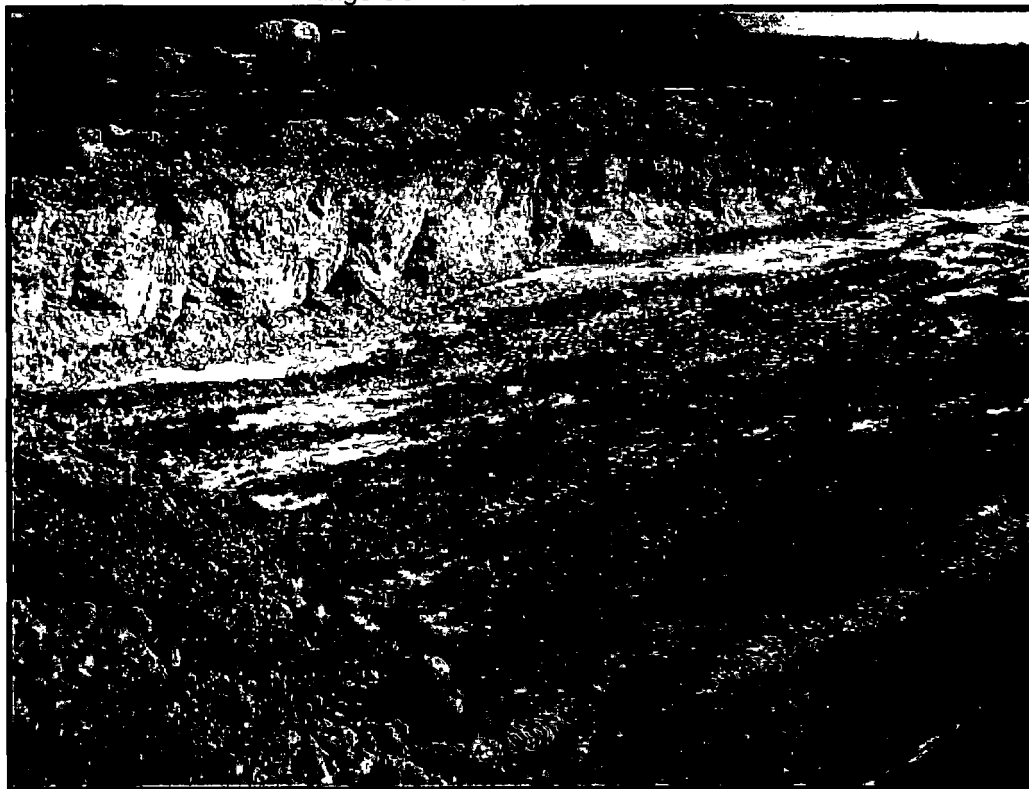
Excavated area facing north

On September 17, 2010, SESI was onsite to begin excavation of release area. The area was excavated to a depth of four (4) feet below grade surface. The highly contaminated soils were transported to a New Mexico Oil Conservation Division (NMOCD) approved facility for disposal. Approximately 1,340 yards of contaminated soils were transported to disposal. Five (5) samples were retrieved at a depth of 4 feet below grade surface at bottom of excavation and transported under Chain of Custody to Cardinal Laboratories to be analyzed for Chlorides (EPA Method 4500 B). The results are as follows:

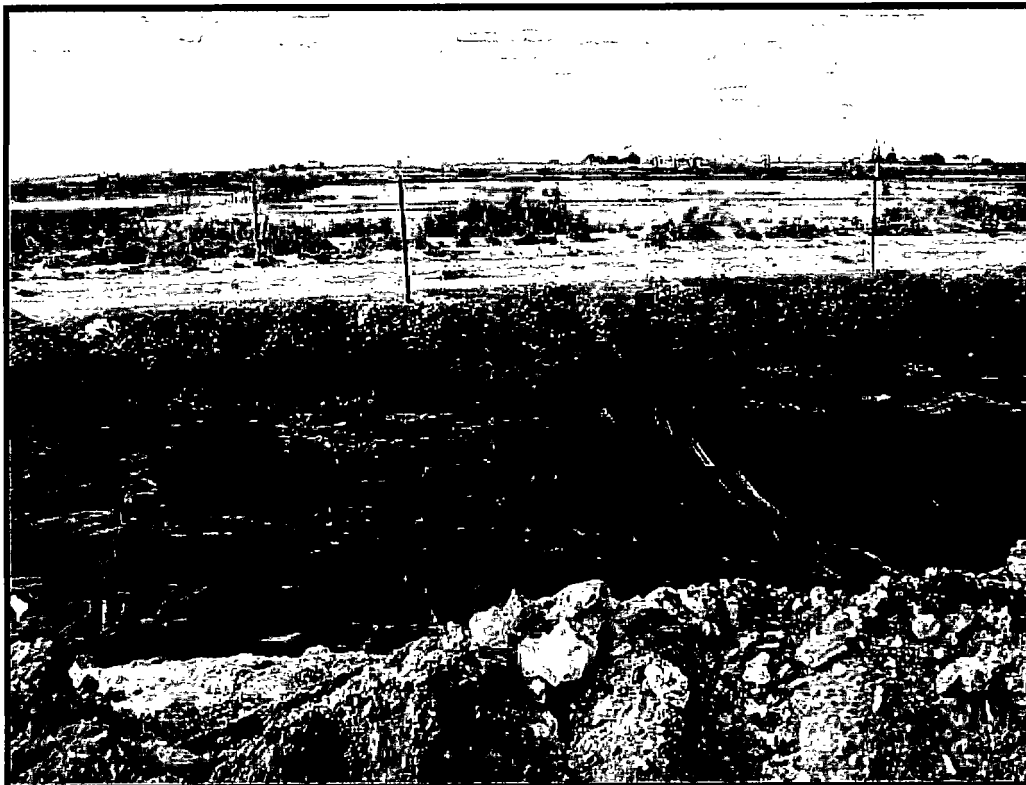
Excavated area lined facing south

A 162' X 40' 20-mil reinforced geo-membrane liner was installed at bottom of excavation. The area was then backfilled with approximately 1,500 yards of caliche from an offsite facility and contoured to its natural grade.

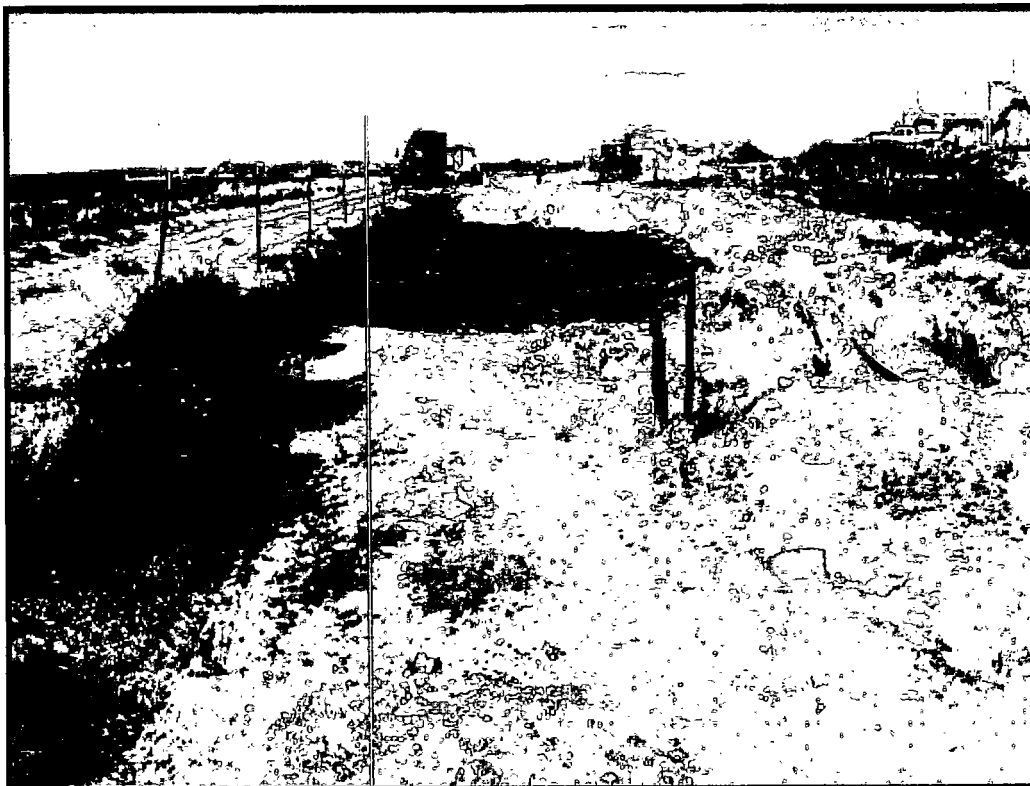
Excavated area lined facing west

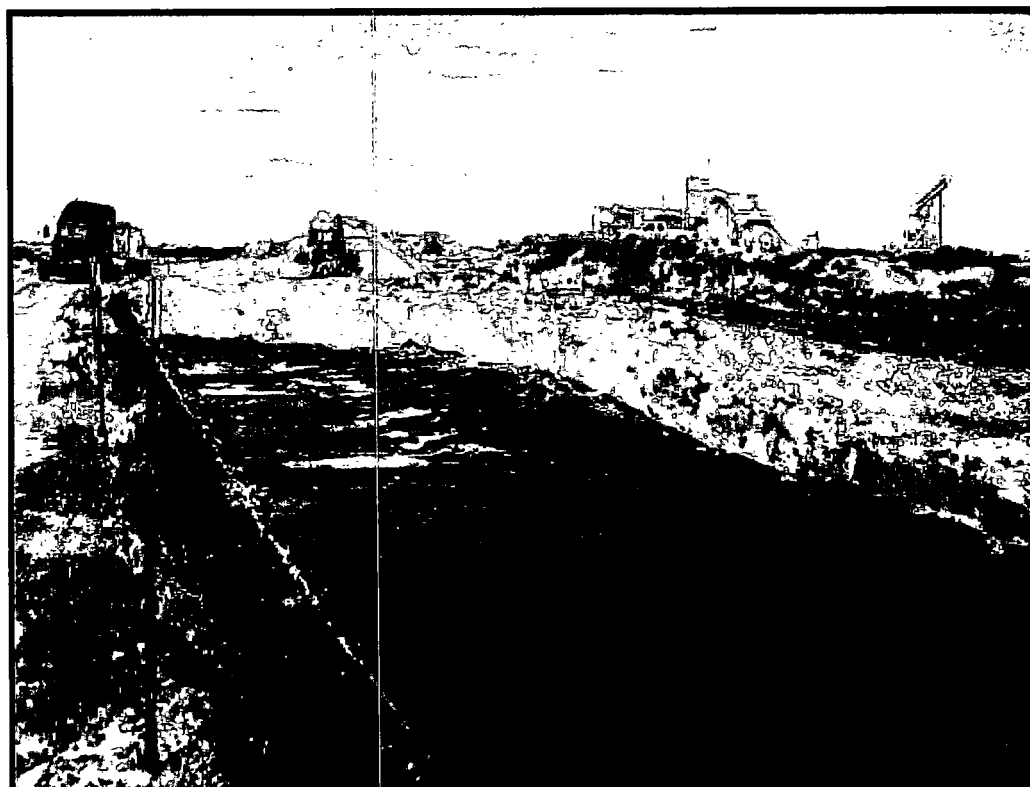
Excavated area lined facing northwest

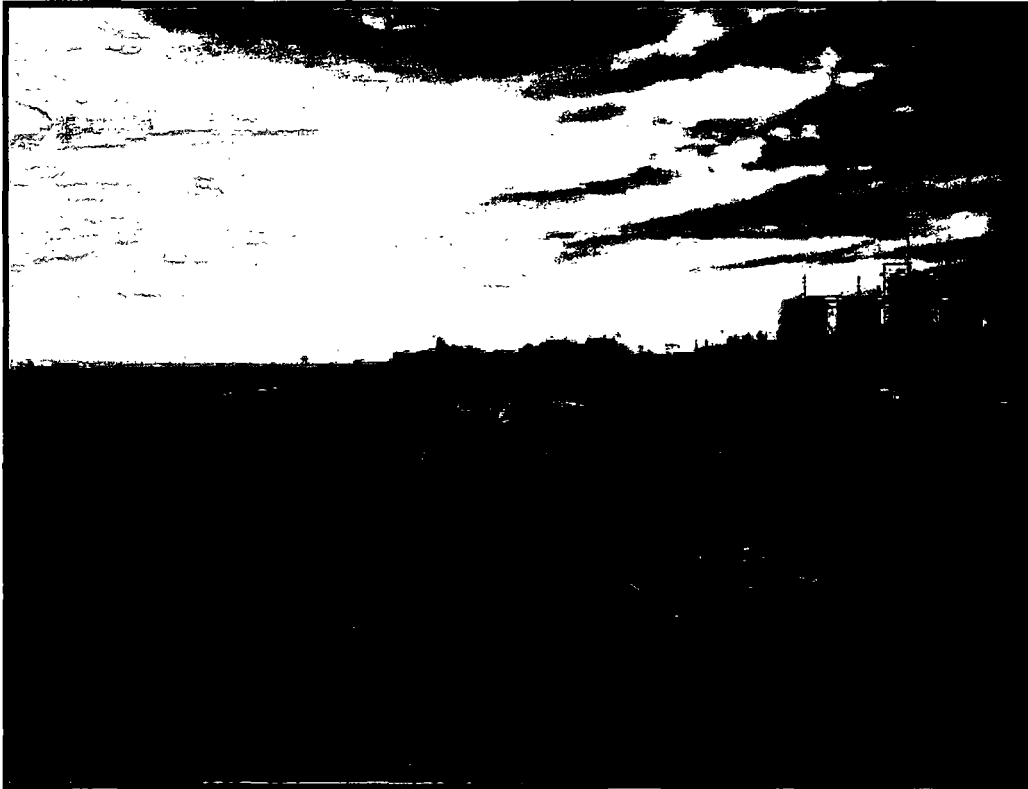
Excavated area backfilled facing west
