**3RP - 1011**

**ENTERPRISE PRODUCTS OPERATING, LLC**

**Release Report/ General  
Correspondence**

Name of Company: Enterprise Field Services LLC	Contact: Thomas Long
Address: 614 Reilly Ave, Farmington, NM 87401	Telephone No. 505-599-2286
Facility Name: Trunk 3A	Facility Type: Natural Gas Gathering Pipeline

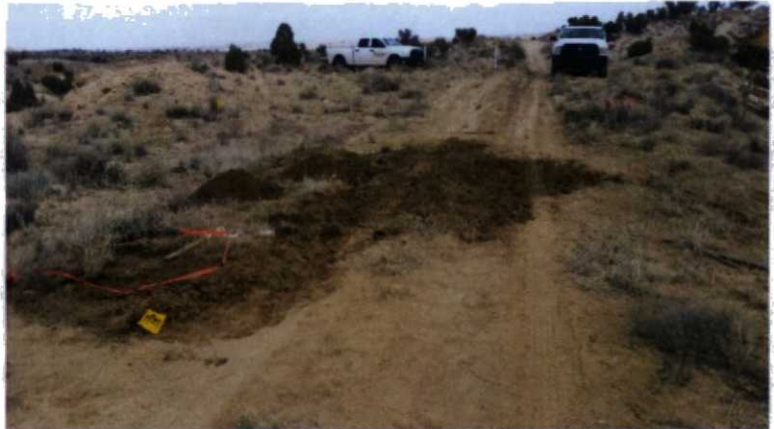
**Photograph 1**

View of the release area, facing northwest.

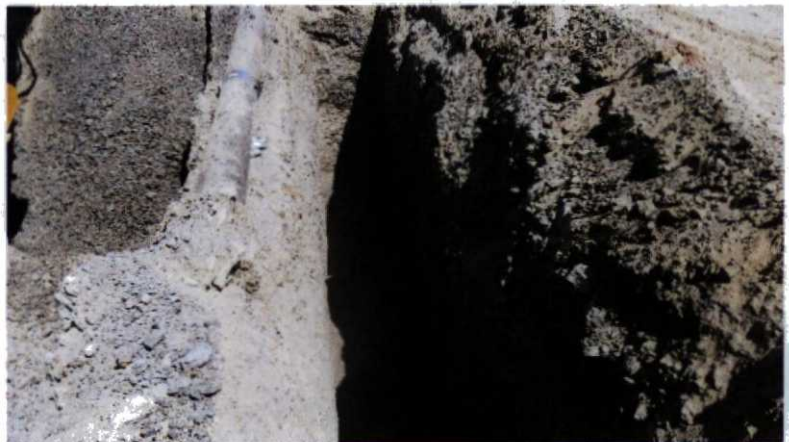
**Photograph 2**

View of in-process corrective action activities, facing northwest.

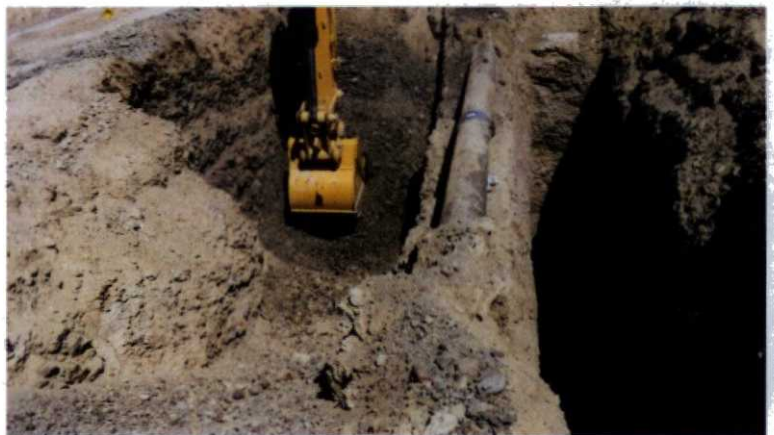
**Photograph 3**

View of in-process corrective action activities, facing northwest.

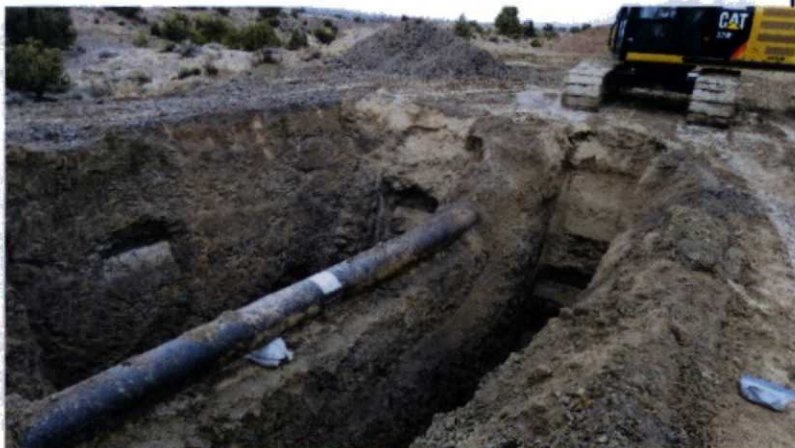
**Photograph 4**

View of the final excavation, facing northwest.

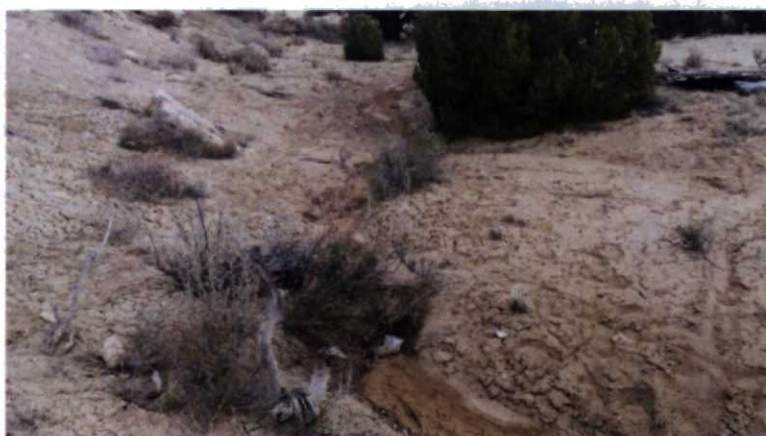
**Photograph 5**

View of the east release flow path, facing northwest.

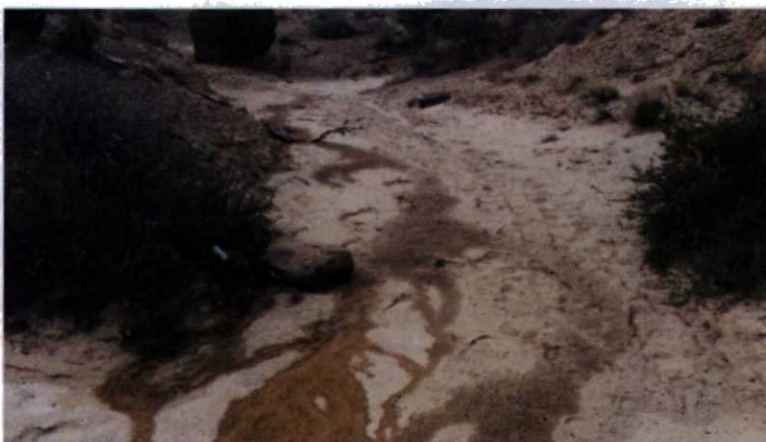
**Photograph 6**

View of the west release flow path, facing south.

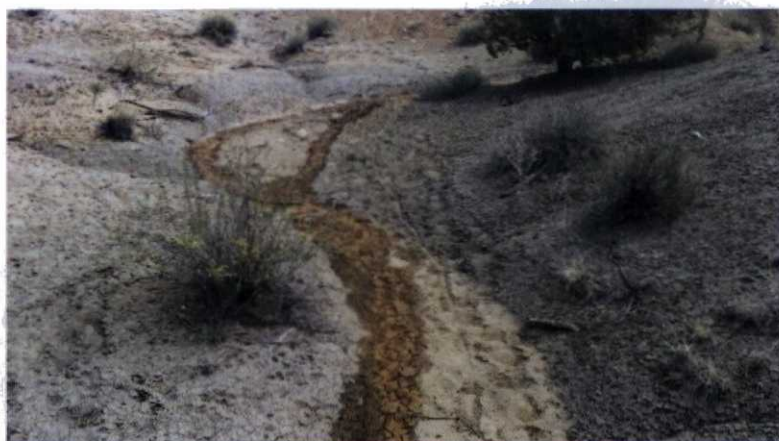
### Photograph 7

View of the west release flow path, facing southeast.

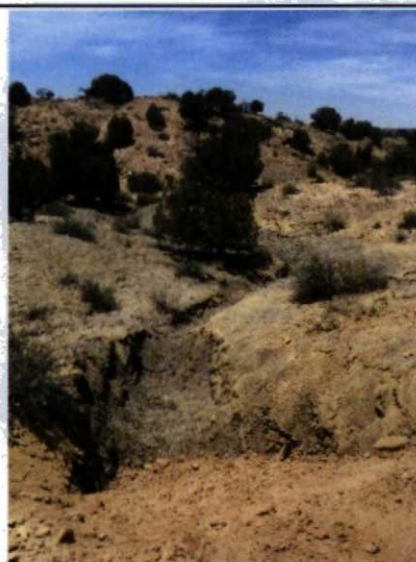
### Photograph 8

View of the remediated west flow path, facing southwest.

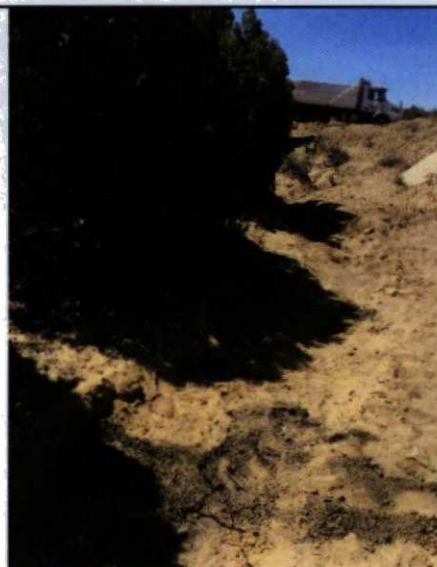
### Photograph 9

View of the remediated east flow path, facing south.

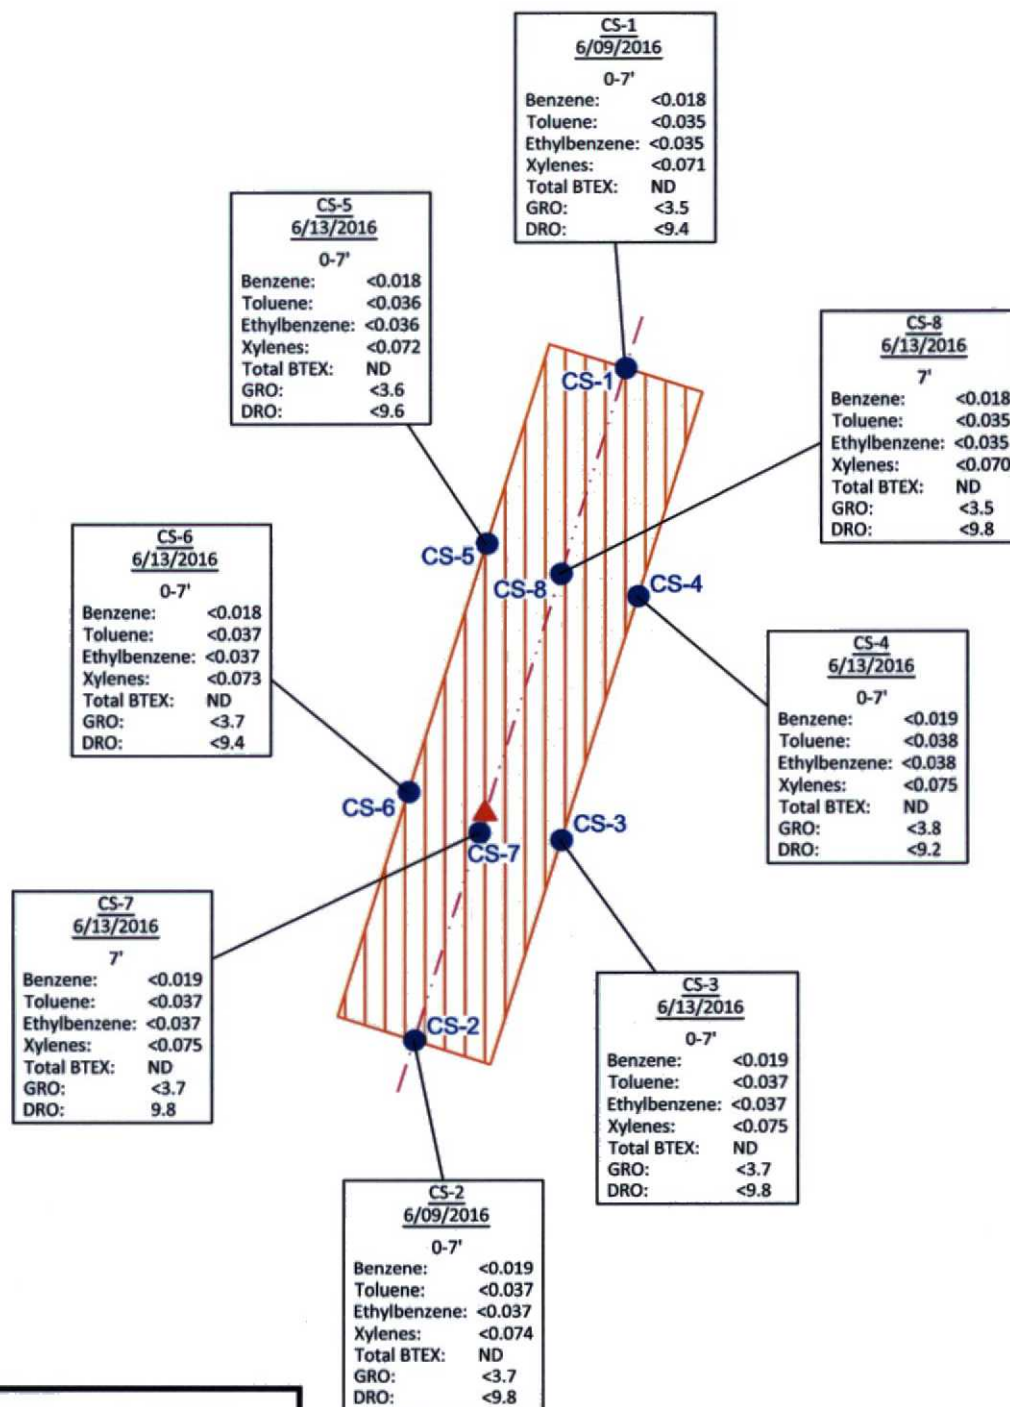
**FIGURE 3**

**Site Map with  
Excavation Soil  
Analytical Results**

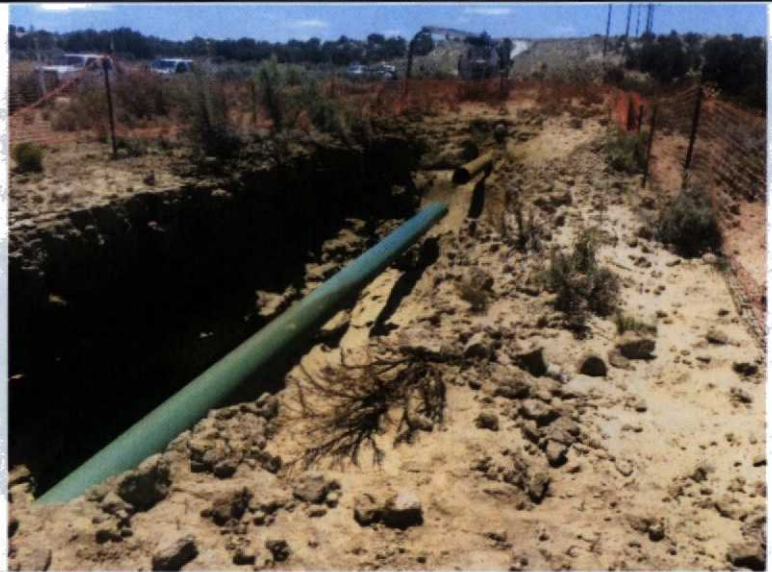
**Photograph 1**

Describe Area Affected and Cleanup Action: A rupture hole of approximately 80 feet long by 20 feet wide approximately 8 feet deep was created. Fluids from the pipeline rupture were sprayed approximately 350 feet to the south. Repair and remediation activities were completed on June 13, 2016. The residual contaminant mass was removed by mechanical excavation. Approximately 58 cubic yards of hydrocarbon impacted soil were excavated and transported to a New Mexico Oil Conservation Division approved land farm facility. A third party corrective action report is included with this "Final" C-141.

View of the blowout "crater", facing southwest.

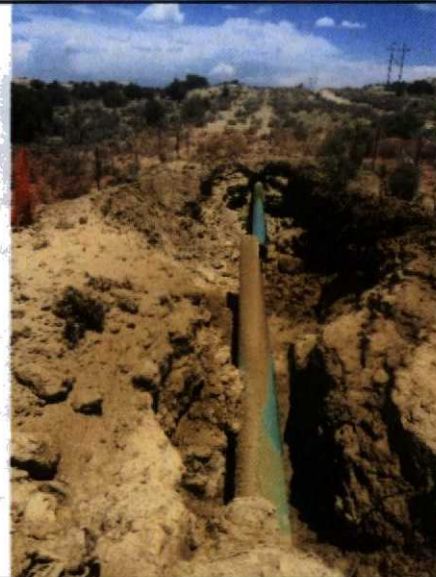
**Photograph 2**

View of the blowout "crater", facing northeast.

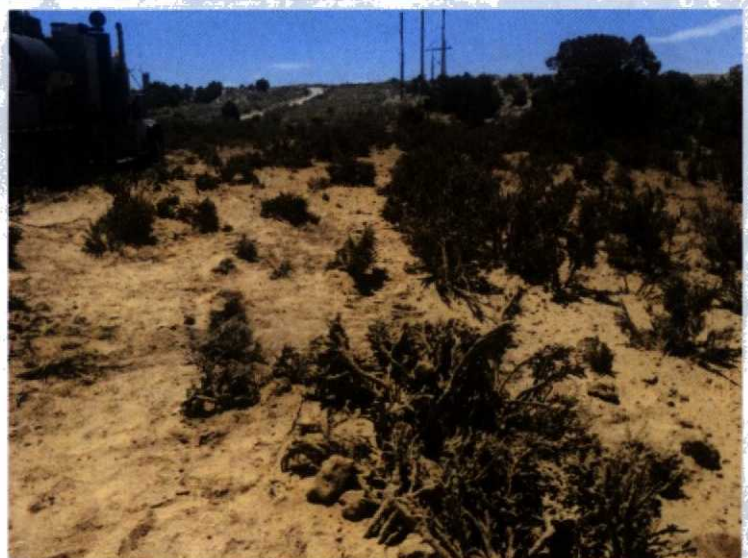
**Photograph 3**

View of the overspray area, facing southwest.

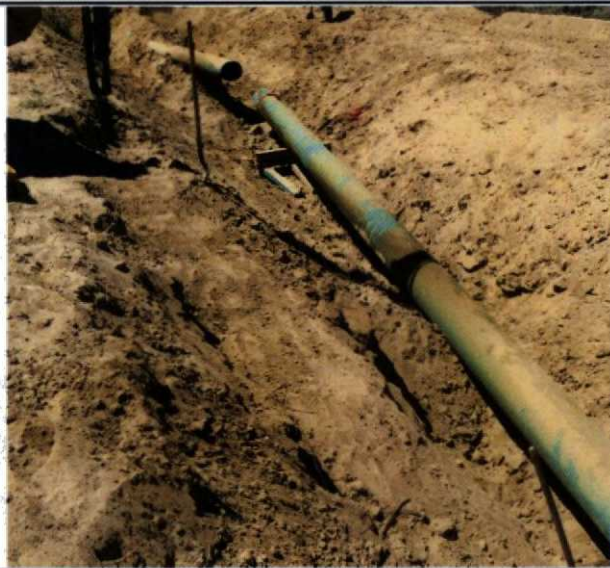
**Photograph 4**

View of the in-process corrective action activities, facing southwest.

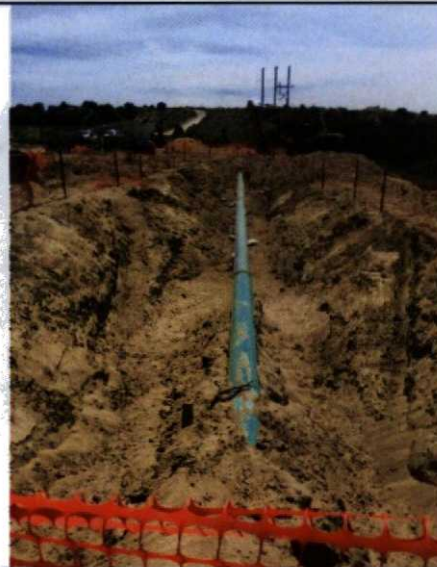
**Photograph 5**

View of the final excavation and repaired pipeline, facing southwest.

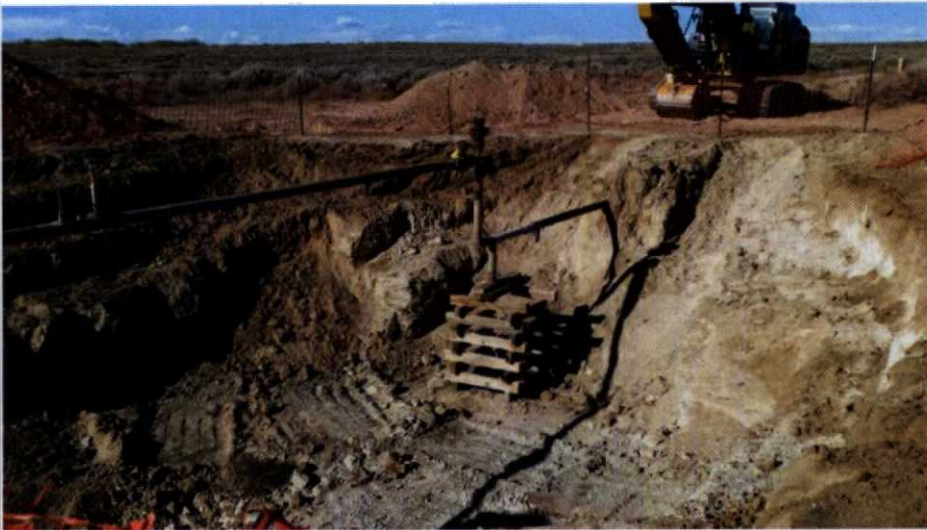
Photograph #1

Client: Enterprise	
Site Name:  Edgar Federal #7 Pipeline Valve Release	
Date Photo Taken: May 3, 2016	
Release Location: N36.58432, W108.05709 P-12-27N-12W San Juan County, NM	
Photo Taken by: Justin Valdez	Description: Facing northeast, view of the final excavation.

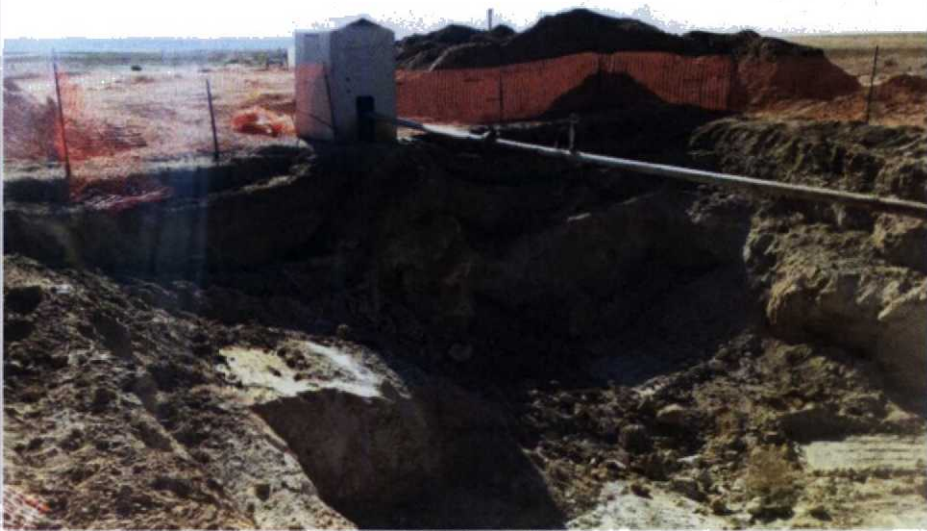
Photograph #2

Client: Enterprise	
Site Name:  Edgar Federal #7 Pipeline Valve Release	
Date Photo Taken: May 3, 2016	
Release Location: N36.58432, W108.05709 P-12-27N-12W San Juan County, NM	
Photo Taken by: Justin Valdez	Description: Facing northwest, view of the final excavation.
