**3R-1011**

**Release Report/ General  
Correspondence**

**Enterprise SJ**

**Release Notification and Corrective Action**

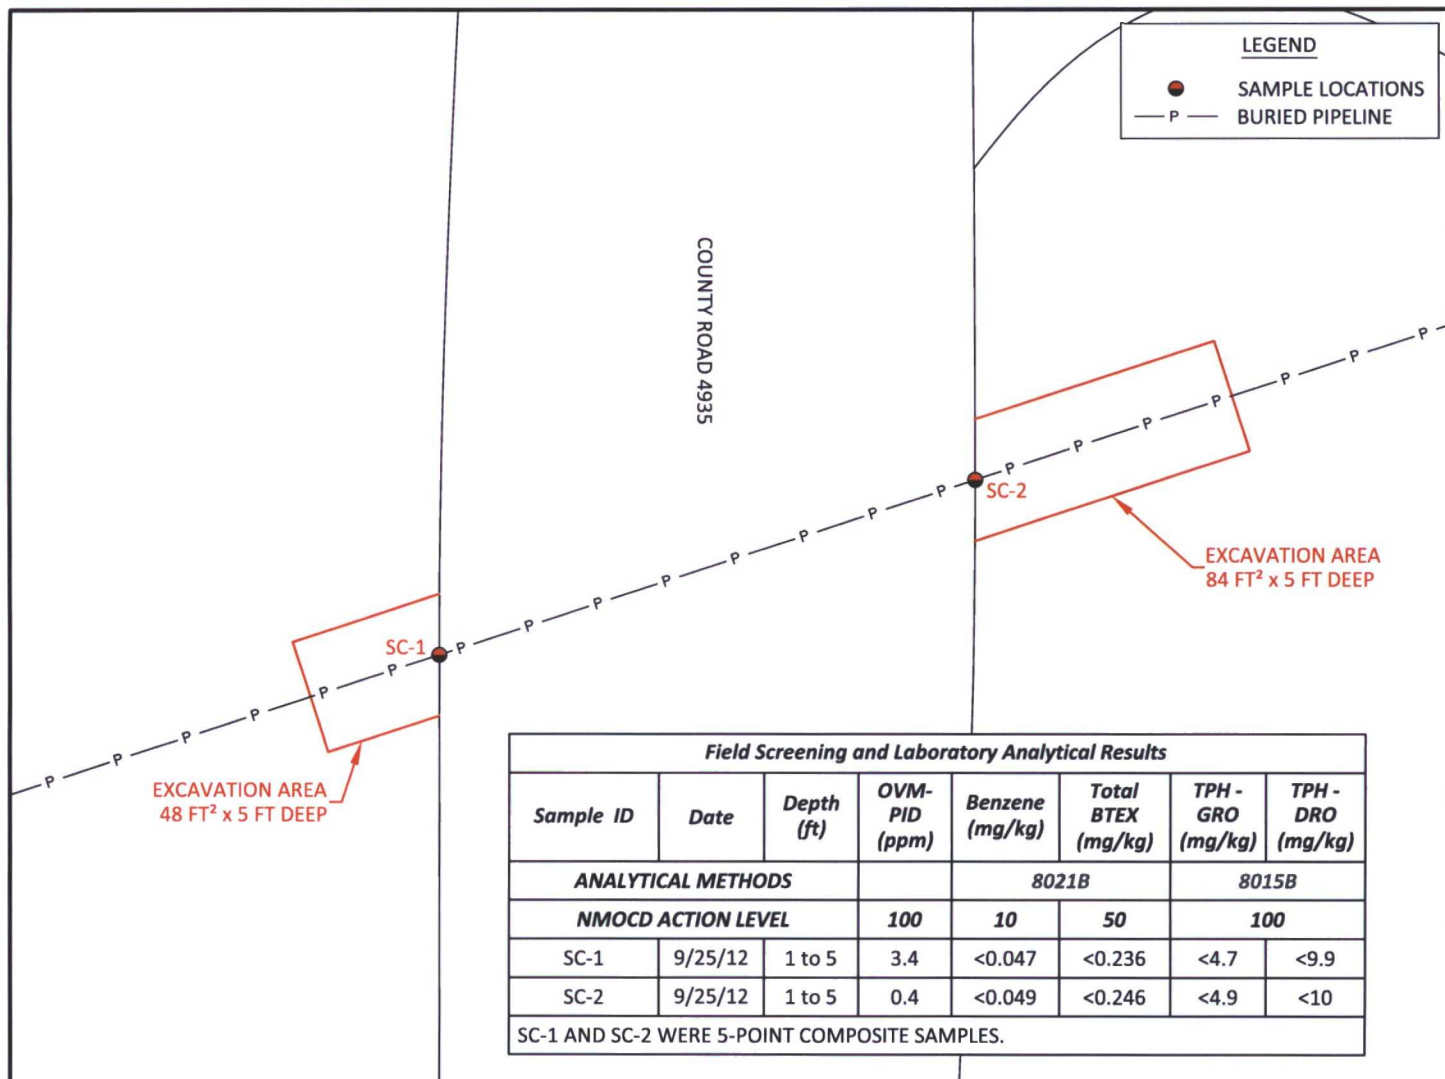
## FIGURE 3

Laboratory Analytical Results											
Sample ID	Date	Depth (ft)	Chlorides (mg/kg)	Arsenic (mg/kg)	Barium (mg/kg)	Cadmium (mg/kg)	Chromium (mg/kg)	Lead (mg/kg)	Mercury (mg/kg)	Selenium (mg/kg)	Silver (mg/kg)
ANALYTICAL METHODS			300.0	6010B	6010B/TCLP	6010B	6010B/TCLP	6010B	7471	6010B	6010B
RCRA STANDARD PER TCLP (mg/L)			NE	5.0	100	1.0	5.0	5.0	0.2	1.0	5.0
SC-1	9/25/12	1 to 5	<7.5	<12	110/<100	<0.50	6.3/<5.0	2.9	<0.033	<12	<1.2
SC-2	9/25/12	1 to 5	8.4	<12	140/<100	<0.50	7.5/<5.0	4.5	<0.033	<12	<1.2

SC-1 AND SC-2 WERE 5-POINT COMPOSITE SAMPLES. NMOCD RELEASE ACTION LEVELS ARE NOT ESTABLISHED FOR REPRESENTED CONTAMINANTS OF CONCERN. NE - NOT ESTABLISHED

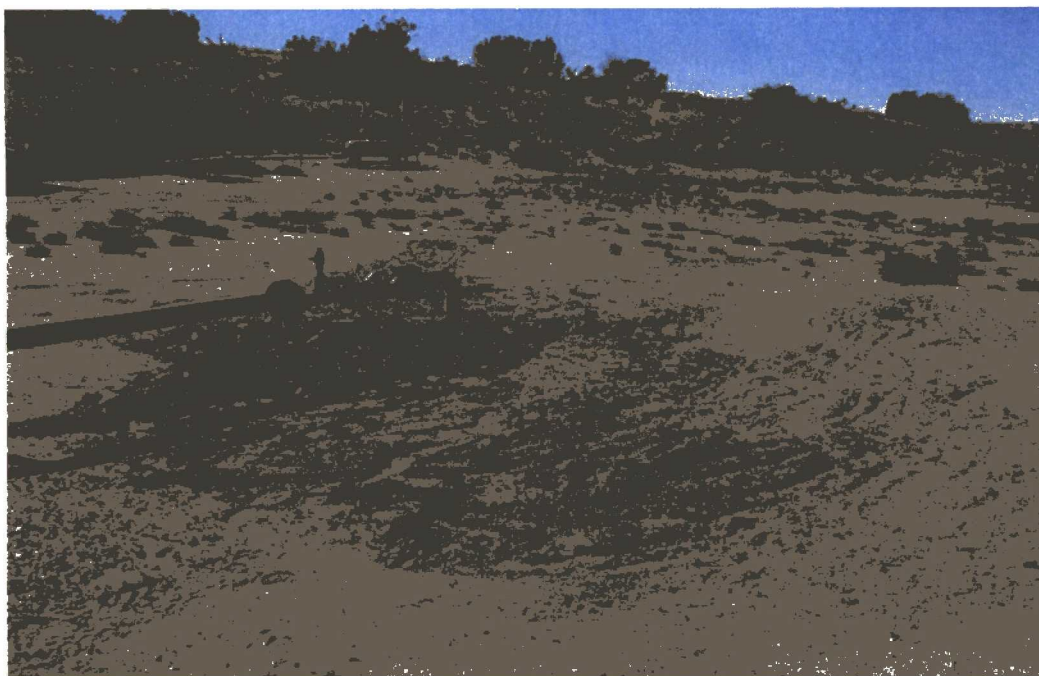
Photo 1: Extent of the release.

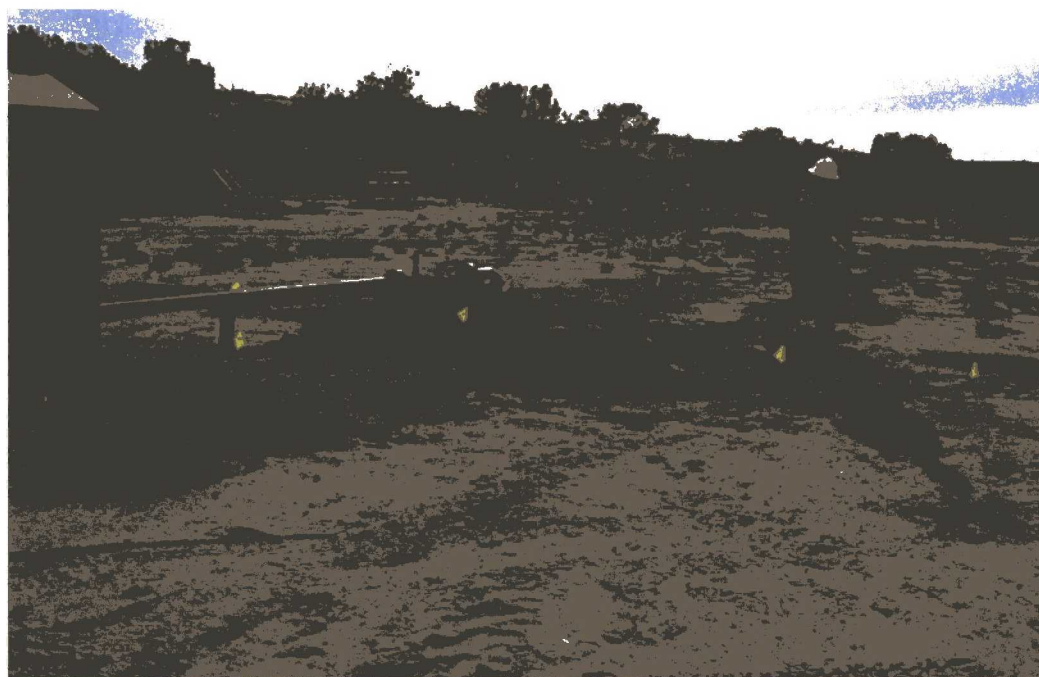
Photo 2: Soil investigation borings delineated with lime-green pin flags

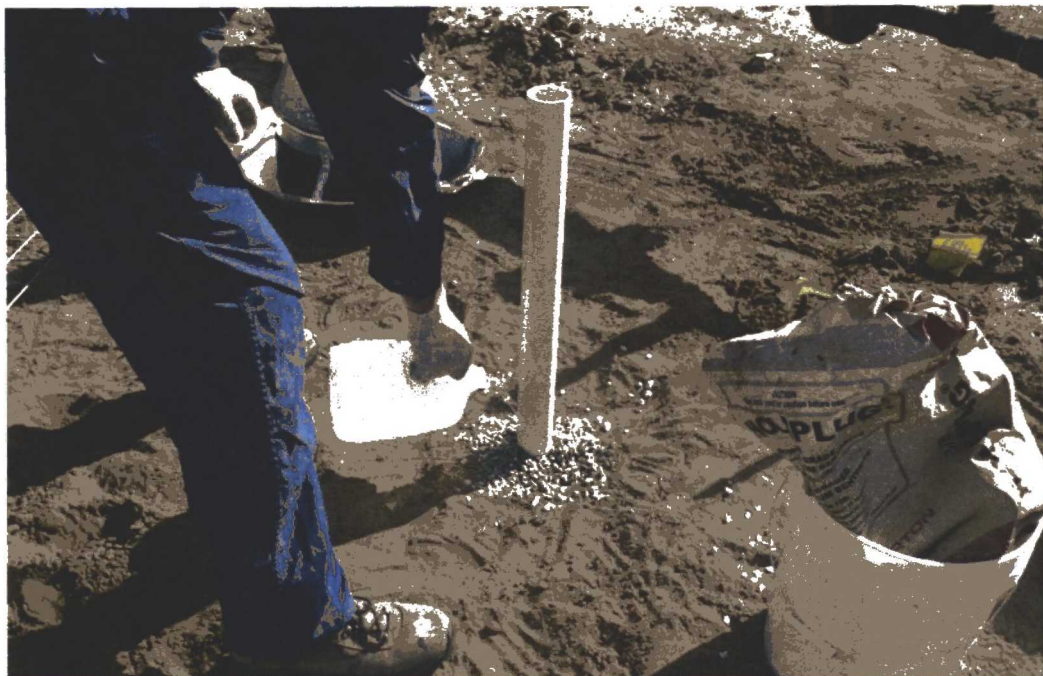
Photo 3: View of the soil vapor extraction well.

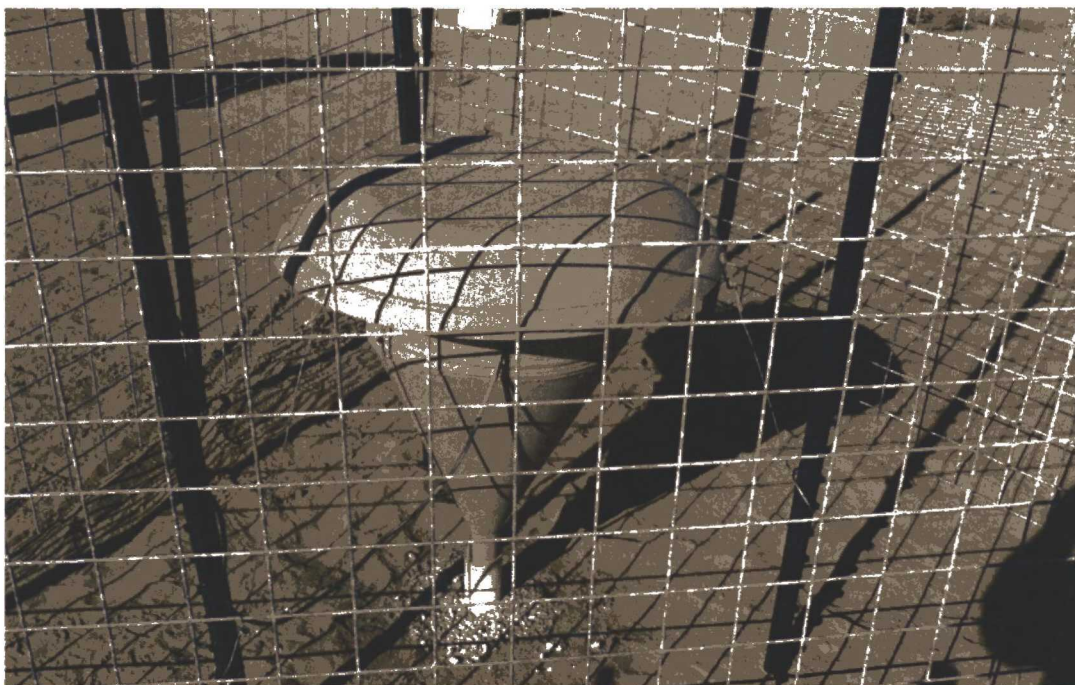
Photo 4: View of the soil vapor extraction ventilation system.

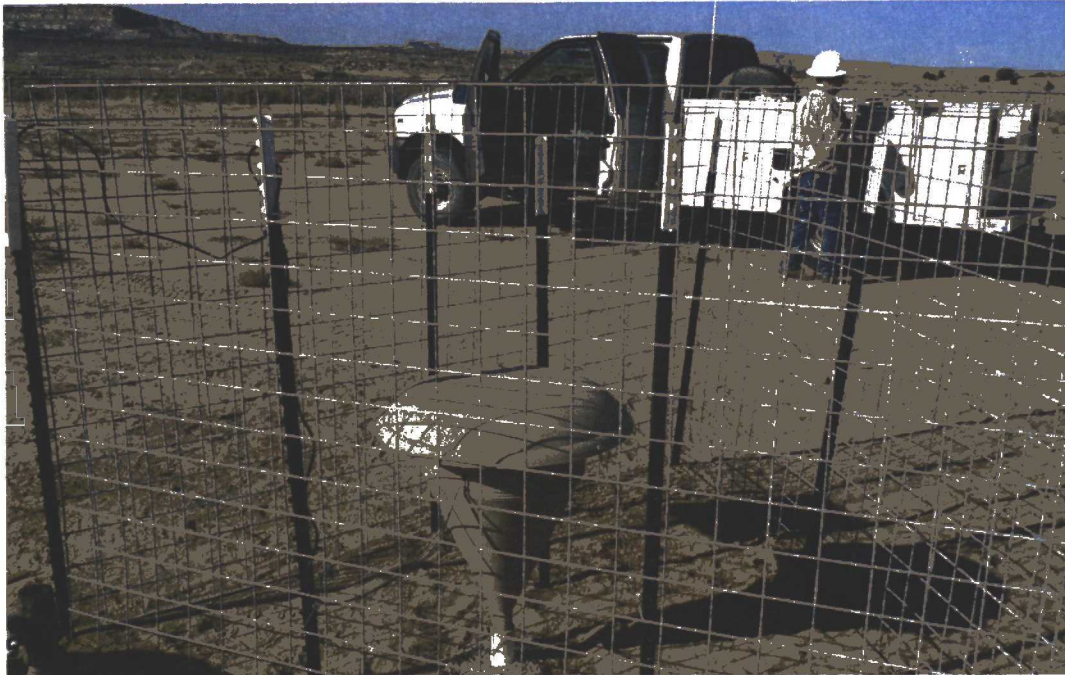
Photo 5: View of the soil vapor extraction ventilation system with security fencing.

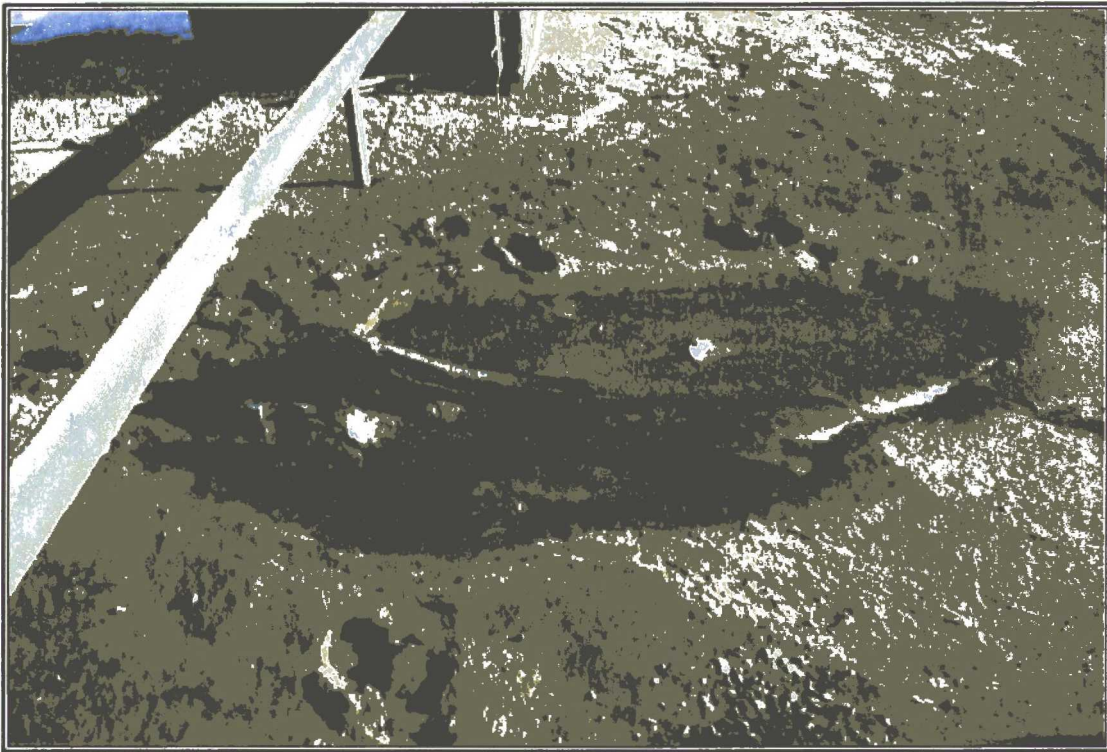
Photo 1: View of the release area for the Turner A #1A meter tube release.

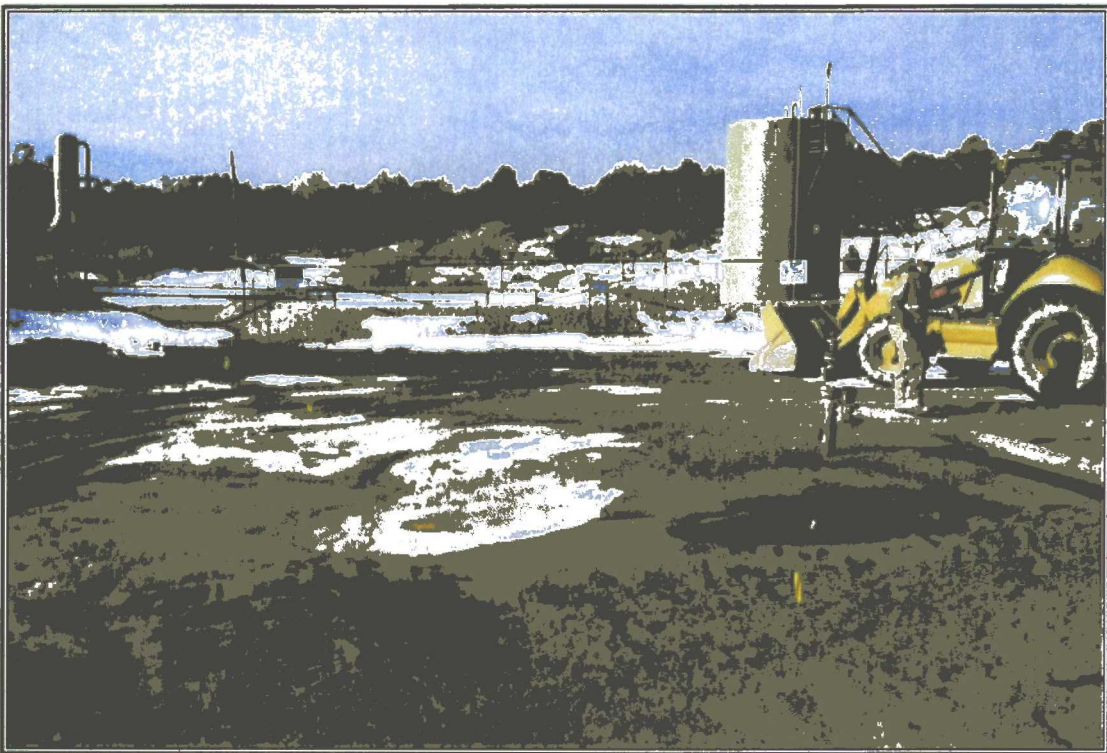
Photo 2: View of the release area at the Turner A #1A well site; Note, ice from snow melt.

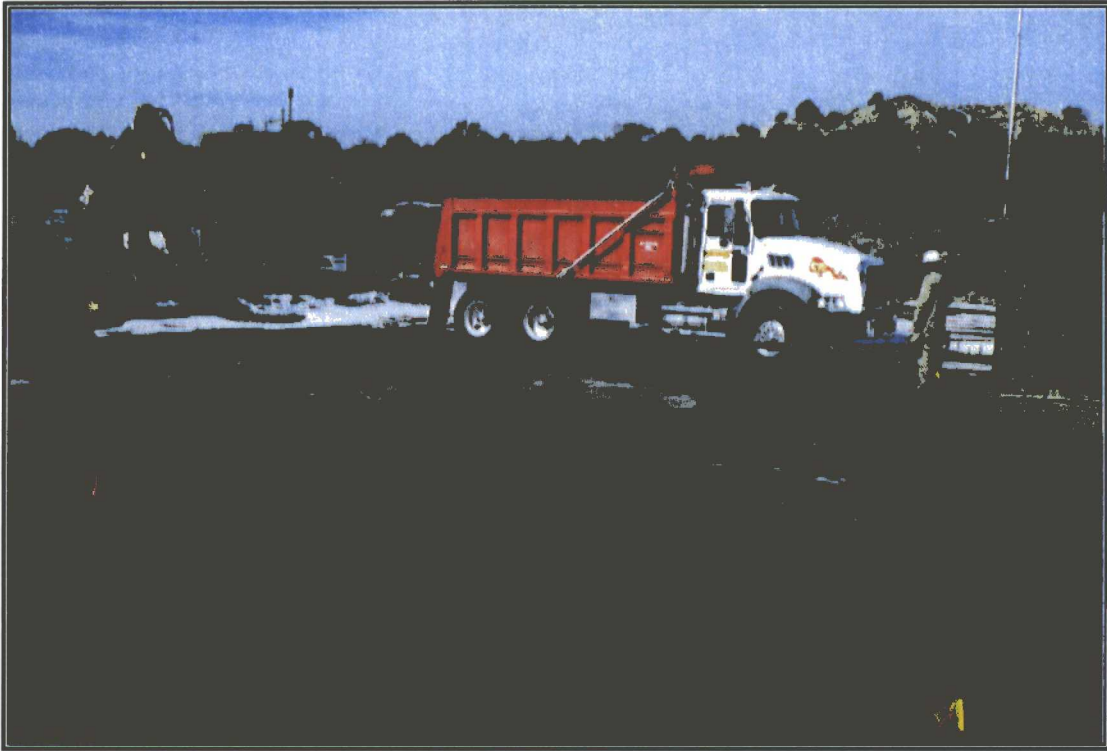
Photo 3: View of the excavation activities for the Turner a #1A well site; note test pits for lateral extent.

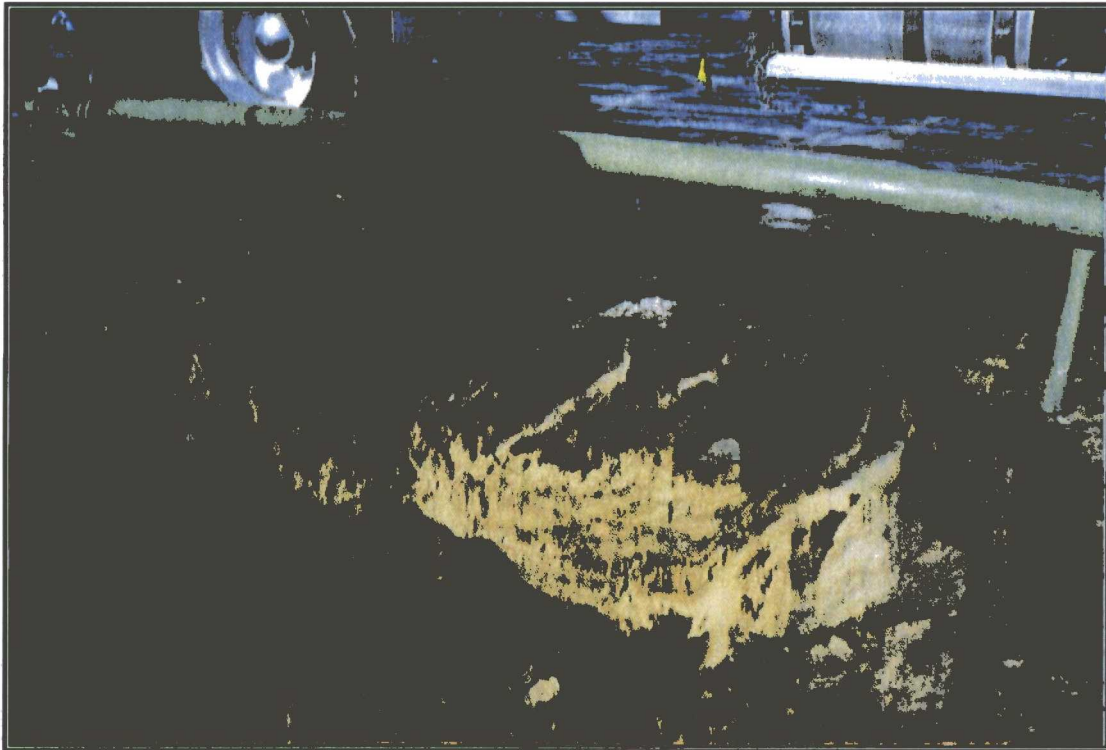
Photo 4: View of the excavation for the Turner A #1A well site at the meter tube break.

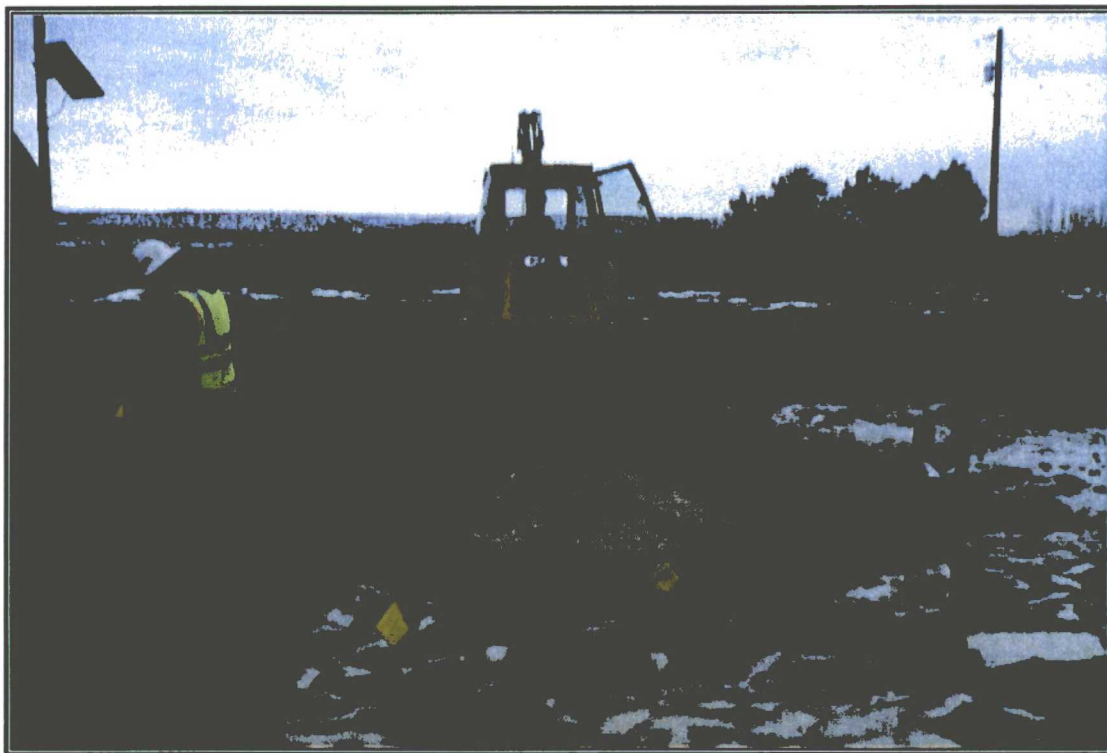
Photo 5: View of backfilling activities after completion of excavation activities and meter tube removal.

Photo 6: View of backfilling activities after completion of excavation activities and meter tube removal.

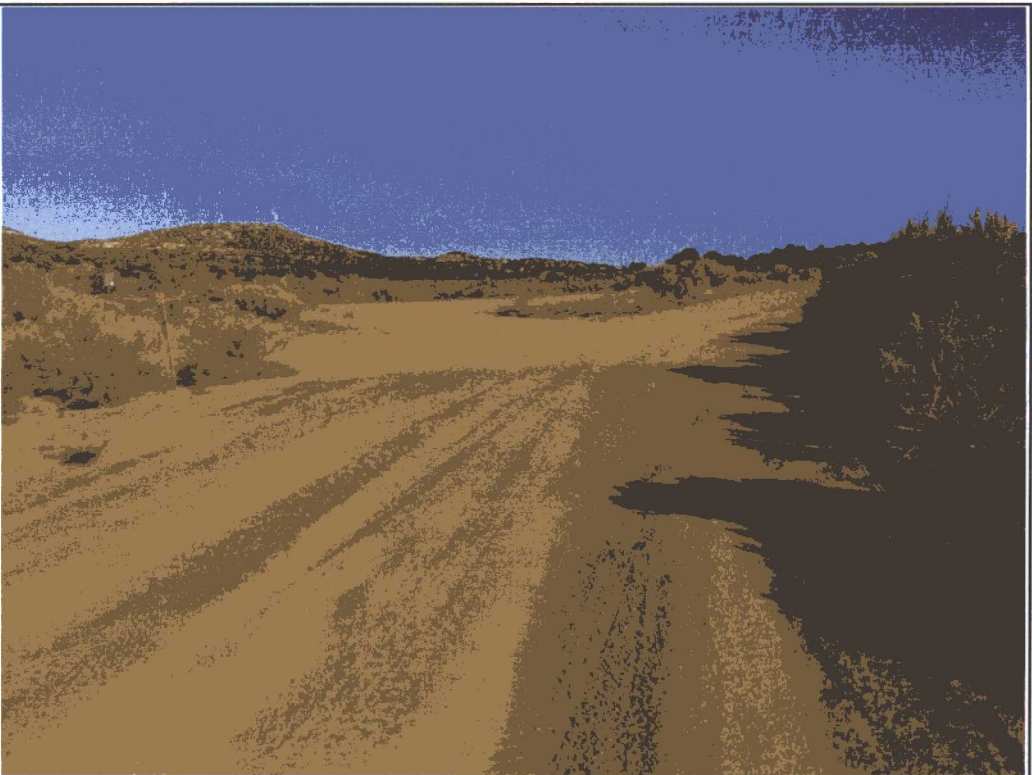
Photo #2

Client: Enterprise Field Services, LLC	
Project: Lateral B-14 Pig Receiver	
Taken by: Tami Ross	
September 27, 2012	
AES Project No: 120923	Description: View to the north of surface staining.

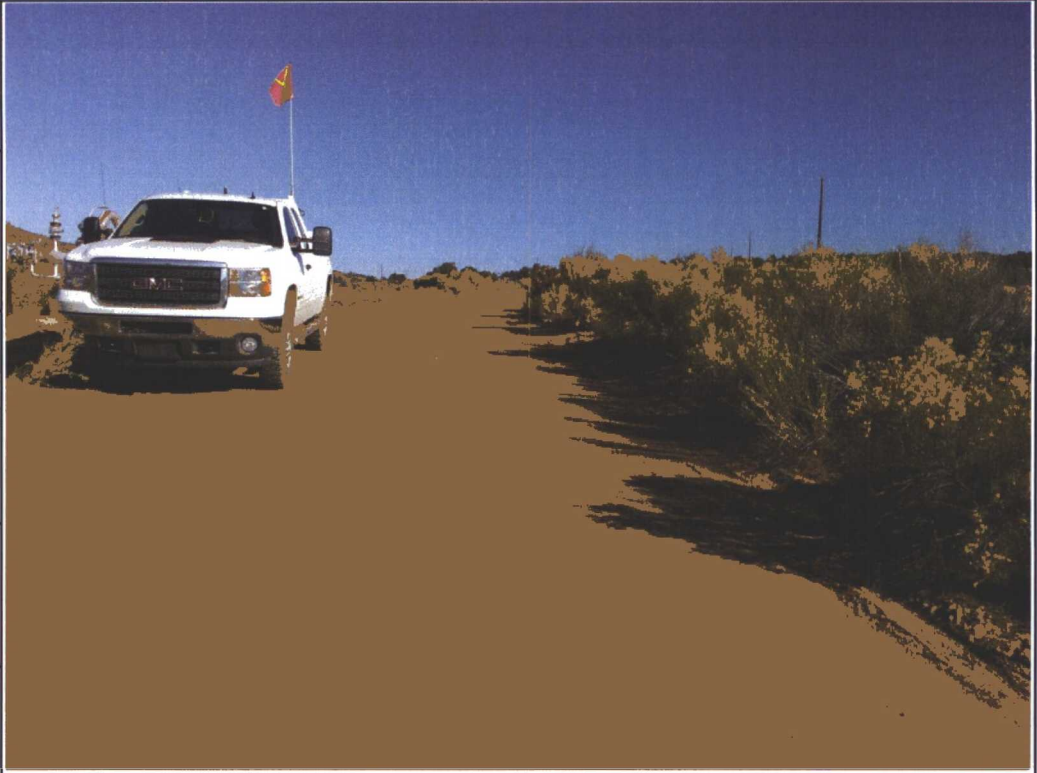
Photo #3

Client: Enterprise Field Services, LLC	
Project: Lateral B-14 Pig Receiver	
Taken by: Tami Ross	
September 27, 2012	
AES Project No: 120923	Description: View to the south of surface staining.

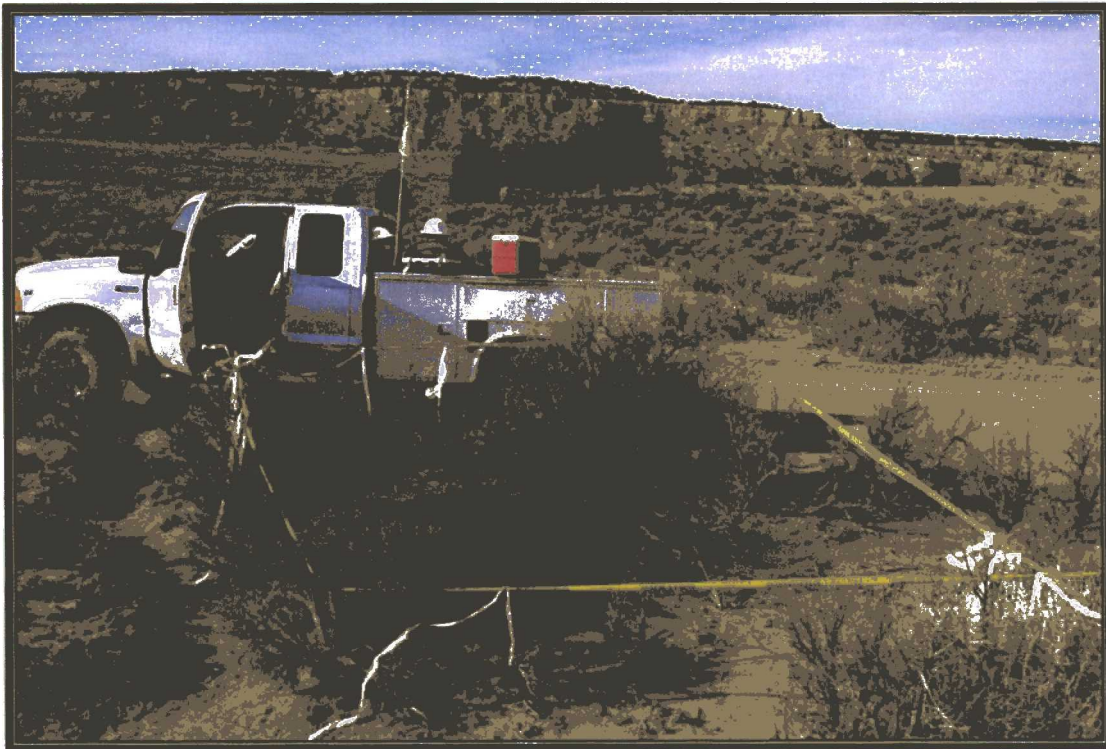
Photo 1: View of the release area for the San Juan 27-5 #133 well tie.

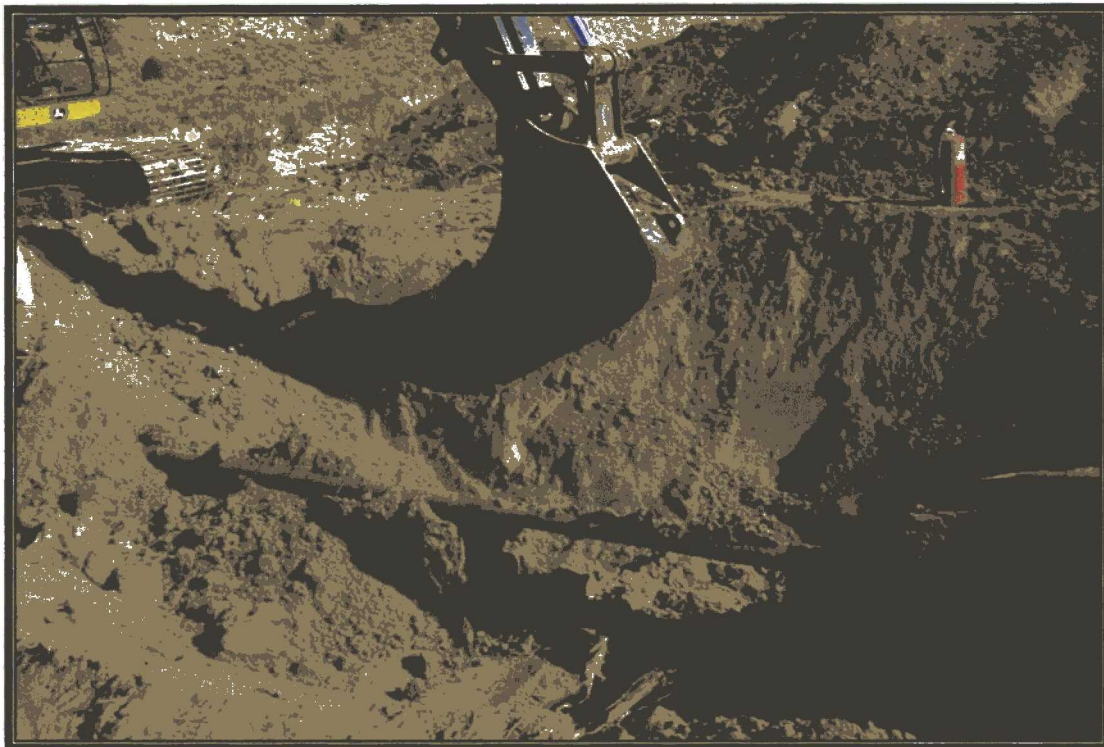
Photo 2: View of the excavation around the San Juan 27-5 #133 well tie.

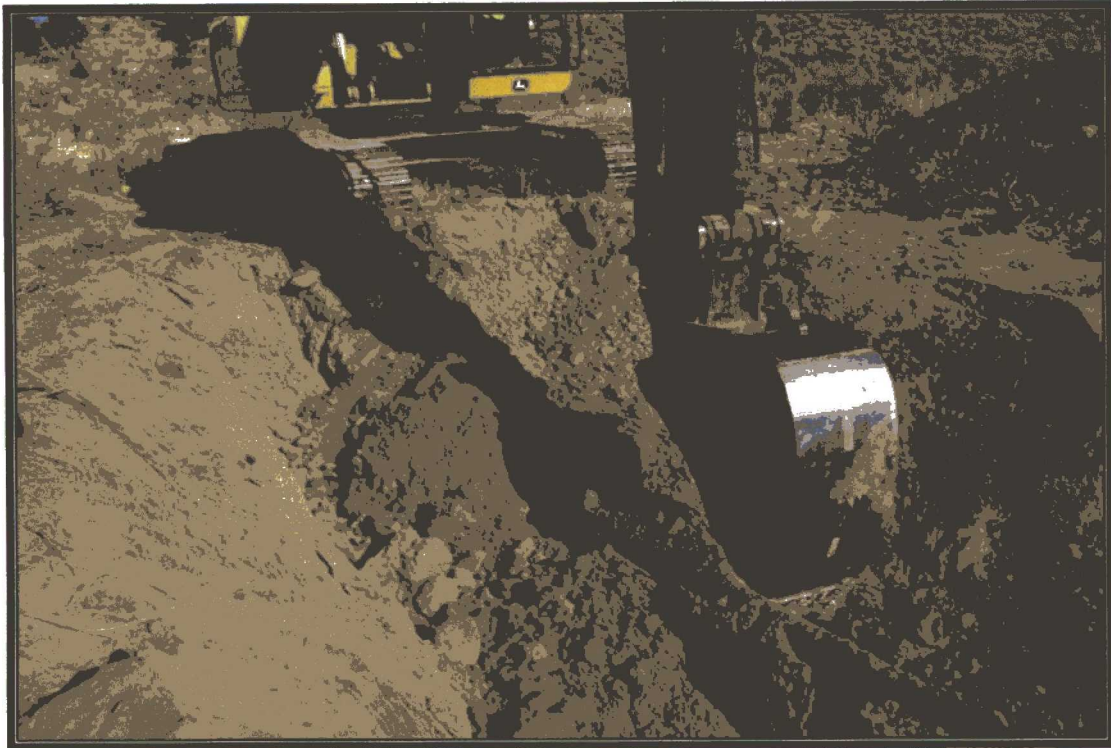
Photo 3: View of the excavation activities for the San Juan 27-5 #133 well tie.

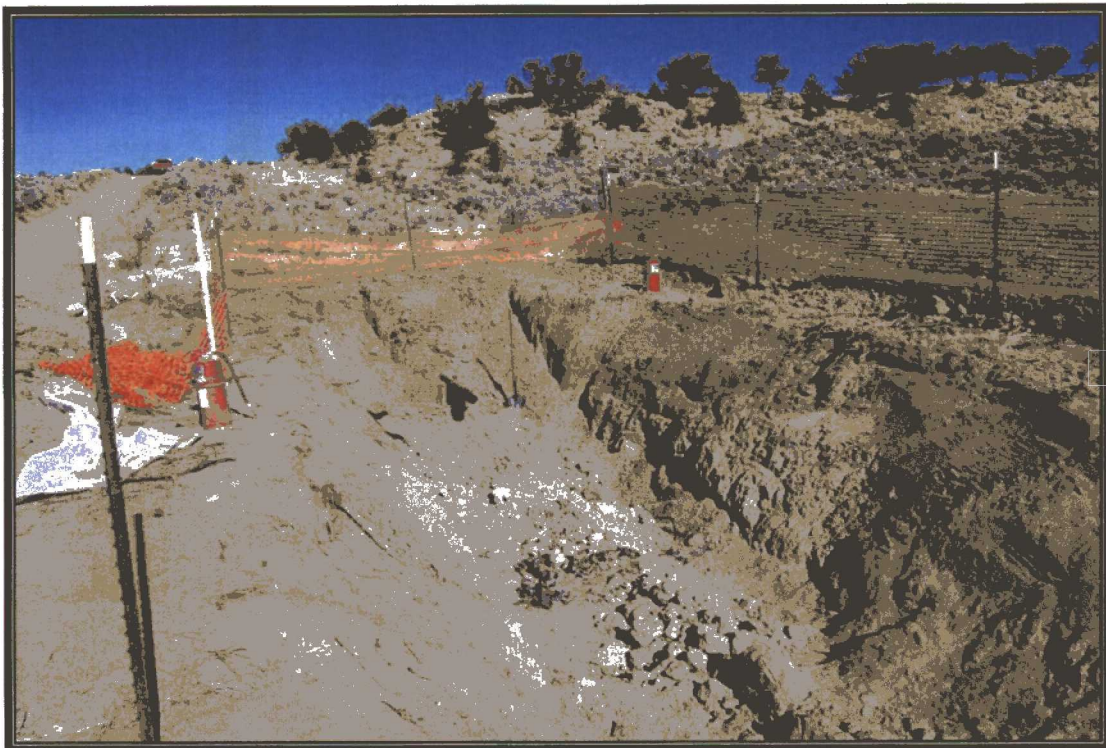
Photo 4: View of the excavation for the San Juan 27-5 #133 well tie after the pipeline was removed.

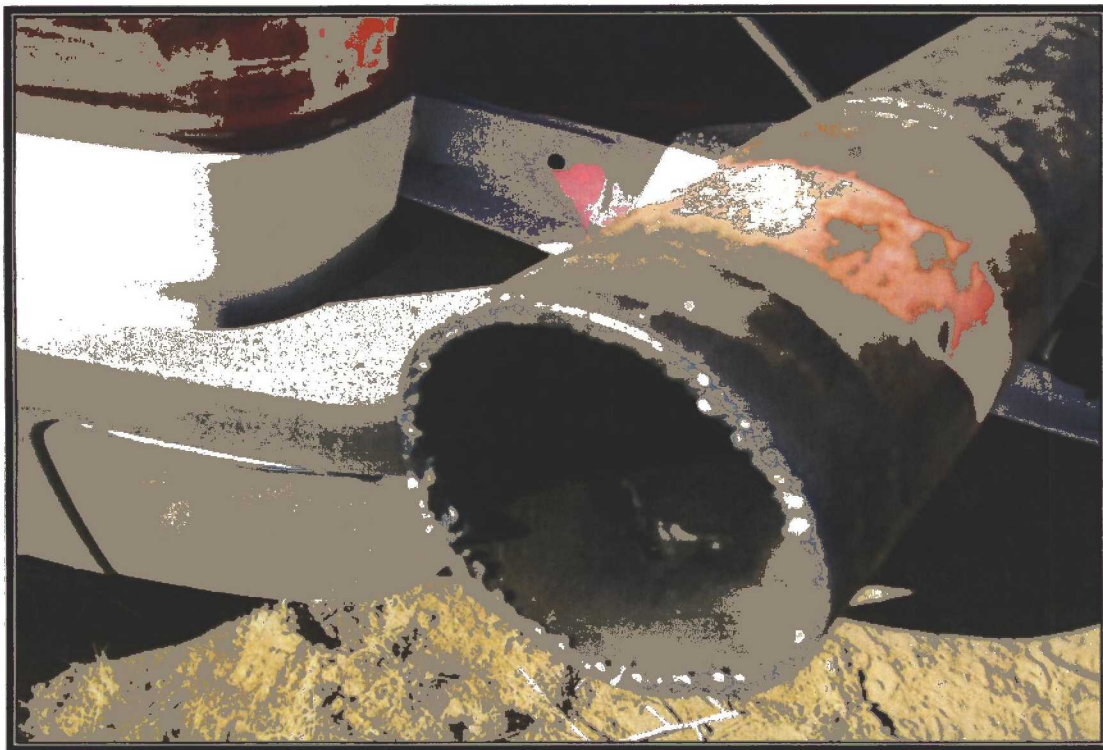
Photo 5: View of the internal corrosion hole in the removed section of pipeline.

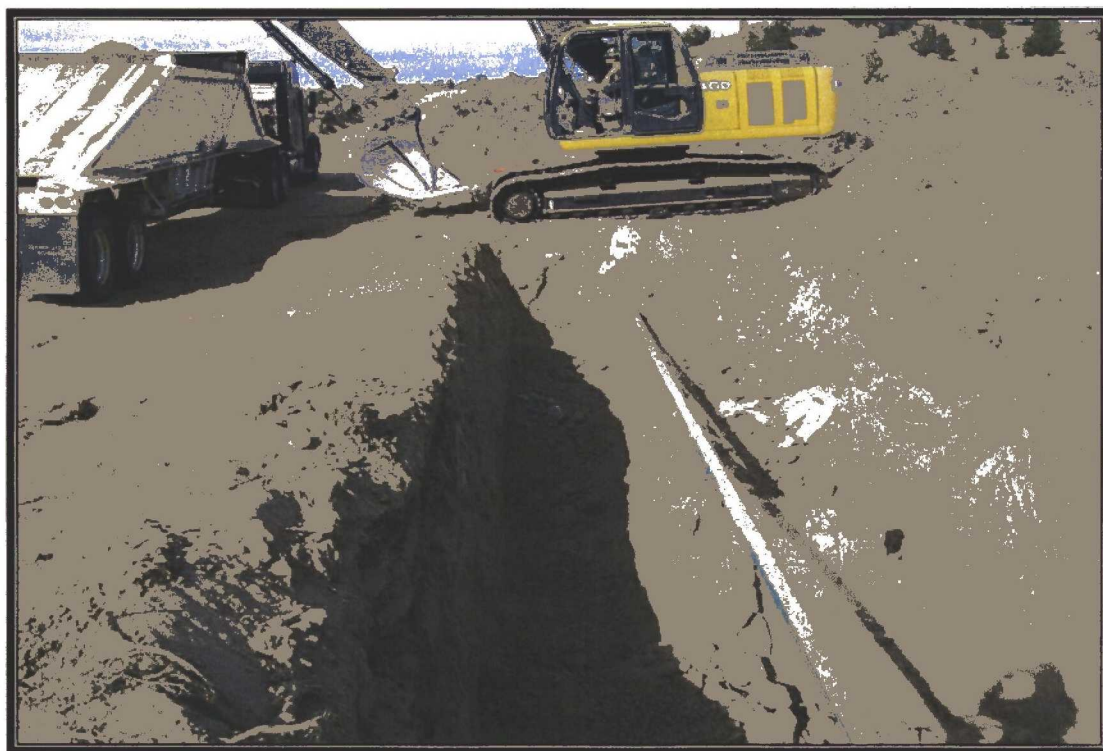
Photo 6: View of the excavation after the pipeline repair was completed.

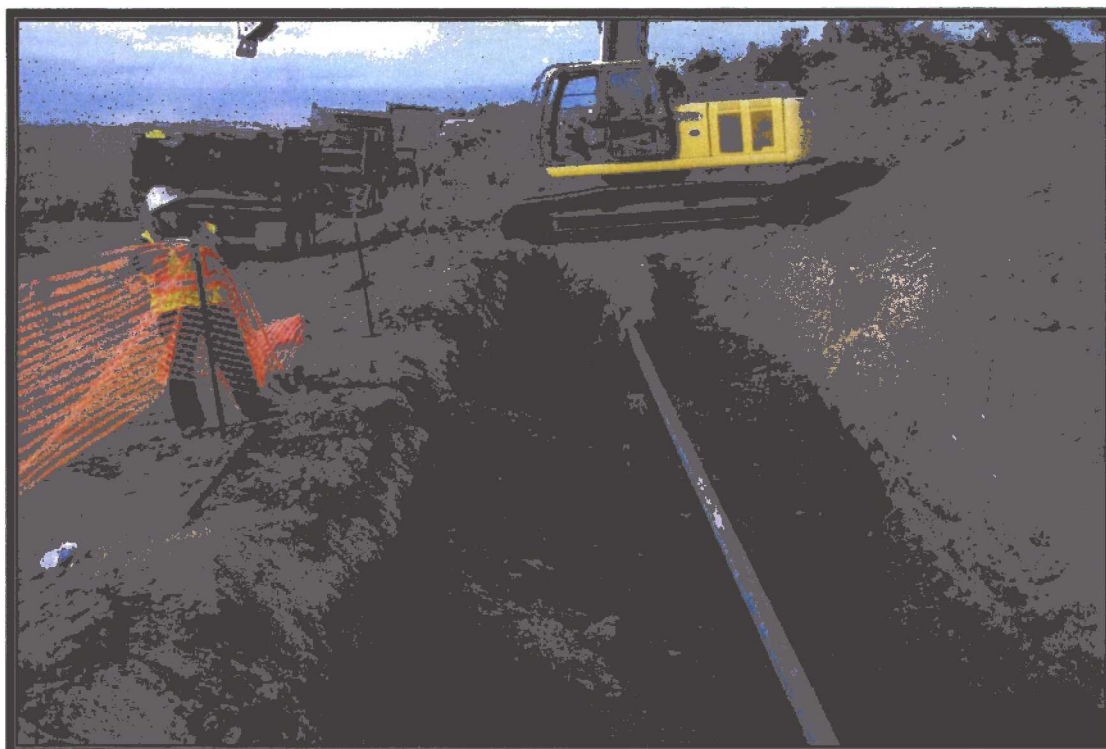
**Photo 7: View of backfilling activities after the completion of excavation activities.**

**Photo 8: View of backfilling activities after the completion of excavation activities.**

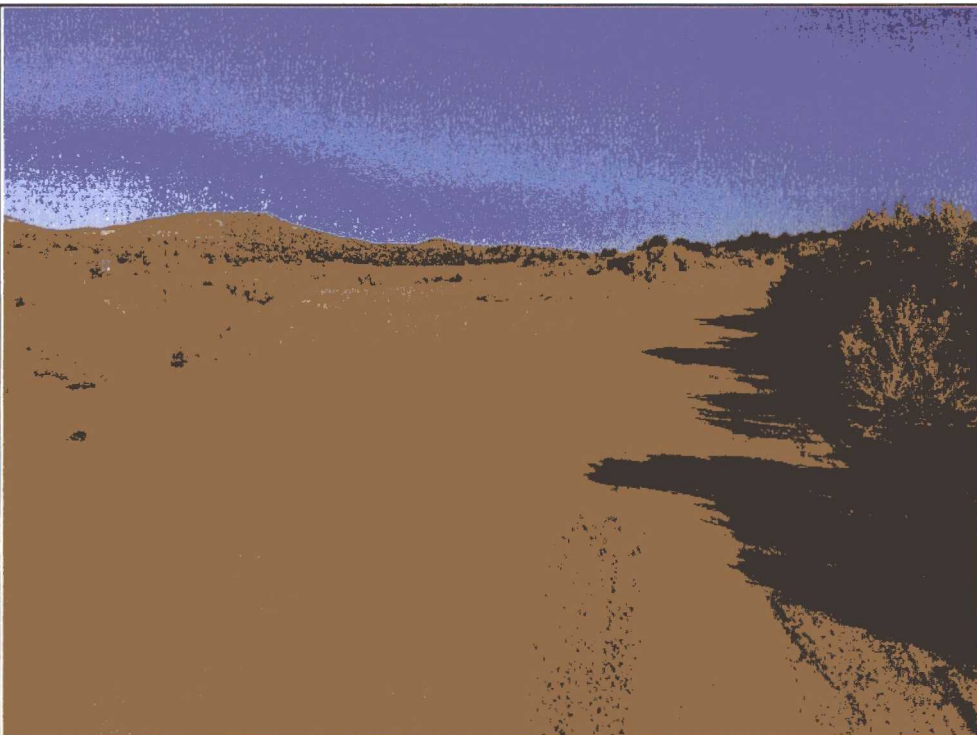
Photo #2

Client: Enterprise Field Services, LLC	
Project: Lateral B-14 Pig Receiver	
Taken by: Tami Ross	
September 27, 2012	
AES Project No: 120923	Description: View to the north of surface staining.

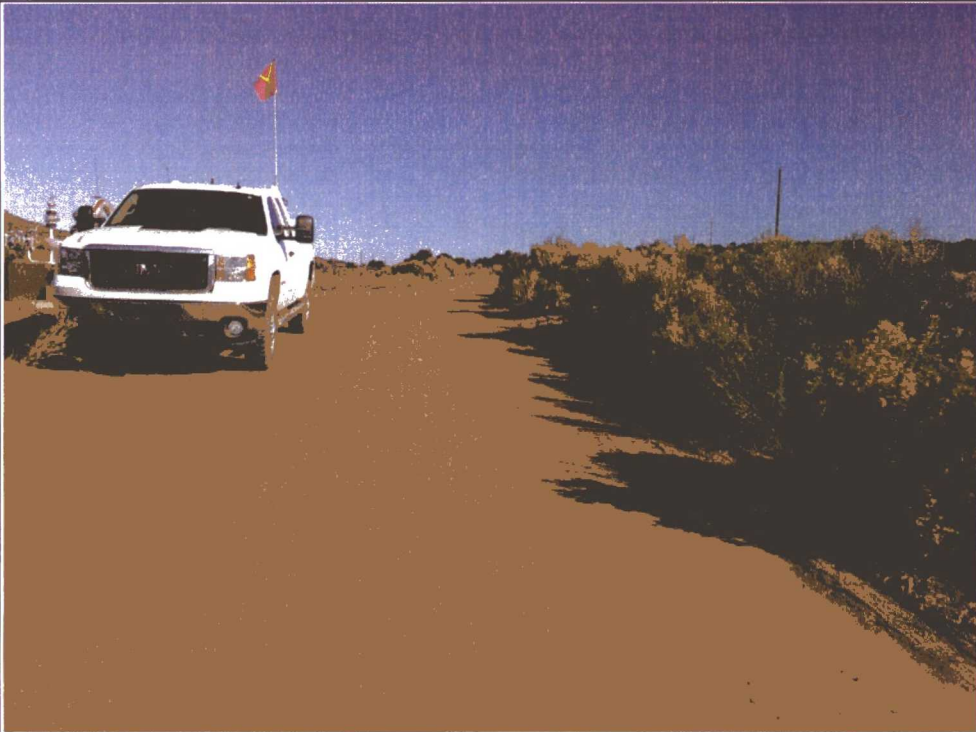
Photo #3

Client: Enterprise Field Services, LLC	
Project: Lateral B-14 Pig Receiver	
Taken by: Tami Ross	
September 27, 2012	
AES Project No: 120923	Description: View to the south of surface staining.
