Report Description

Williams Four Corners, LLC

**Release Report/ General
Correspondence**

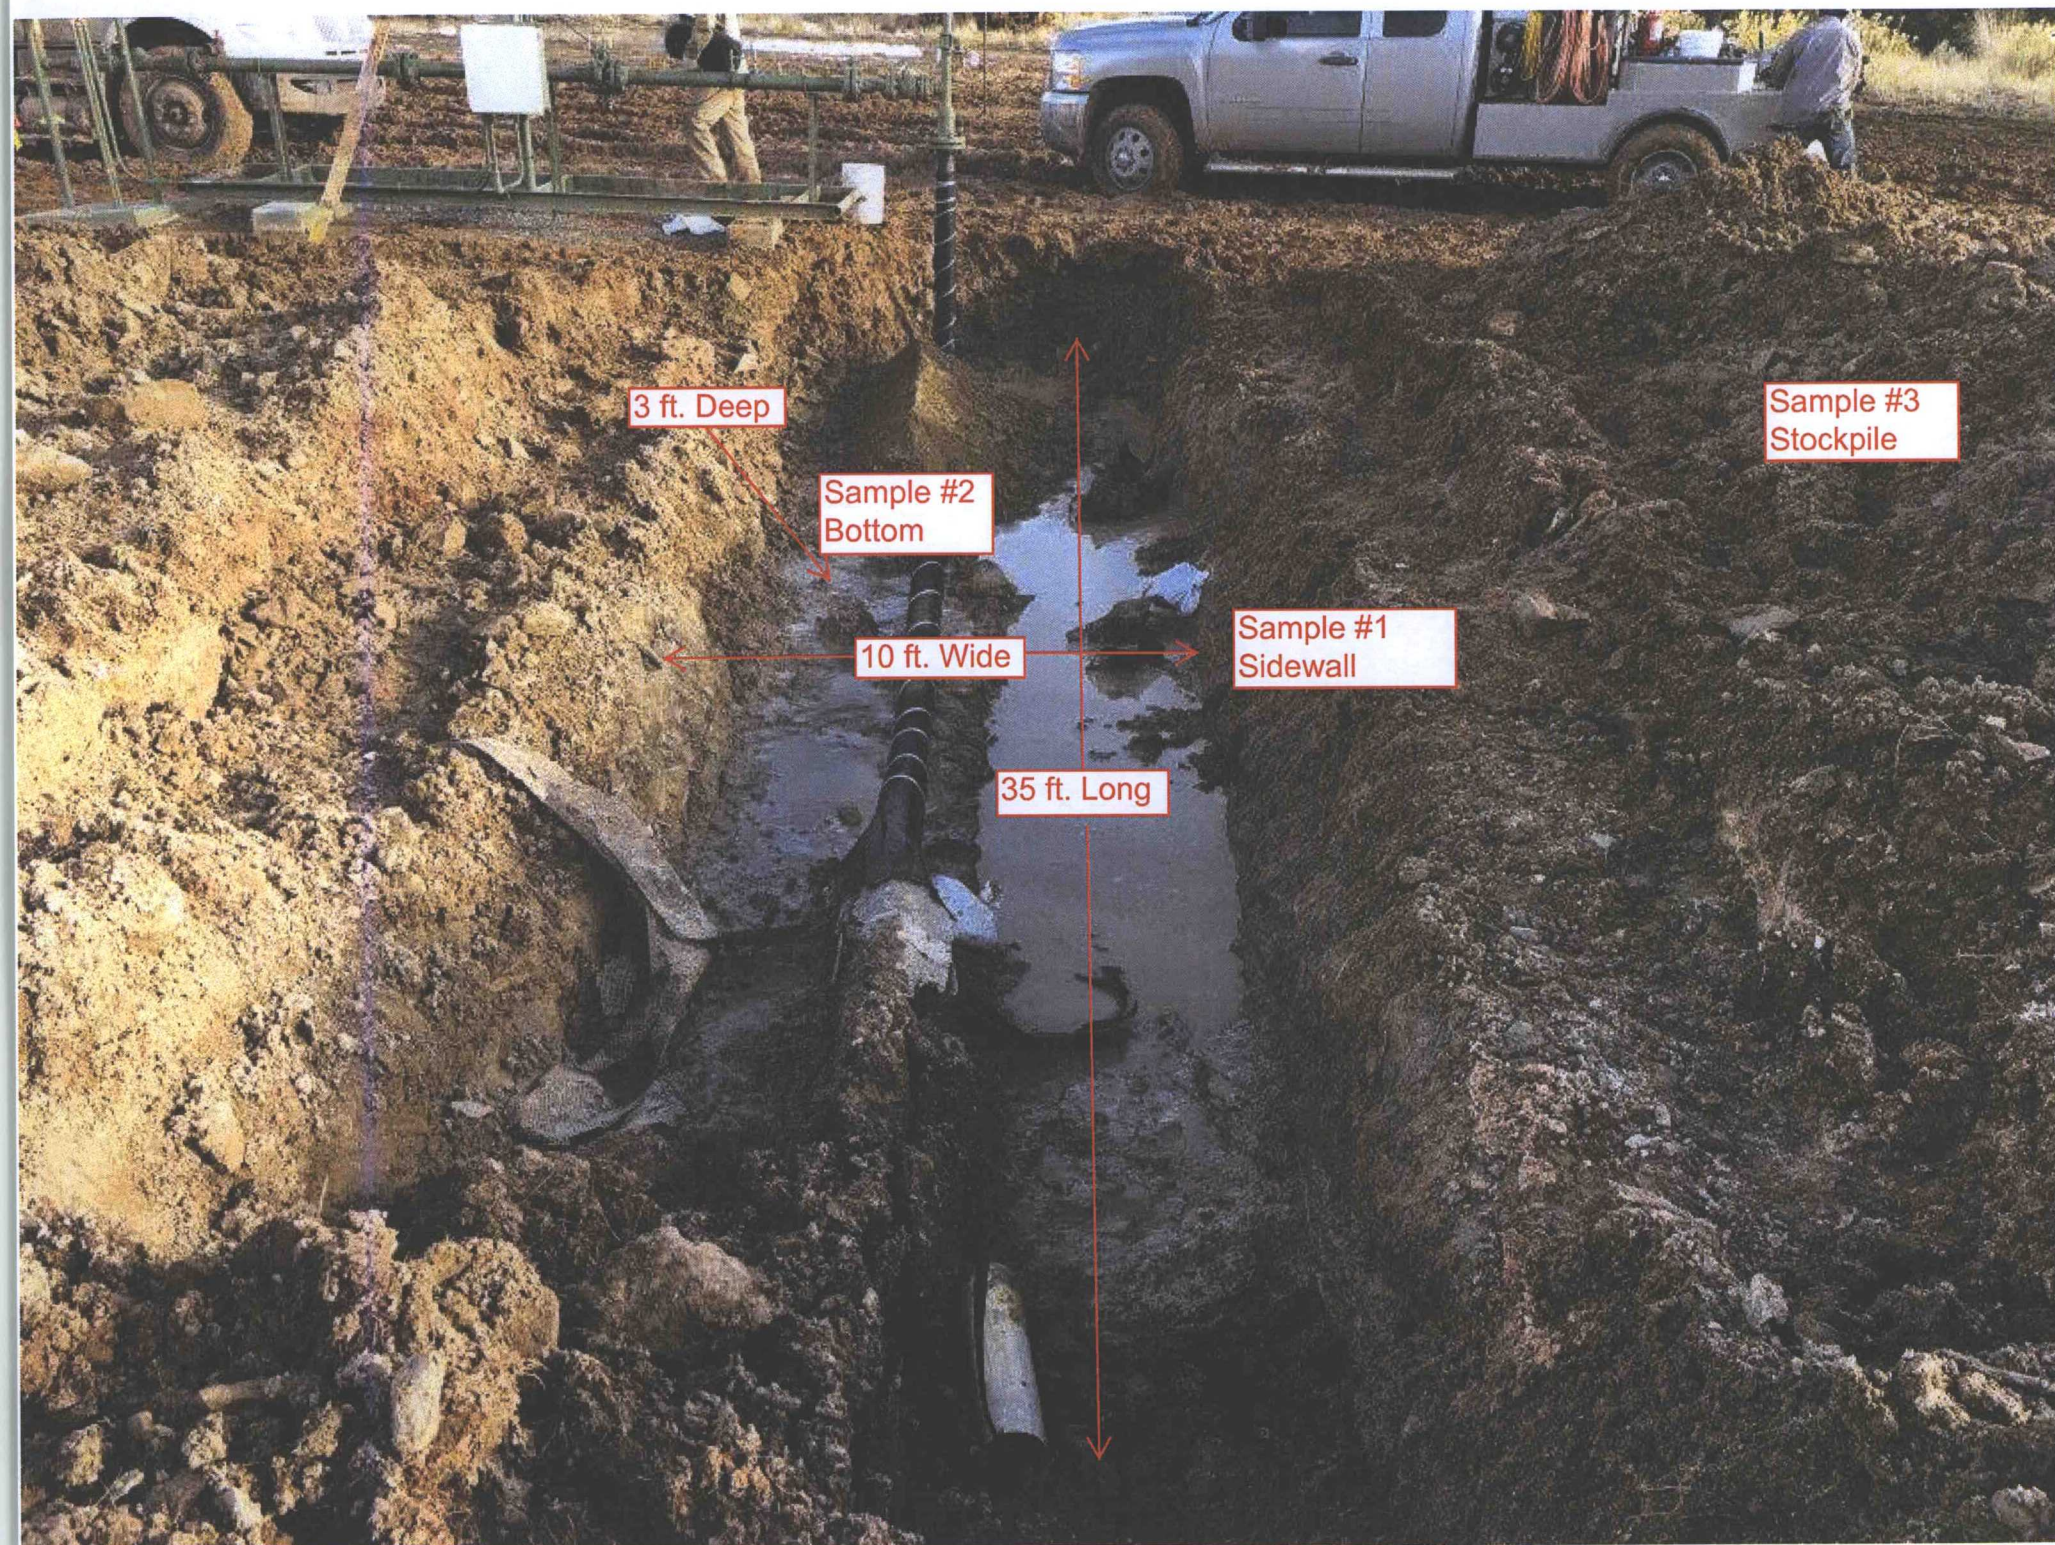
3 ft. Deep

Sample #2
Bottom

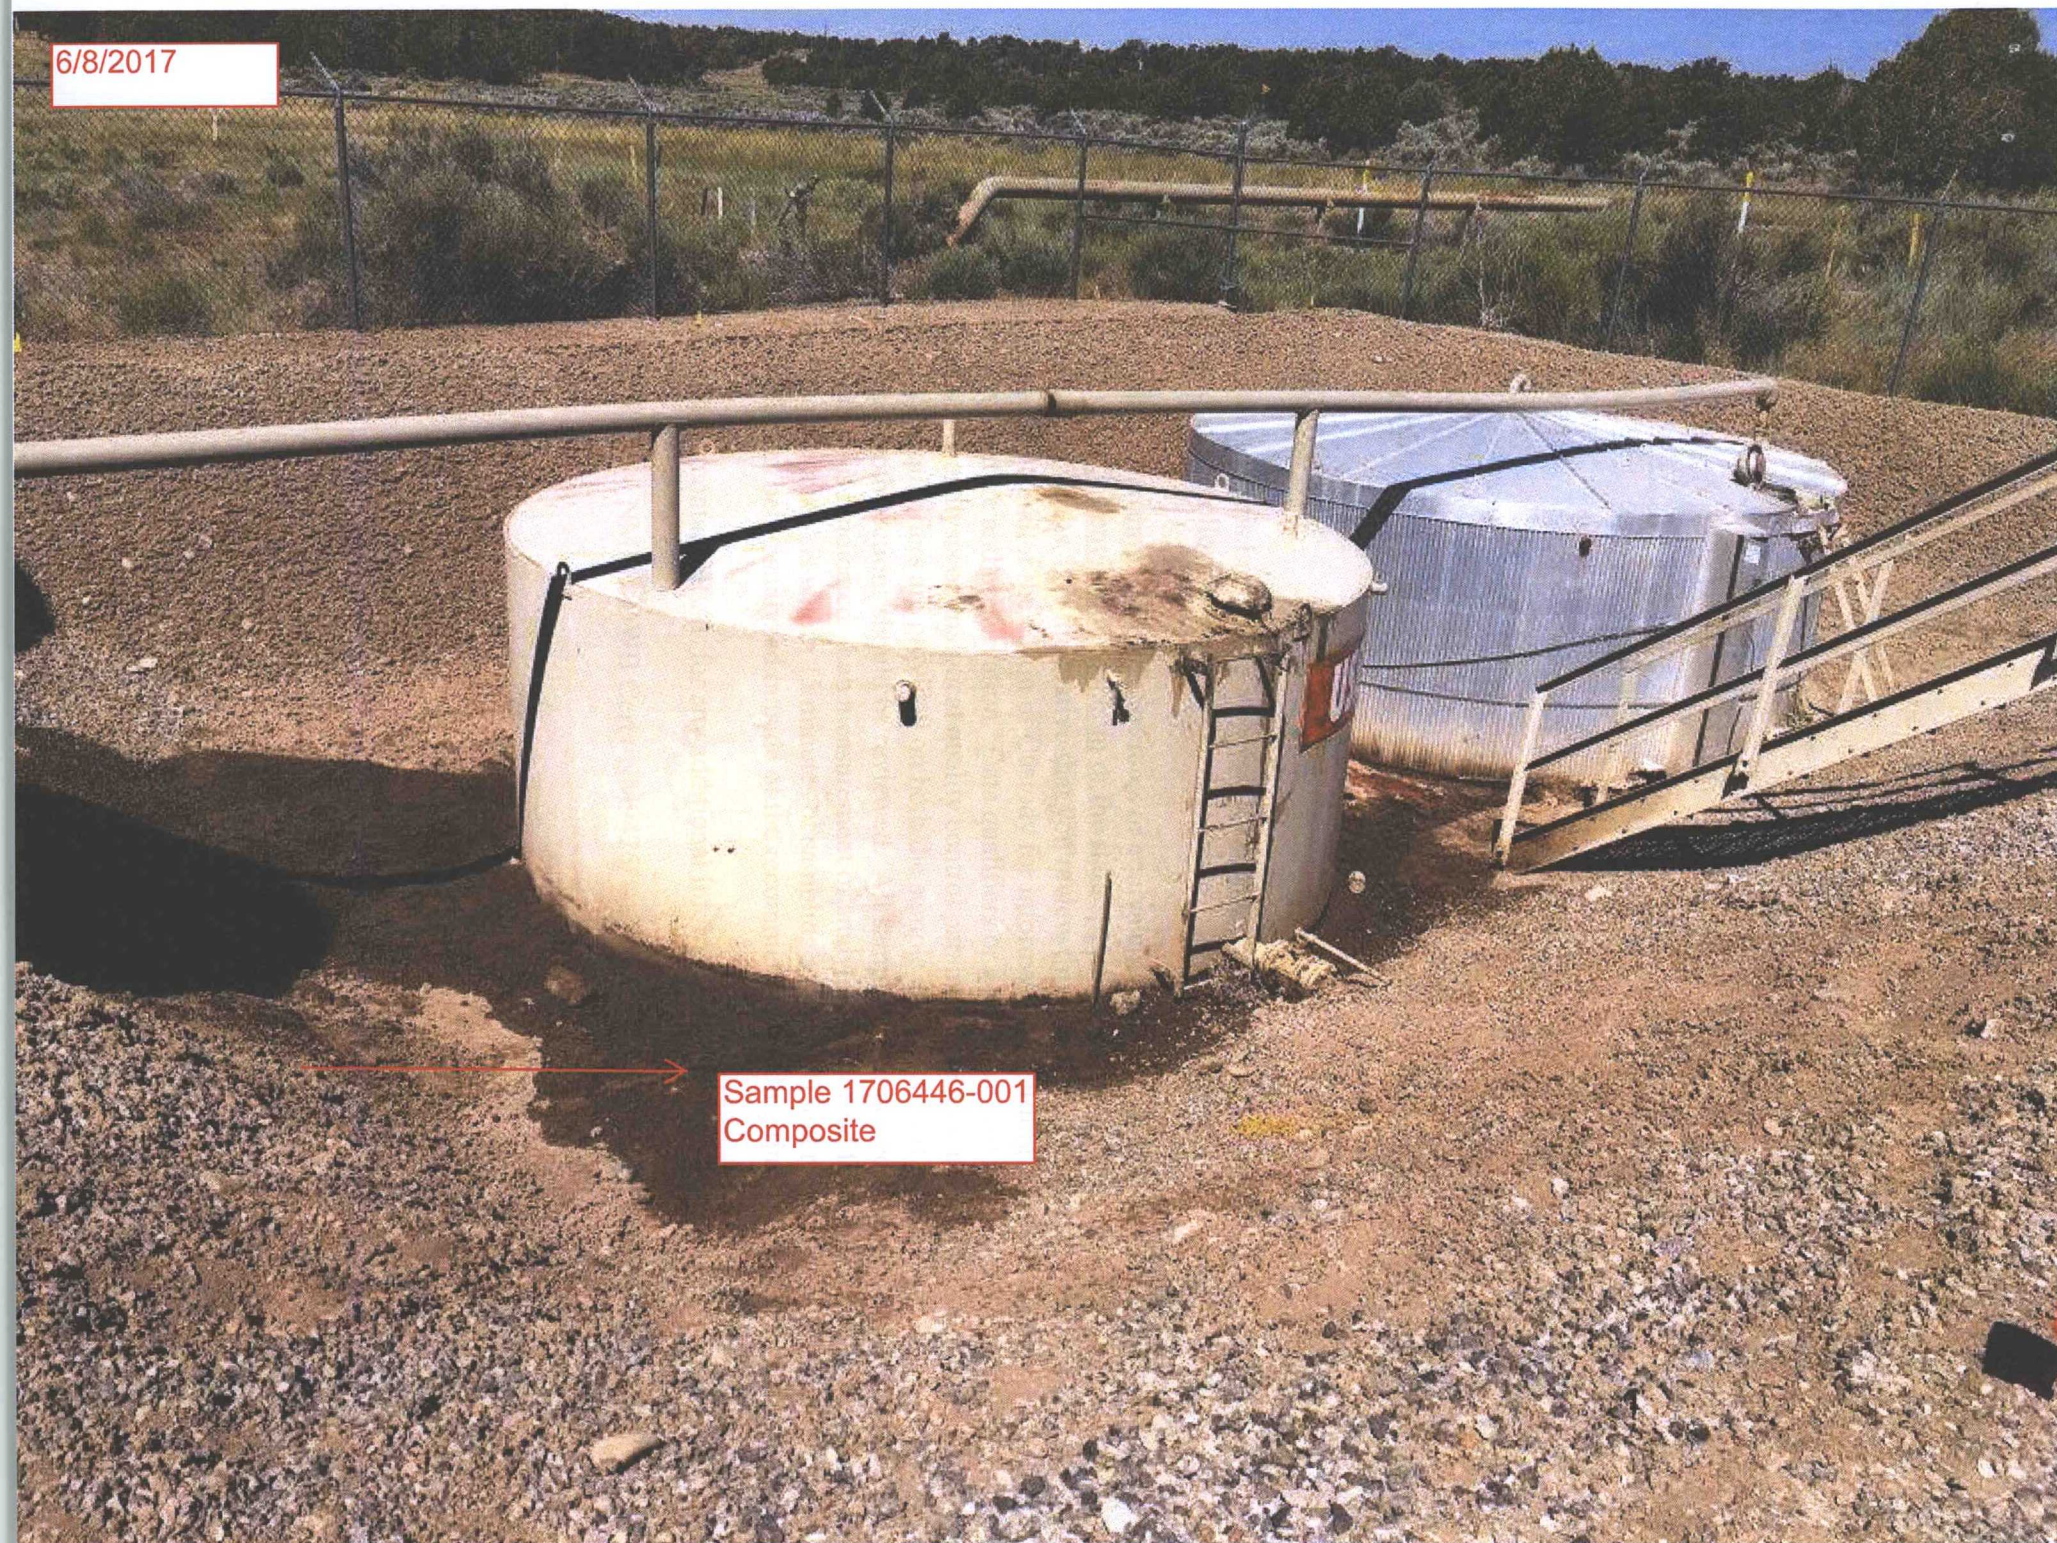
6/8/2017

Sample 1706446-001
Composite

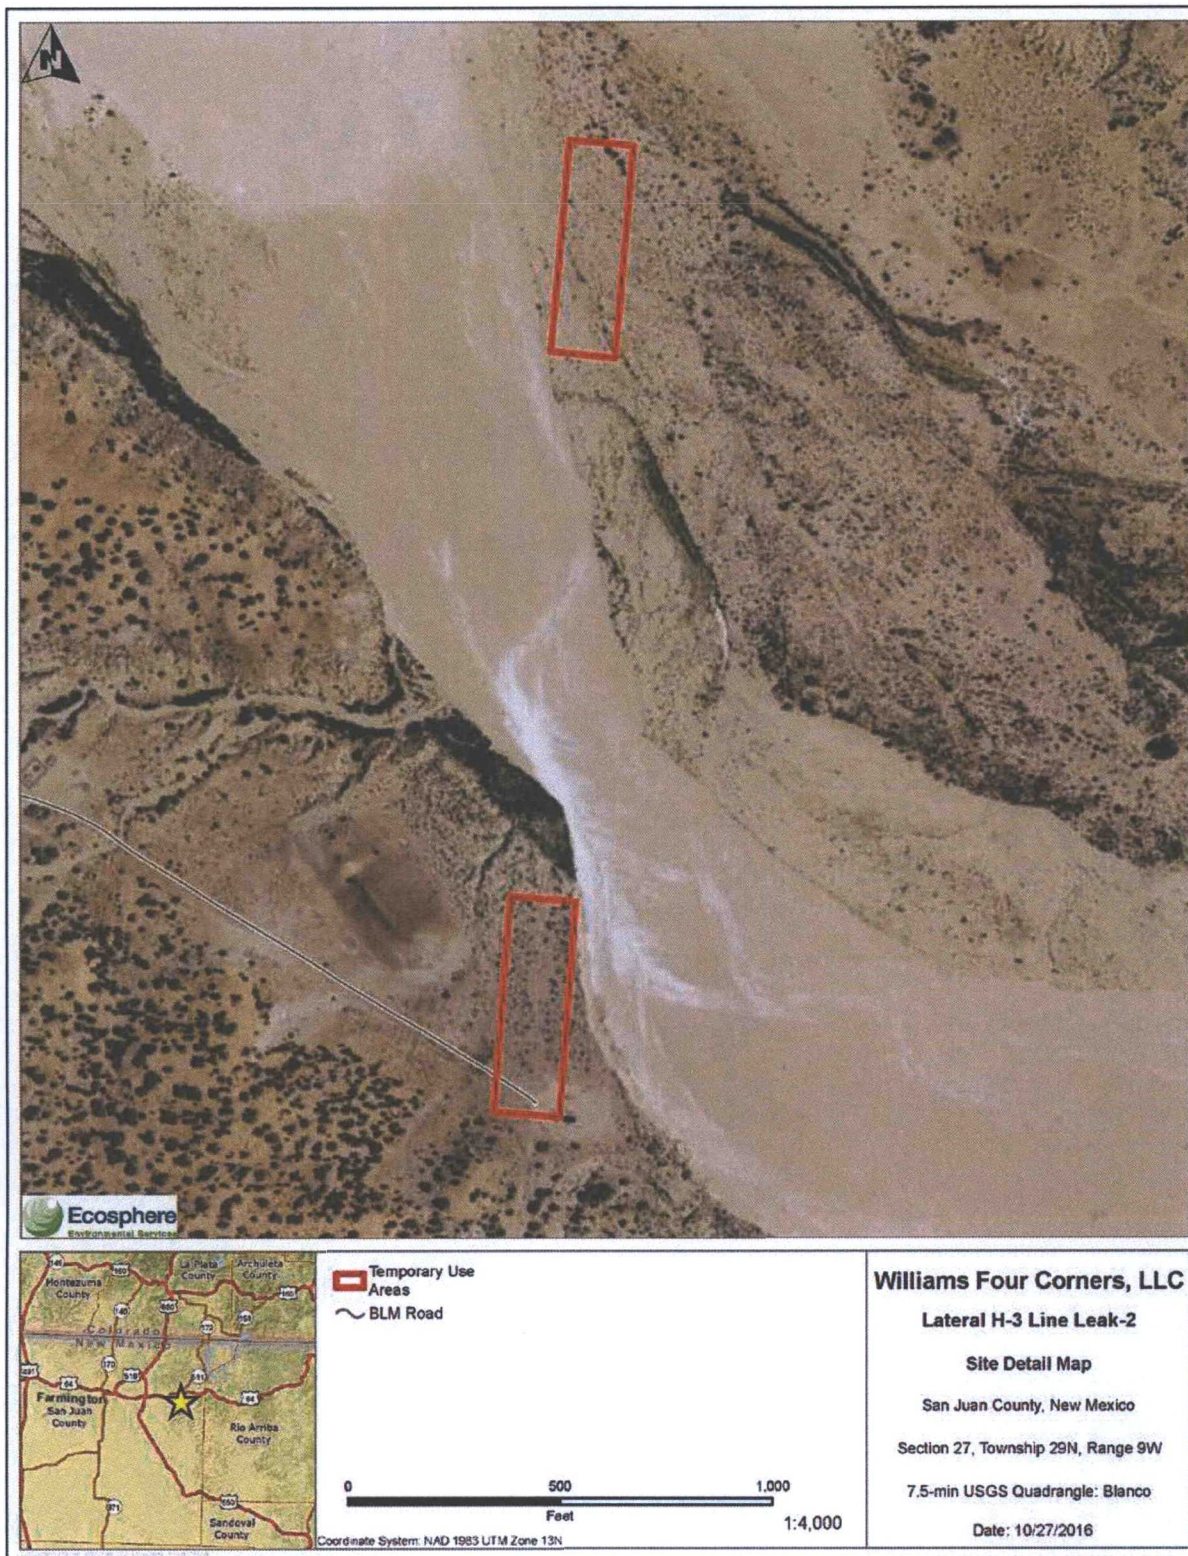
Map 3. Lateral H-3 Line Leak-2 Site Detail Map

Williams personnel discovered a minor gas leak during a leak locating survey on the Lateral H-3 Pipeline, which runs across Largo wash. No liquids were observed and the gas loss was calculated to be less than 50 MCF. Williams immediately isolated the pipeline.

Due to the depth of the pipeline under Largo Canyon Wash and the observed shallow groundwater, Williams is currently evaluating options to either repair, replace, or reroute the gathering line.
