**Release Notification and Corrective Action**

Subject: South Blanco Federal 22-5 Release

**RE: Release Assessment Report  
South Blanco Federal 22-5 Tank Battery  
San Juan County, New Mexico**

**TOPOGRAPHIC SITE LOCATION MAP**  
DJ RESOURCES (FORMERLY BEE LINE SERVICES)  
SOUTH BLANCO FEDERAL 22-5 TANK BATTERY  
SE¼ SE¼, SECTION 22, T24N, R8W  
SAN JUAN COUNTY, NEW MEXICO  
N36.29416, W107.66206

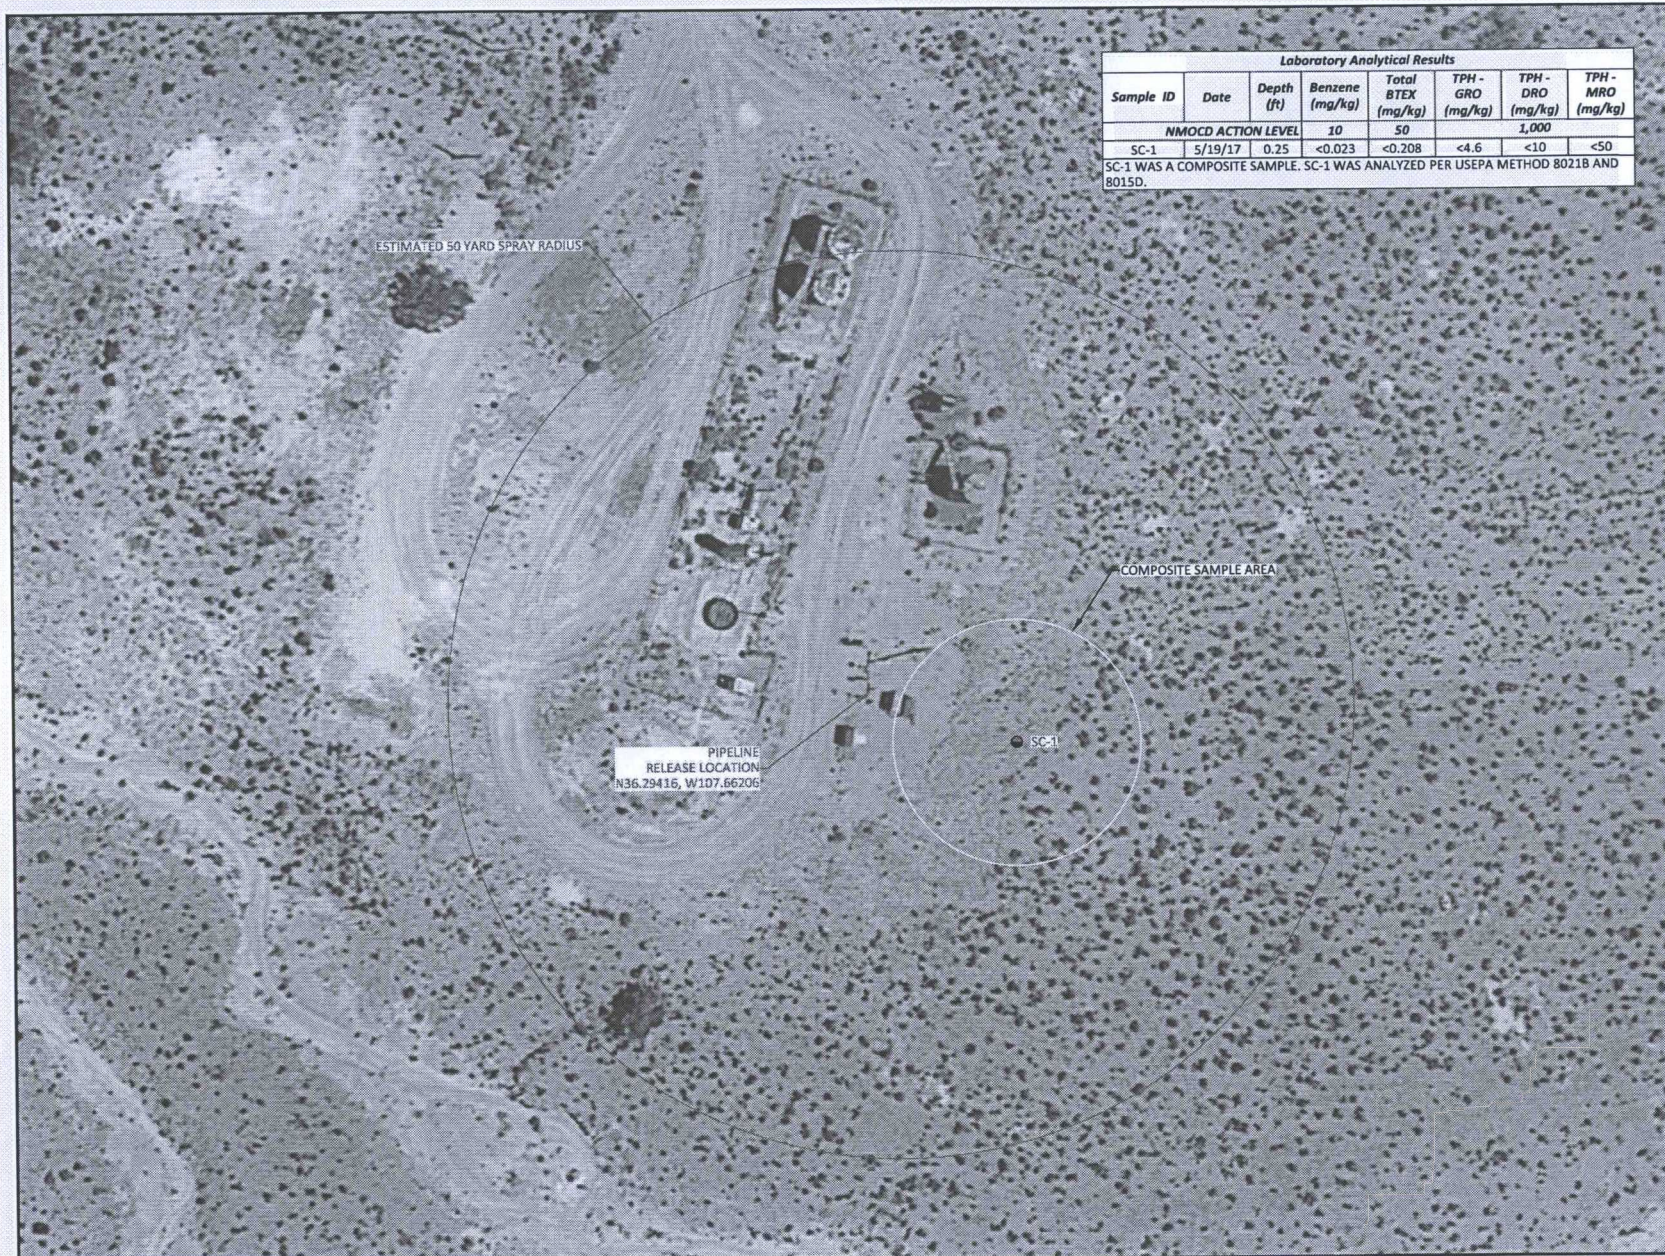
**FIGURE 2**

**AERIAL SITE MAP  
SAMPLE LOCATIONS AND RESULTS  
MAY 2017**  
DJ RESOURCES (FORMERLY BEE LINE SERVICES)  
SOUTH BLANCO FEDERAL 22-5 TANK BATTERY  
SE¼, SE¼, SECTION 22, T24N, R8W  
SAN JUAN COUNTY, NEW MEXICO  
N36.29416, W107.66206

Laboratory Analytical Results							
Sample ID	Date	Depth (ft)	Benzene (mg/kg)	Total BTEX (mg/kg)	TPH - GRO (mg/kg)	TPH - DRO (mg/kg)	TPH - MRO (mg/kg)
NMOCD ACTION LEVEL			10	50	1,000		
SC-1	5/19/17	0.25	<0.023	<0.208	<4.6	<10	<50

SC-1 WAS A COMPOSITE SAMPLE. SC-1 WAS ANALYZED PER USEPA METHOD 8021B AND 8015D.

Laboratory analytical results are summarized in Table 1 and presented on Figure 2. The laboratory analytical report is attached.
