**PRELIMINARY SITE INVESTIGATION REPORT
and
REMEDIAATION/CLOSURE PLAN**

**Plains Marketing, L.P.
Livingston Ridge Station Tank 113038
Lea County, New Mexico
Plains EMS # 2006-086**

**Unit D, Section 6, Township 21S, Range 32E
Latitude 32° 25, 36.5" North, Longitude 103° 43, 21.2" West**

April 13, 2006

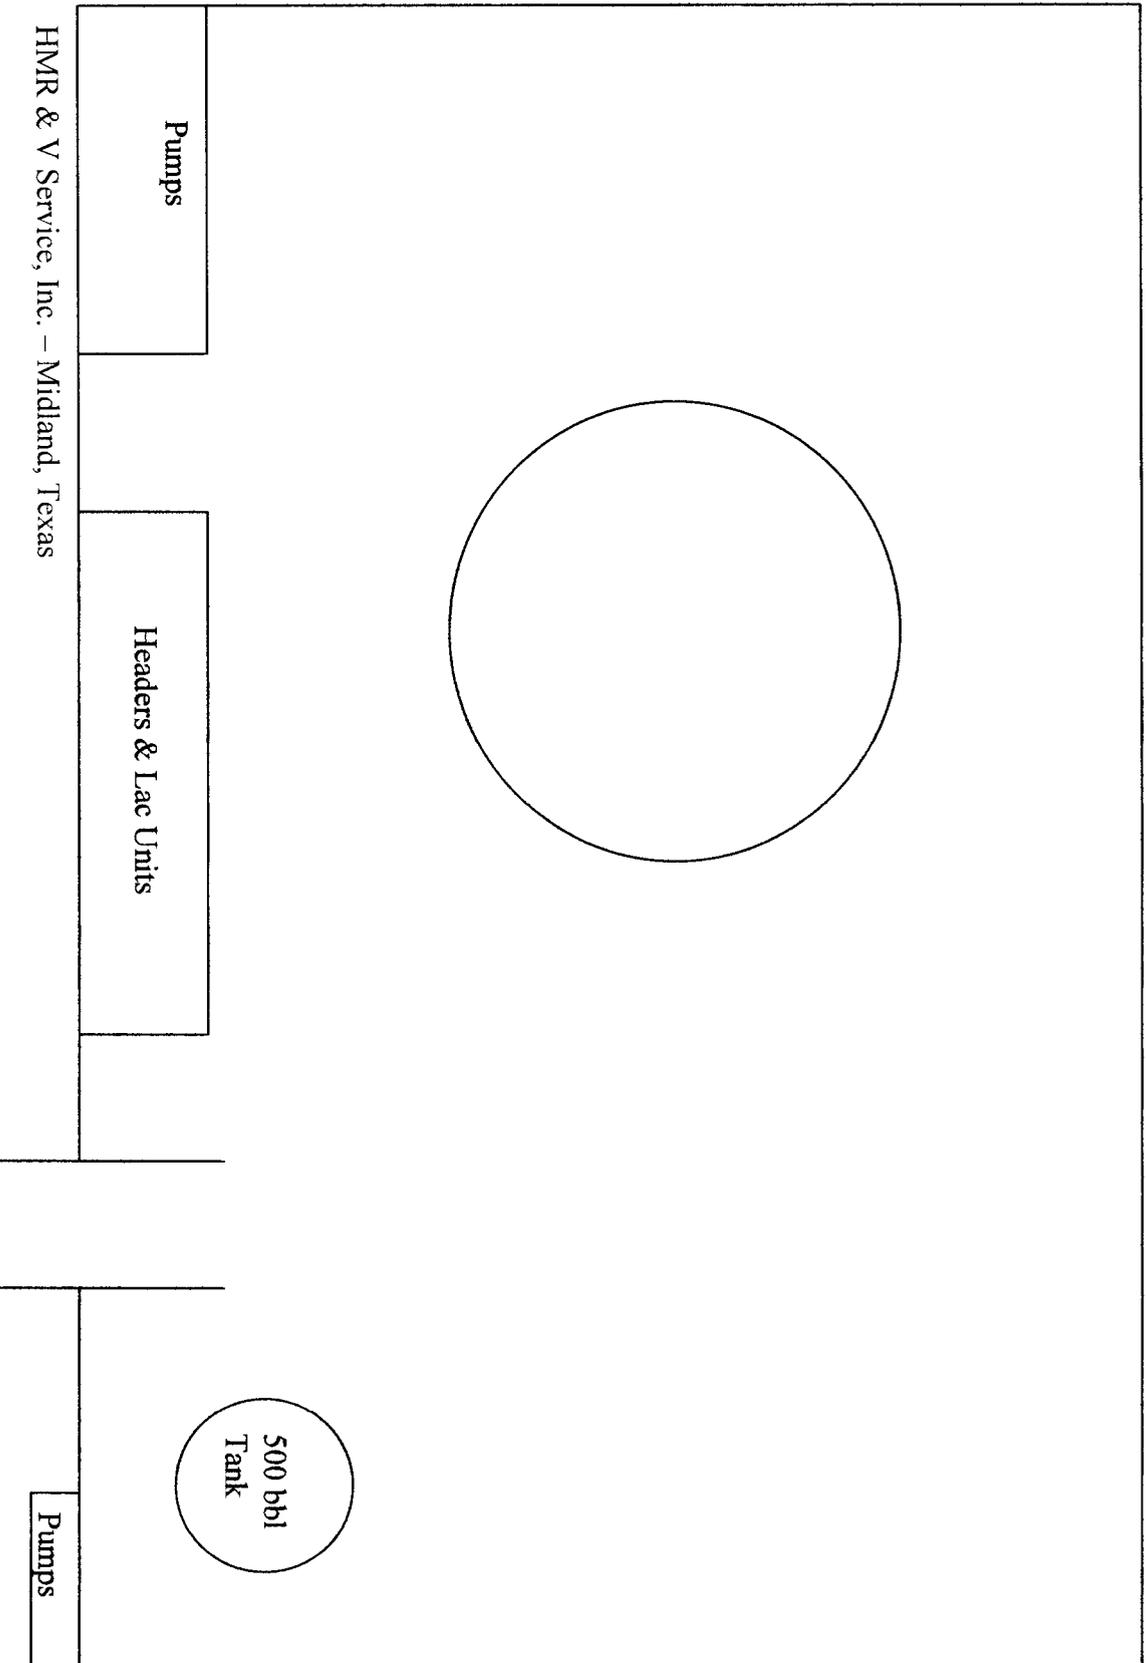
Figure 2:

The release point and flow path areas were excavated to approximately 64 feet long by 41 feet wide and depths ranging approximately 2 feet bgs to 3 feet bgs (see Figure 2, Site Map) with no visual evidence of crude oil impact evident on the floor or the sidewalls of the excavation. Confirmation soil samples were collected from excavation on March 10, 2006. The soil samples were field screened with a PID and analyzed for concentrations of BTEX and TPH. Laboratory data sheets and chain-of-custody forms are attached (Appendix B).

Site Map

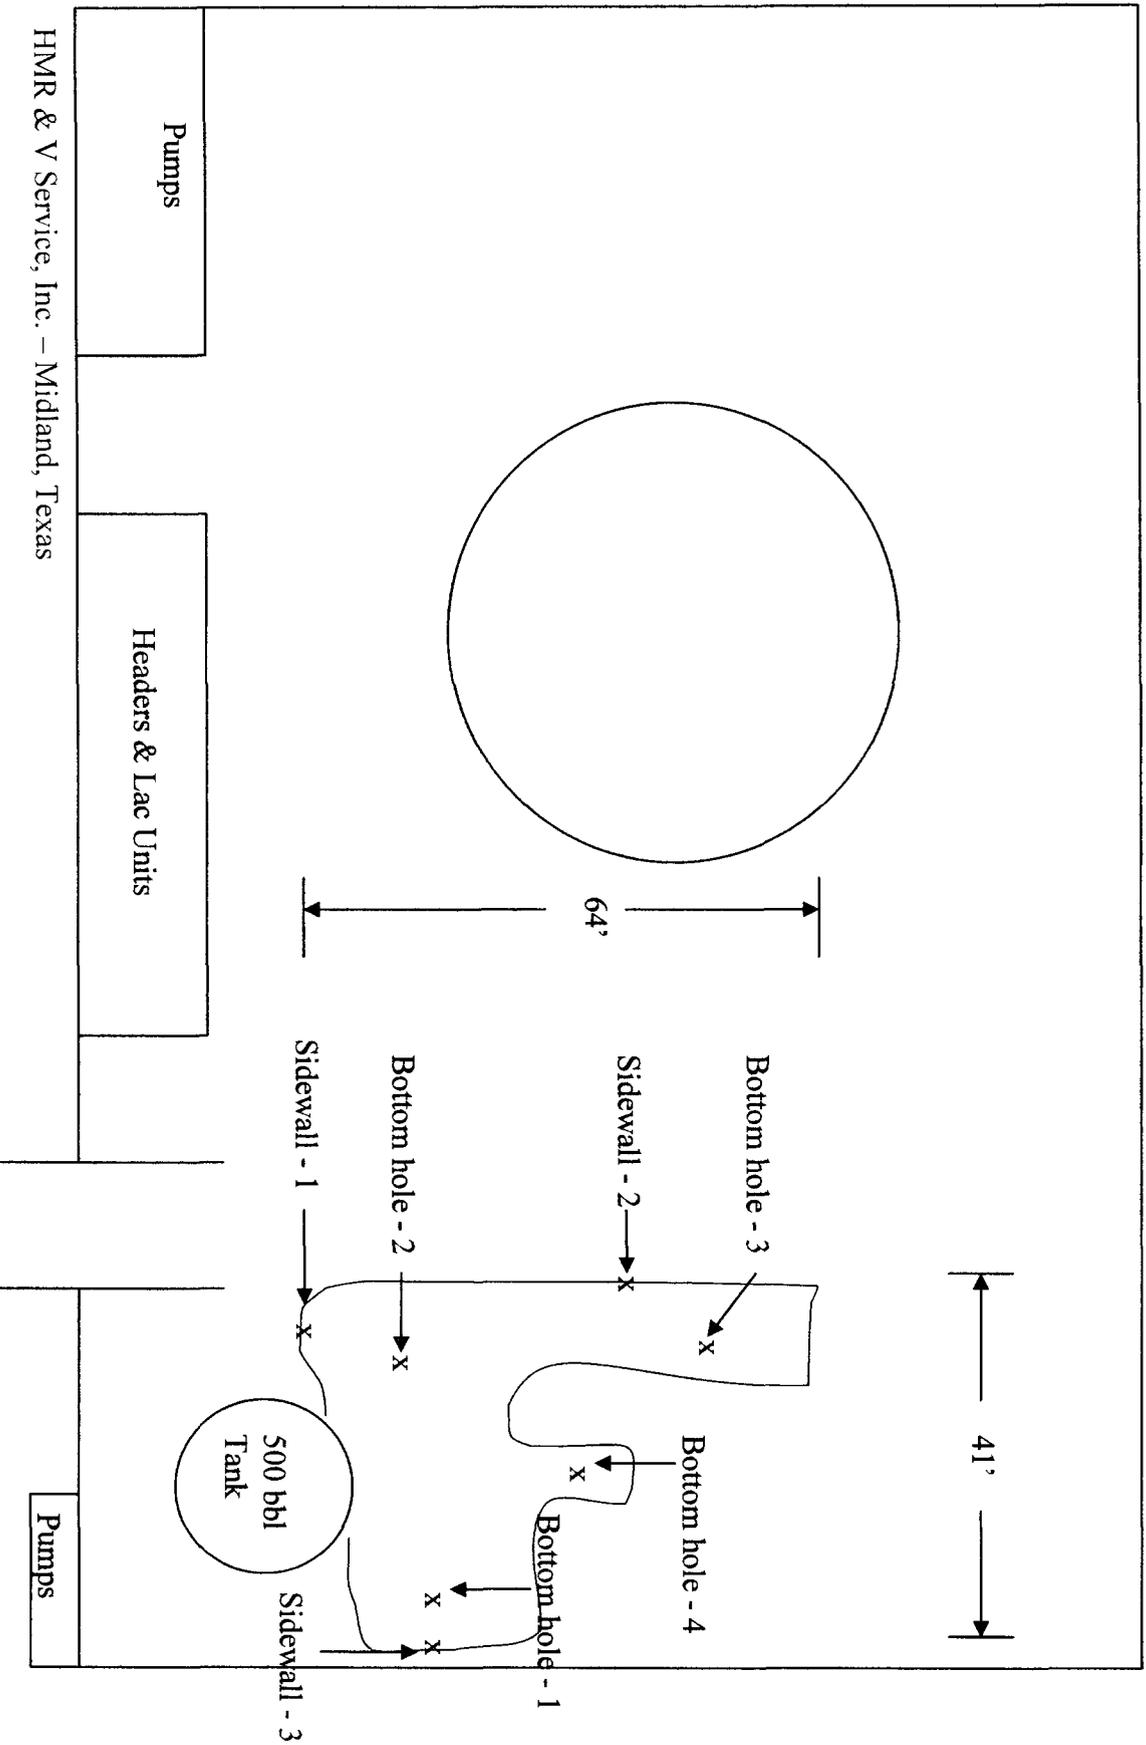
Figure 3:

On March 10, 2006, confirmation soil samples were collected from the excavated area. The confirmation soil samples collected were field screened with a Photoionization Detector (PID), (see Figure 3, Soil Sampling Locations). All selected soil samples were analyzed for benzene, toluene, ethylbenzene, and xylenes (BTEX), and total petroleum hydrocarbons – gasoline range organics/diesel range organics (TPH-GRO/DRO). Laboratory results of the confirmation soil samples indicated that the walls and floor of the excavated area are below NMOCD regulatory standards for BTEX and TPH constituent concentrations (see Table 1, Soil Chemistry Table).

Soil Sampling

Analytical results from the March 10, 2006 confirmation soil sampling event indicated that detectable BTEX and TPH concentrations were below NMOCD regulatory standards for the bottom and sidewalls. Analytical results indicate that the TPH concentrations from the excavation stockpile samples are above NMOCD regulatory standards.

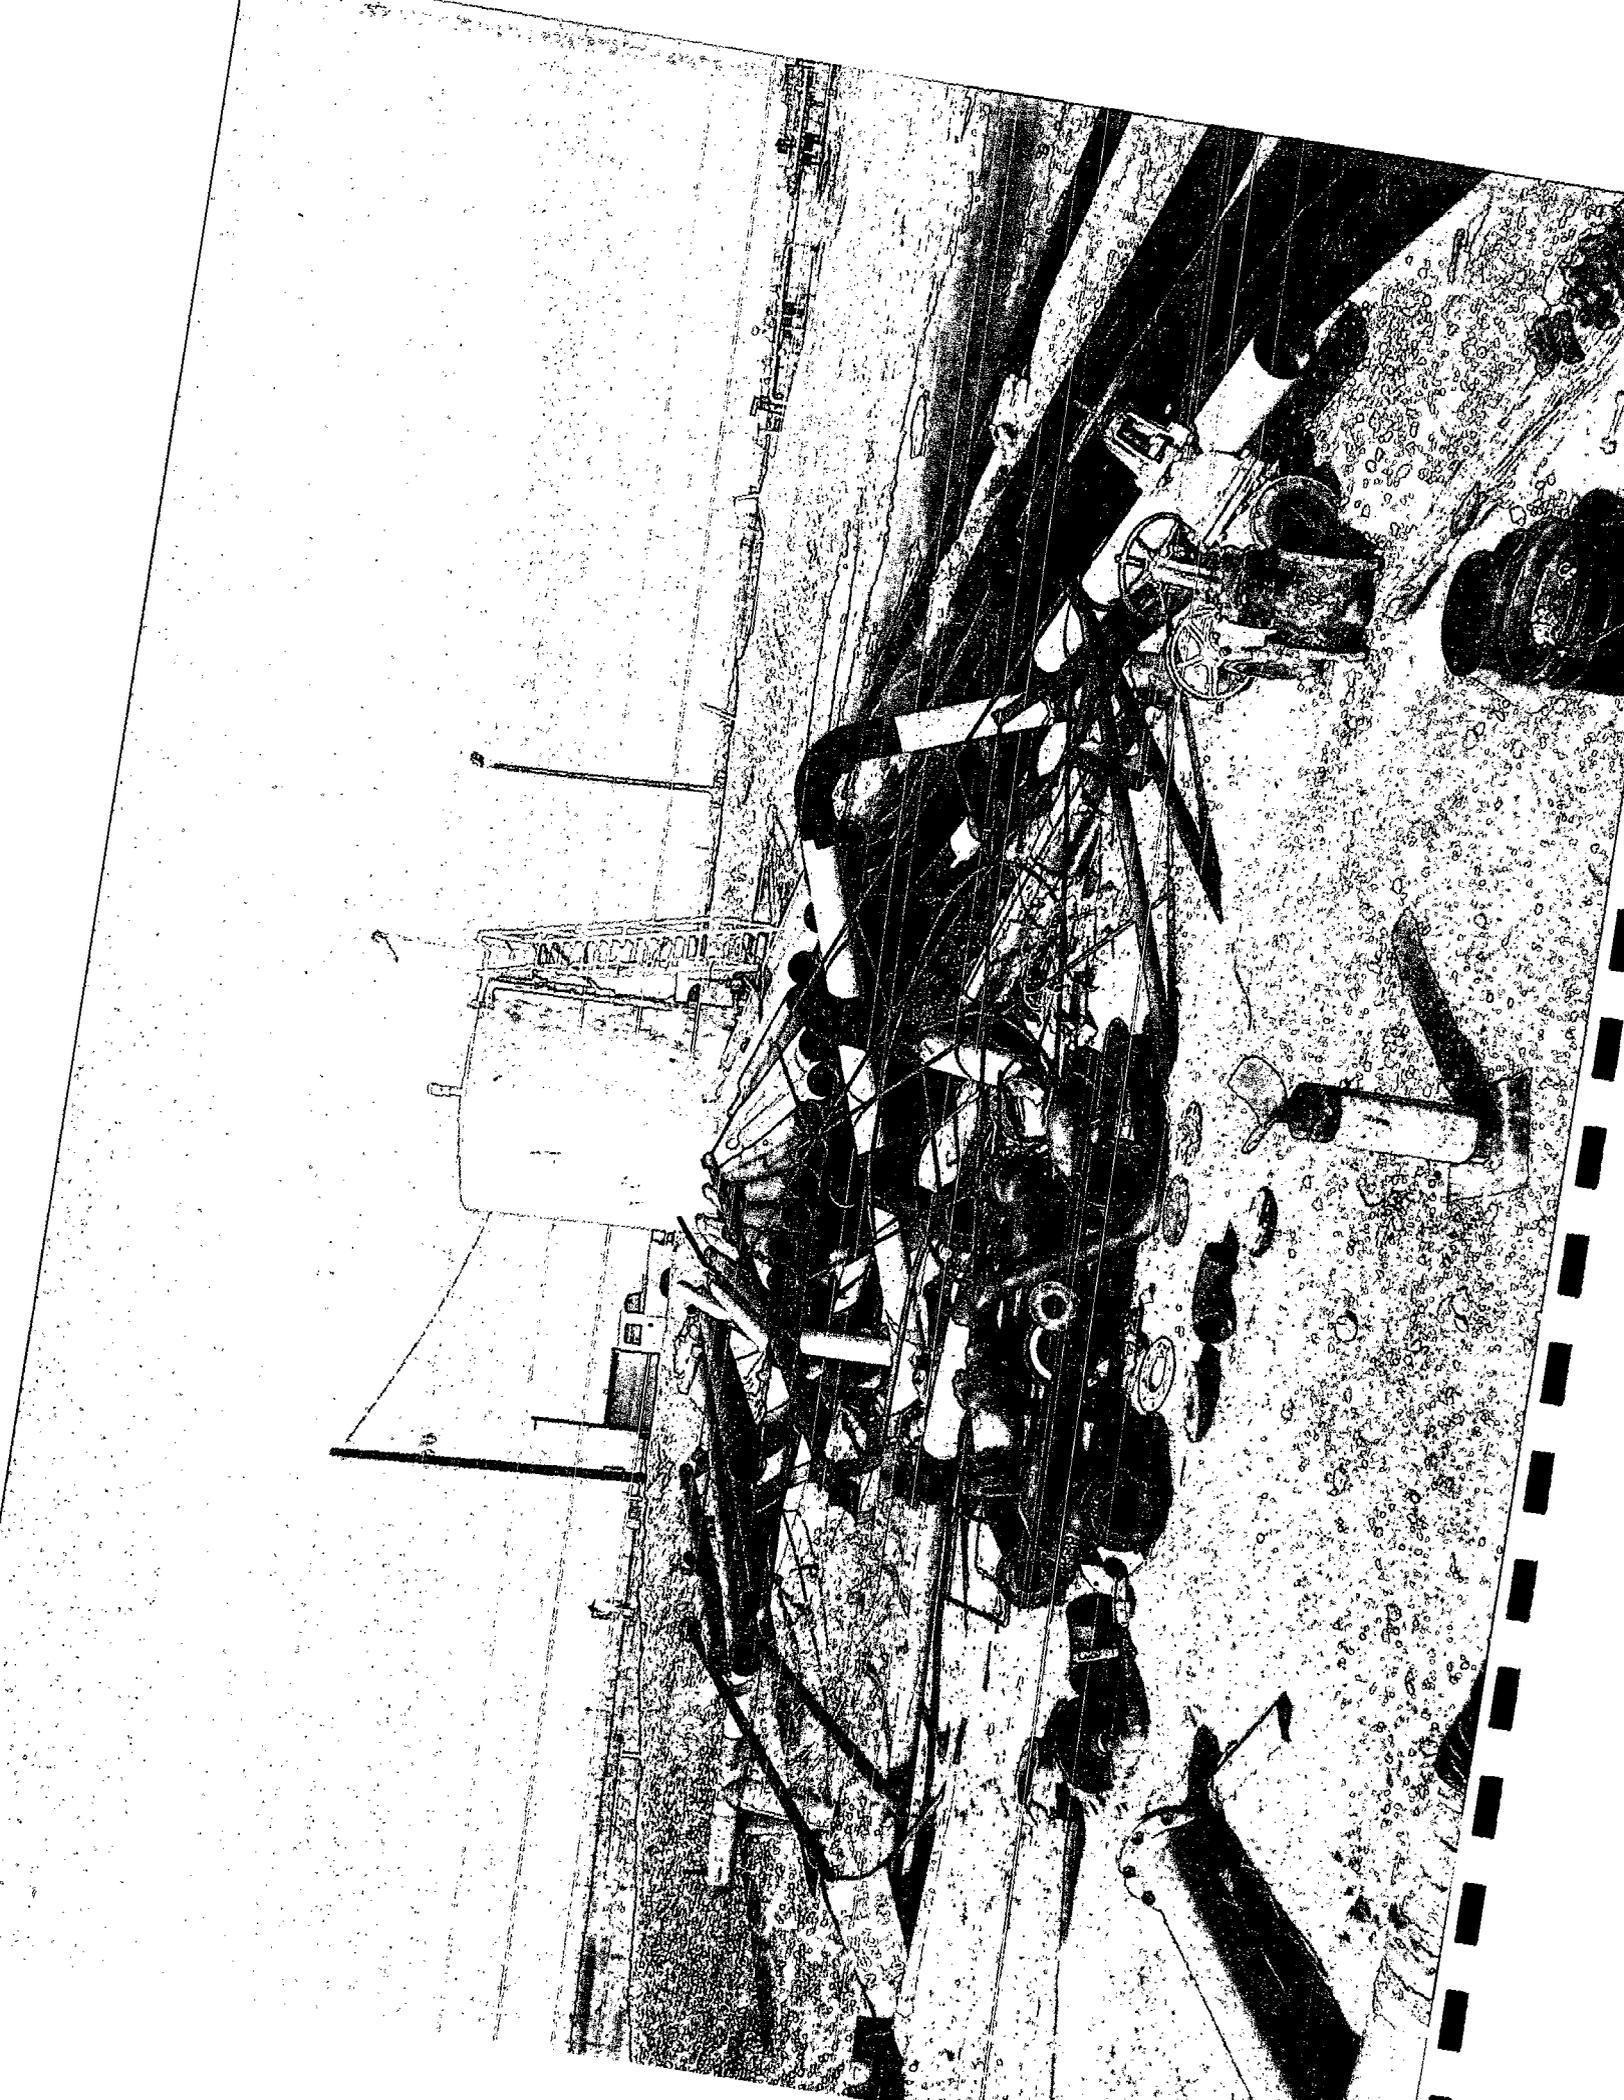
Figure 4:

Digital Photos

Approximately 300 cubic yards of impacted soil were excavated and stockpiled on-site resulting from the emergency response and remediation activities. Based on the results of the remedial activities conducted, Plains requests approval to transport the impacted soil to the Plains Lea Station Landfarm (LSLF). A permit (NMOCD Form C-138) will be obtained from the NMOCD for the transporting of the contaminated soils to LSLF. The backfill material will be obtained from the LSLF. This is material that has been treated, tested and authorized for reuse by the NMOCD. The excavation will be backfilled and contoured to the original rangeland grade surrounding the tank battery. Upon completion of backfilling and contouring, Plains will submit a request for closure to NMOCD pursuant to *NMOCD Guidelines for Remediation of Leaks, Spills, and Releases (1993)*.
