Release Notification and Corrective Action

DJR Production Upstream Remediation Final Report

Project: Environmental Remediation of Natural Gas Release

RE: Excavation Clearance Report
Lybrook South 9-11 & 15 Pipeline Release
Rio Arriba County, New Mexico

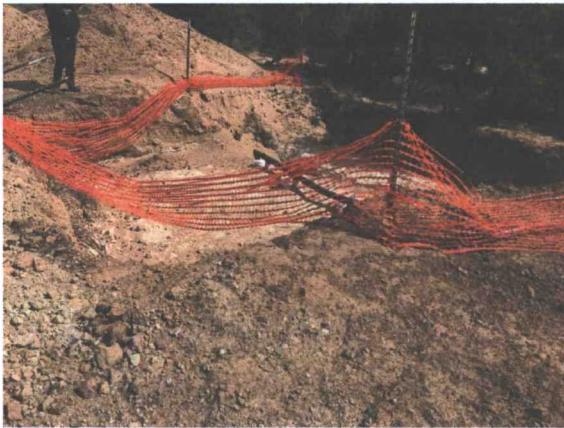
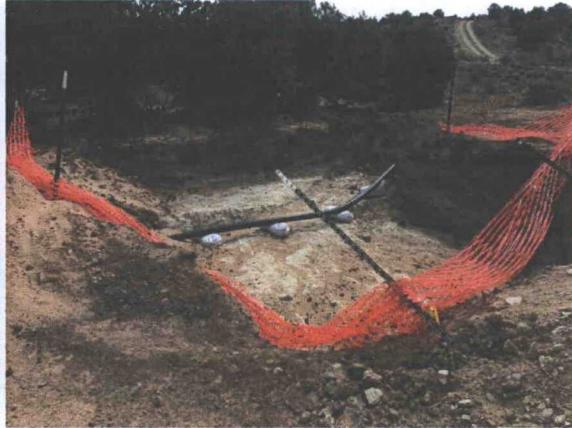
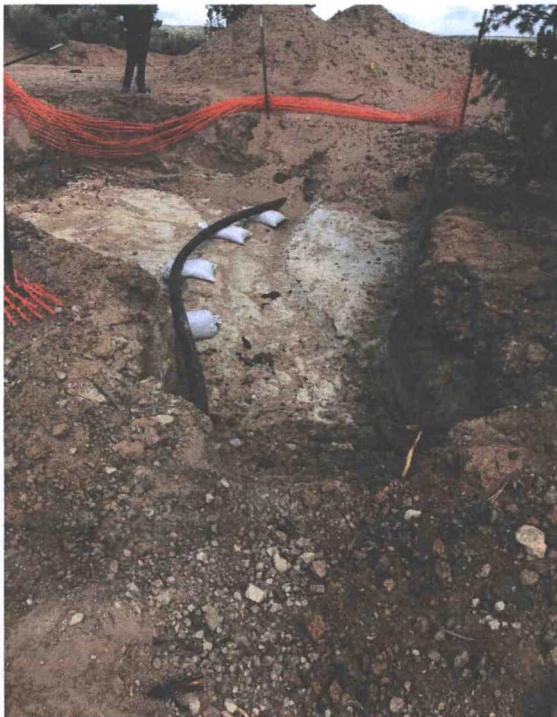
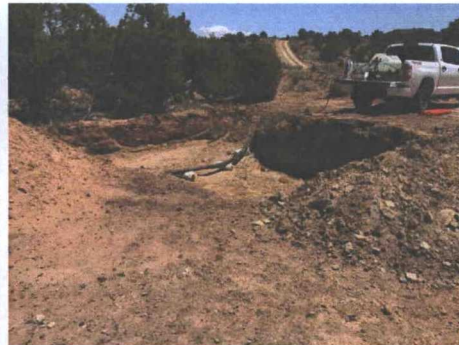
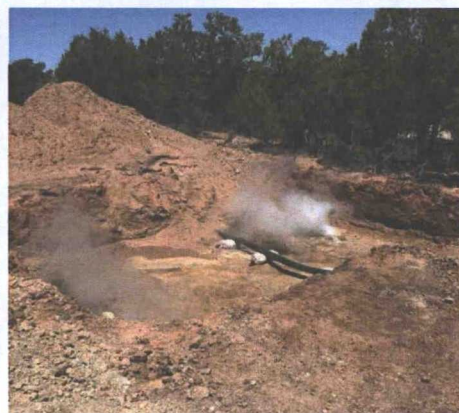
Before

With the use of hand tools, Microbial Energy plans to spray the solution onto the contaminated walls and base of the open pit. Once the pit is sprayed, the soil already on location can be used to backfill the pit pictured in the *Appendix*.

Being already approved by New Mexico Bureau of Land Management to use an oxidizing agent, Microbial Energy recommends using a 34% concentration of H_2O_2 , better known as Hydrogen Peroxide. Hydrogen peroxide oxidizes hydrocarbons into mineralized products such as CO_2 , salts, and readily available organic fragments. Being both relatively safe and cost-effective, Hydrogen Peroxide will save DJR additional capital.

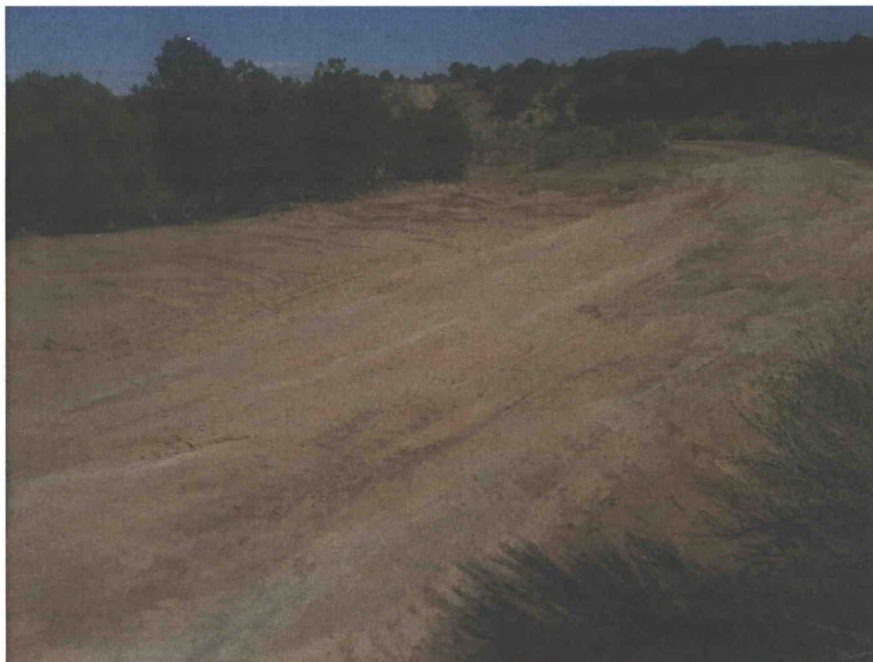
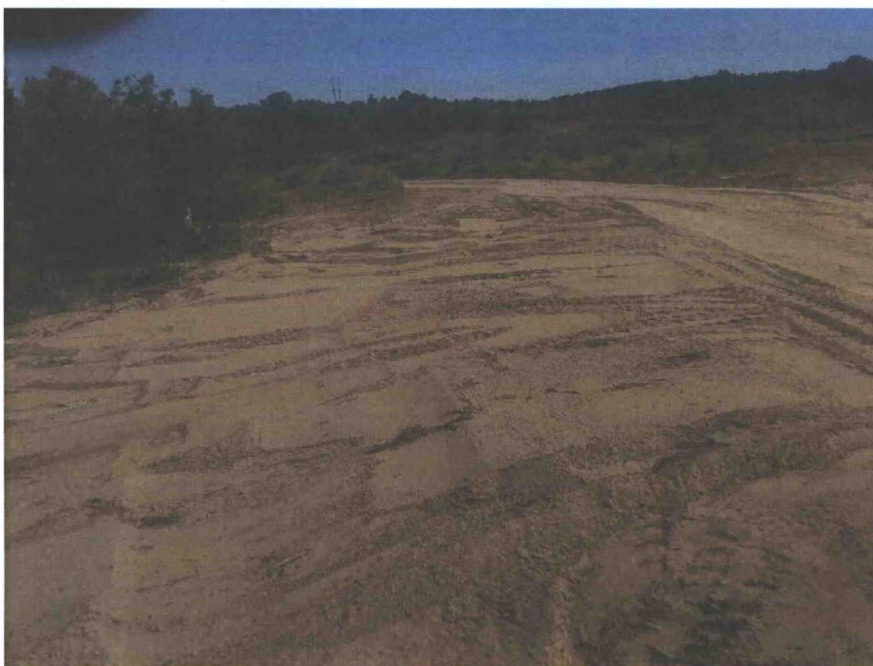
After

On 3-2-18 (after one-call) they excavated 40 bbls of soil and took it to IEI's land farm. This area has a total ranking score of 10. We sprayed this location with an oxidization agent (please see attached). We used soil purchased from Envirotech to backfill the location.

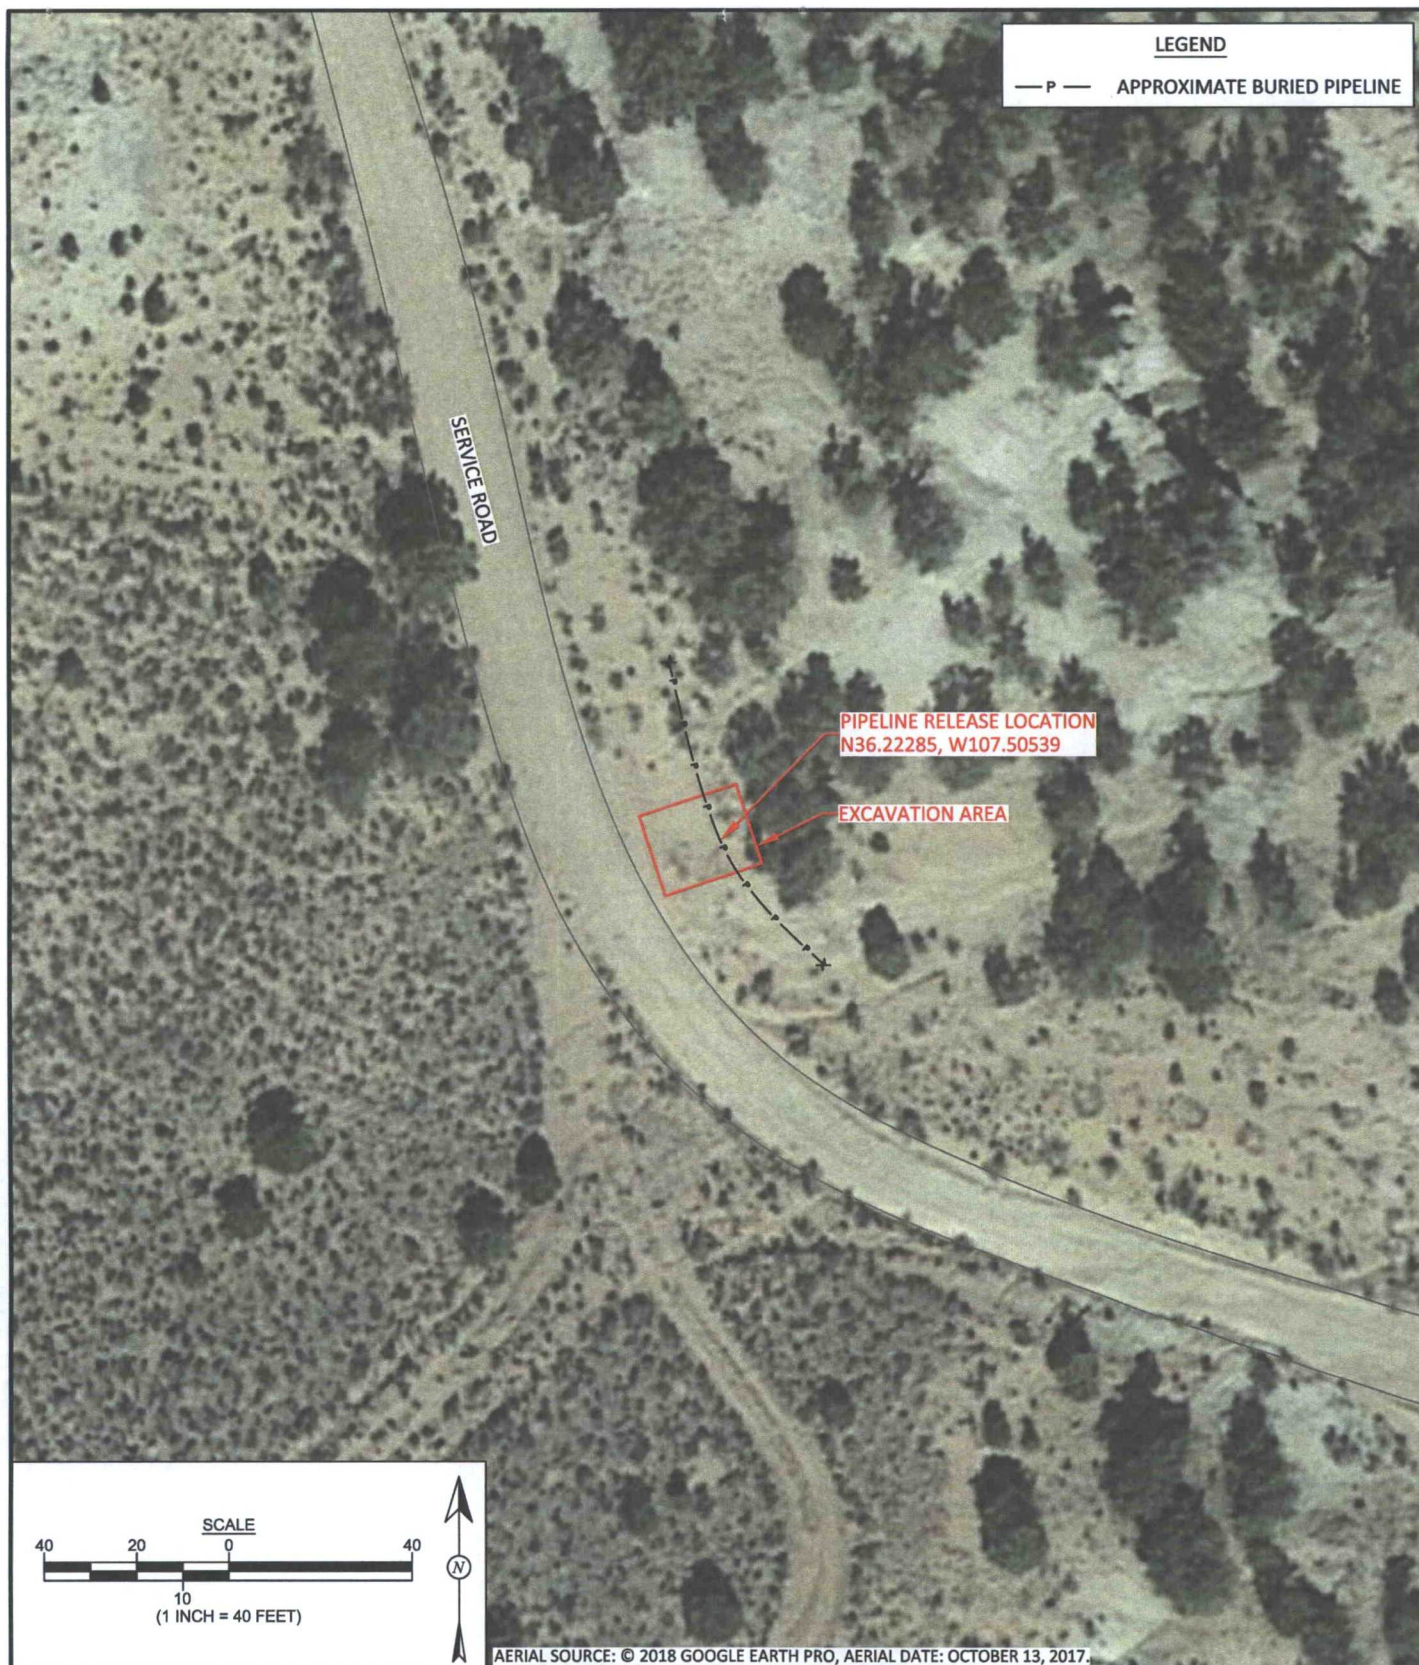
FIGURE 2

AERIAL SITE MAP MARCH 2018
