Pit, Below-Grade Tank, or
Proposed Alternative Method Permit or Closure Plan Application

CLOSURE REPORT

On November 13, 2017, the New Mexico Oil Conservation Division (NMOCD) notified Enterprise Products Operating, LLC (Enterprise) via email, that during inspections in the area, an inspector found an earthen pit near an Enterprise pipeline. Enterprise confirmed it was the operator of the earthen pit and that it was an out of service in-line drip previously used to remove produced water and condensate from the adjacent pipeline. During subsequent email correspondence with NMOCD, Enterprise was instructed to submit a closure plan for approval prior to implementation of closure activities.

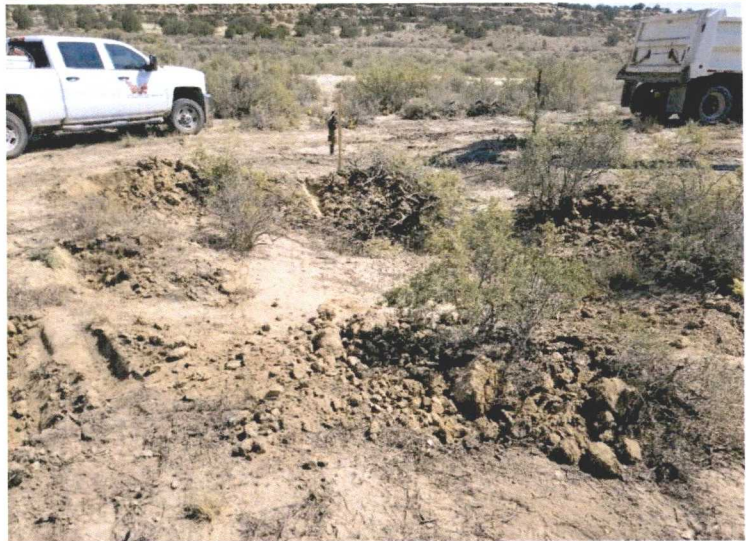
Photograph 1

View of the earthen pit after fence was removed.

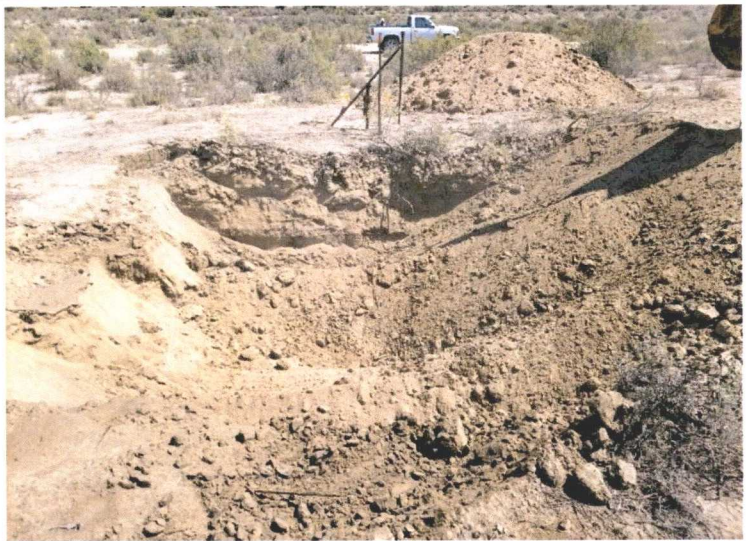
Photograph 2

View of in-process excavation activities, facing northeast.

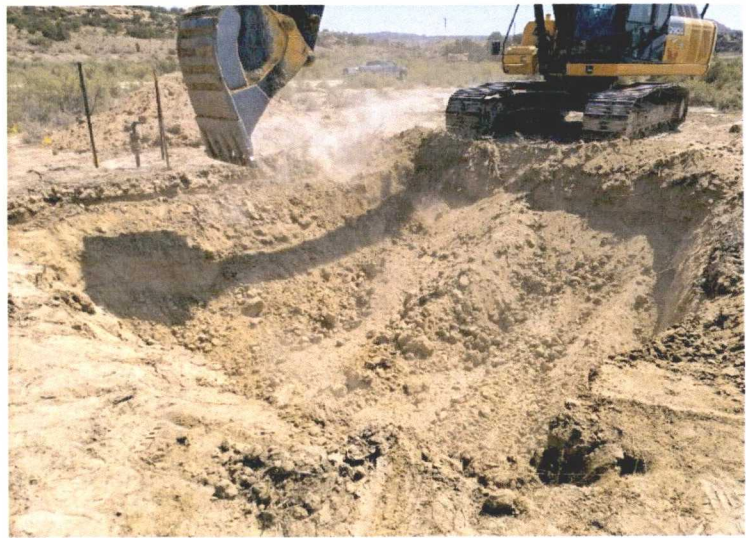
Photograph 3

View of in-process excavation activities, facing east.

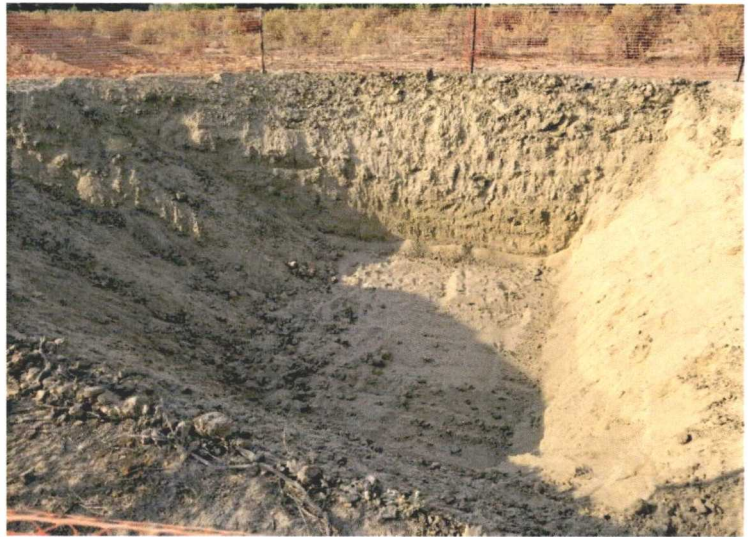
Photograph 4

View of the final excavation, facing south.

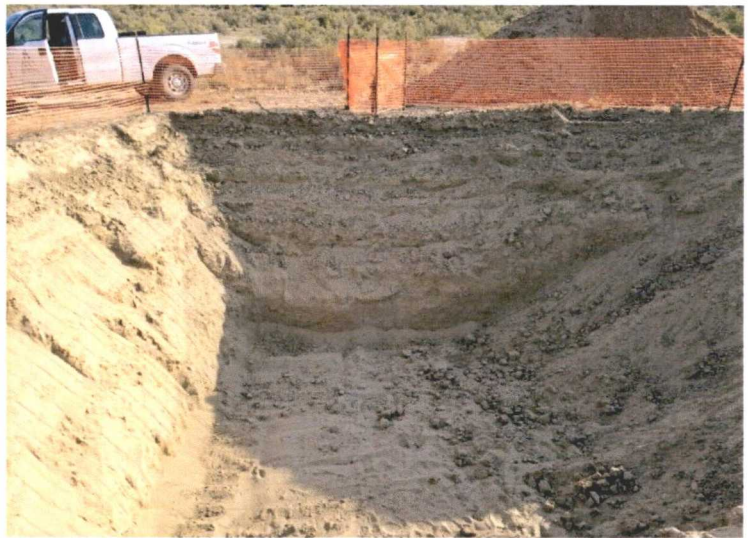
Photograph 5

View of the final excavation, facing northeast.

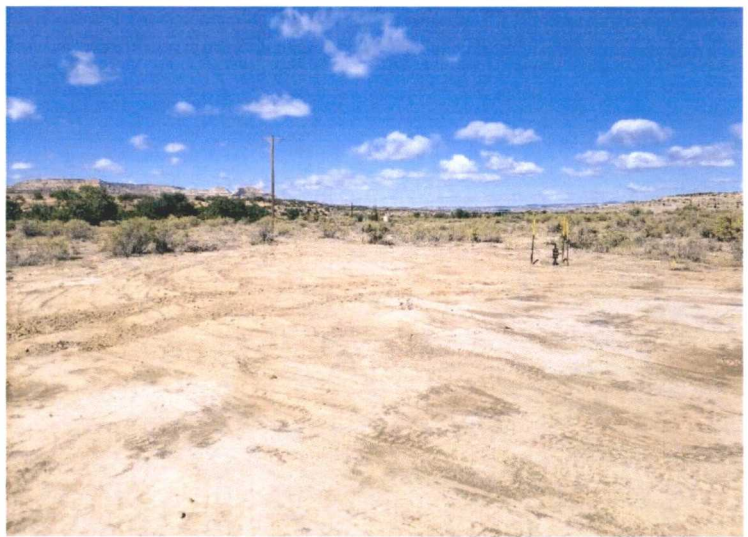
Photograph 5

View of the final excavation after initial restoration, facing north.

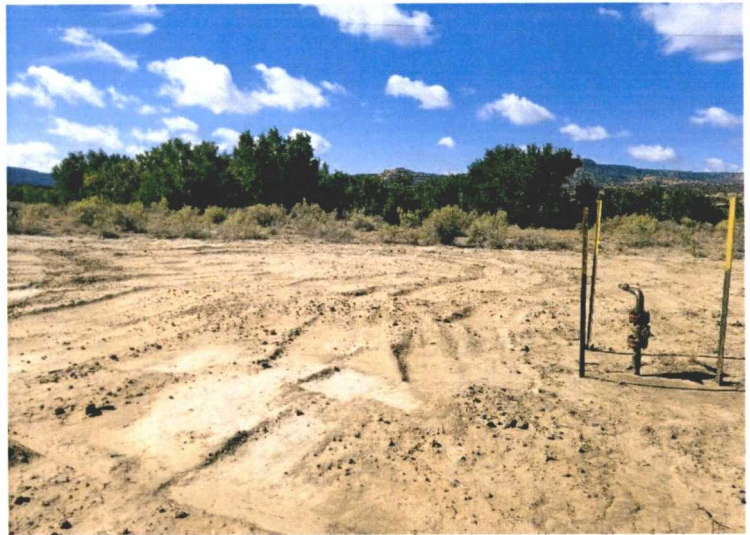
Photograph 5

View of the final excavation after initial restoration, facing northwest.
