## Release Notification

Site Name	CBU Tank Battery	Site Type	Tank Battery
Date Release Discovered	July 9, 2018	API# (if applicable)	NA

**RE: Excavation Clearance Report  
CBU Tank Battery  
NE¼ NW¼, Section 5, T25N, R12W  
San Juan County, New Mexico**

**DJR Operating, LLC**  
**CBU Tank Battery Initial and Final Excavations**

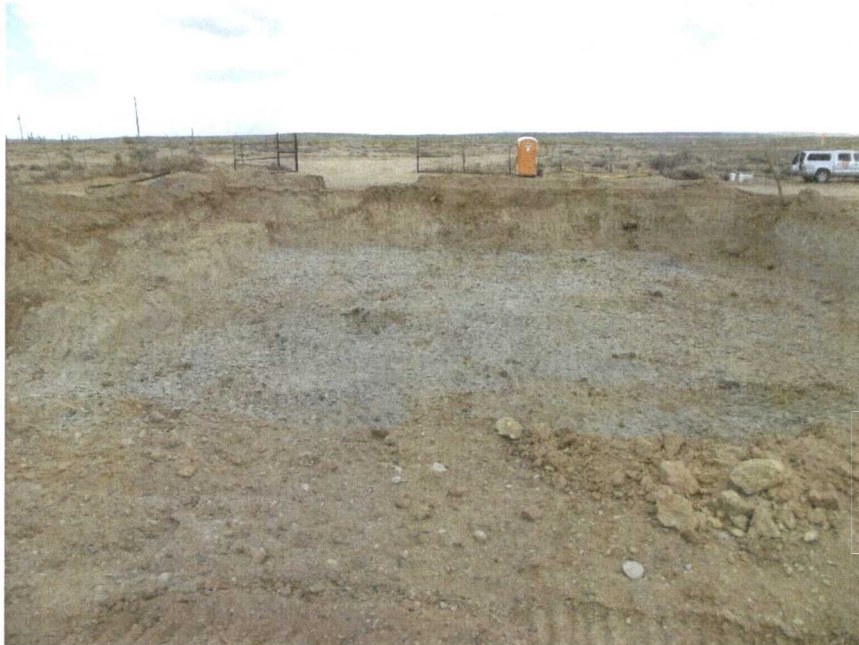
Photo 1: Initial north excavation area. Photo taken July 23, 2018.

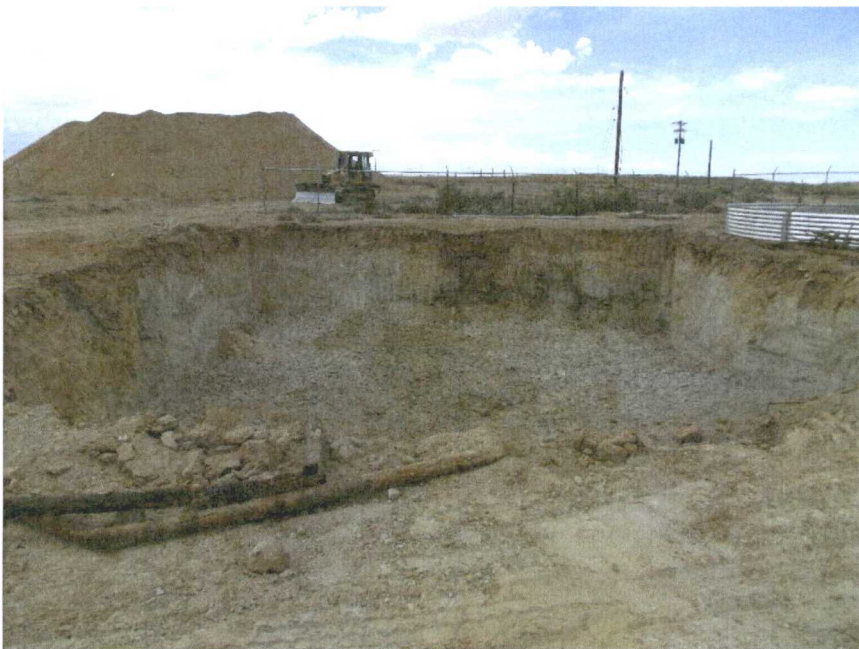
Photo 2: Initial LACT excavation area. Photo taken July 23, 2018.

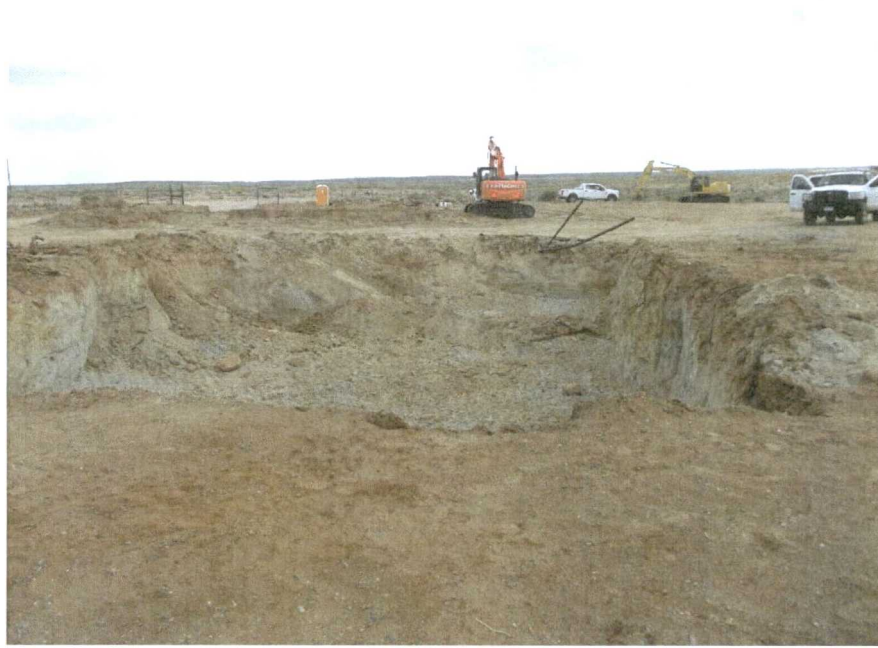
Photo 3: Looking east at both the initial LACT and North excavation areas. Photo taken July 23, 2018.

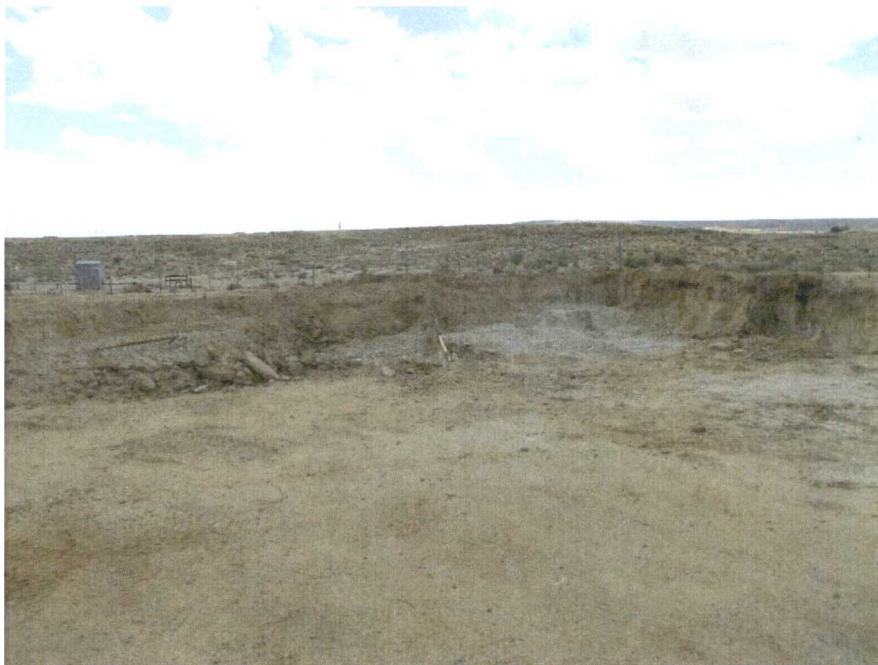
Photo 4: Looking south at the South excavation area. Photo taken July 23, 2018.

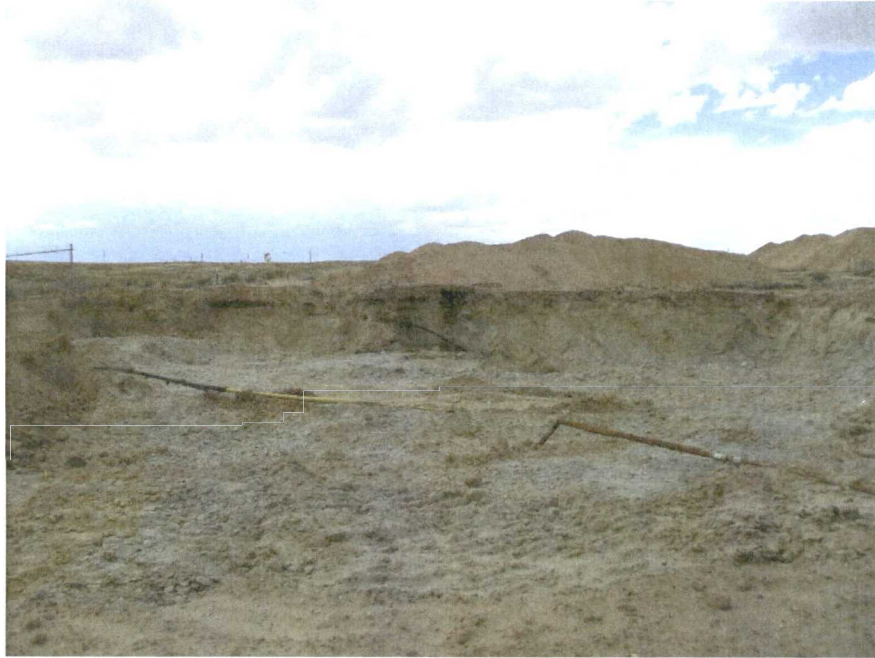
Photo 5: Looking west at the South excavation area. Photo taken July 23, 2018.

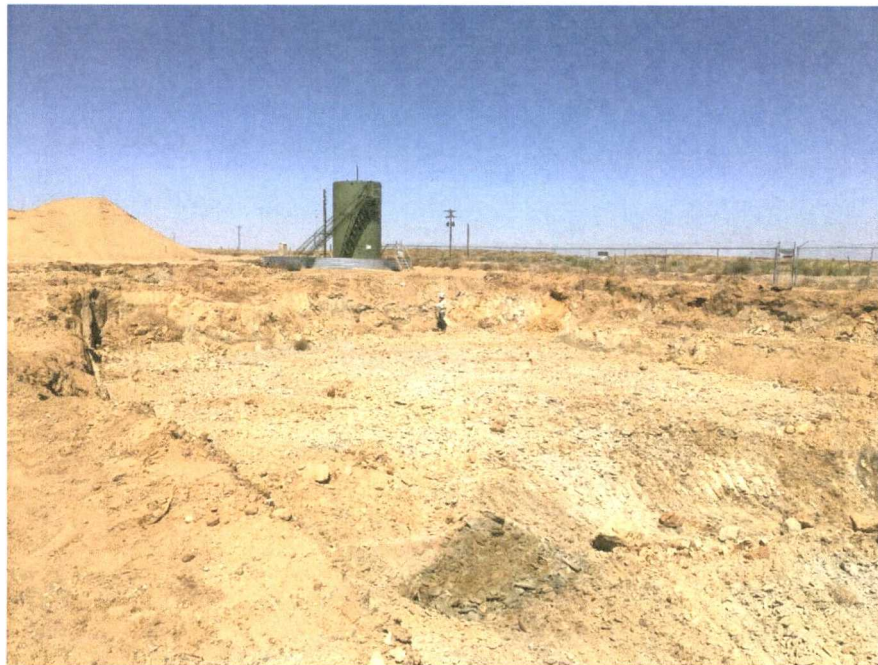
Photo 6: North excavation extension area. Photo taken August 13, 2018.

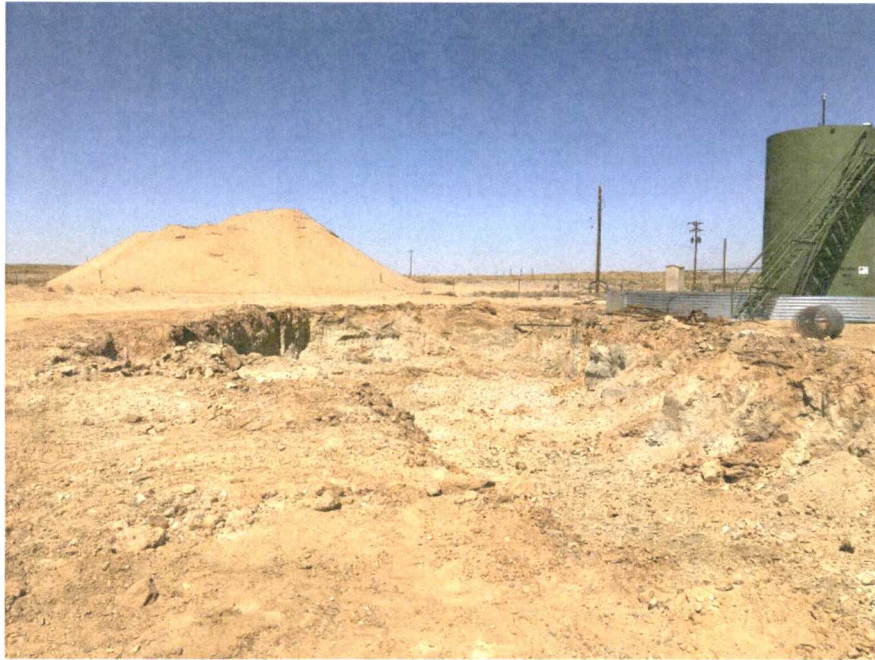
Photo 7: LACT excavation extension area. Photo taken August 13, 2018.

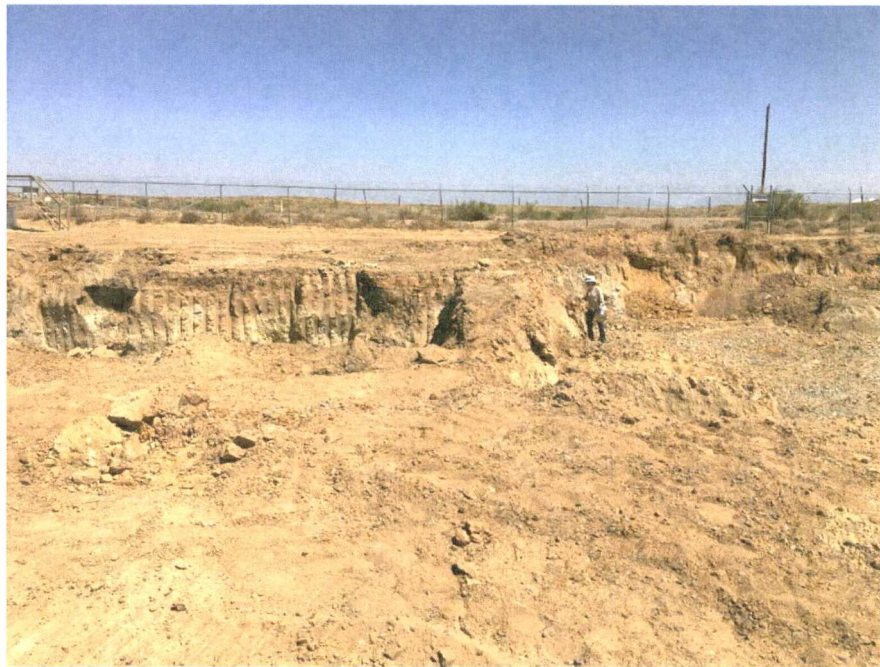
Photo 8: East end of LACT excavation to the west end North excavation area. Photo taken August 13, 2018.

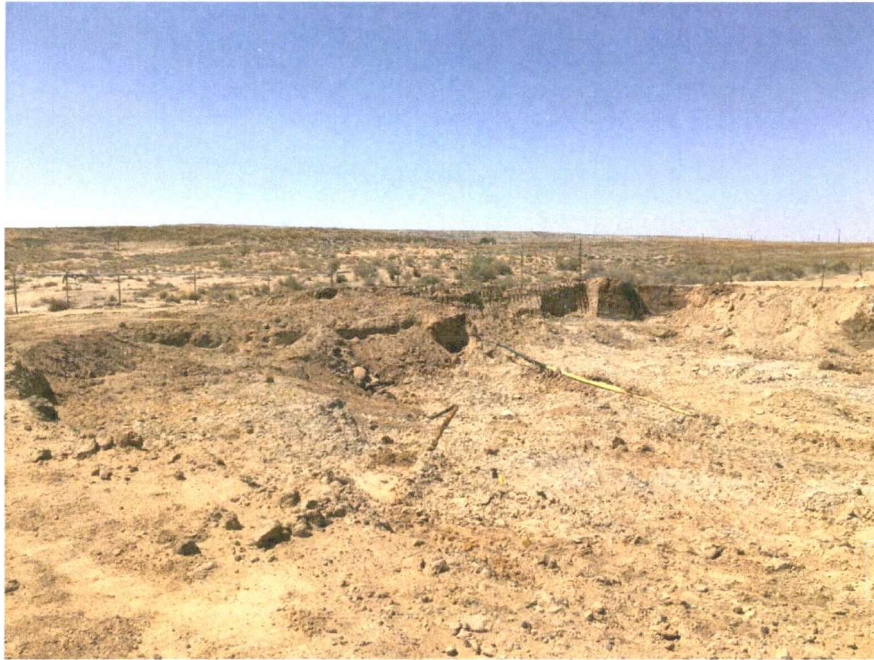
Photo 9: South excavation area extension. Photo taken August 13, 2018.

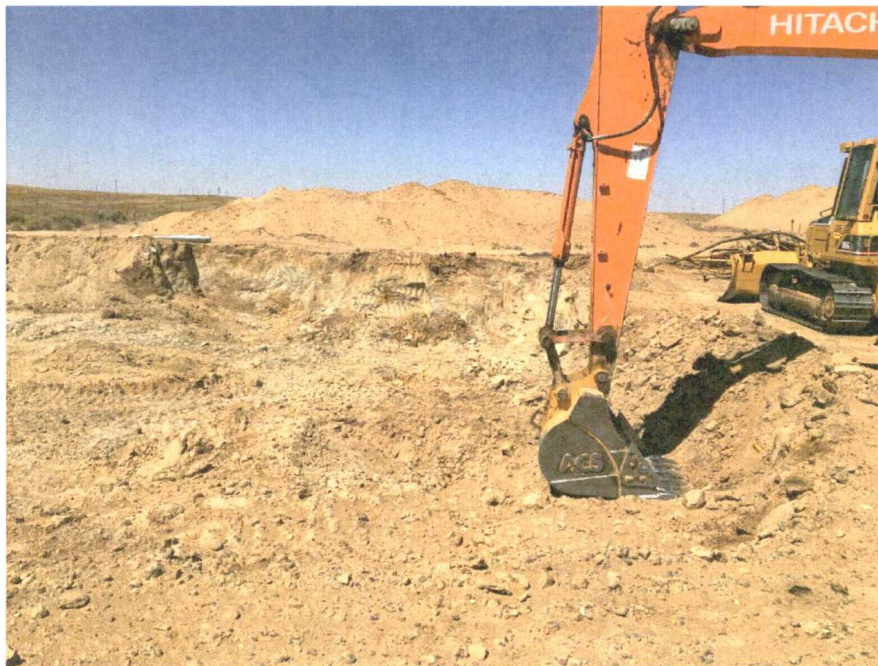
Photo 10: South excavation area extension. Photo taken August 13, 2018.

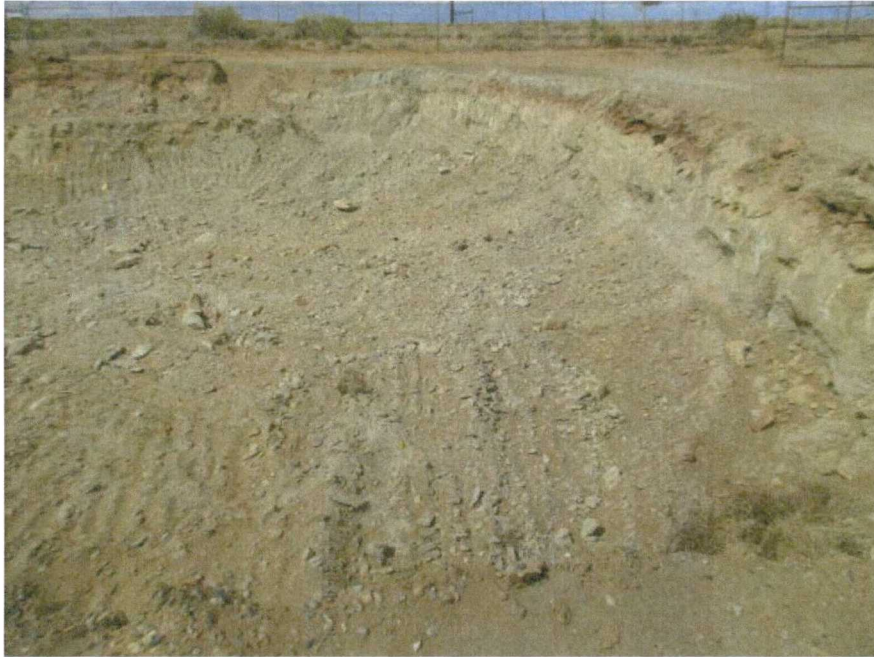
Photo 11: North excavation area extension. Photo taken by Blagg Engineering on September 6, 2018.

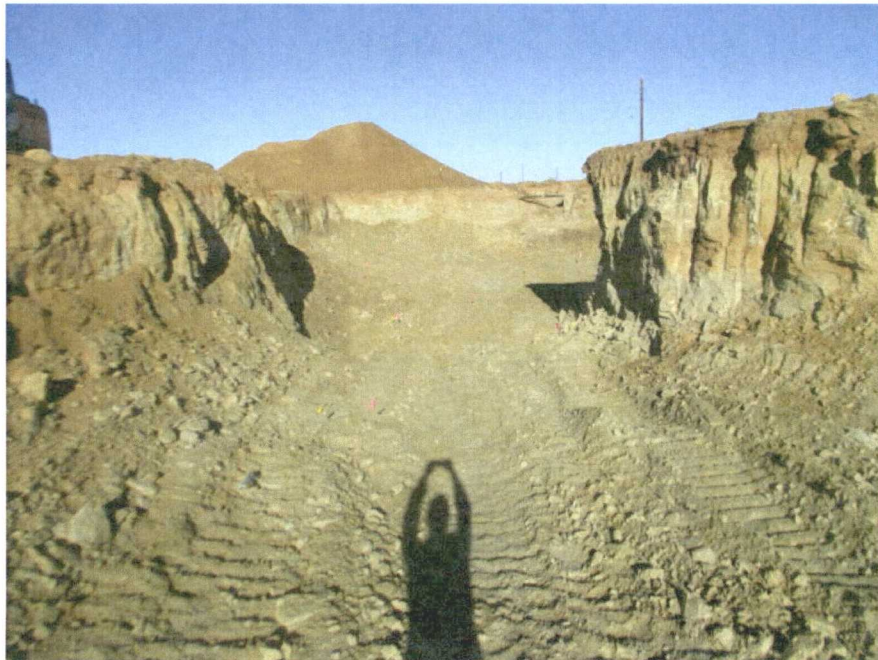
Photo 12: North excavation area connection to the LACT excavation area. Entire excavation now North excavation area. Photo taken by Blagg Engineering on September 6, 2018.

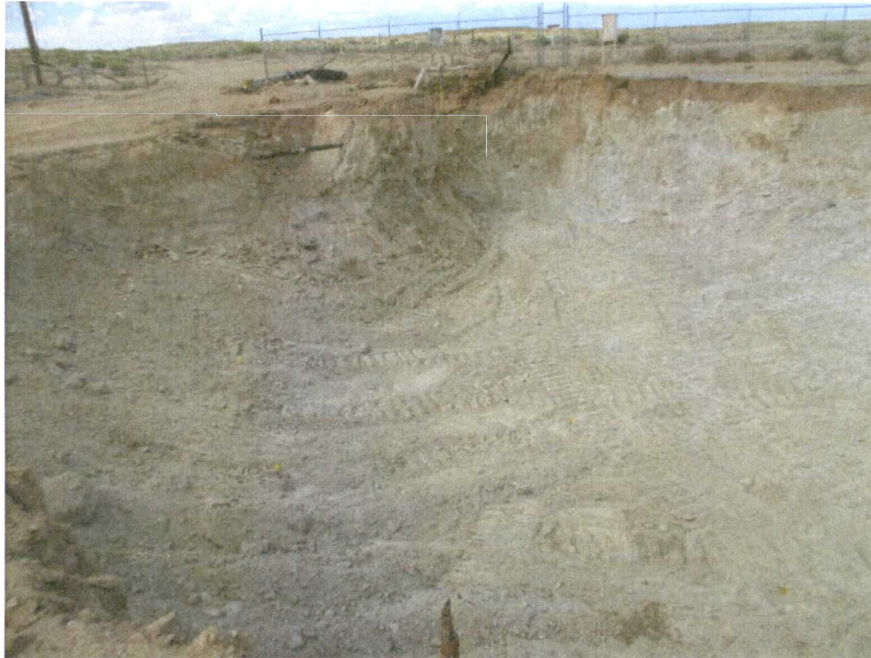
Photo 13: LACT area excavation extension. Photo taken by Blagg Engineering on September 6, 2018.

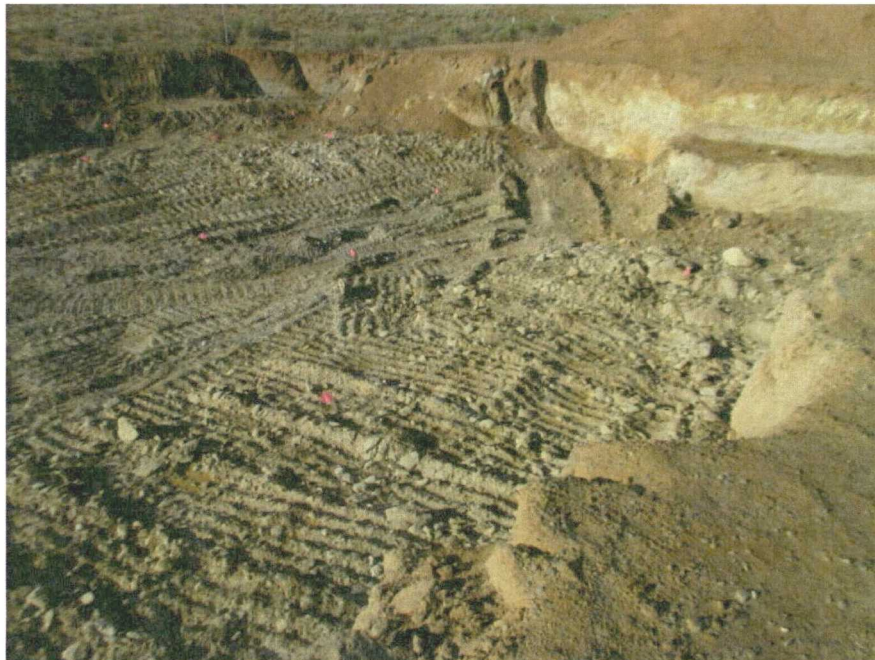
Photo 14: South excavation area extension. Photo taken by Blagg Engineering on September 6, 2018.

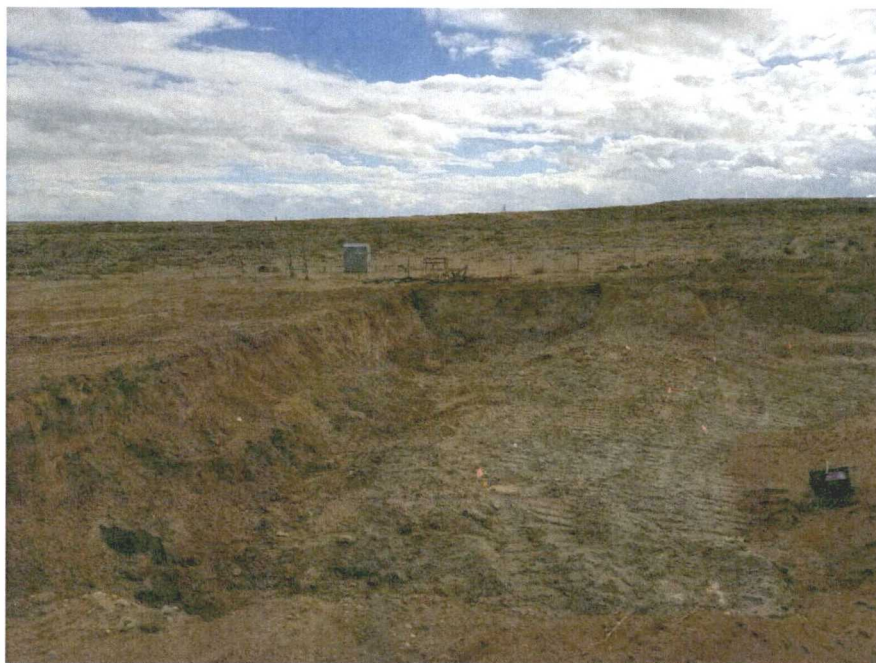
Photo 15: Final South excavation east half area. West half area back filled. Photo taken October 11, 2018.

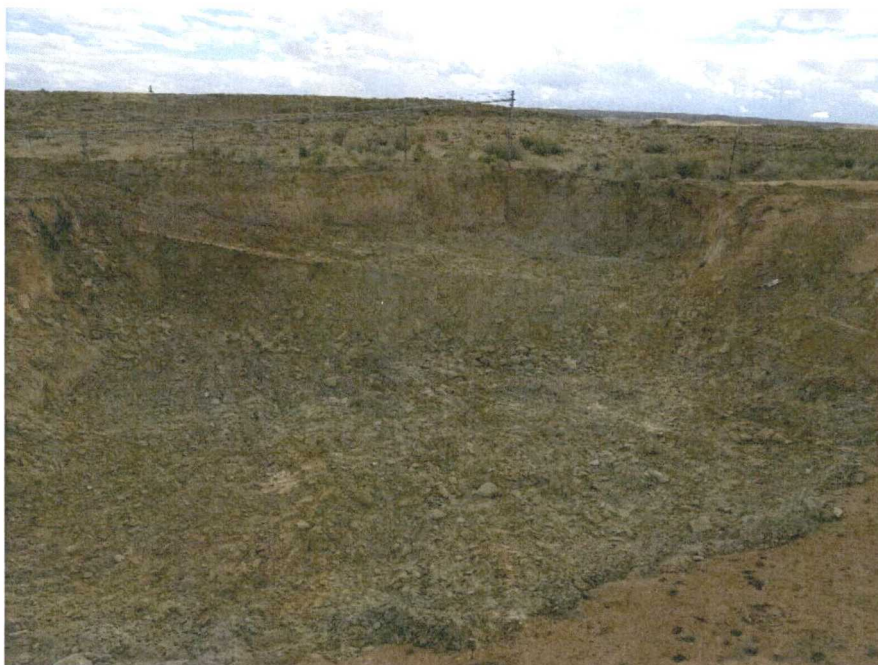
Photo 16: Final South excavation SW Base area extension. Photo taken October 11, 2018.

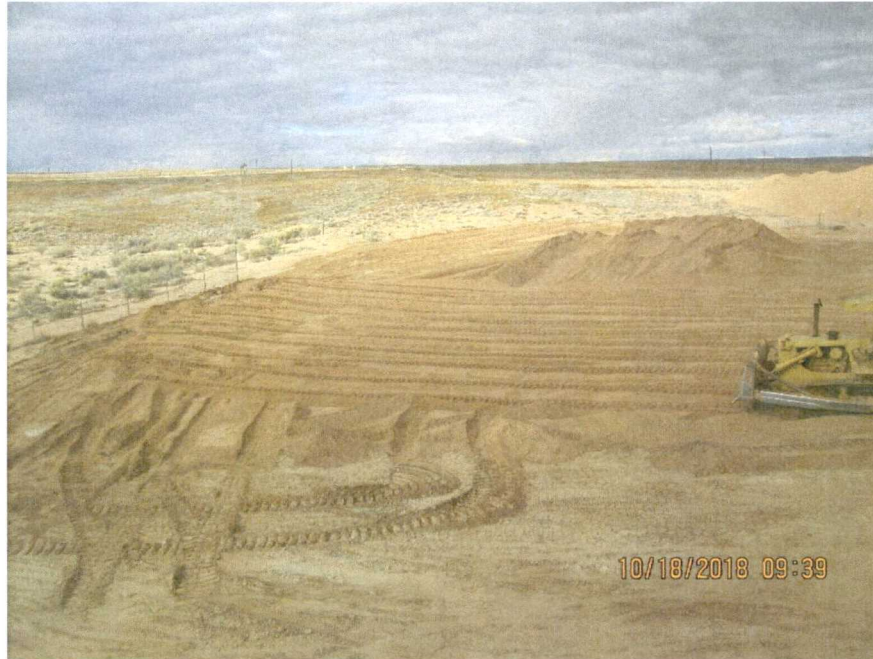
Photo 21: South excavation area back filled. Photo taken by DJR Operating on October 18, 2018.

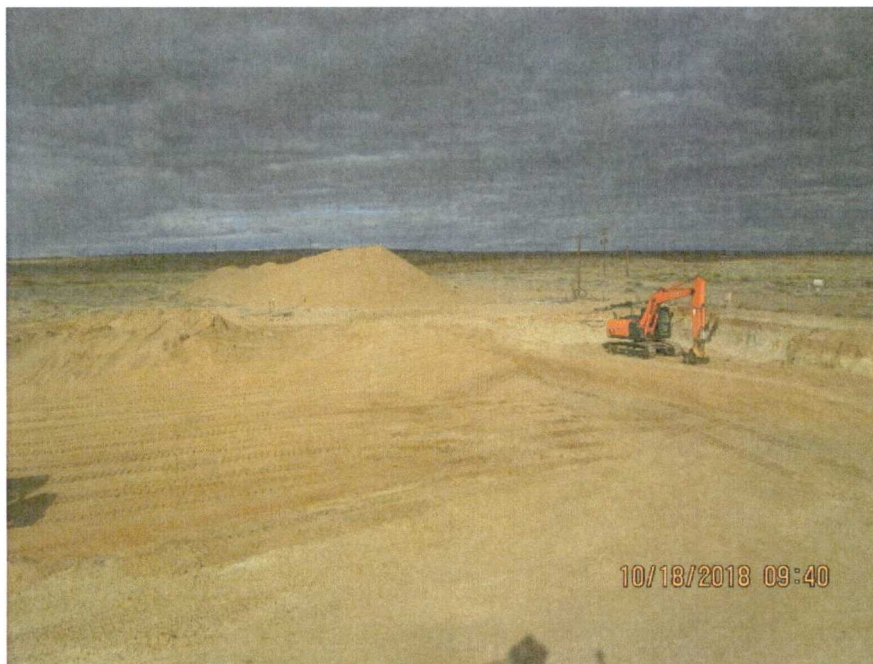
Photo 22: South excavation area back filled. Photo taken by DJR Operating on October 18, 2018.

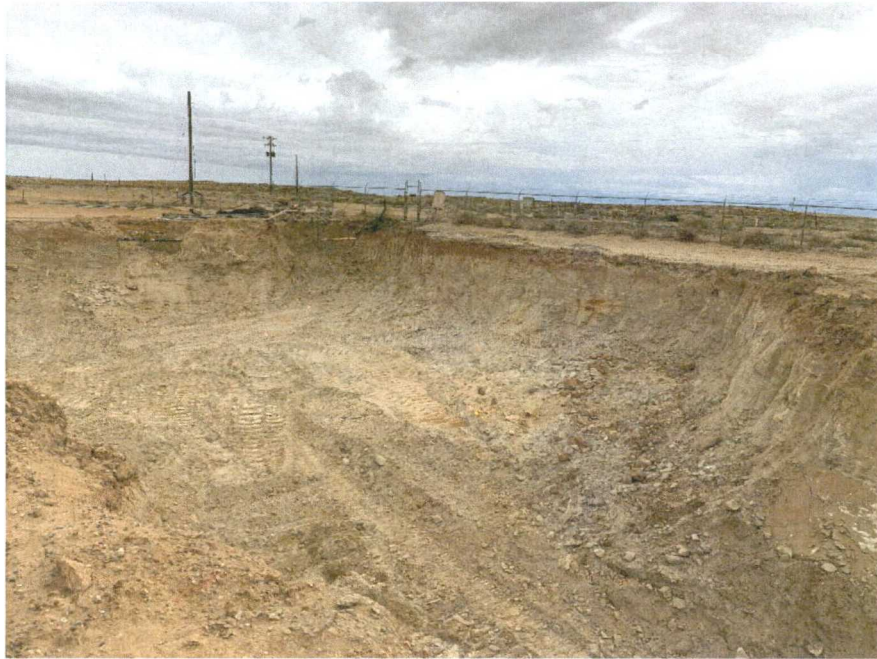
Photo 19: North excavation LACT area. Photo taken October 23, 2018.

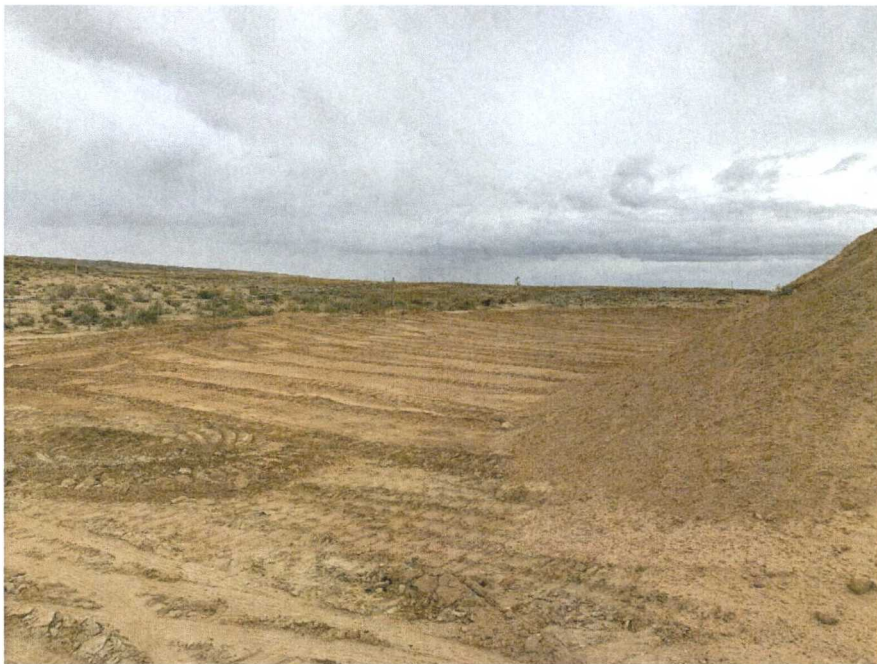
Photo 20: South excavation area backfilled. Photo taken October 23, 2018.

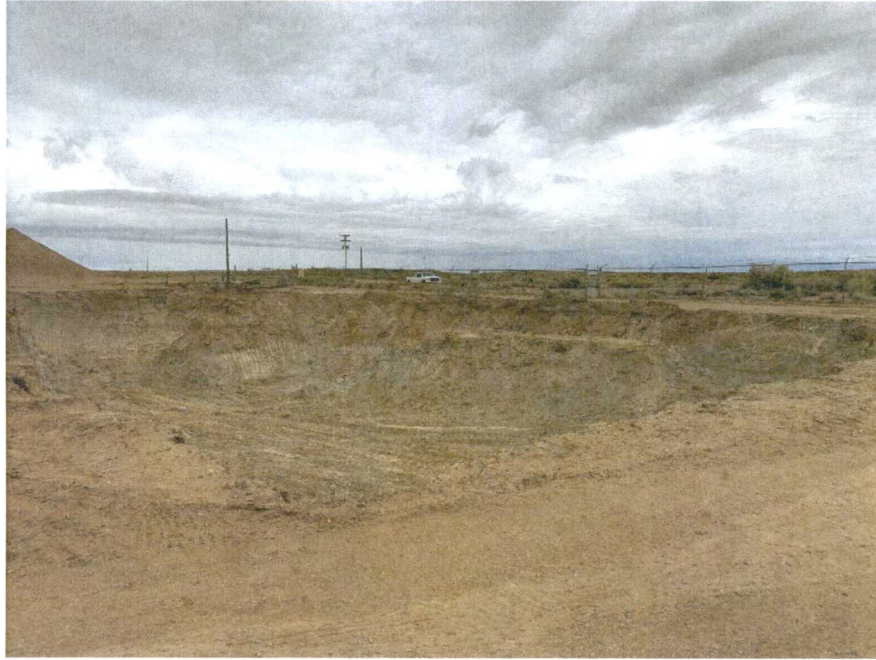
Photo 17: North excavation area. Photo taken October 23, 2018.

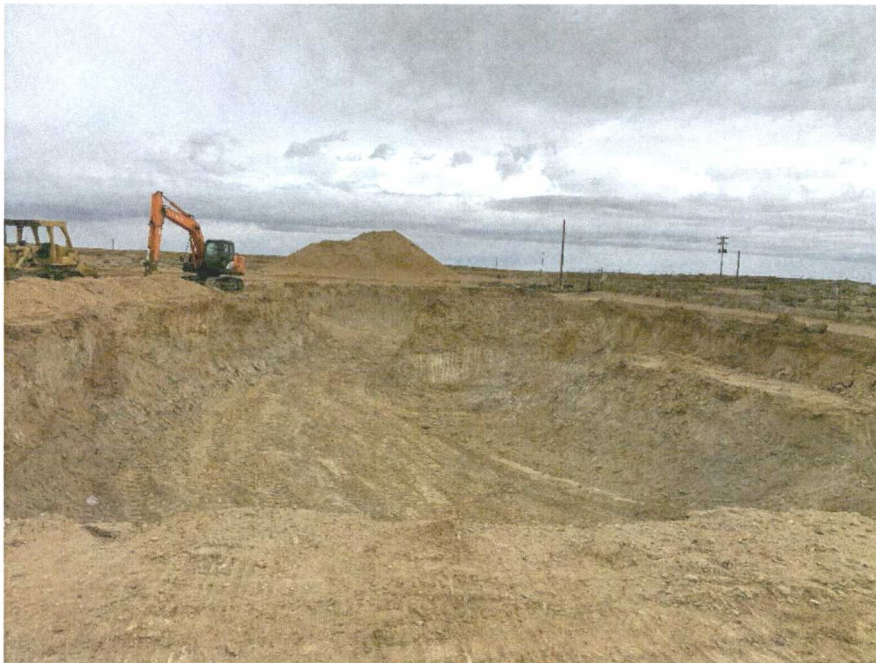
Photo 18: North excavation area. Photo taken October 23, 2018.

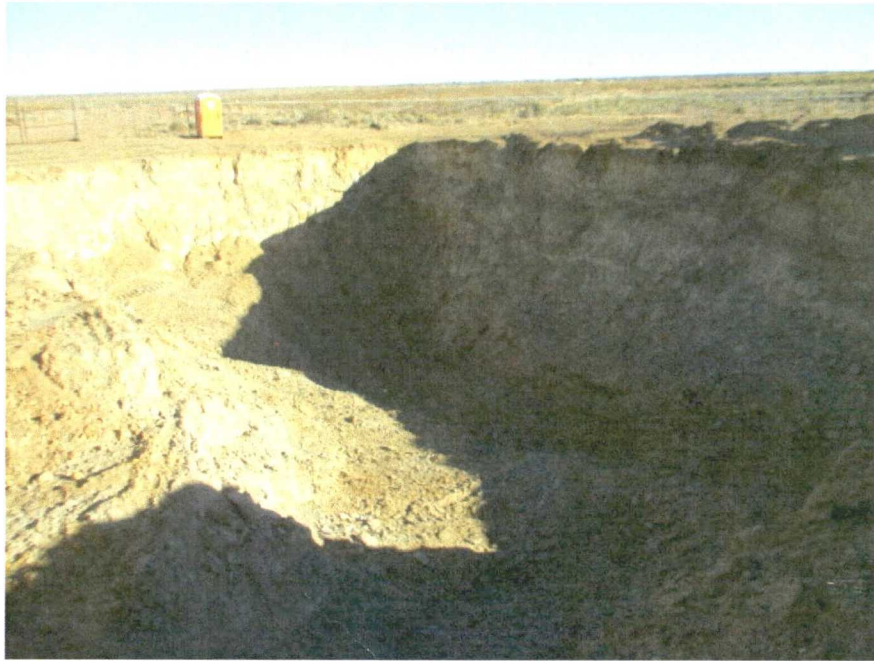
Photo 23: Final North excavation area. Photo taken by Blagg Engineering on November 26, 2018.

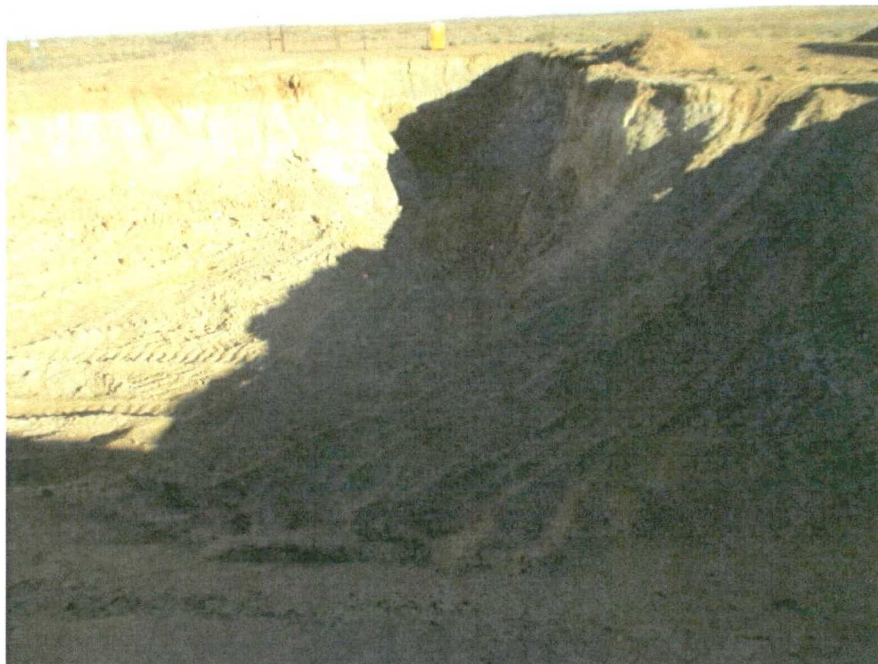
Photo 24: Final North excavation LACT area. Photo taken by Blagg Engineering on November 26, 2018.

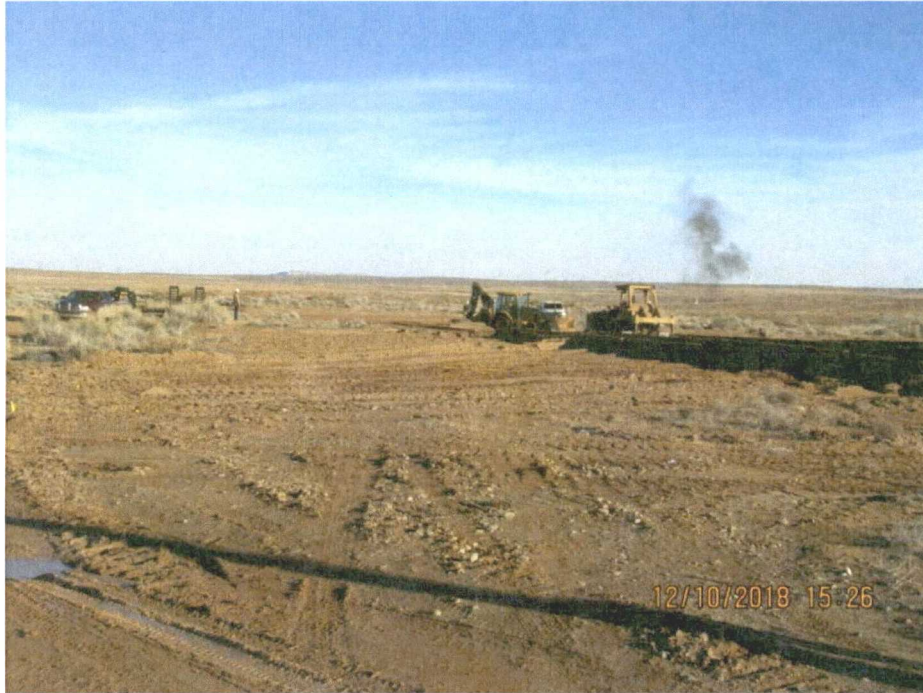
Photo 25: Final North excavation area. Photo taken by DJR Operating on December 10, 2018.

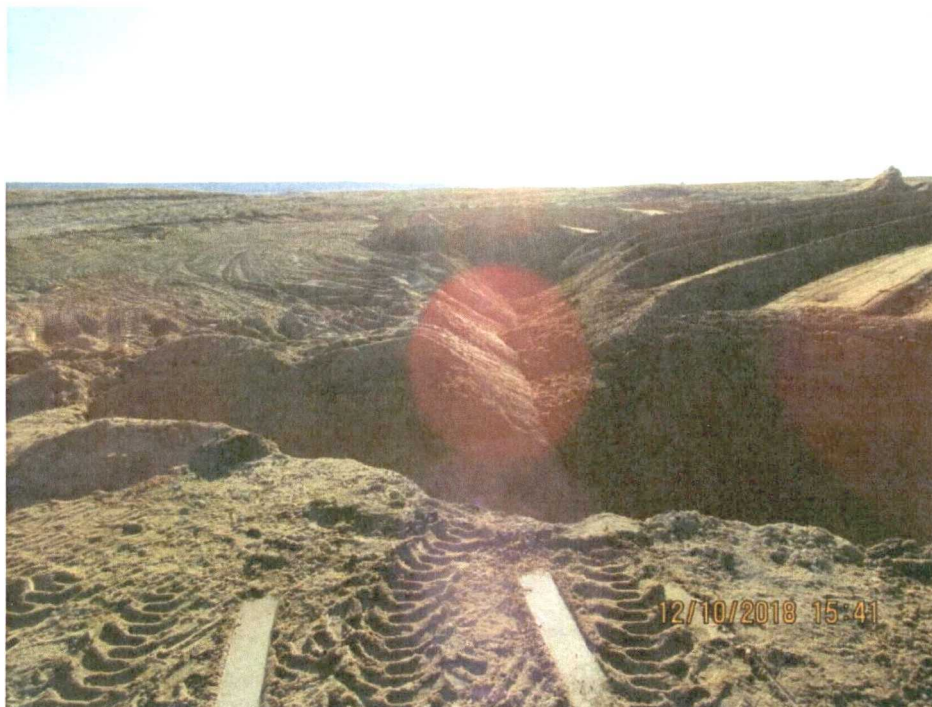
Photo 26: Final North excavation area. Photo taken by DJR Operating on December 10, 2018.
