CORRECTIVE ACTION REPORT

Val Verde Plant Amine and Water Release (April 2018)
NE ¼, S14 T29N R11W
San Juan County, New Mexico

October 9, 2018
Apex Project No. 725040112442

Val Verde Plant Amine and Water Release (April 2018)

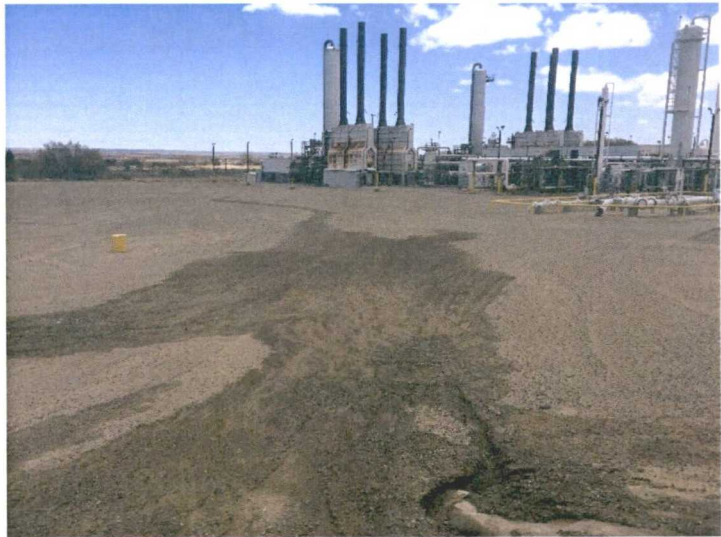
Photograph 1

View of the flow path, facing south-west.

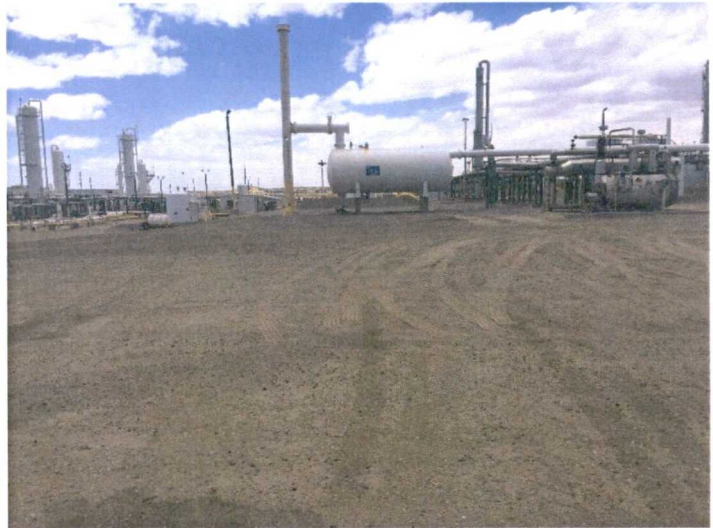
Photograph 2

View of the flow path, facing east.

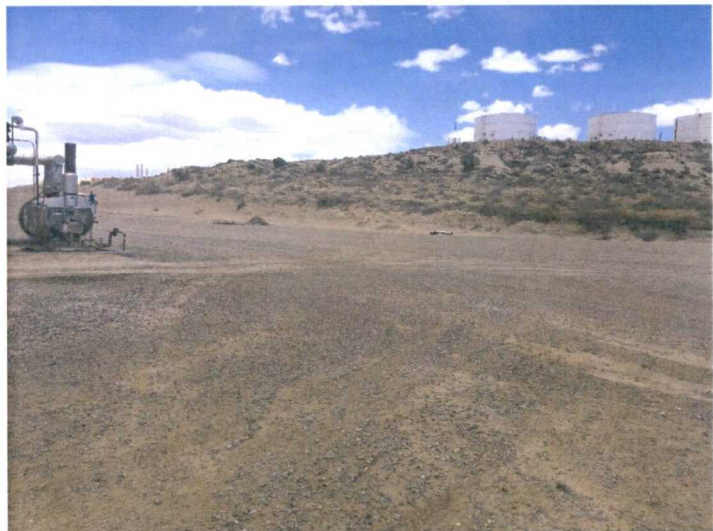
Photograph 3

The extent of the total flow path measured approximately 332 feet in length and six (6) to 90 feet in width, with a maximum depth of approximately five (5) inches. The overspray area measured approximately 120 feet long and 112 feet wide

View of the overspray area, facing northeast.

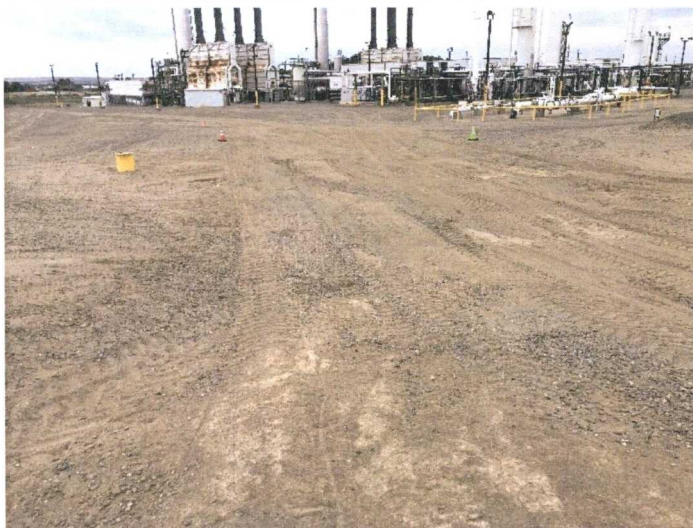
Photograph 4

View of the final scraped/excavated flow path, facing southwest.

separate reports). The excavation was backfilled with imported fill and resurfaced with gravel to provide a suitable driving/parking area.

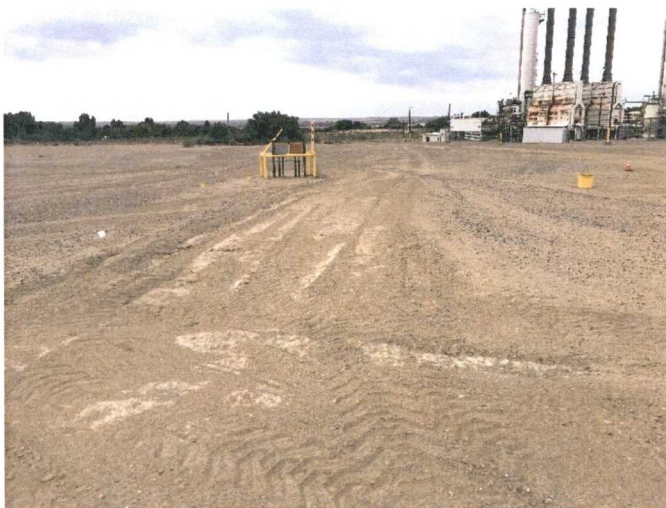
Photograph 5

View of the final scraped/excavated flow path, facing southwest.

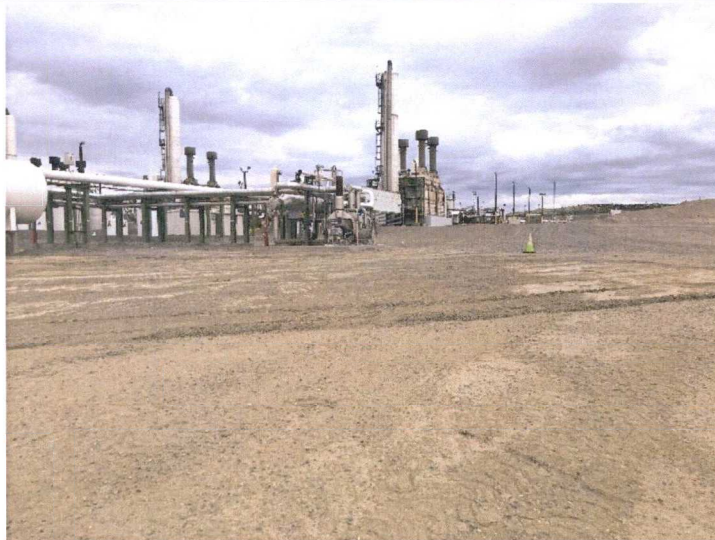
Photograph 6

View of the final scraped/excavated flow path, facing northwest.

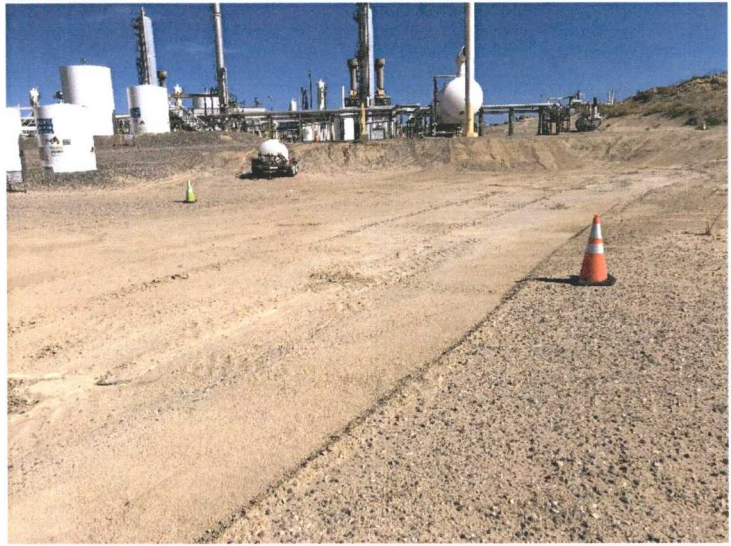
Photograph 7

View of the final scraped/excavated flow path, facing north.
