Release Notification

CLOSURE REPORT

**Lateral K-61 (8/10/18) Pipeline Release
NE 1/4, S14 T27N R6W
Rio Arriba County, New Mexico**

October 25, 2018
Apex Project No. 725040112506

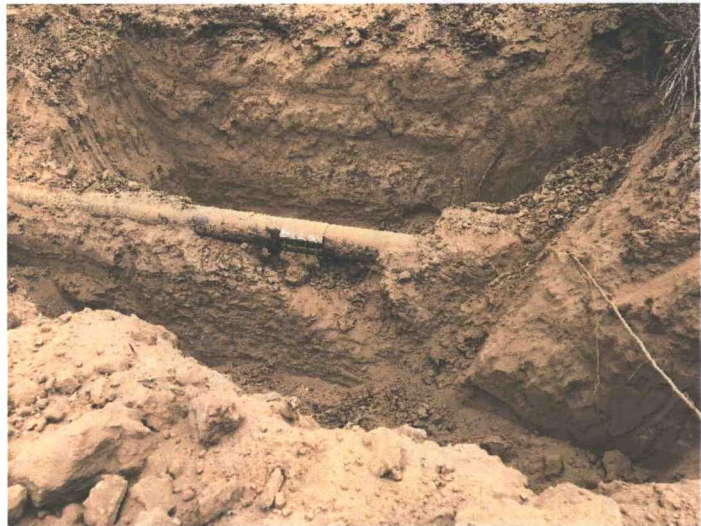
Photograph 2

View of the in-process excavation activities, facing north.

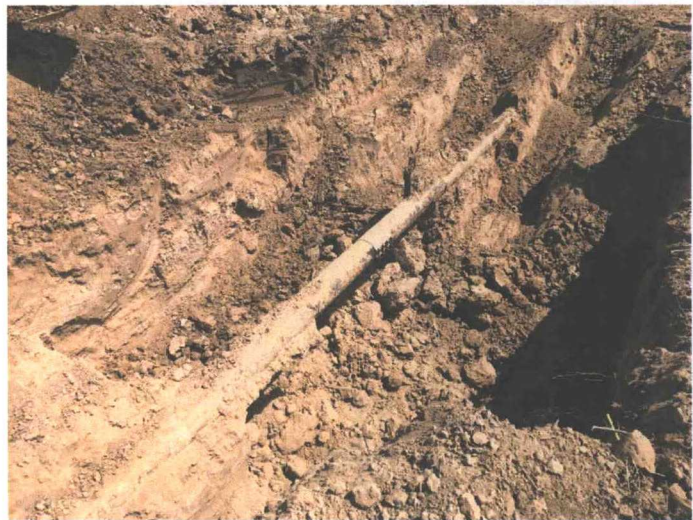
Photograph 3

View of the in-process excavation activities, facing northeast.

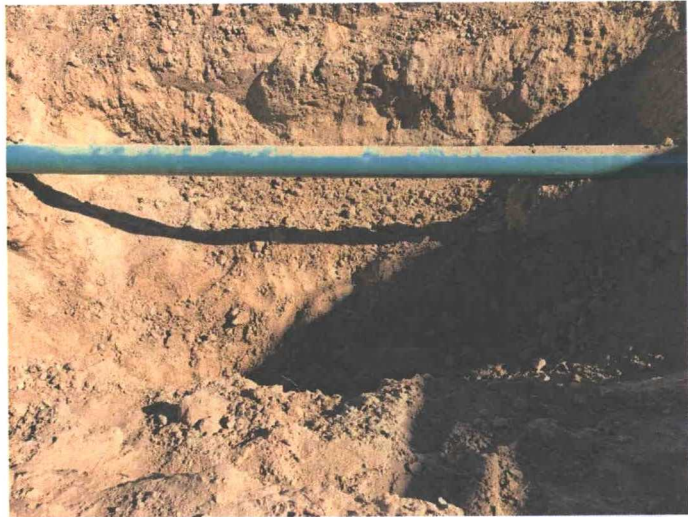
Photograph 4

View of the final excavation.

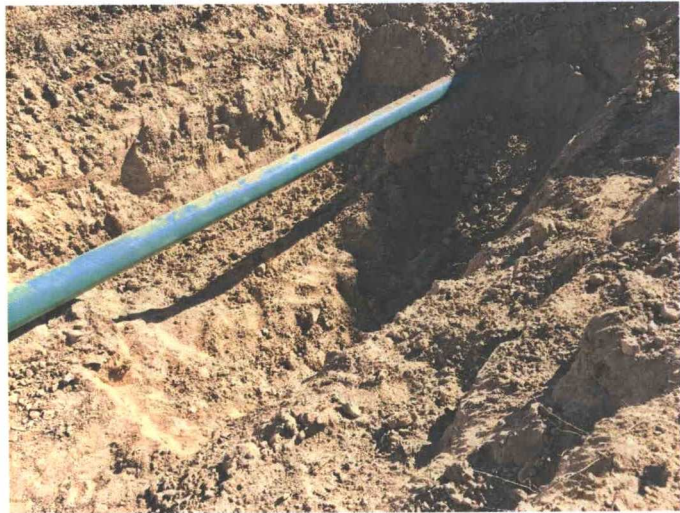
Photograph 5

View of the final excavation.

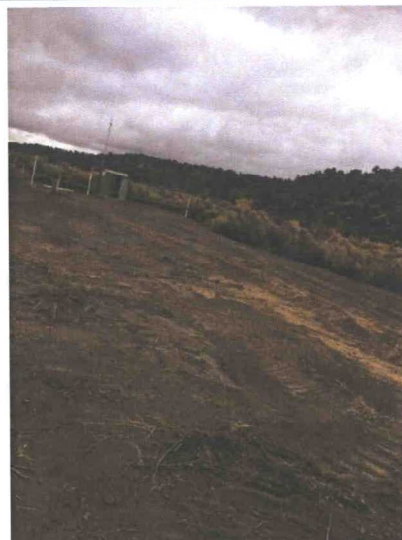
Photograph 6

View of the final excavation after initial restoration.

The excavation was backfilled with imported fill and contoured to the surrounding grade. Enterprise will re-seed the Site with a BLM Farmington Field Office approved seeding mixture at the beginning of the next favorable growing season.
