CLOSURE DOCUMENTATION

“SV” CHIPSHOT RELEASE SITE

REF: #160037

LEA COUNTY, NEW MEXICO

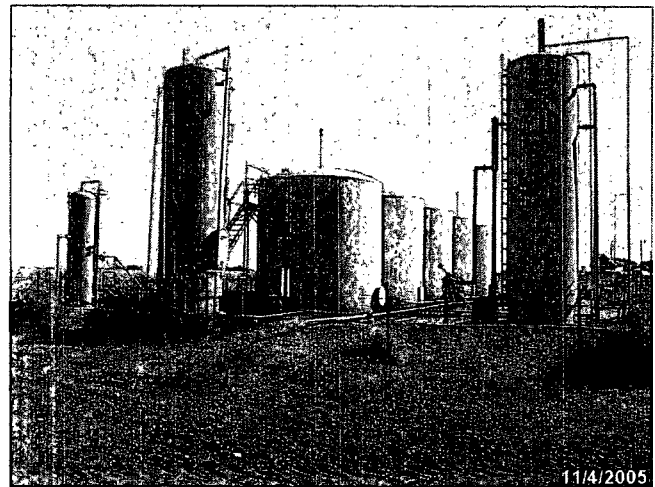
Photograph #2 – Looking easterly at bermed tank battery.

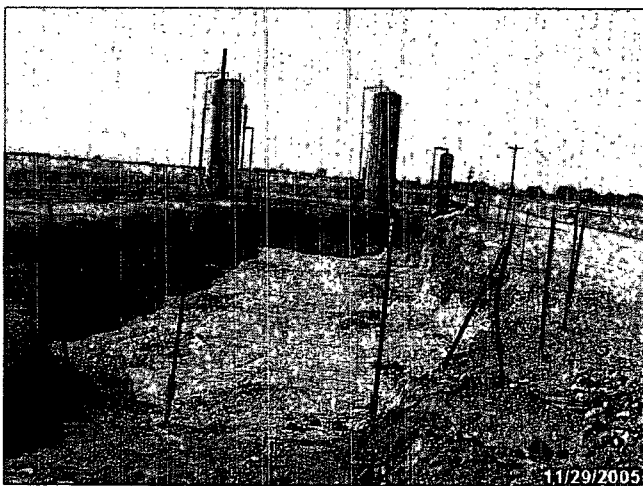
Photograph #11 – Looking westerly at excavation activities as of November 29, 2005.
