Re: Closure Approval: Pure Resources B-2 Line NMOCD 1-RP# 45
Site Reference UL- p, Sec-25 T-16S R-36E
Initial Notification Date: July 17, 2005
Closure Request Dated: September 21, 2006

ENVIRONMENTAL PLUS, INC.

RE: Duke Energy Field Services (DEFS)- Pure Resources B-2 Line – NMOCD IRP #45; EPI Ref. #130026
UL-P (SE¼ of the SE¼) of Section 25, Township 16 South, Range 36 East
Latitude N 32° 53' 17.58" and Longitude W 103° 18' 2.04"

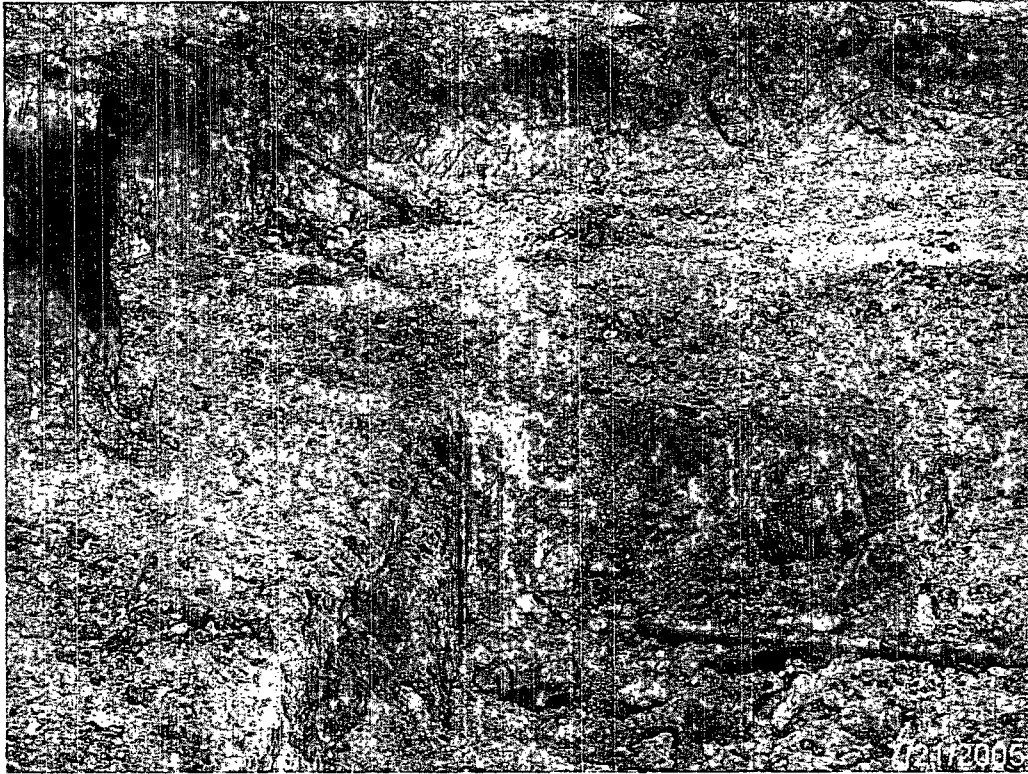
Photograph #1- Looking westerly at point of release.

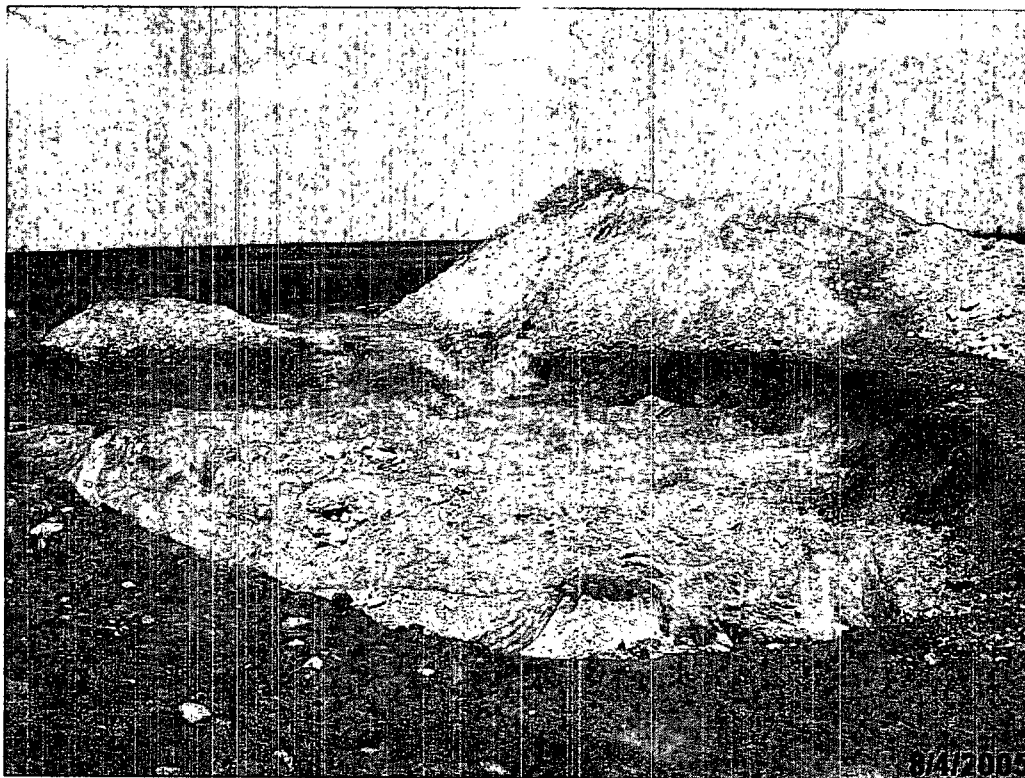
Photograph #3- Looking northeasterly across excavation as of August 4, 2005.

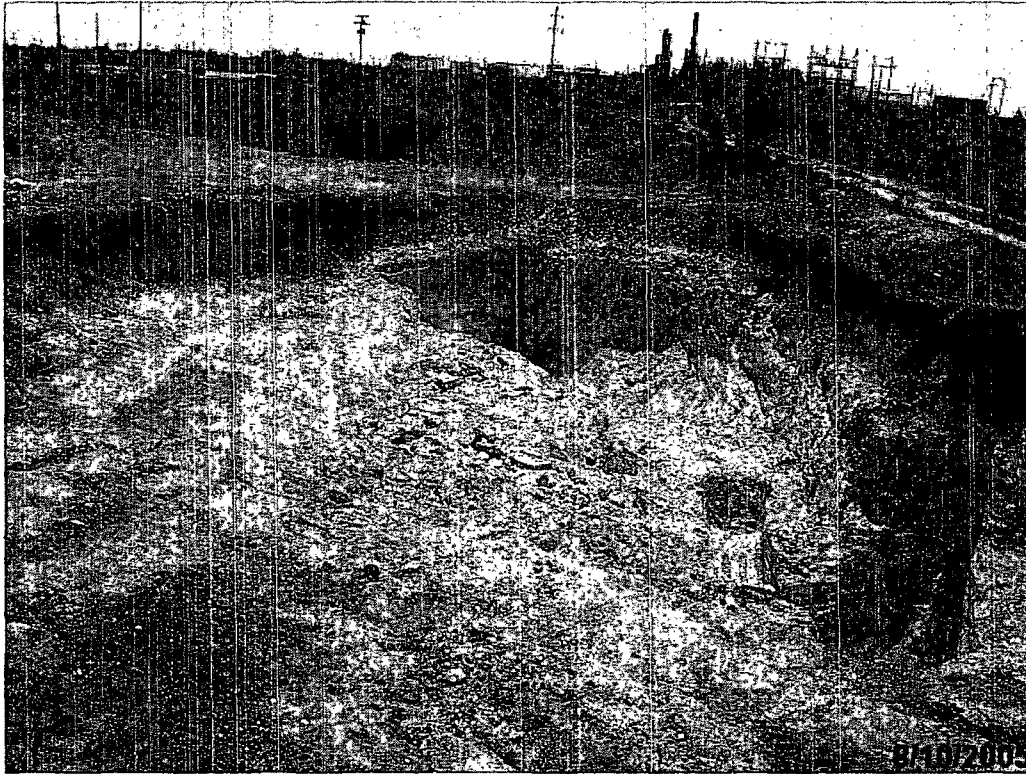
Photograph #5- Looking southerly across excavation as of August 10, 2005.

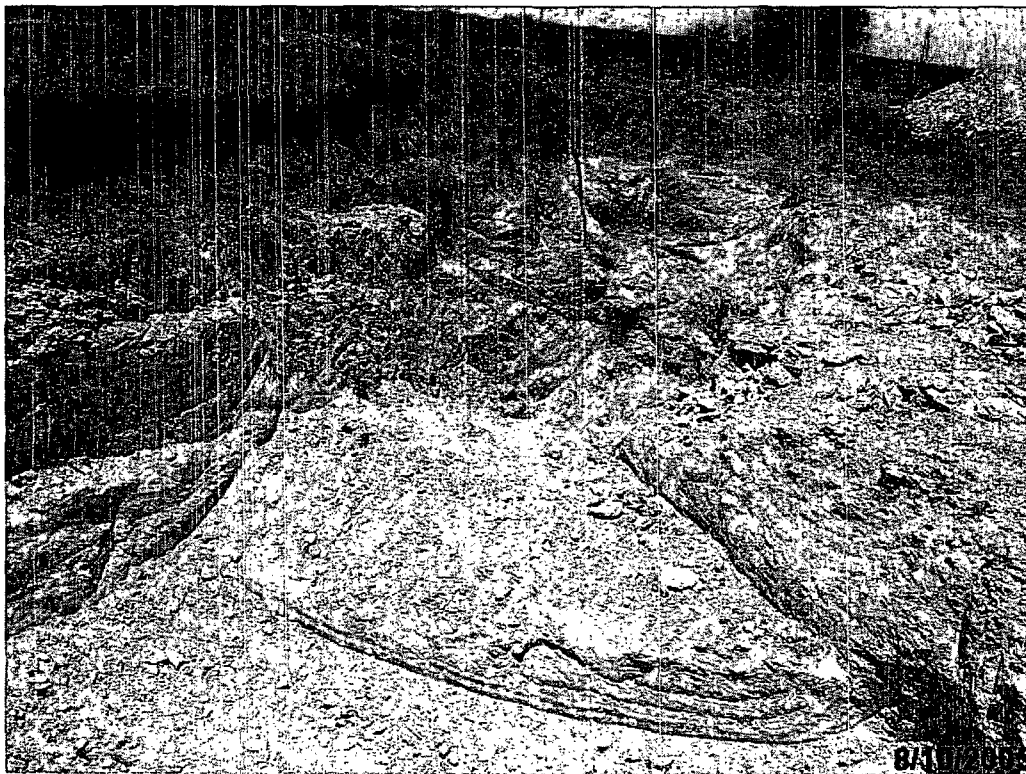
Photograph #6- Looking northerly across excavation as of August 10, 2005

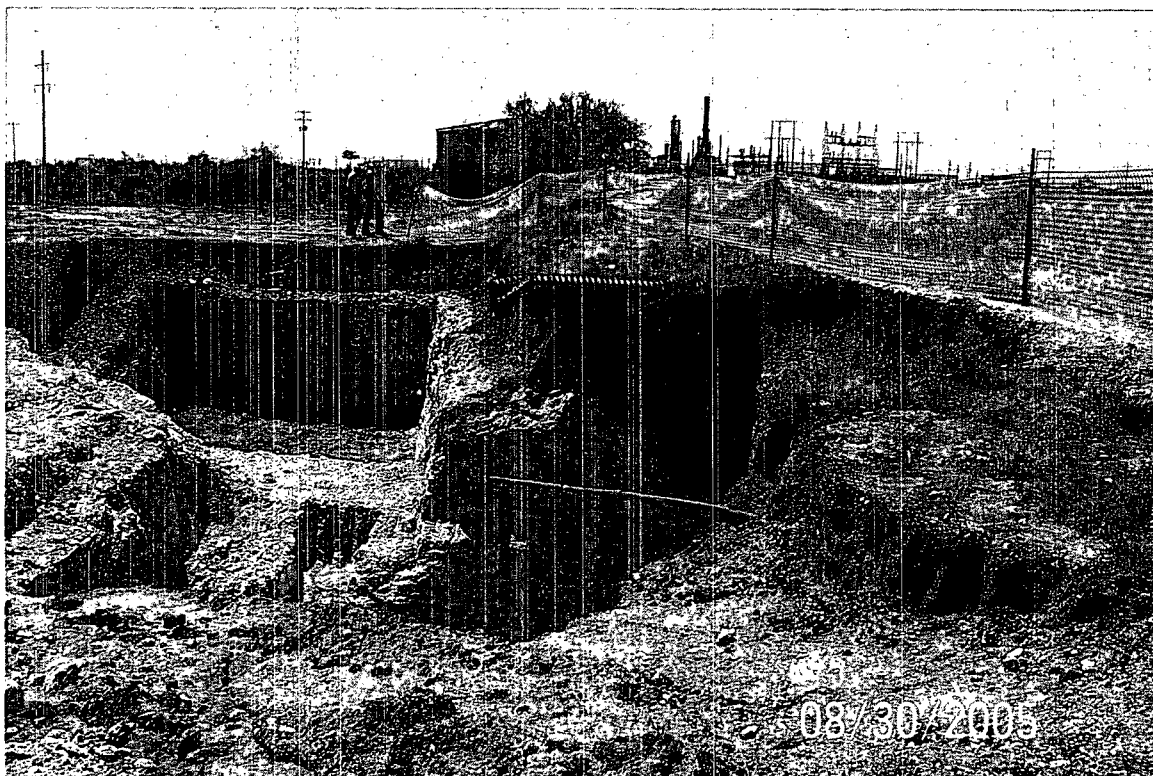
Photograph #7- Looking southerly across excavation as of August 30, 2005.
