CLOSURE REPORT

NEWMAN 32 STATE #2

1RP #: 1002

AUGUST 2006

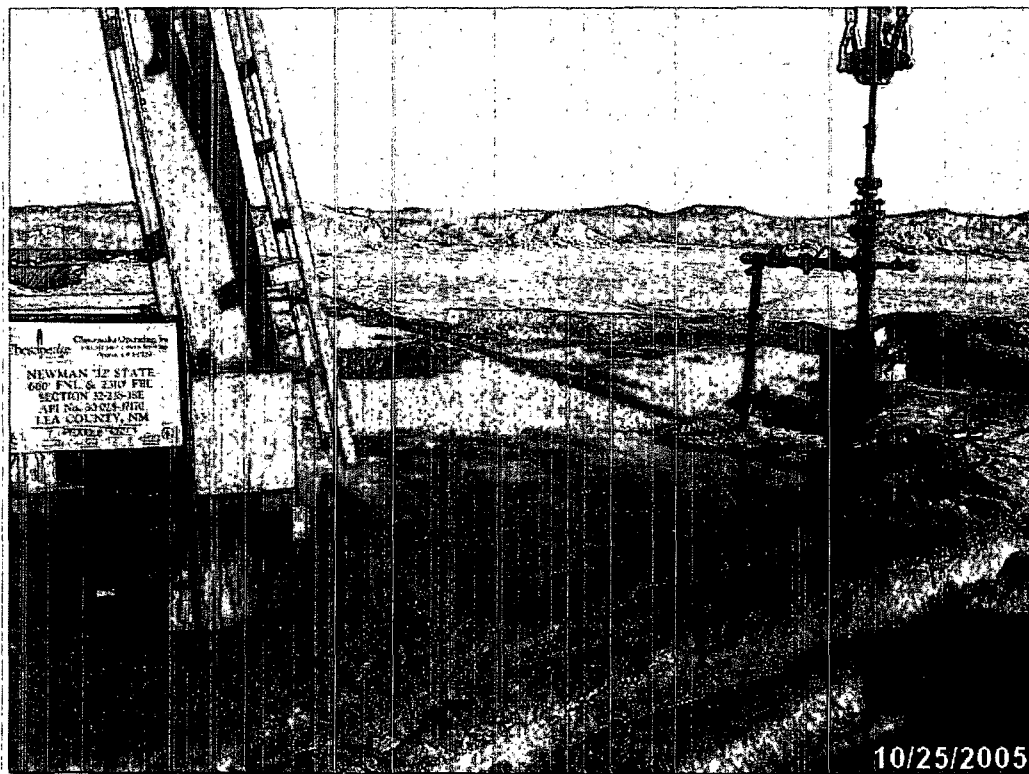
Photograph #2 – Looking northeasterly at release area.

Stuffing box on pumping unit blew out of an operating pumpjack. The release area was confined to the well pad.

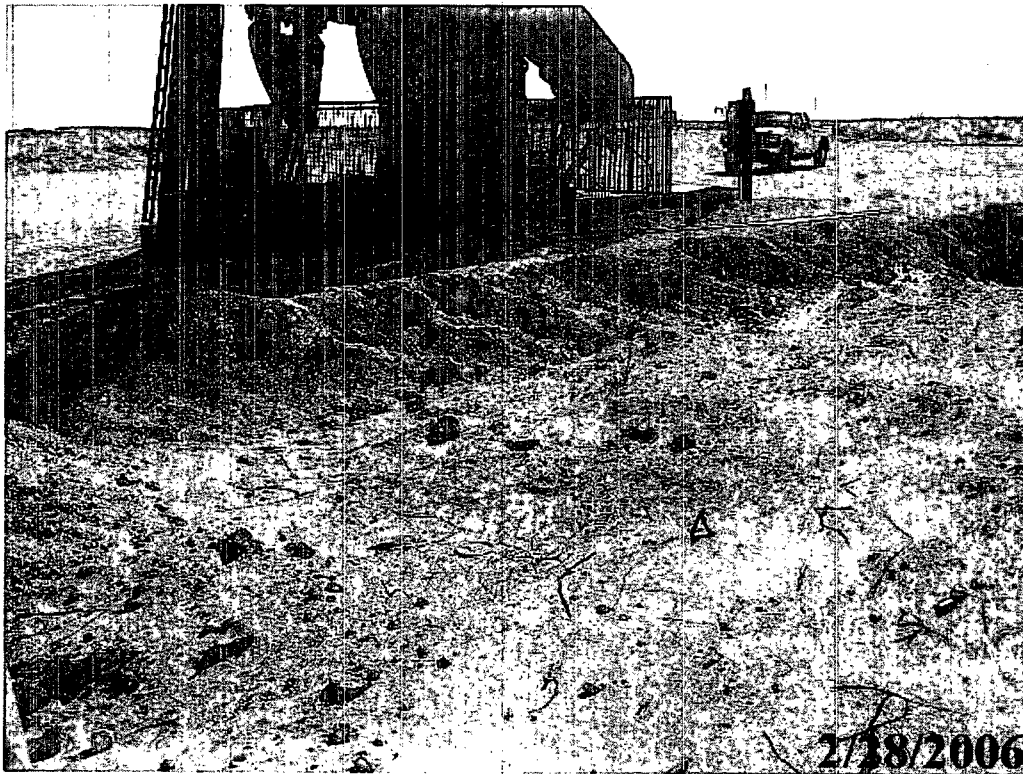
Photograph #5 – excavation looking southerly.

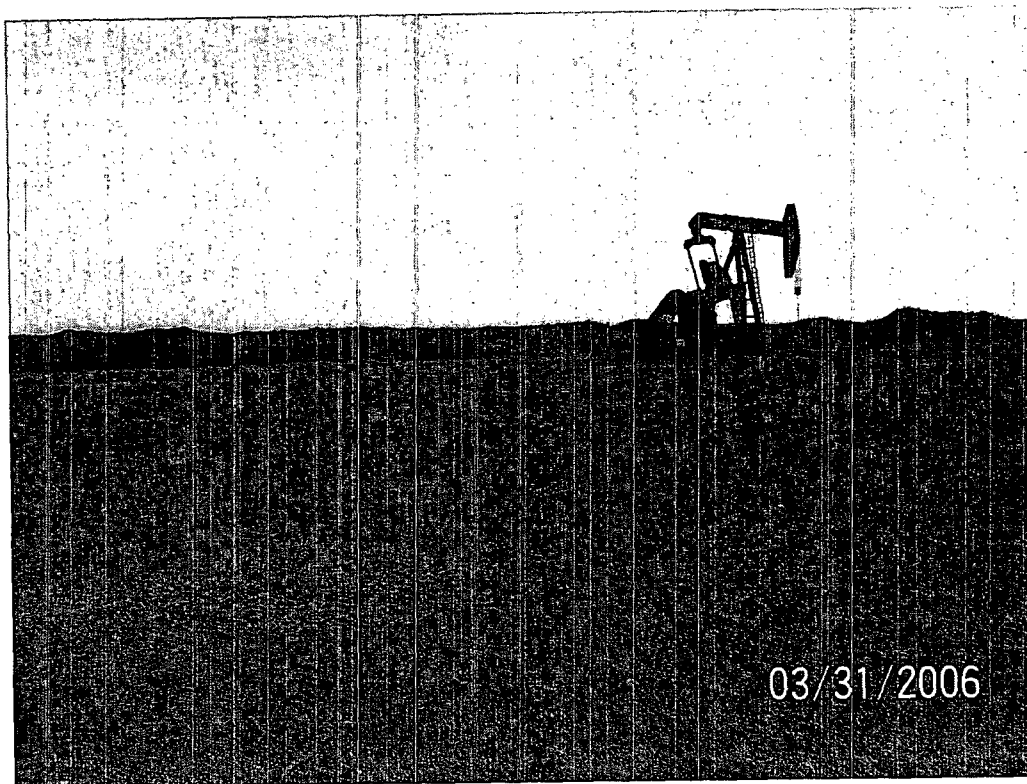
Photograph #7 – Site graded and contoured, looking northwesterly.

Approximately 1,160 cubic yards of hydrocarbon impacted soil above the NMOCD remedial thresholds for TPH and BTEX constituents were excavated and transported to the Environmental Plus, Inc. Land Farm for treatment. Laboratory analytical results of soil samples collected on November 4, 2005 indicated NMOCD remedial thresholds have been achieved. Approximately 1,150 cubic yards of clean soil were purchased from the State of New Mexico and utilized as backfill material. Upon completion of backfilling, the site was graded to allow natural drainage. The site will not be revegetated until the pumping unit is decommissioned.
