Re: 1RP-755, Crude Oil and Produced Water Spill Remediation Report, John H. Hendrix Corporation, Amanda Sims Tank Battery, Unit I (NE/4, SE/4), Section 25, Township 22 South, Range 37 East, Lea County, New Mexico

Re: 1RP-755 Remediation Report of the Amanda Sims Tank Battery, John H. Hendrix Corporation, Unit I (NE/4, SE/4), Section 25, Township 22 South, Range 37 East, Lea County, New Mexico

Photographs

U.L. I, NE/4, SE/4, SECTION 25, T-22-S, R-37-E, LEA COUNTY NEW MEXICO
AMANDA SIMS TANK BATTERY

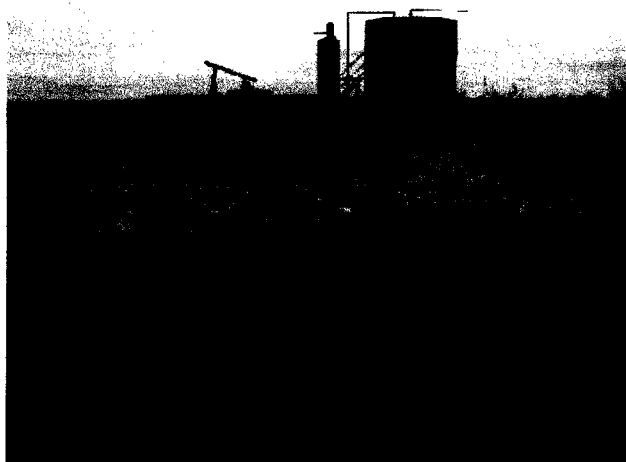
2. Amanda Sims Tank Battery -
Spill Location West of Water Tank,
Looking East, April 10, 2006

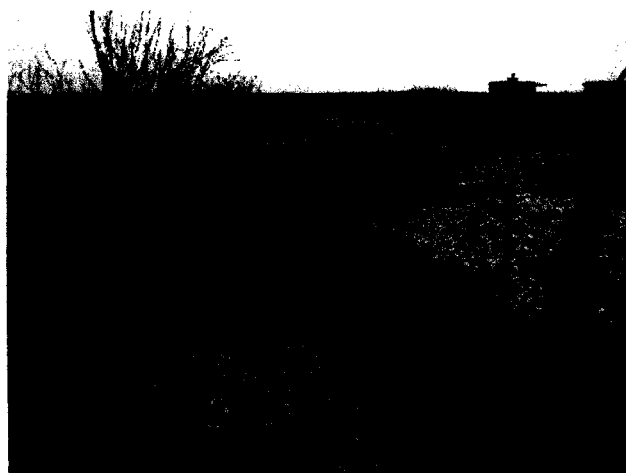
3. Amanda Sims Tank Battery -
Spill Location North of Water Tank,
Looking East, April 10, 2006

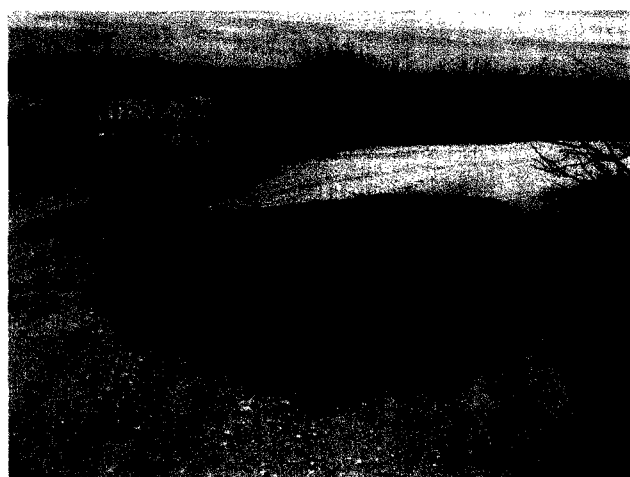
5. Amanda Sims Tank Battery -
Spill Location Northeast of Water
Tank, Looking Southwest, April 10,
2006

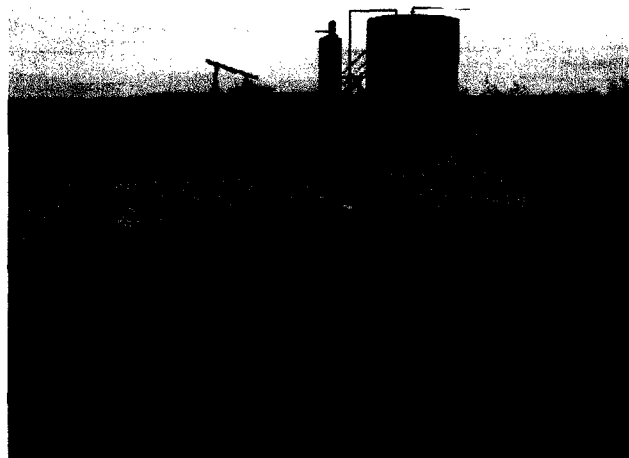
2. Amanda Sims Tank Battery -
Spill Location West of Water Tank,
Looking East, April 10, 2006

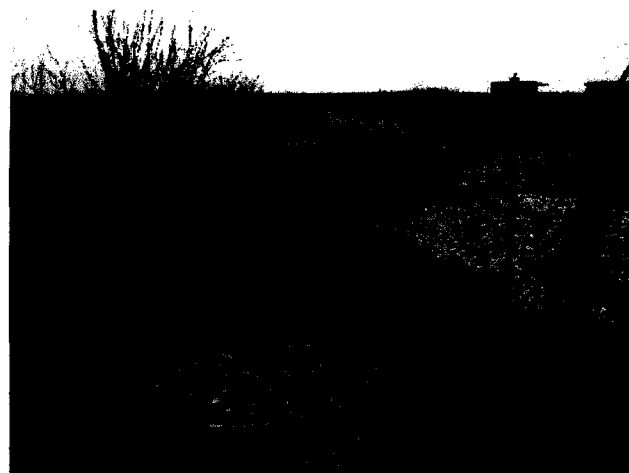
3. Amanda Sims Tank Battery -
Spill Location North of Water Tank,
Looking East, April 10, 2006

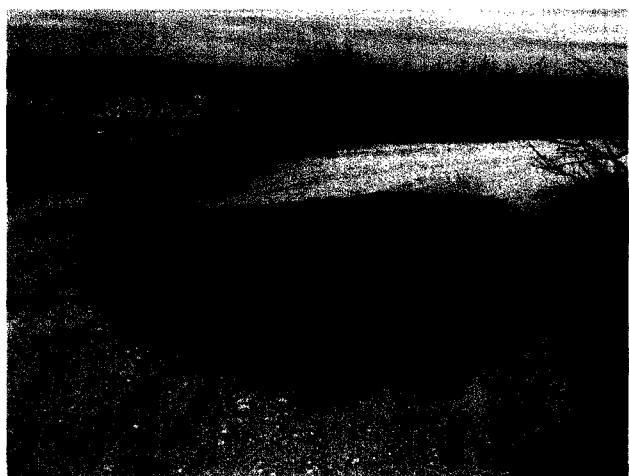
5. Amanda Sims Tank Battery -
Spill Location Northeast of Water
Tank, Looking Southwest, April 10,
2006

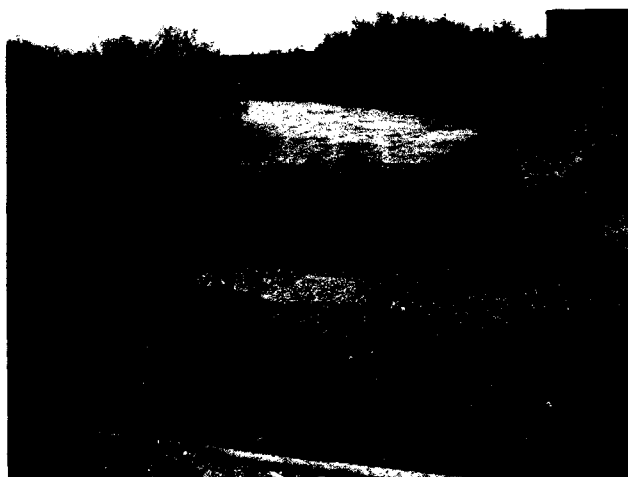
2. Amanda Sims Tank Battery -
Spill Location East of Water Tank,
Looking East, September 14, 2006

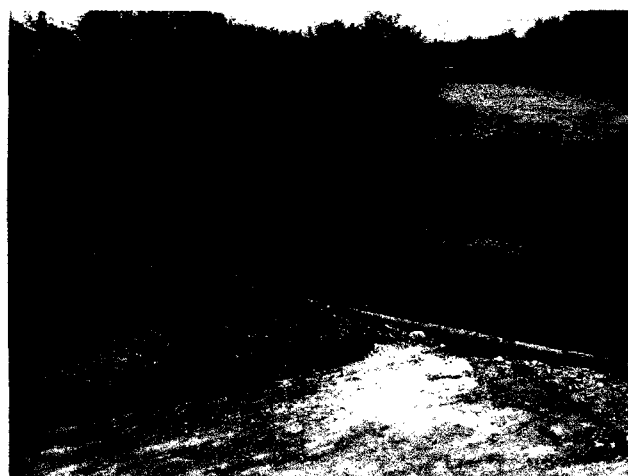
3. Amanda Sims Tank Battery -
Spill Location East of Water Tank,
Looking Southeast, September 14,
2006

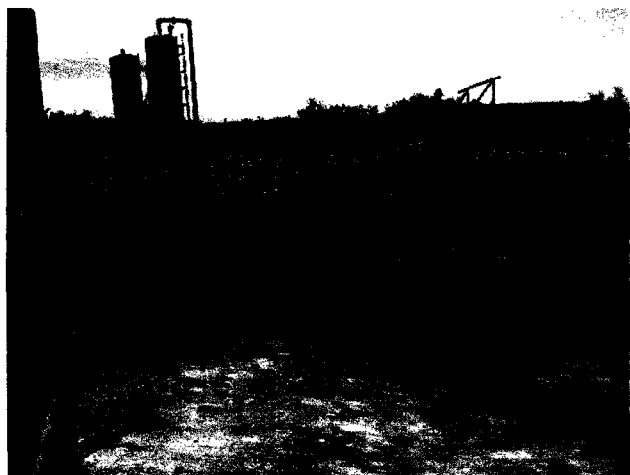
4. Amanda Sims Tank Battery -
Spill Location East of Water
Tank, Looking Southwest,
September 14, 2006
