# CLOSURE REPORT

## A-8-13-1 EXT. RELEASE SITE

**1RP # 880**

**LEA COUNTY, NEW MEXICO**

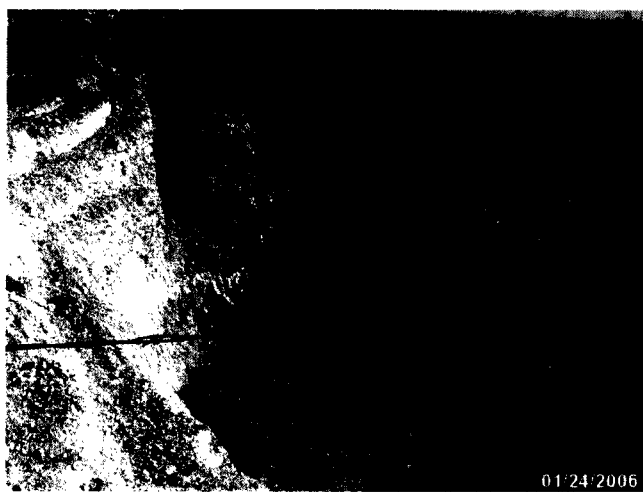
**Photo #3:** Excavation area, looking northeasterly.

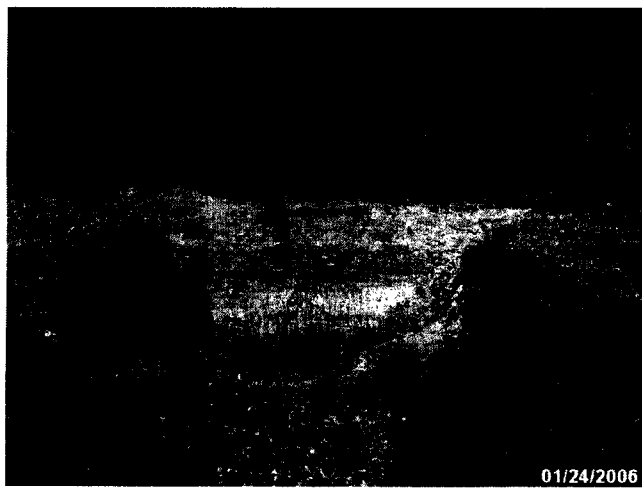
**Photo #5:** Excavation area, looking north-northwesterly.

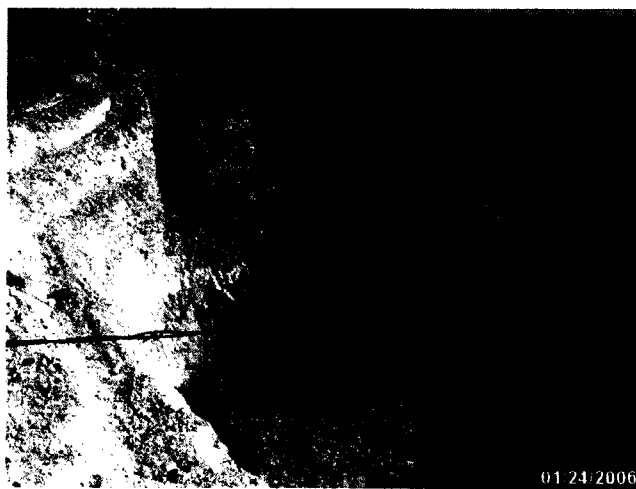
**Photo #6:** Excavation area, looking east-northeasterly.
