# SITE CLOSURE REPORT

**J. A. AKENS -A- OIL UNIT TANK BATTERY**

**EPI REF: #160043**

**OCTOBER 2006**

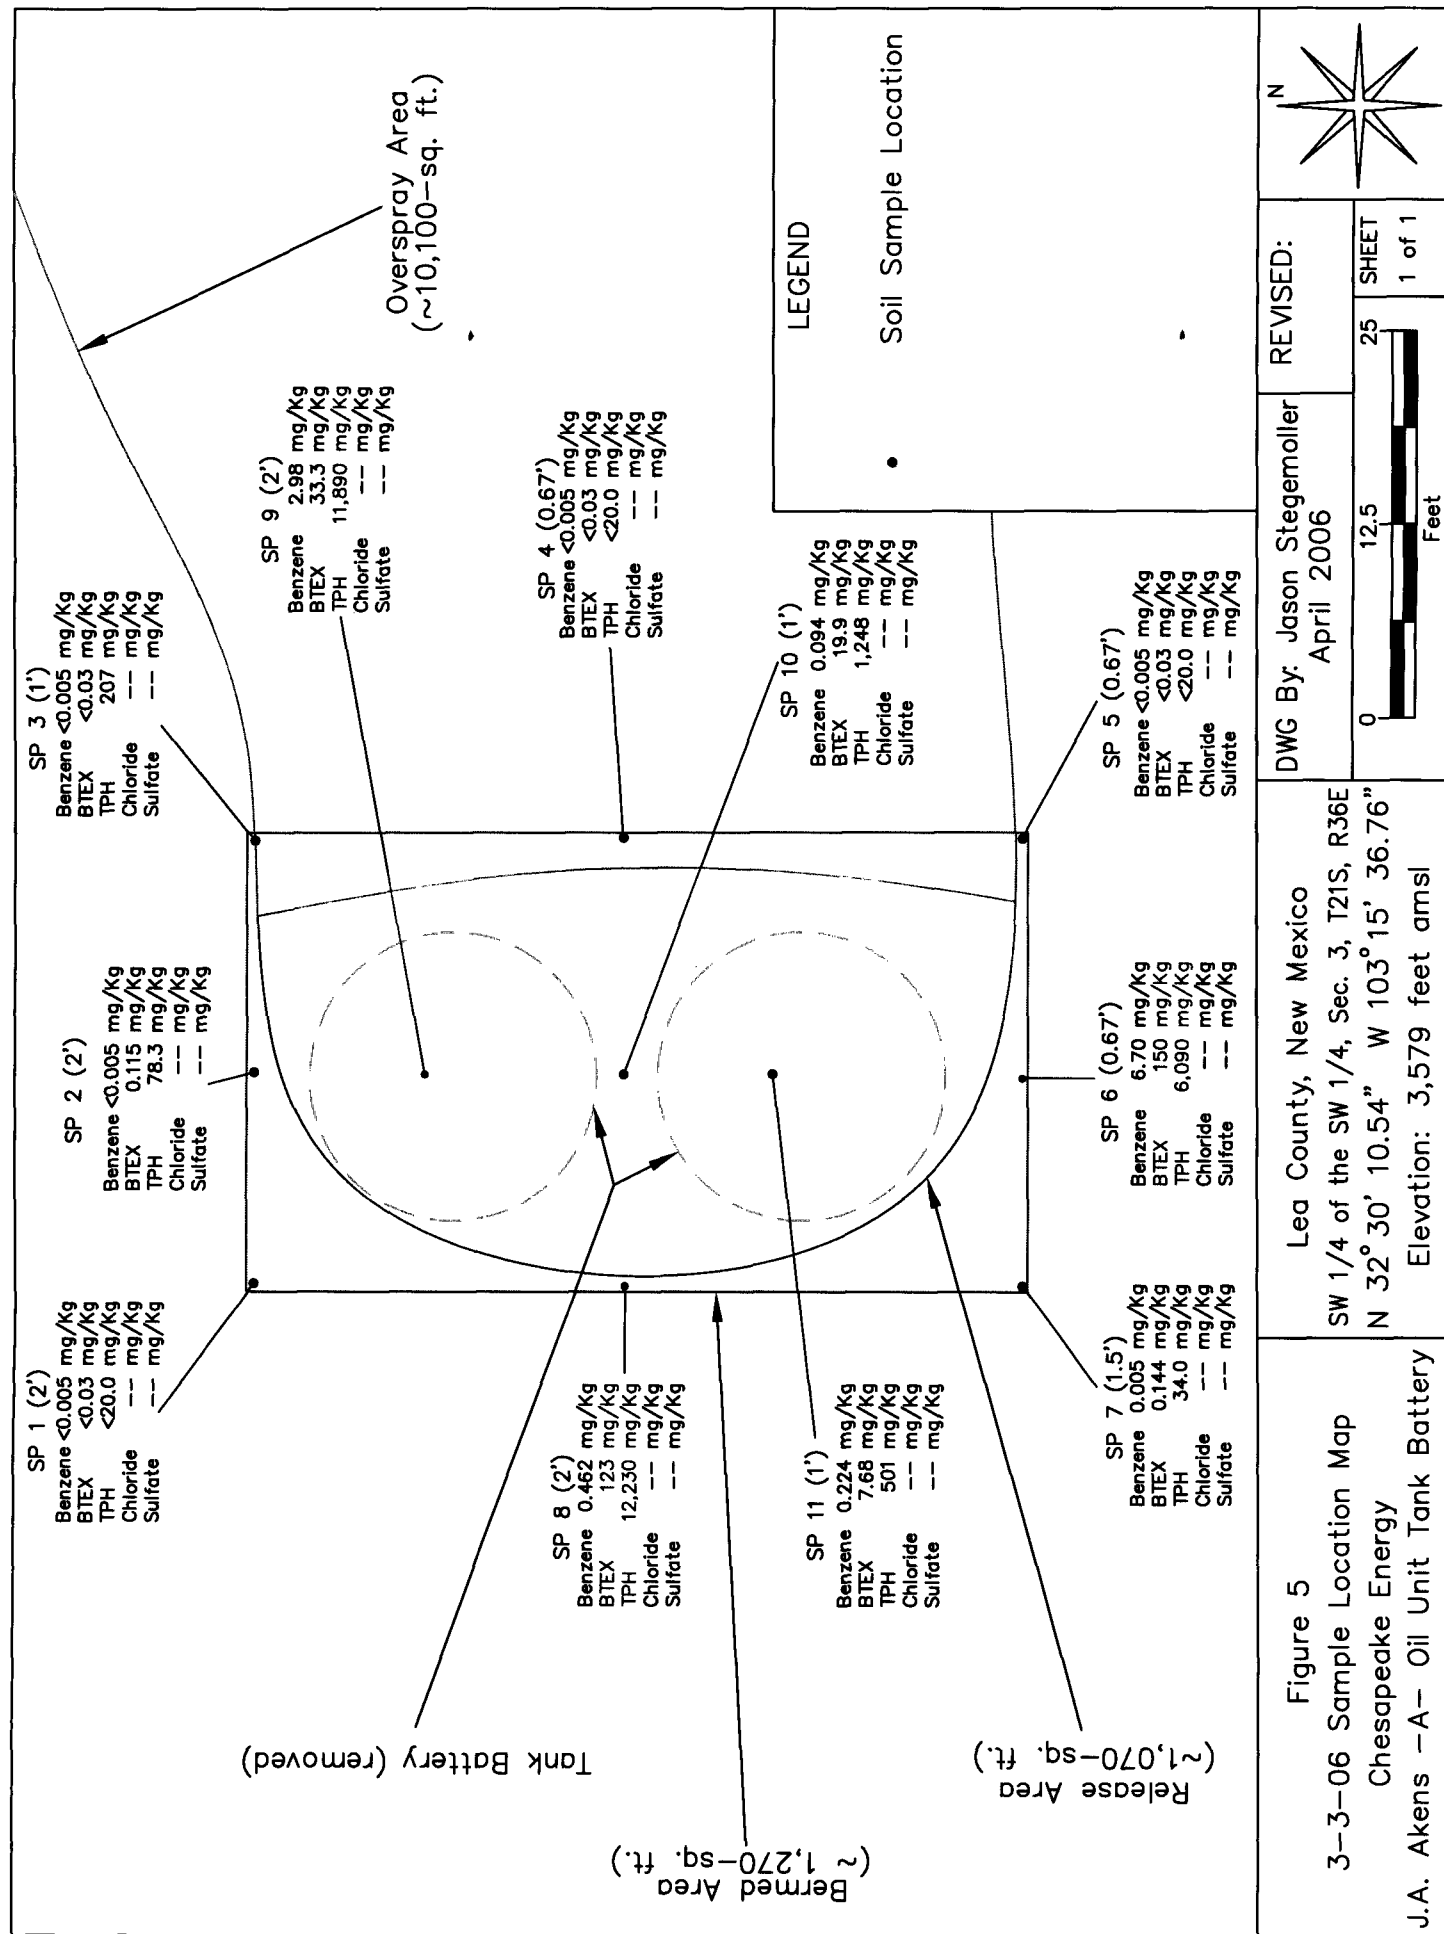
On March 3, 2006 eleven (11) soil samples were collected at various locations and depth from the excavation. Soil samples were analyzed for concentrations of BTEX and TPH. Benzene concentrations ranged from at or below laboratory analytical MDL in several sample points to 6.70 mg/Kg (SP-6 @ 8"). Benzene concentrations were below NMOCD remedial threshold goals of 10 mg/Kg at all sample points. Total BTEX concentrations ranged from at or below laboratory analytical MDL in several sample points to 150 mg/Kg (SP-6 @ 8"). Laboratory analytical data for BTEX concentrations for the eleven (11) sample points indicated only two (2) were above NMOCD remedial goals of 50 mg/Kg (SP-6 @ 8" bgs and SP-8 @ 2' bgs). Laboratory analytical data for TPH concentrations ranged from at or below laboratory analytical MDL in three (3) sample points (SP-1 @ 2', SP-4 @ 0.67' and SP-5 @ 0.67') to 12,230 mg/Kg (SP-8 @ 2' bgs). TPH concentrations were above NMOCD remedial threshold goals of 5,000 mg/L in two (2) of the eleven (11) sample points (SP-8 @ 2' and SP-9 @ 2') (reference *Figure 5* and *Table 3*).

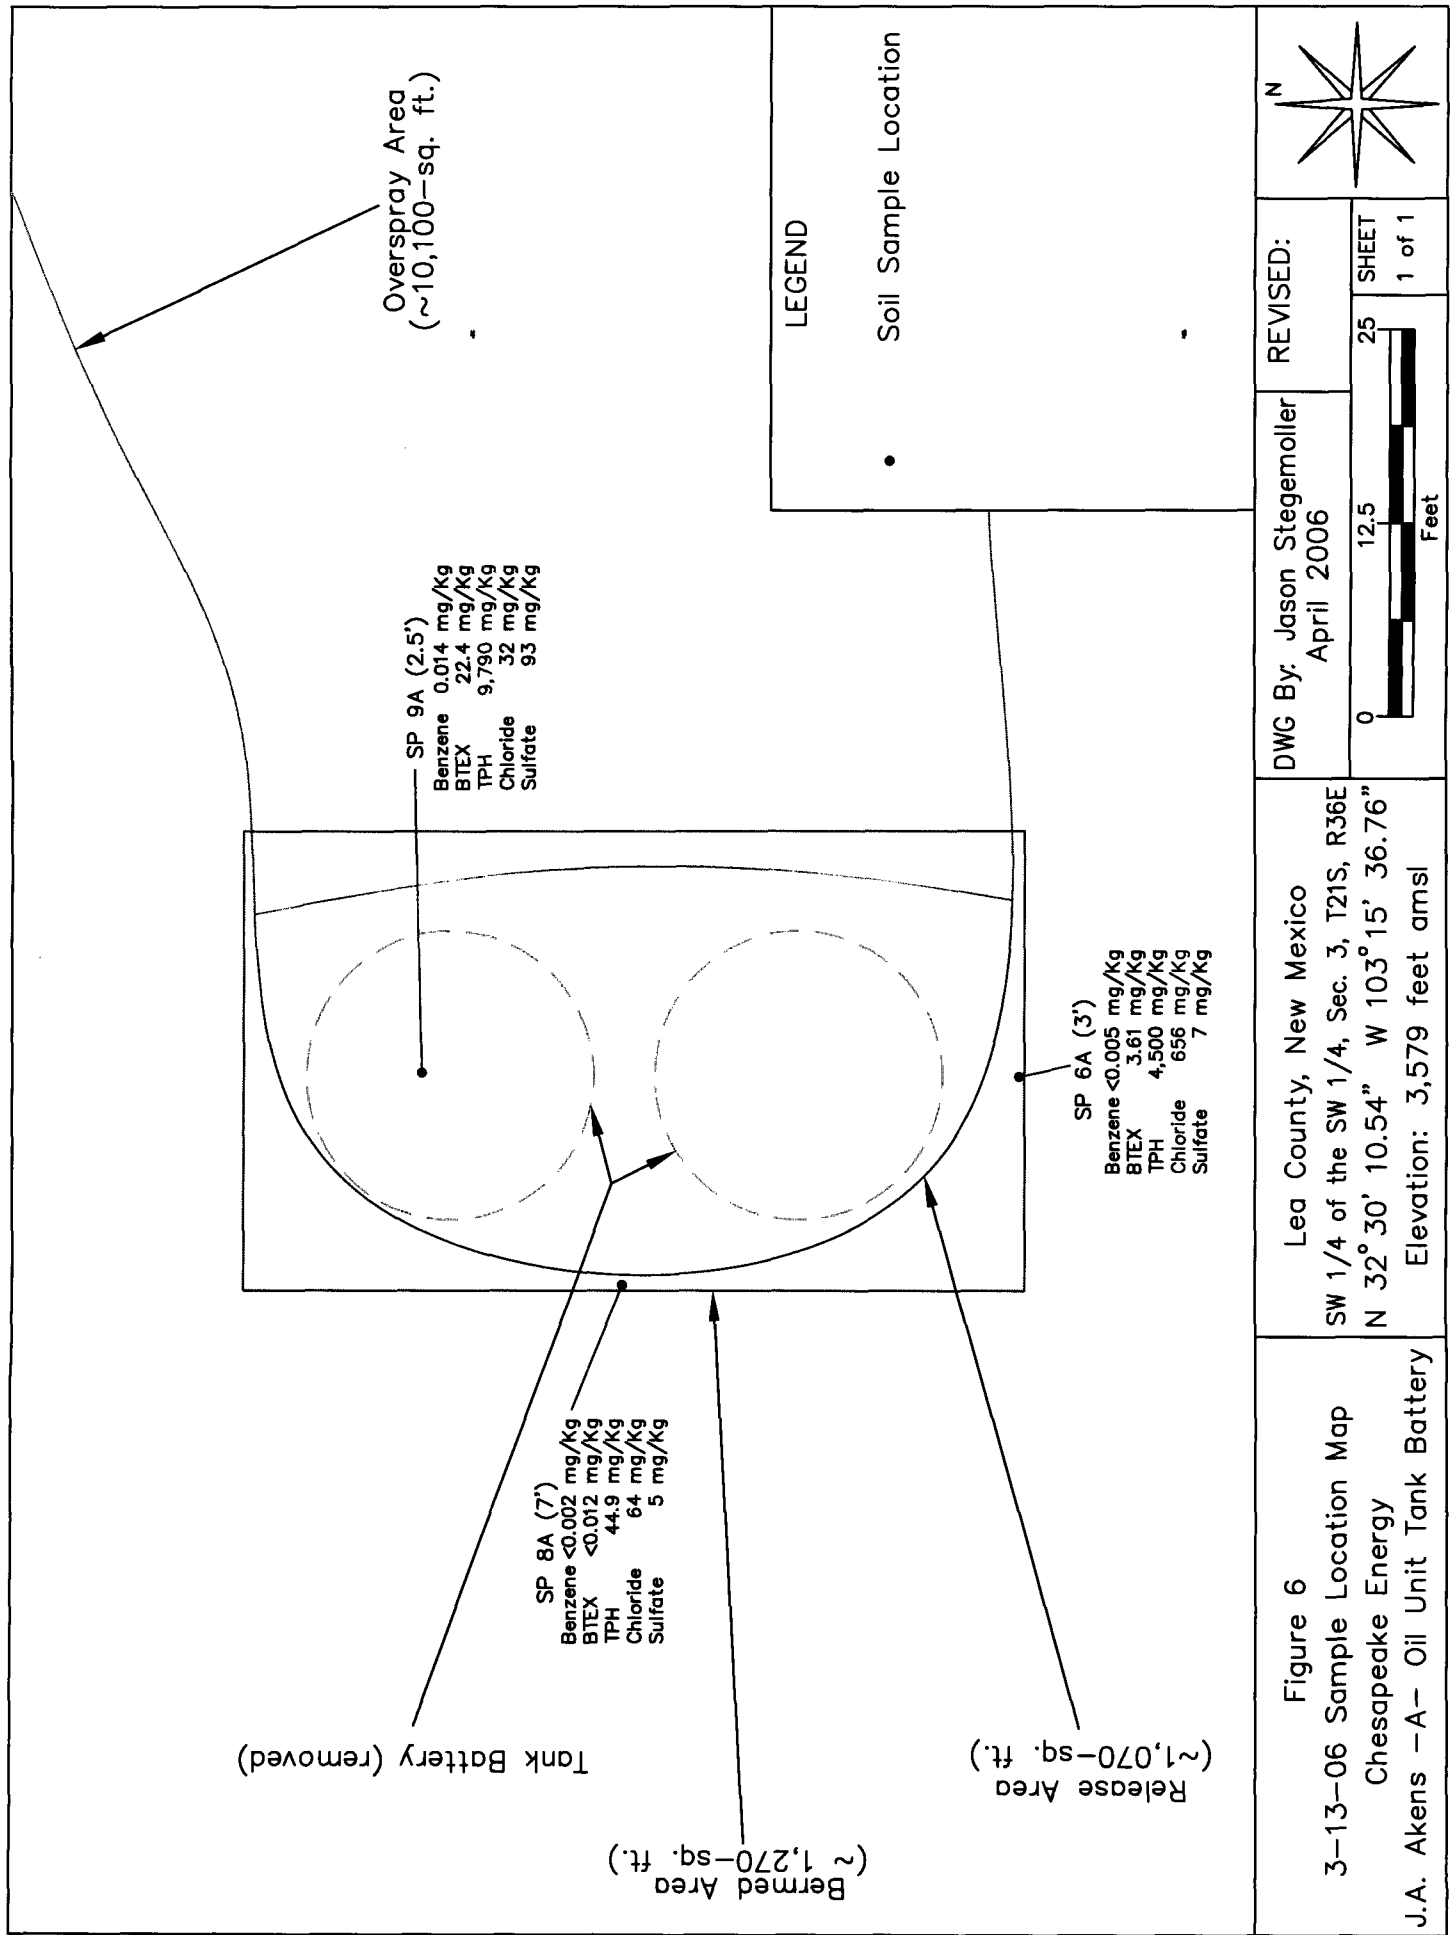
Based on laboratory analytical data from the March 3, 2006 sampling event, additional soil which exceeded NMOCD remedial threshold goals were excavated on March 10, 2006. On March 13, 2006 three (3) soil samples were collected from sample points in areas with contaminant concentrations elevated above NMOCD remedial threshold goals. Benzene concentrations ranged from at or below laboratory analytical MDL in two (2) soil sample points (SP-6A @ 3' and SP-8A @ 7') to 0.014 mg/Kg (SP-9A @ 2.5'), below NMOCD remedial threshold goals of 10 mg/Kg. BTEX concentrations ranged from at or below laboratory analytical MDL (SP-8A @ 7') to 22.4 mg/Kg (SP-9A @ 2.5') with all three (3) soil samples below NMOCD remedial threshold goals of 50 mg/Kg. Concentrations for TPH ranged from 44.9 mg/kg (SP-8A @ 7') to 8,460 mg/Kg (SP-6A @ 3'). Two (2) of the three (3) soil samples were above NMOCD remedial threshold goals of 5,000 mg/Kg with the third sample indicating TPH concentration of 4,498 mg/Kg (SP-6A @ 3') (reference *Figure 6* and *Table 3*).

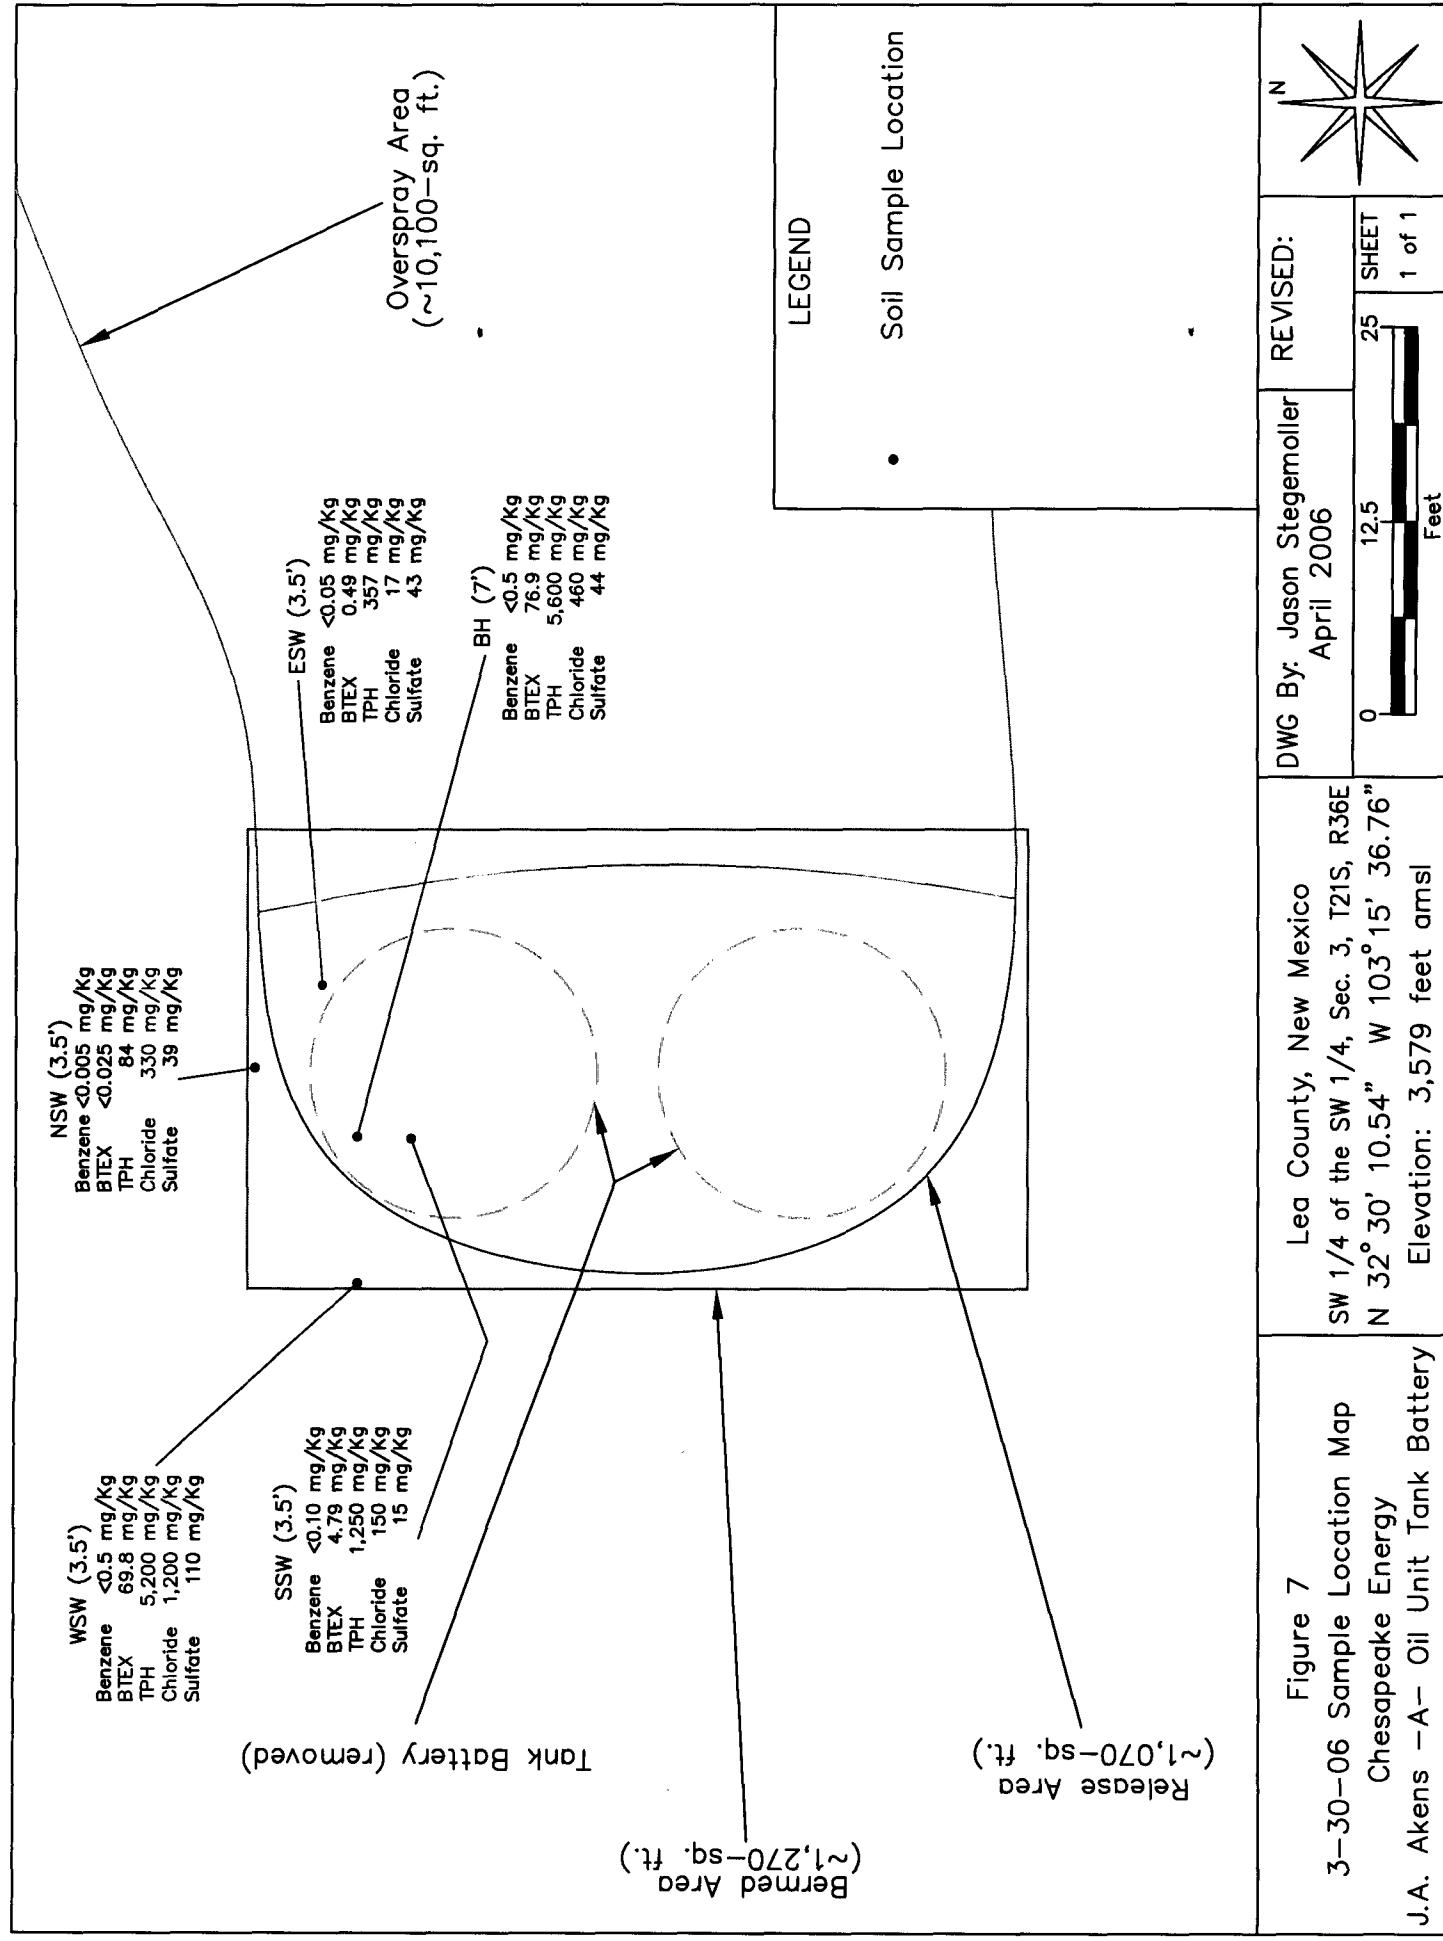
After the areas of elevated contamination identified in the March 13, 2006 sampling event were excavated, four (4) soil samples were collected on March 30, 2006 from the sidewalls and bottom of the excavation. Benzene concentrations were below NMOCD remedial threshold goals of 10 mg/Kg. BTEX constituent concentrations ranged from at or below laboratory analytical MDL (NSW @ 3.5') to 76.9 mg/Kg (BH @ 7') above NMOCD remedial threshold goals of 50 mg/Kg. TPH concentrations ranged from 84 mg/Kg (NSW @ 3.5') to 5,600 mg/Kg (BH @ 7') above NMOCD remedial threshold goals of 5,000 mg/Kg. Chloride concentrations ranged from 17 mg/Kg (ESW @ 3.5') to 1,200 mg/Kg (WSW @ 3.5') exceeding NMWQCC Groundwater Standards of 250 mg/Kg. Sulfate concentrations were below NMOCD remedial threshold goals of 600 mg/Kg for all samples (reference Figure 7 and Table 3).

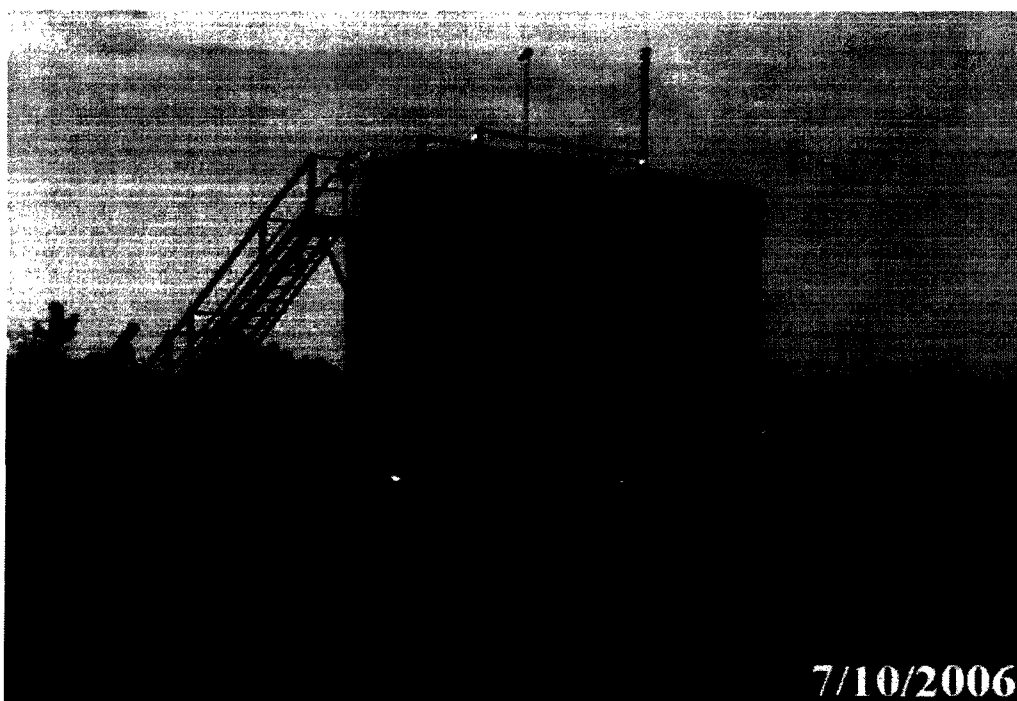
Photograph #10 – Looking southeasterly at Tank Battery and piping
