SOIL CLOSURE REPORT VACUUM TO JAL 14" MAINLINE #4

PLAINS SRS NO. 2003-00126

Lea County, New Mexico NMOCD No. 1RP-374

Project No. 204155.00

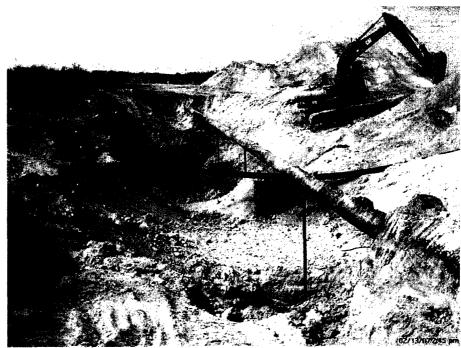
Photograph 3: Photograph shows how support stands were used to support the pipeline during excavation activities. Photo taken viewing north.

To prevent the pipeline from sagging and potentially being damaged as the excavation continued B&H braced the pipeline by placing support materials under the pipeline. These support braces were placed approximately 30 feet apart along the line (Photographs 2 and 3, Appendix C). The excavation extended approximately 40 feet south of the intersection between the two pipelines and approximately 125 feet north of the pipeline intersection (Photograph 4, Appendix C). During excavation, the sidewalls were sloped at a ratio of approximately 1 to 1.5 to prevent caving.

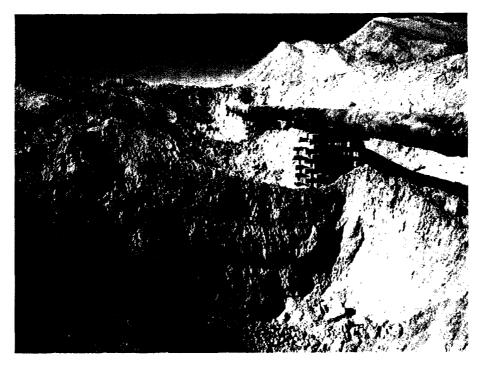
Photograph 4: Photograph shows a portion of the northern portion of excavation.

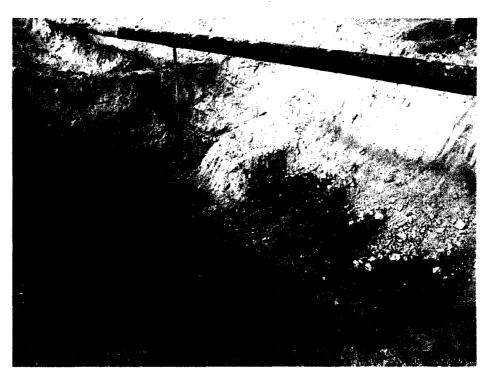
Photograph 5: Photograph illustrates the greenish gray clay unit encountered at approximately 15 feet bgs, north of the pipeline intersection.

The average width at the base of the excavation was approximately 27 feet, while the depth ranged between 11 and 16 feet bgs (Figure 3, Appendix A). The soil is primarily silty sand with some caliche and one area of clay. A greenish gray clay layer was encountered approximately 50 feet north of the pipeline intersection. The clay layer was present beneath the location of the original release at approximately 15 feet bgs (Photograph 5, Appendix C). Excavated soil was temporarily stockpiled on both sides of the pipeline.

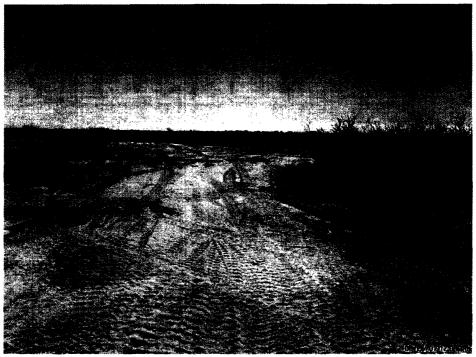
Photograph 6: Photograph of the excavated area after backfilling and grading activities were completed. Photo taken on February 26, 2007, viewing south.

Upon determination that excavation was complete based on sidewall and bottom sample analytical results, the excavation was backfilled with clean surface soil from an on-site, nearby sand dune, as requested by the property owner. The filled trench was compacted using the track hoe and returned to the natural grade. Photograph 6 (Appendix C) shows the area after the backfilling and grading activities were completed. The surface vegetation will be restored by reseeding or as negotiated with the landowner.

- The open excavation was filled with clean soil from an on-site, nearby sand dune (as requested by the property owner). Using the backhoe, the excavation was filled in, compacted, leveled and graded and the Site was brought back to it's natural grade as part of completing the project.
