CLOSURE REPORT

ANTELOPE RIDGE UNIT #5-2

NMOCD REF: 1RP #1280

APRIL 2007

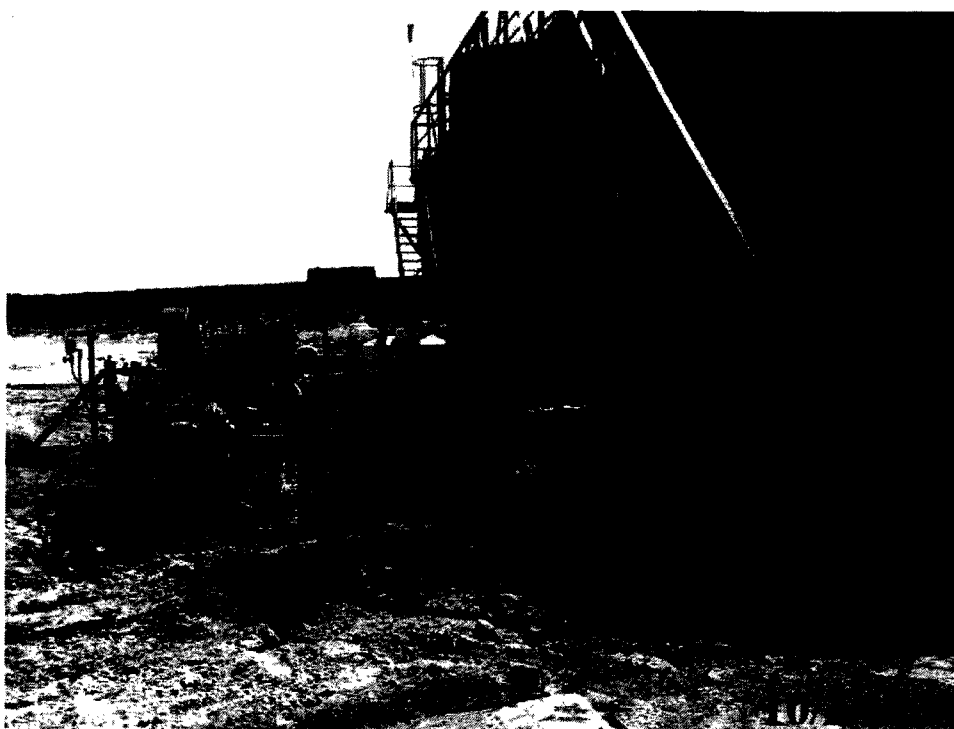
Photograph #2 – Looking south at the release area and tank battery with berm.

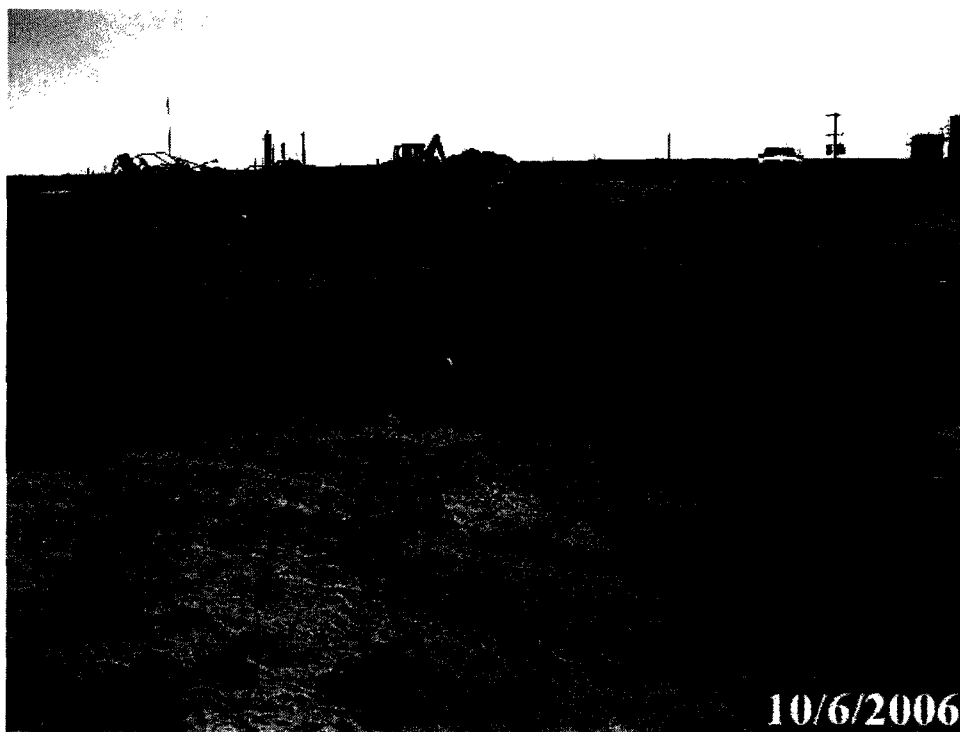
Photograph #7 – Looking southwesterly at excavation area.
