# CLOSURE PROPOSAL

## SS-9 PIPELINE

**1RP # 1197**  
**COMPANY No. 36785**  
**EPI REF: 130027**

**MAY 2007**

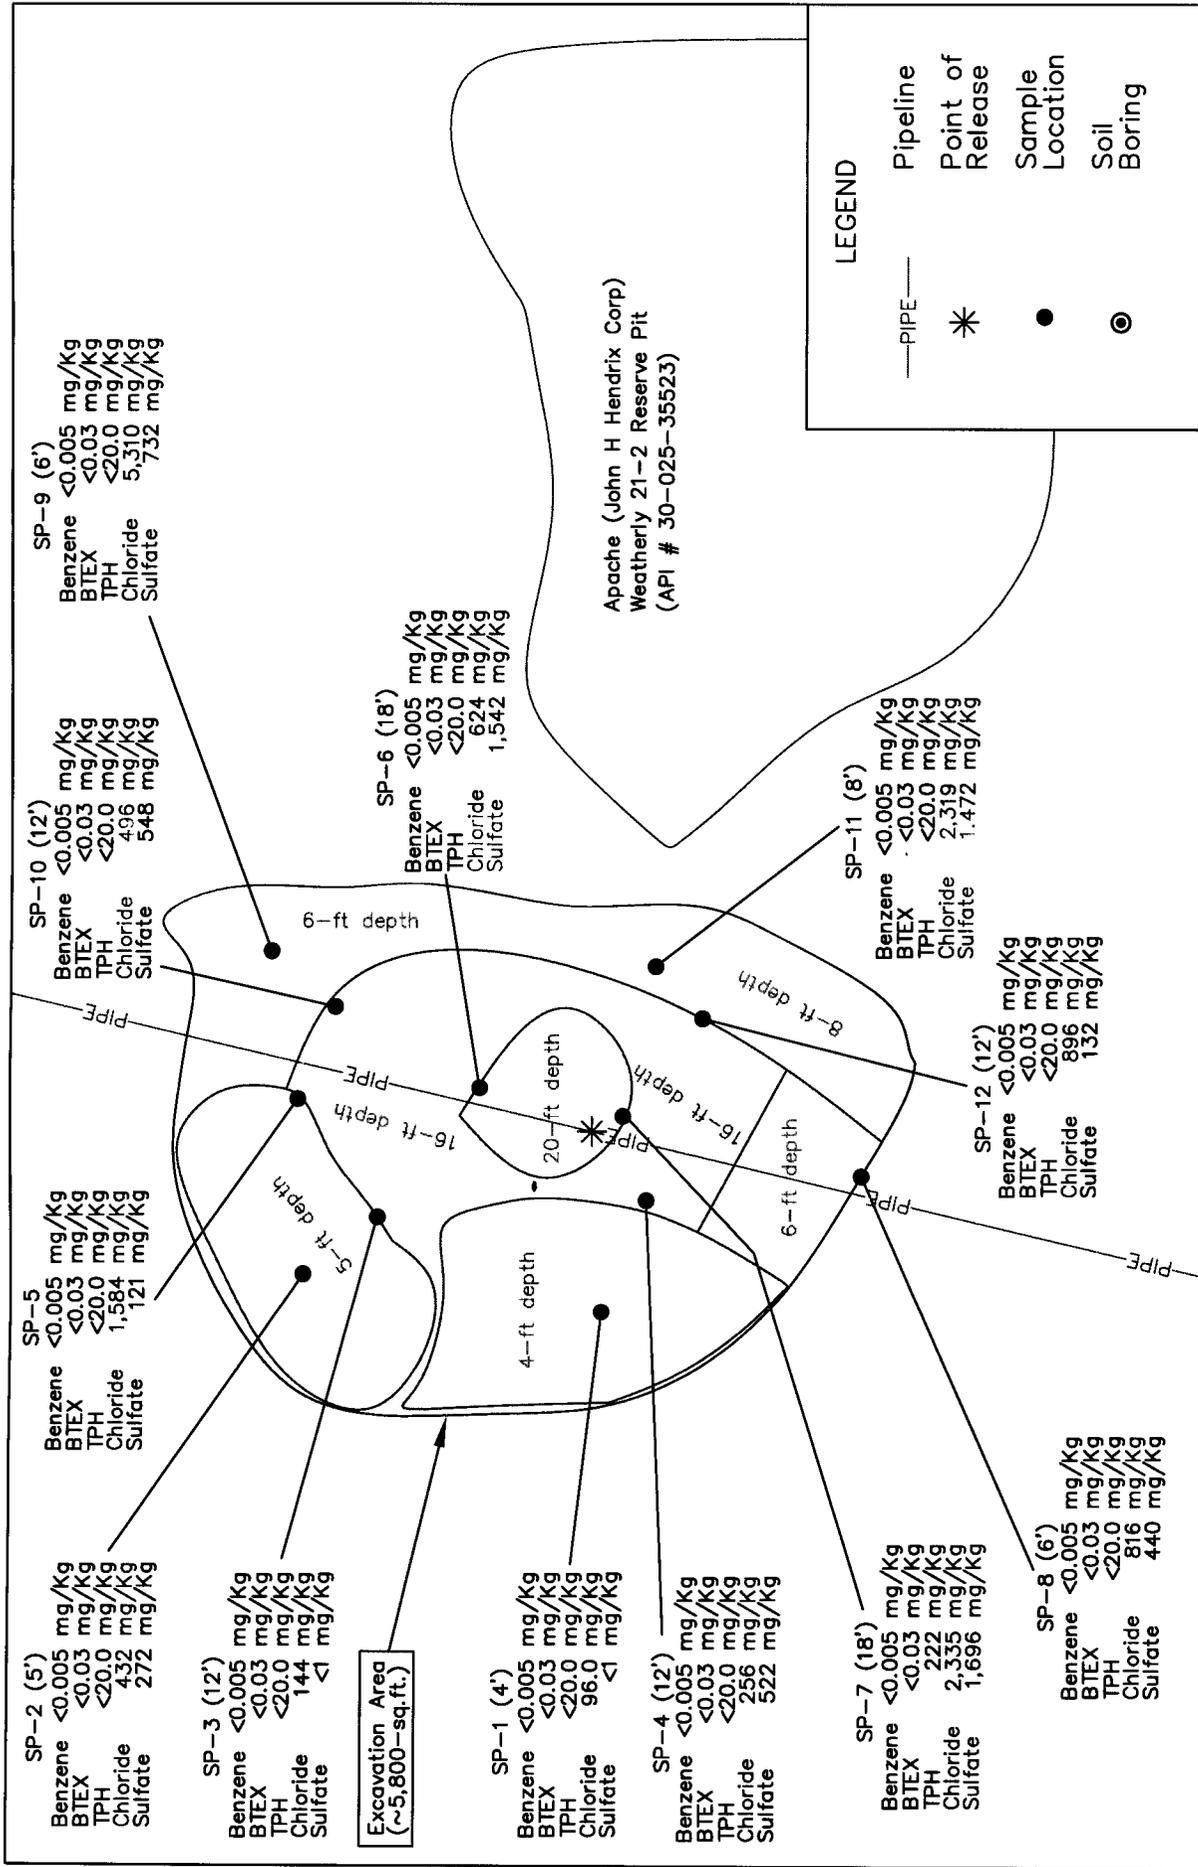
**Figure 5**  
Excavation Sample Location Map  
DCP Midstream, LLC  
SS-9

Soil samples were collected on September 14, 2005 from the excavation sidewalls and floor at twelve (12) discreet sample locations. Soil sample locations were chosen to provide the best representative example of soil within the excavation floor, benches and sidewalls (reference *Figure 5*).

Laboratory analyses of soil samples collected on September 14, 2005 from the excavation floor, sidewalls and benches indicated BTEX constituent concentrations were non-detectable (ND) at or above laboratory analytical method detection limits (MDL). TPH concentrations ranged from ND to 222 mg/Kg. Chloride concentrations ranged from 96.0 to 5,310 mg/Kg (reference *Table 2* and *Figure 5*).

Laboratory analyses of soil samples collected on September 2005 from the excavation sidewalls, benches and floor indicate in situ soil is below NMOCD remedial thresholds for TPH and BTEX constituent concentrations. Chloride concentrations were in excess of the remedial goal of 250 mg/Kg in ten (10) of the twelve (12) soil samples. Sulfate concentrations were in excess of the remedial goal of 600 mg/Kg in four (4) of the twelve (12) collected soil samples (reference *Table 2* and *Figure 5*).

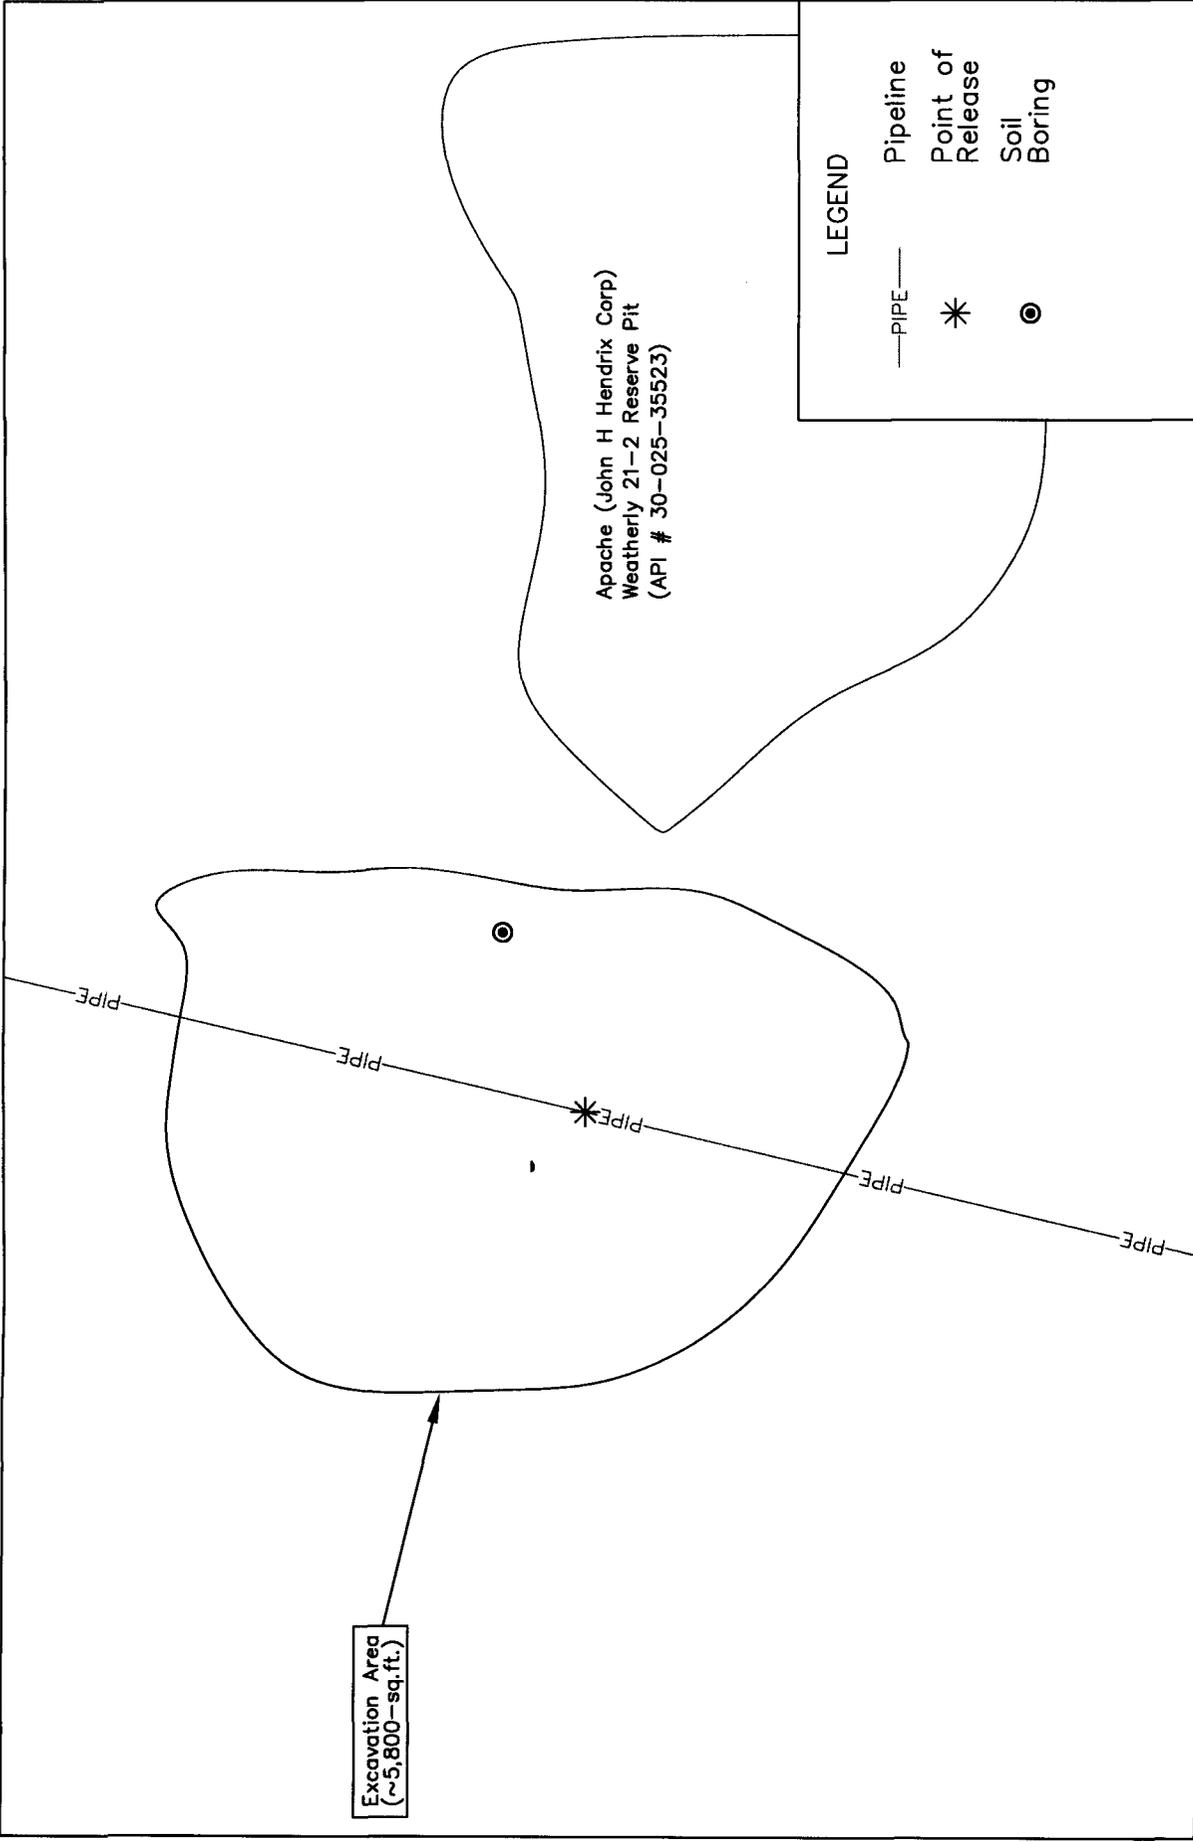
Figure 6  
 Soil Boring Location (2-2-2007)  
 DCP Midstream, LLC  
 SS-9

Soil samples were collected on February 2, 2007 from soil boring SB-1 at 6- and 9-foot bgs and five (5) foot intervals thereafter to 34-foot bgs. Soil boring location was chosen to collect samples to delineate total depth of impacted soil between the Apache reserve pit and the excavation (reference *Figure 6*).

Laboratory analyses of soil samples collected on February 2, 2007 from soil boring SB-1 indicated chloride residuals ranged from 16.0 mg/Kg to 336 mg/Kg with greatest concentrations exhibited at 19 to 24-feet bgs. Chloride concentrations subsequently decreased to 16.0 mg/Kg at 34-feet bgs (reference *Table 3* and *Figure 6*).

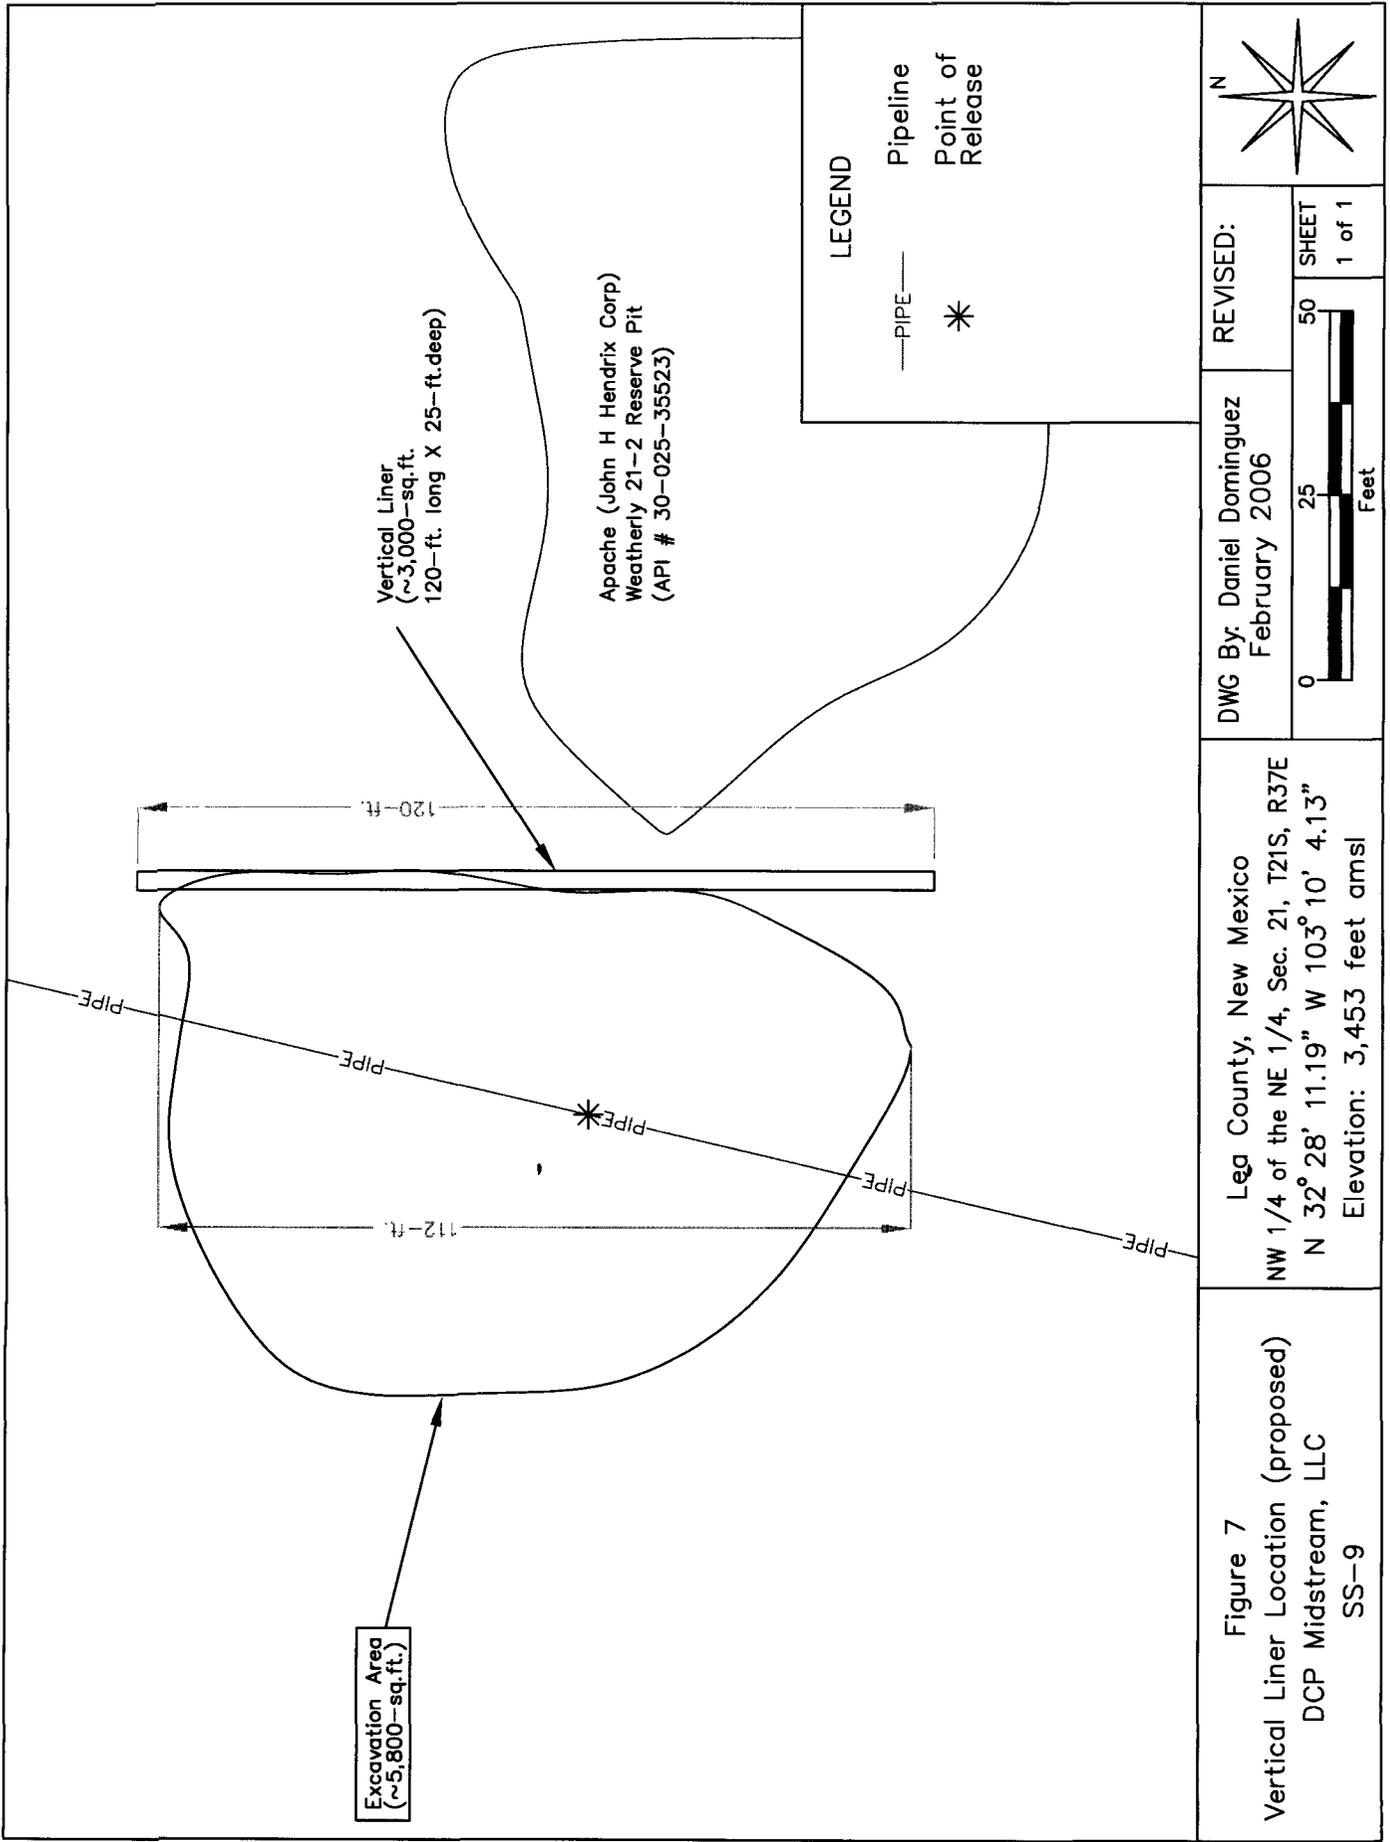
Figure 7  
Vertical Liner Location (proposed)  
DCP Midstream, LLC  
SS-9

Laboratory analyses of excavation soil samples indicate hydrocarbon impacted soil above NMOCD remedial thresholds has been excavated. Within the excavation, chloride residuals above the 250 mg/Kg remedial goal may be capable of impacting local groundwater. With a horizontal impermeable barrier placed over the excavation (i.e., isolating chloride residuals from vertical migration) groundwater should not be impacted by this release. With a vertical impermeable barrier placed between the Apache reserve pit and the excavation (i.e., isolating inflow from the reserve pit) remediated soil should not be impacted/re-impacted from external sources (reference *Figure 7*).

- b) Excavate a 120-foot long trench to approximately 24-feet bgs between the Apache reserve pit and SS-9 excavation. Upon completion of excavation, place a vertical impermeable barrier comprised of 40-mil polyethylene to isolate the DCP Midstream site from inflow of reserve pit contaminants; and

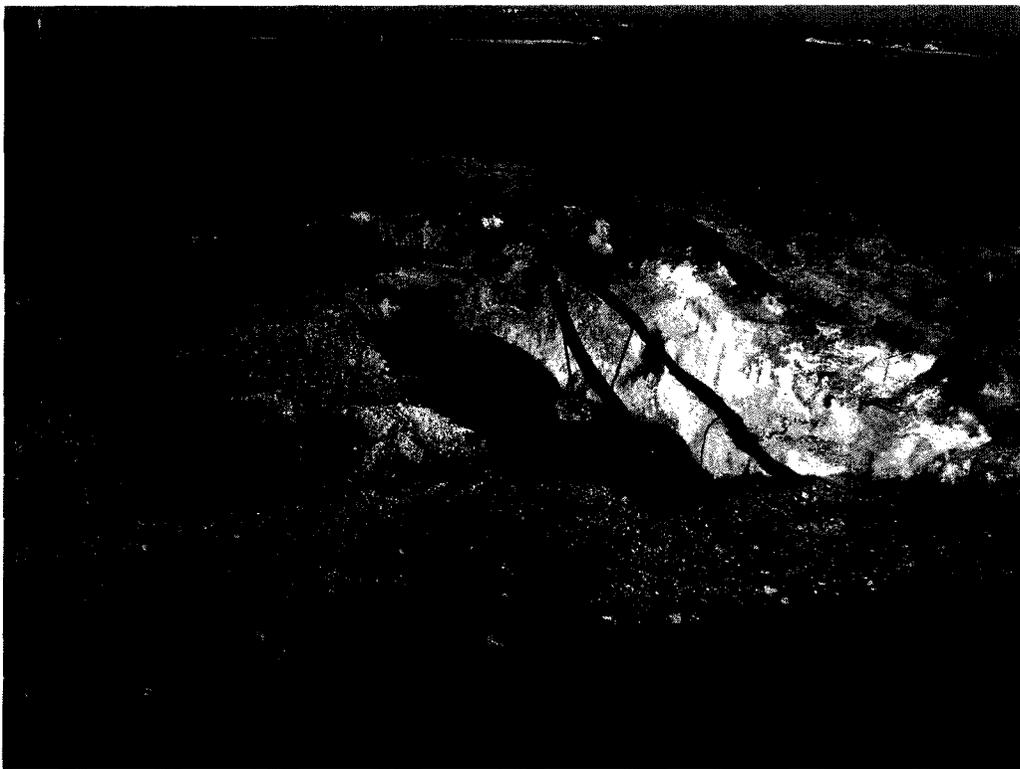
*Photo #4:* Looking northerly across excavation as of November 21, 2006.
