ENVIRONMENTAL SITE
ASSESSMENT
Plantation Operating, LLC
Britt A-6 #3
Spill

White Buffalo Environmental Services was retained by John Allred on behalf of Plantation Operating, LLC to conduct an Environmental Site Assessment (ESA) and necessary cleanup on the Britt A-6 #3 located in Monument, NM. The 60 bbl release was reported to the Oil Conservation Division of New Mexico.

Plantation Operating, LLC
Monument, NM
Britt A-6#3 Spill Cleanup

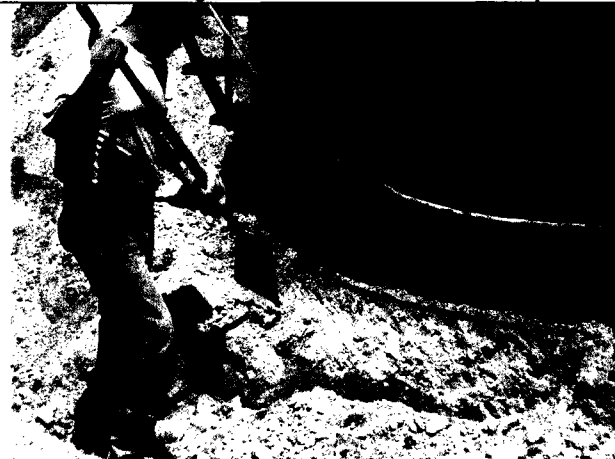
Excavating on south side of tank battery

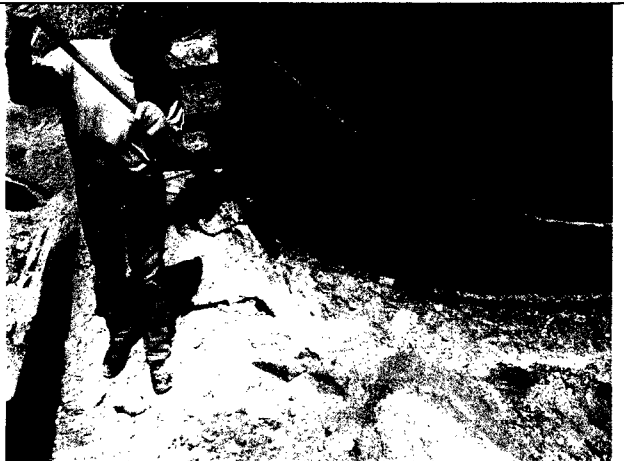
Excavating northeast side of tank battery

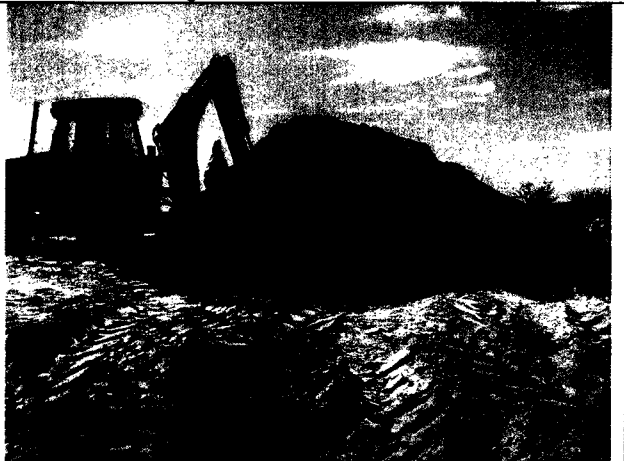
Excavated materials to be removed from site

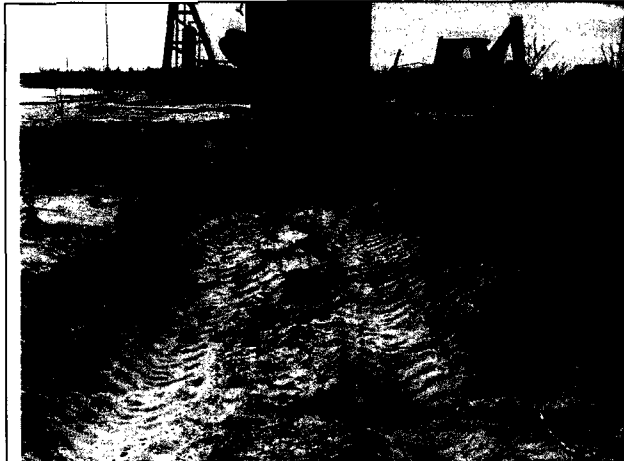
North side of battery after excavating

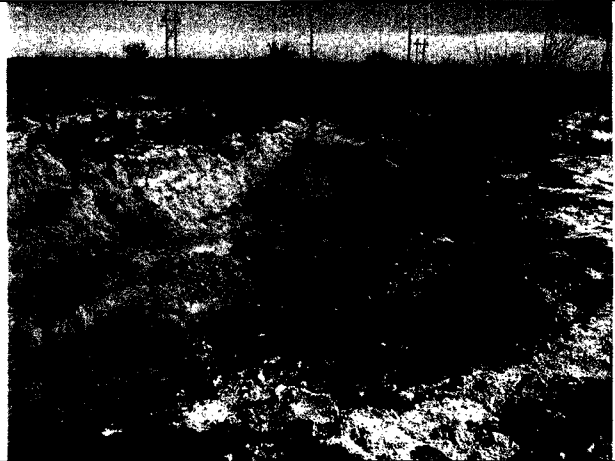
North side of battery after excavating facing north

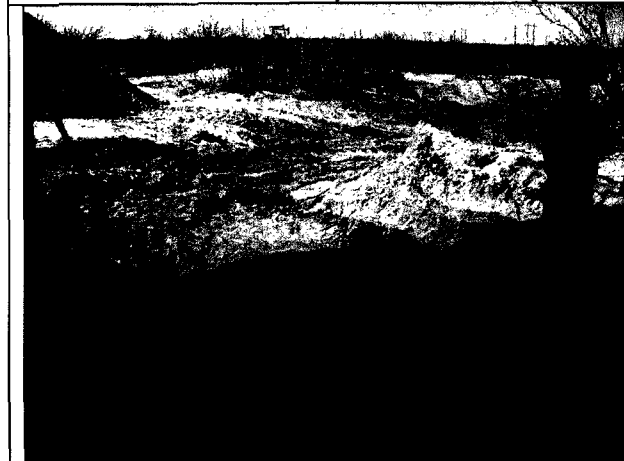
Excavated approximately 4 feet in spill areas

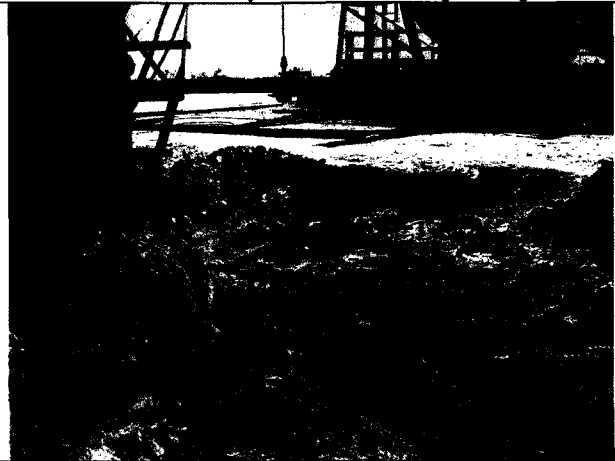
West side of tank after excavating

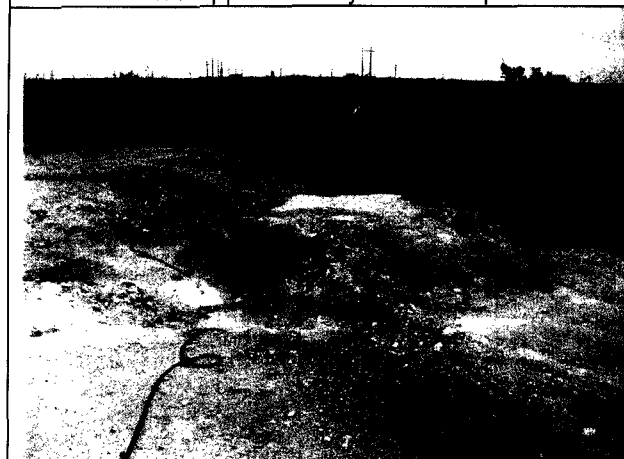
Additional excavation conducted on 5-26-07 after tank was removed to reach elevated areas from the spill

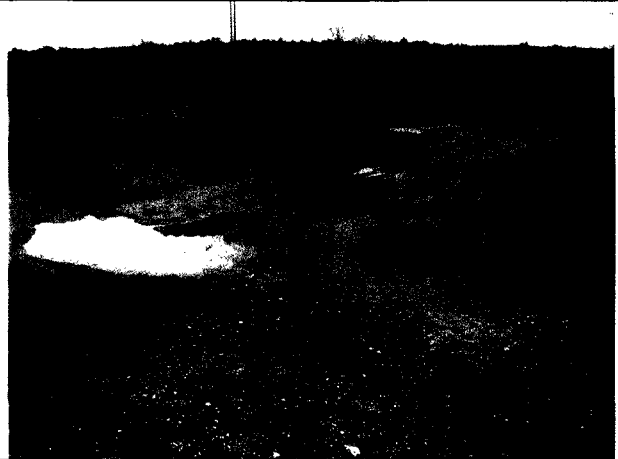
Additional excavation conducted on 5-26-07
northwest of tank battery

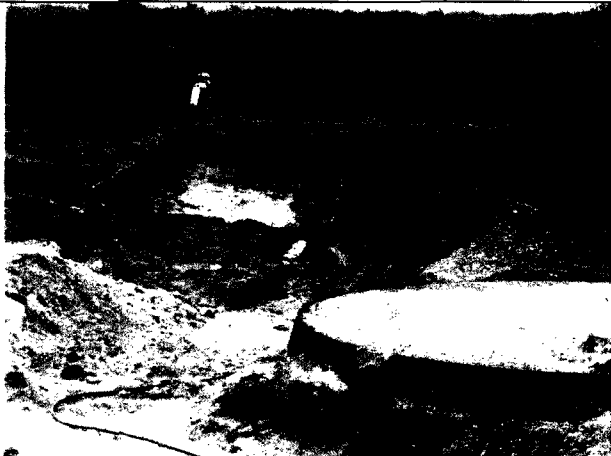
Additional excavation conducted on 5-26-07
northwest of tank battery

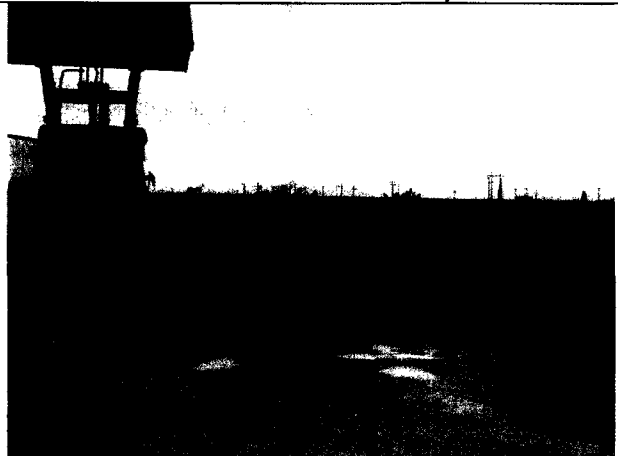
Additional excavation conducted on 5-26-07

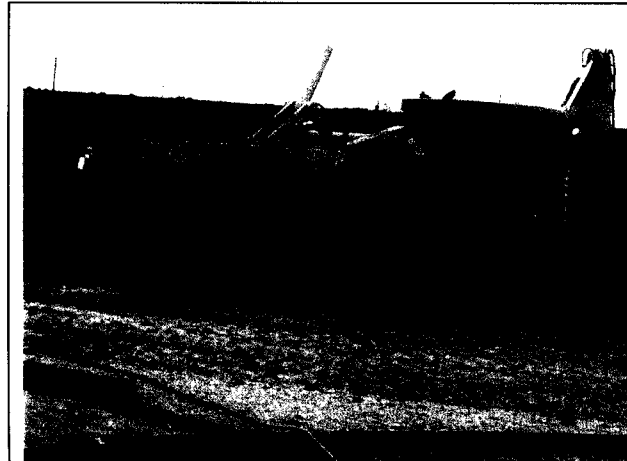
Additional excavation conducted on 5-26-07

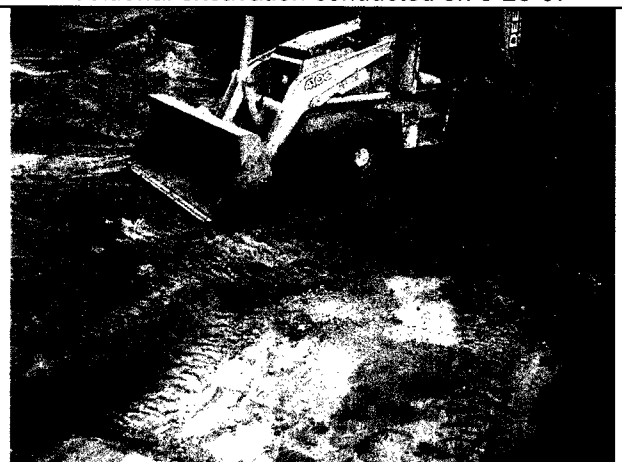
Additional excavation conducted on 5-26-07

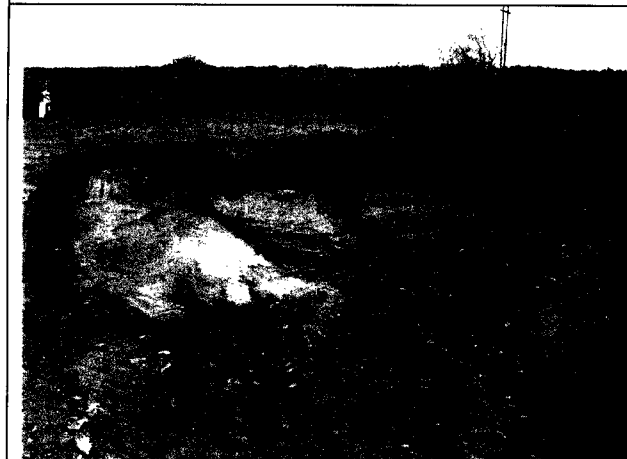
Additional excavation conducted on 5-26-07

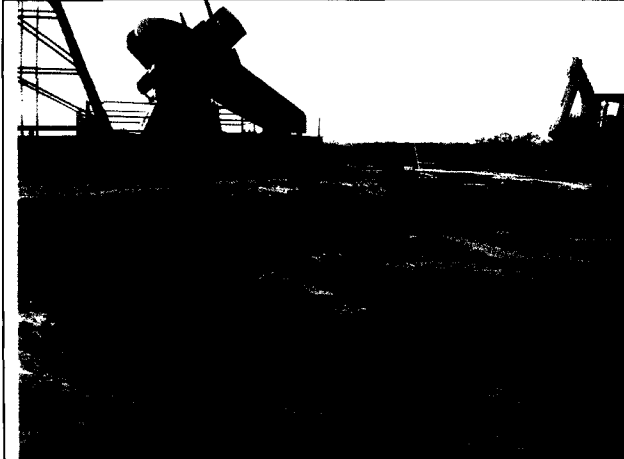
Area where tank sat after additional excavation on
5-26-07

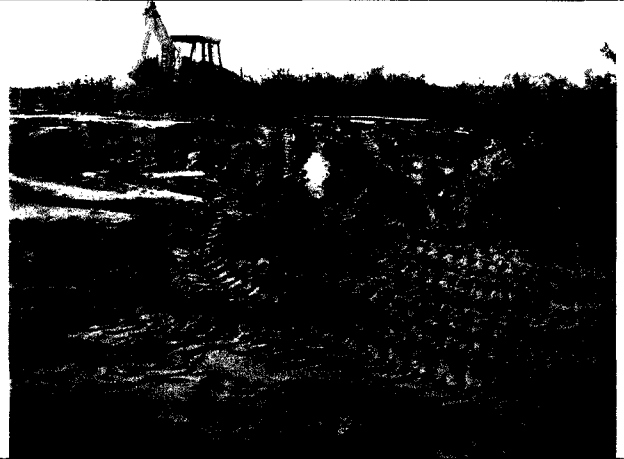
Area where tank sat after additional excavation on
5-26-07

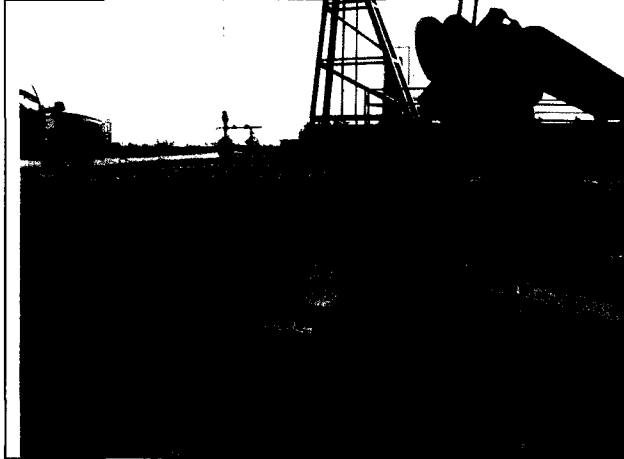
Area where tank sat after additional excavation on
5-26-07

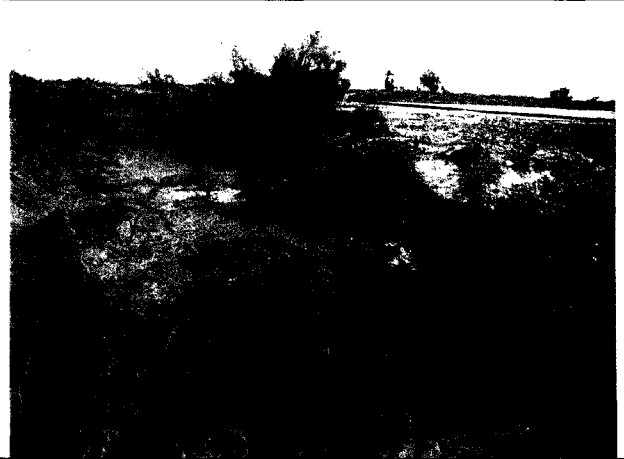
Area where tank sat after additional excavation on
5-26-07
