FINAL CLOSURE REPORT

SELBY MAVEETY #3 FLOWLINE

EPI REF: 240015

NMOCD REF. 1RP#1032

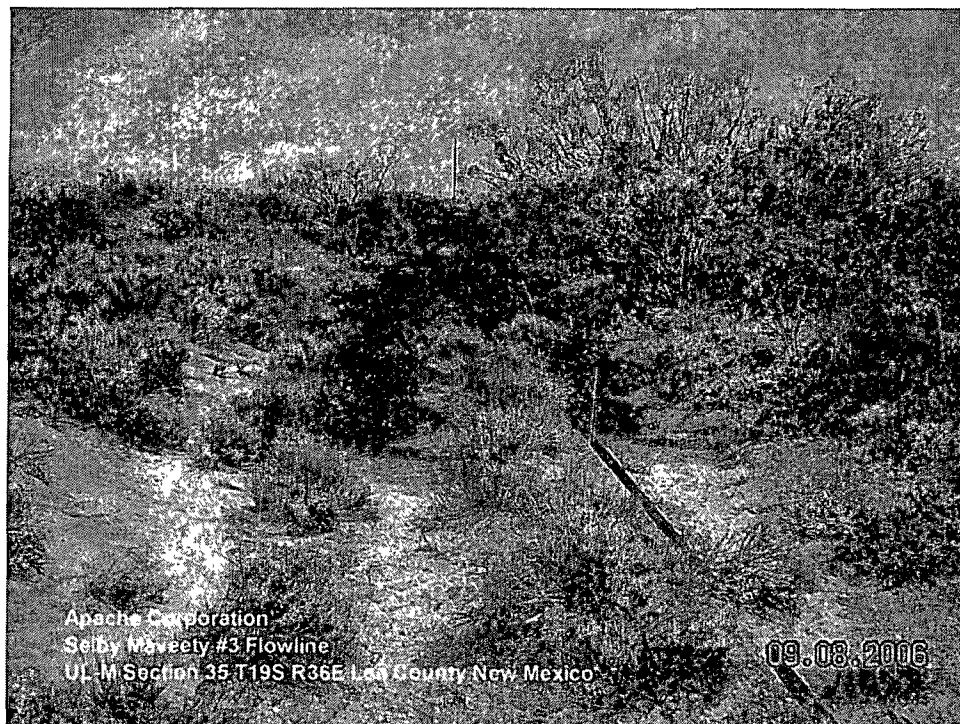
Photograph #2 – Looking west at pipeline and release area.

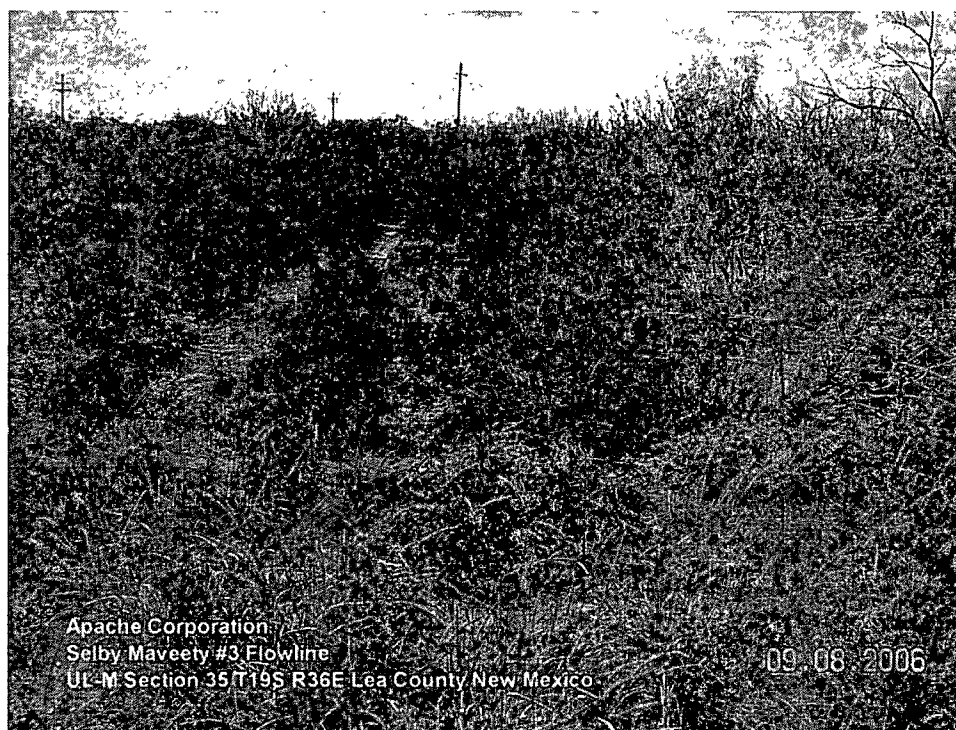
Photograph #3 – Looking west at point of release.

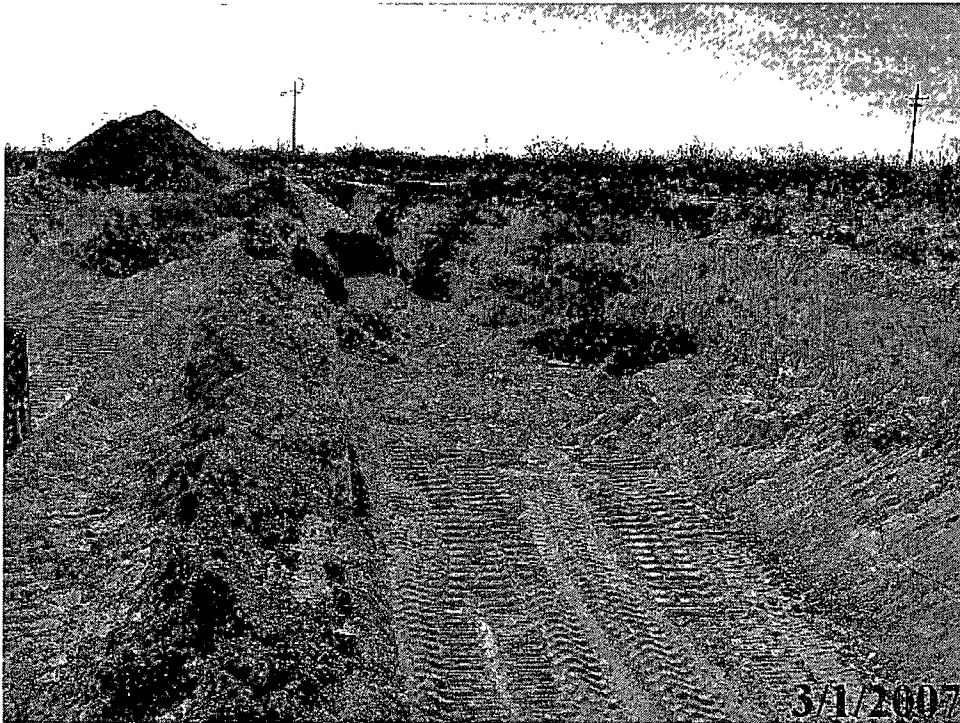
Photograph #6 – Looking west at excavation and benching of sidewalls.

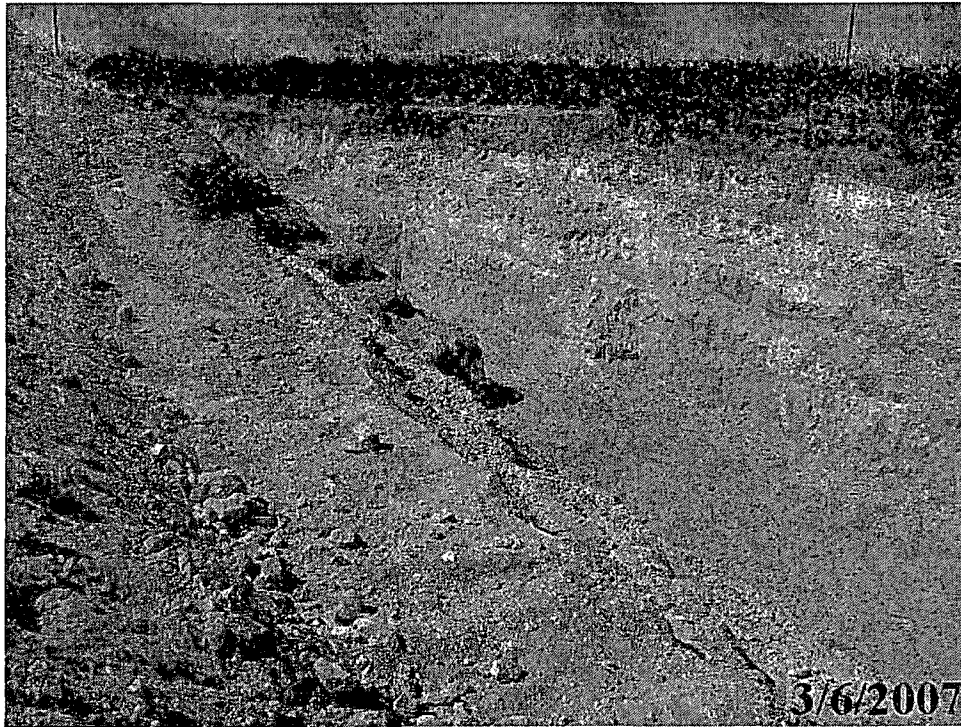
Photograph #7 – Looking northwesterly at excavation.

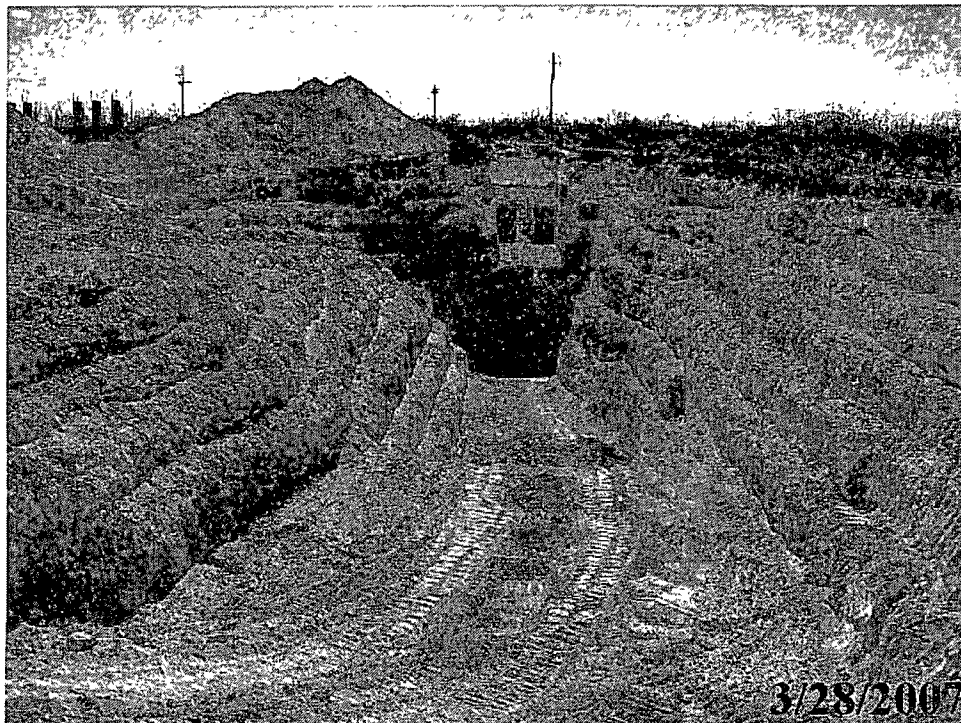
Photograph #8 – Looking west at excavation and benching of sidewalls.

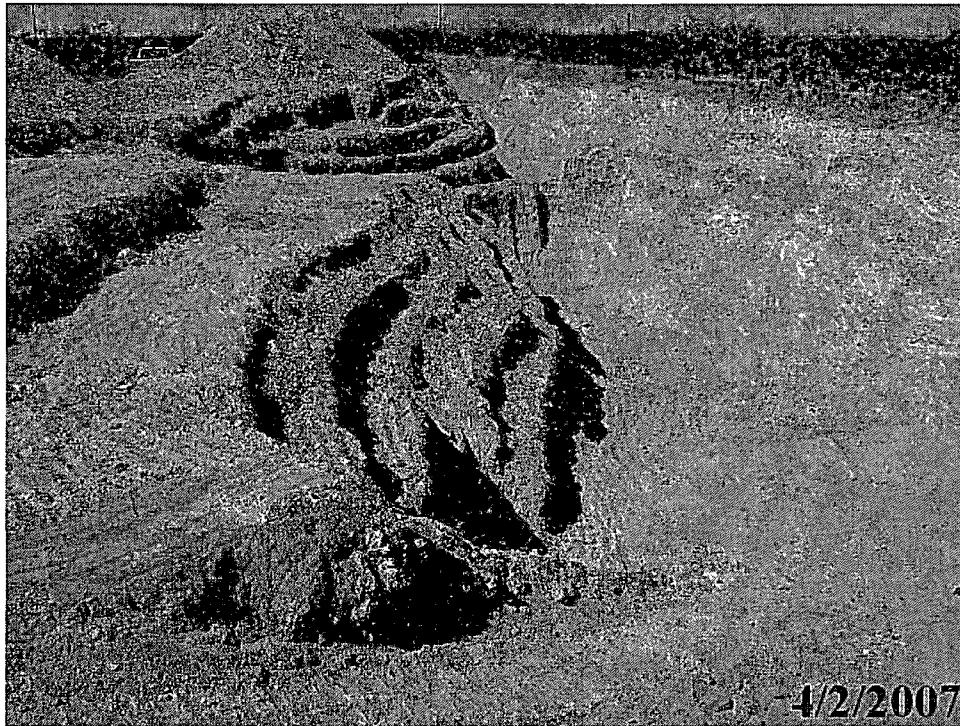
Photograph #9 – Looking west at backfilling of excavation.
