RE: 1RP-1238
Final Closure Letter
South Hobbs Unit Satellite #1 Test Vessel
UL 'K', Sec. 5, T-19-S, R-38-E

Release Notification and Corrective Action

SPILL MAP

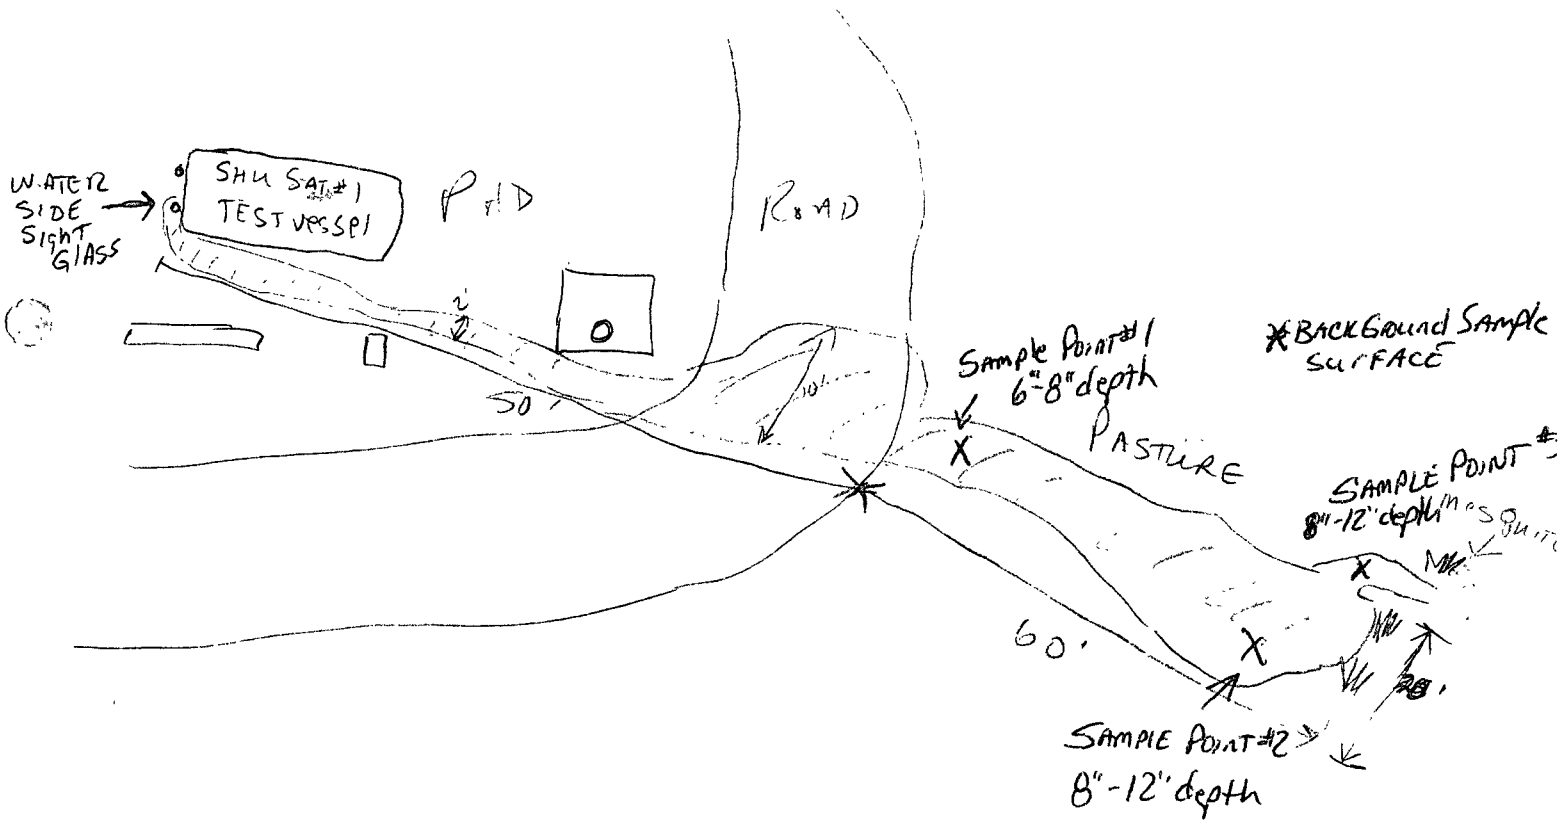
PLEASE DRAW SKETCH OF SPILL AND INDICATE WHERE SPILL ORIGINATED.

02/28/07 ØBO x 15 BW REC ØBO x 10 BW
SHU SAT #1 BROKEN SITE GLASS ON TEST SEPARATOR
UL'K' Sec 5, T-19 S, R-33-E
N 32° 41' 10.03" W 103° 10' 22.17"

1. Affected area was excavated and soil was disposed of at Sundance Services, Parabo Facility near Eunice, NM. 36 yards of soil was taken to the Parabo Facility.
2. Soil samples were gathered from affected area. See attached map for sample points and depths.
3. NMOCD guidelines were used to insure entire site is in compliance with guidelines.
4. Any soils removed will be replaced with clean fresh soils, where needed.
5. Soil analysis data is submitted with this final closure letter. See attached Cardinal Labs soil analysis data dated 07/17/2007.
