Release Notification and Corrective Action

Name of Company: Targa Midstream Services L P	Contact: James Lingnau 505.394.2534, Chuck Tolsma 505.631.6026
Address: PO Box 1909 Eunice, NM 88231	Telephone No. (505) 394-2534
Facility Name: Eunice Gathering System	Facility Type Gas Processing Plant

DECK ESTATE 16"

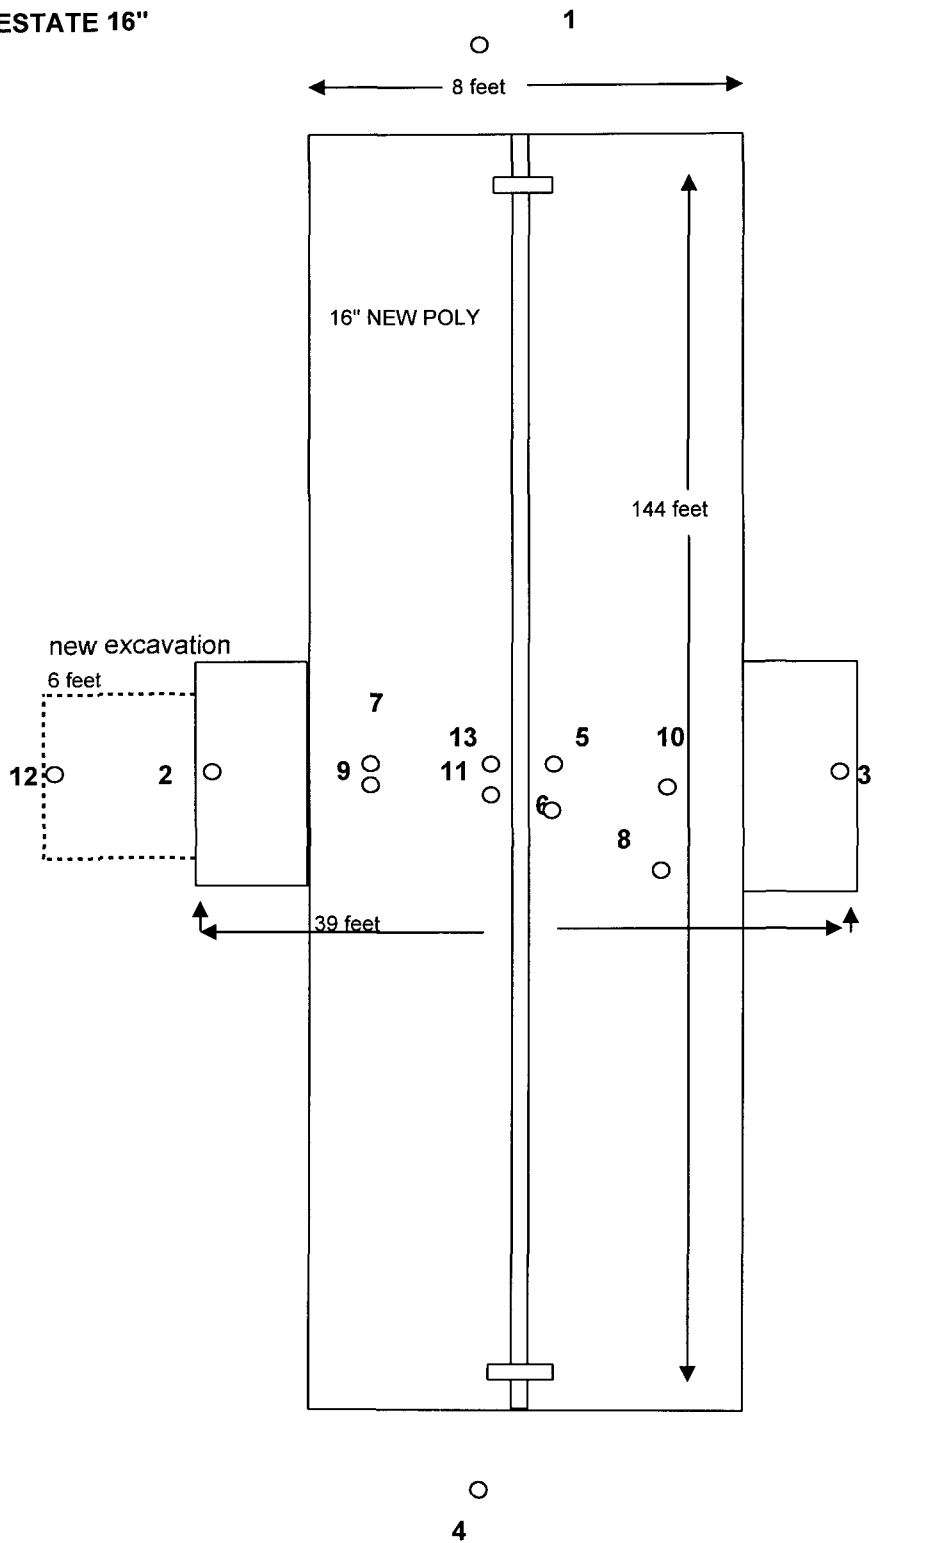
SAMPLE #	SAMPLE DATE	SAMPLE I.D.	SOIL STATUS	TPH GRO	TPH DRO	CHLORIDE
1	5/30/2007	West 5-30	In Situ	<10	<10	<16
2	5/30/2007	South 5-30	Excavated	<10	<10	16
3	5/30/2007	North 5-30	Excavated	<10	<10	288
4	5/30/2007	East 5-30	In Situ	<10	<10	<16
5	6/12/2007	DE Bottom 3'	Excavated	<10	853	2290
6	6/12/2007	DE Bottom L-3'	Excavated	<10	22.6	15000
7	6/12/2007	DE SS-L-2'	Excavated	15.5	3030	9120
8	6/12/2007	DE L-SS-8'N2'	Excavated	<10	560	64
9	7/18/2007	DE SS 4'	Excavated	<10	42.6	4840
10	7/18/2007	DE NS 4'	In Situ	<10	<10	16
11	7/18/2007	DE Bottom 8'	Excavated	<10	13.1	4240
12	8/14/2007	SS 10'	In Situ	<10	<10	32
13	8/14/2007	Bottom 12'	In Situ	<10	<10	32
