RP 1204

## Final Report

NMGSAU # 2109

Flowline Release

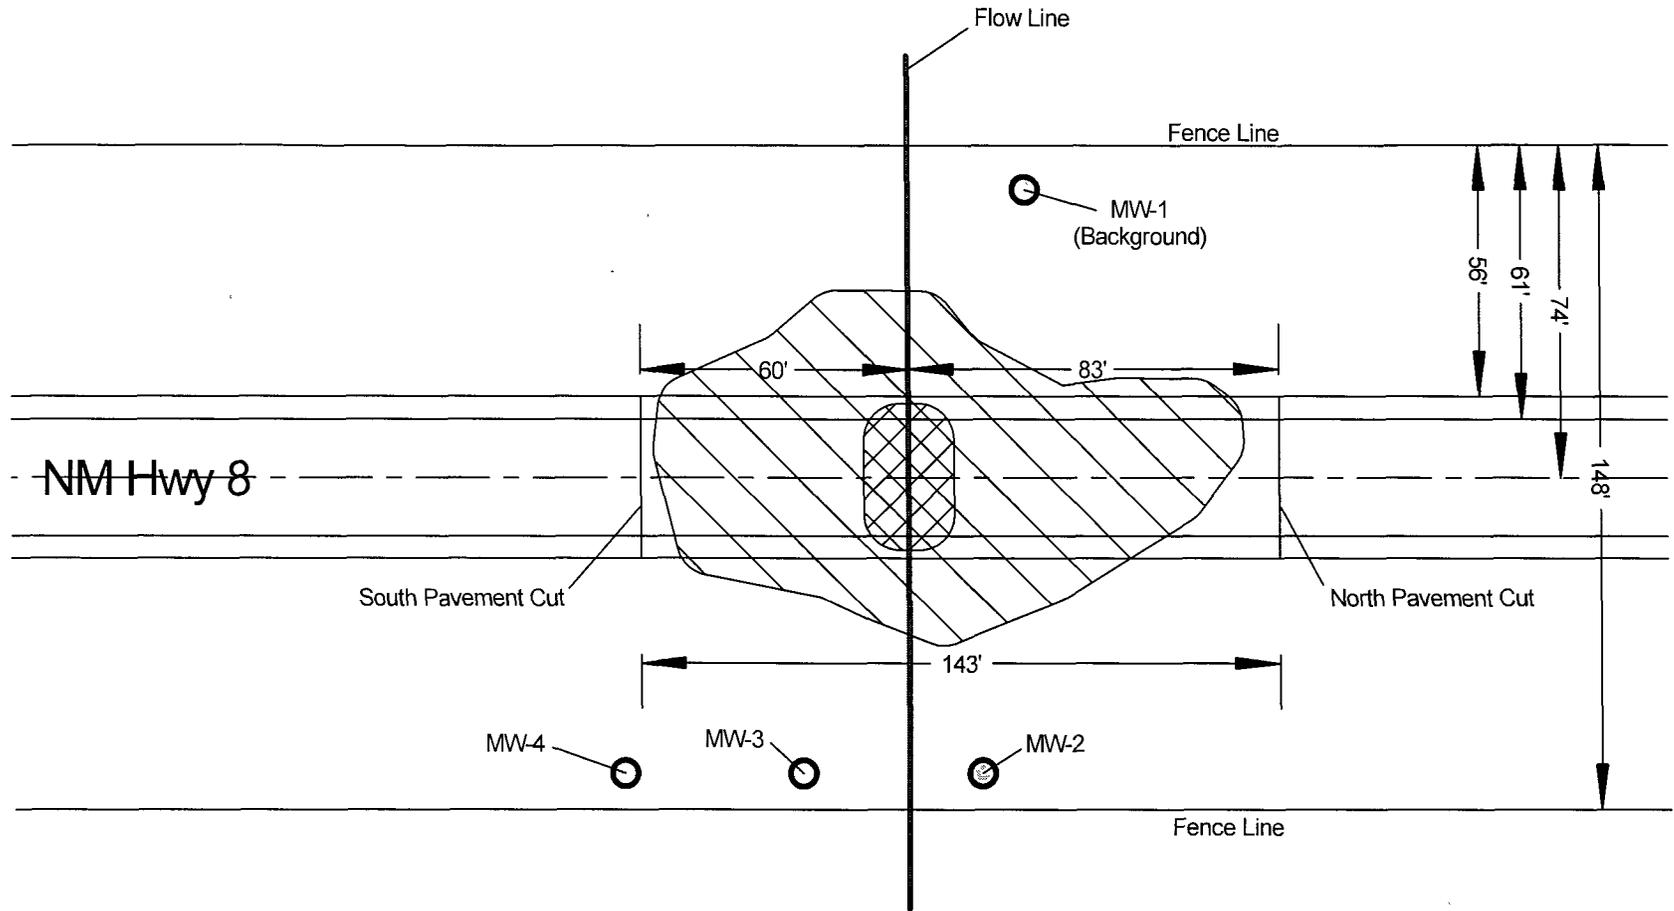
Plate 4 Site Detail Drawing Apache Corporation NMGSAU #2109	Lea County, New Mexico UL-H SECTION 5 T20S R37E 32° 36.021' N, 103° 15.897' W Elevation: ~3560-ft amsl	Drawing by: John Good March - 2007	Rev: 1	
		SCALE: 1" = 40'

Release Area (under pavement)		Excavated Area		Proposed Monitor Wells	
----------------------------------	--	-------------------	--	---------------------------	--

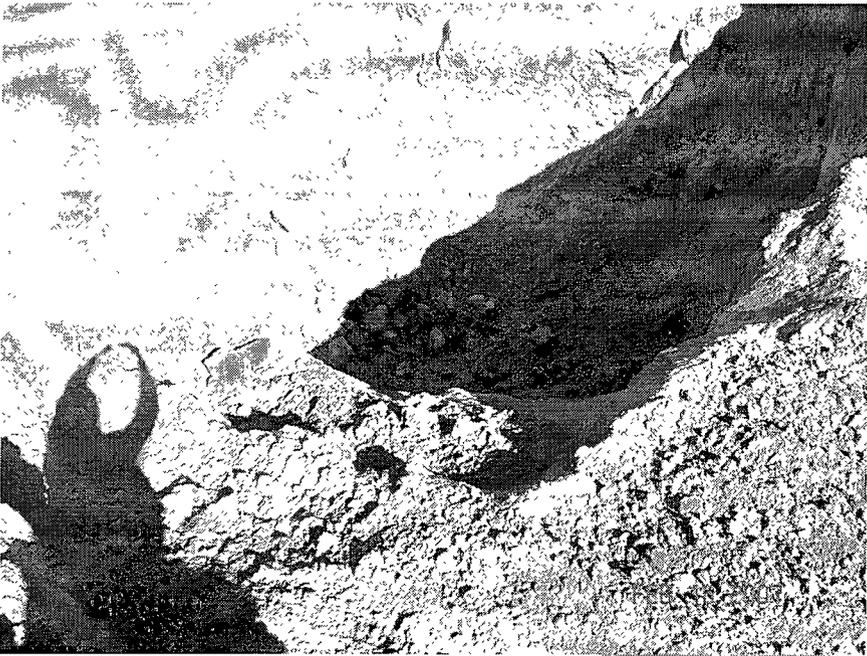
Excavation on Friday,  
2/16

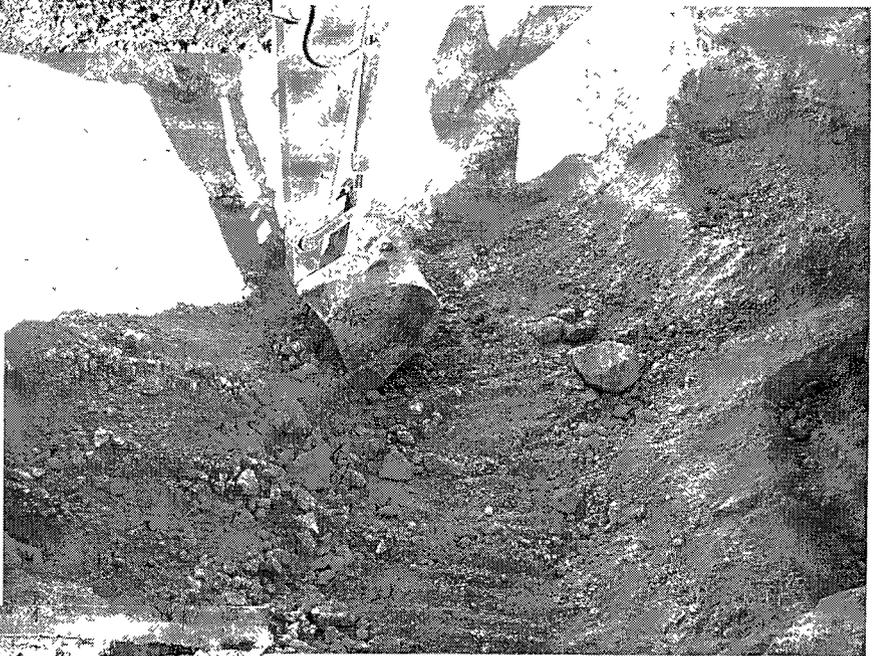
Excavation bottom on 2/16

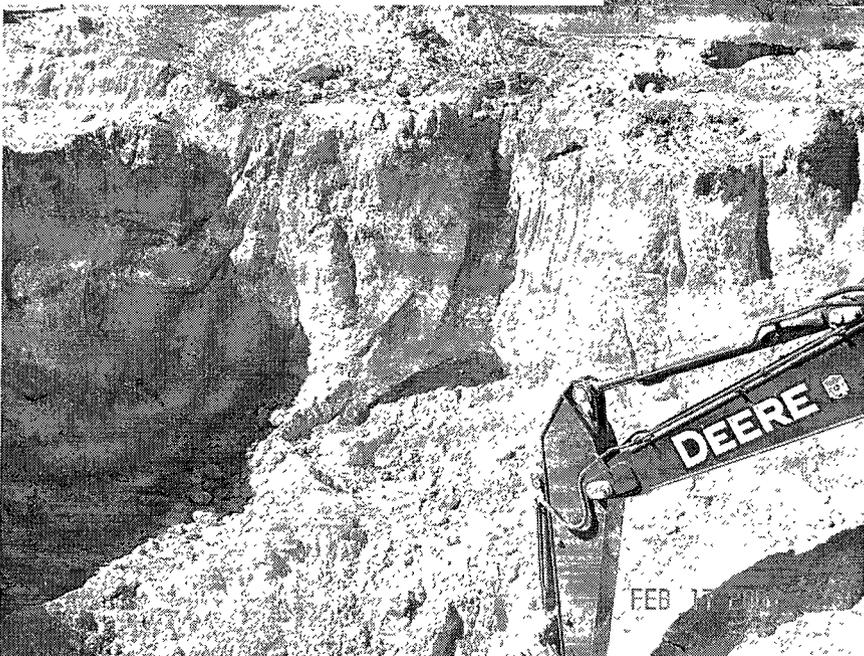
West sidewall @ 25'

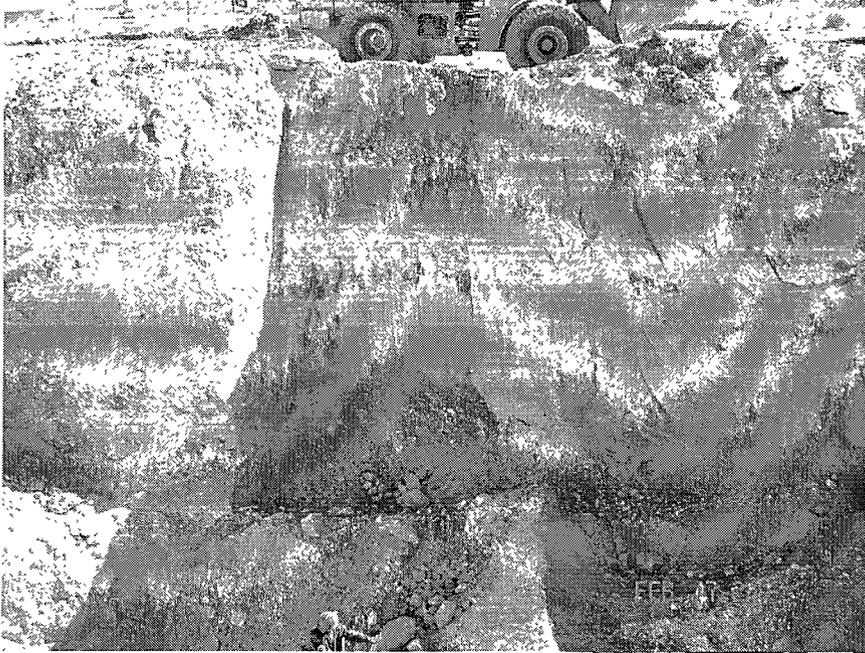
East sidewall @ 25'

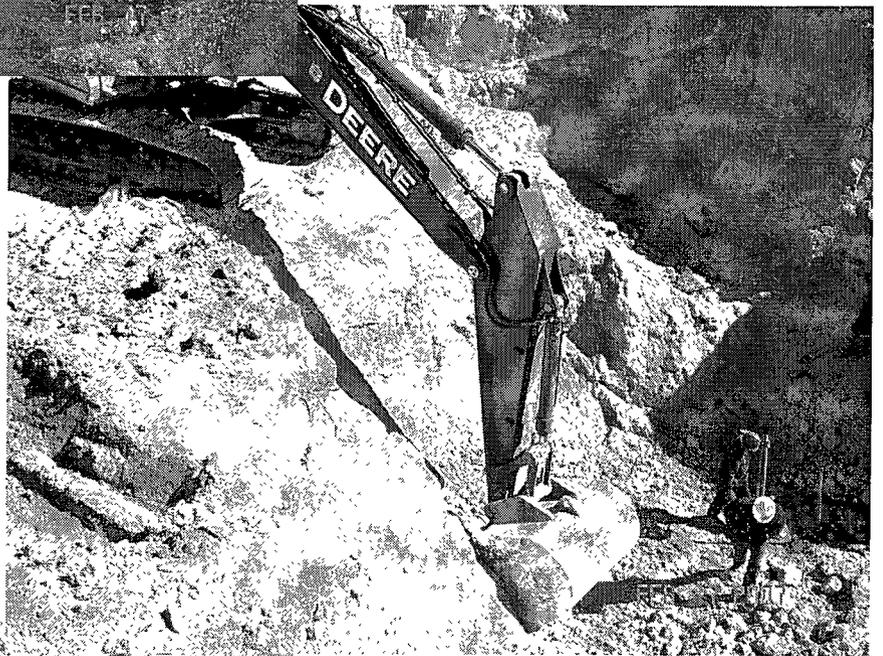
North sidewall @ 25'  
and hand excavation to  
ground water

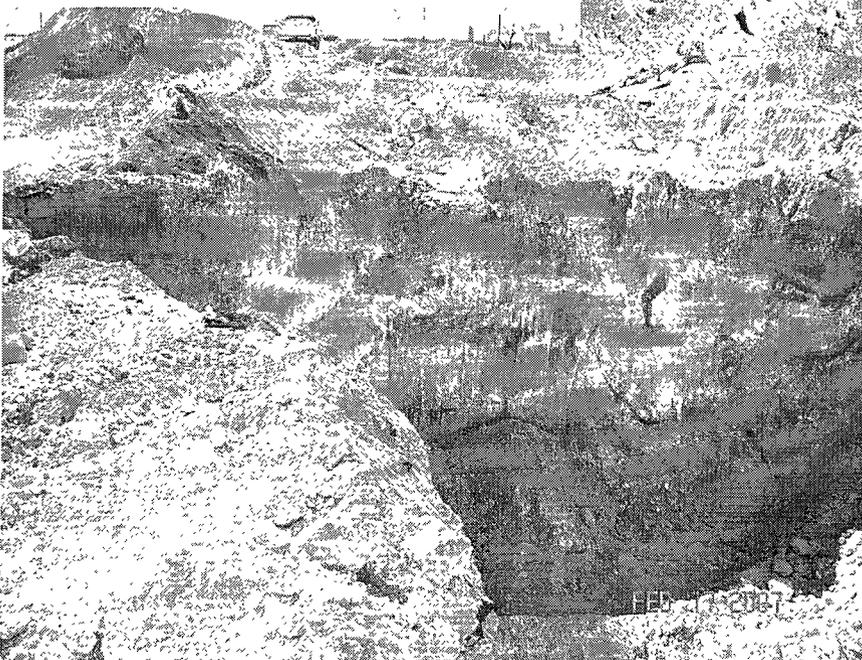
South sidewall @ 25'

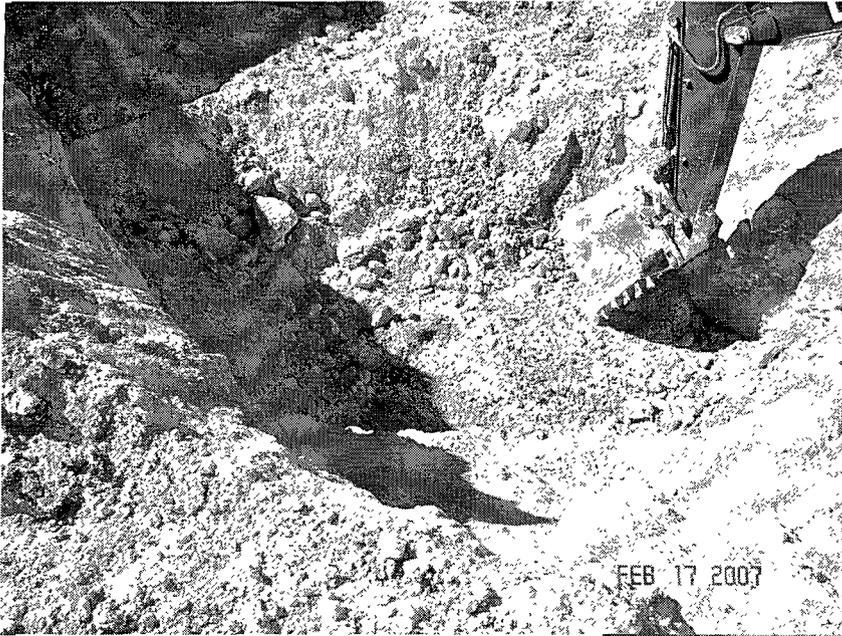
The excavation was vertically extended to 31-ft bgs where “red sand” was encountered, indicating that the saturated zone would soon be encountered. This red sand from 31-ft bgs was field tested for chlorides with a resultant ~800-ppm. A sample was collected for laboratory analysis. A small area of the bottom (3’ X 3’) was manually extended to 32-ft bgs, where it promptly filled with ground water. The ground water was field tested with a resultant ~600-ppm indication. A ground water sample was collected for laboratory analysis. A sample of the clean backfill material purchased off-site was also collected for laboratory analysis. Cardinal Laboratories, Hobbs, NM accommodated us by agreeing to analyze the samples on Saturday afternoon. The samples were delivered to Cardinal Labs at 1:00 PM and we had results by 3:00 PM. Results of the analyses are as follows:

Red sand @ 31'

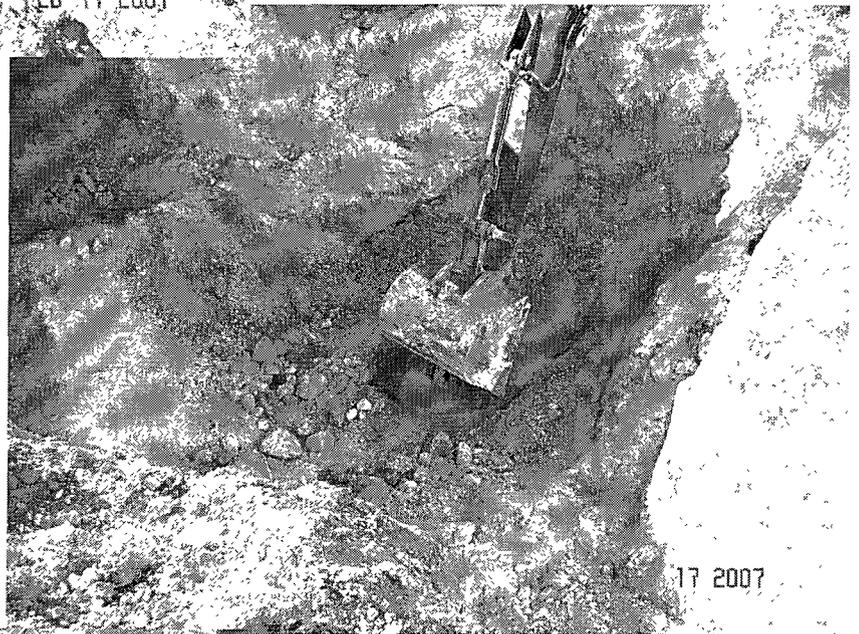
Placing bentonite to plug exposed ground water

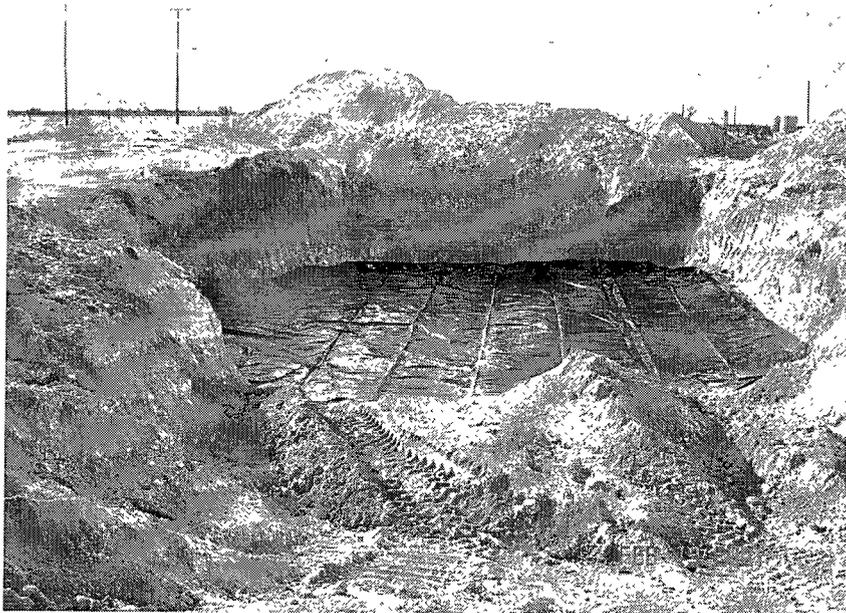
At 8:45 AM, Monday, 2/19/07, a 50' X 50' 20-mil plastic liner was installed over the center of the release location at the 10-ft bgs elevation. The excavation was then backfilled, compacted and certified by NMDOT up to the 6-ft bgs elevation. At this 6-ft level a 160-ft long, 12" diameter steel conduit was placed across the location to allow replacement of the Apache flow line. This conduit was anti-corrosion treated along its entire length.

20-mil woven plastic  
liner installed @ 10'

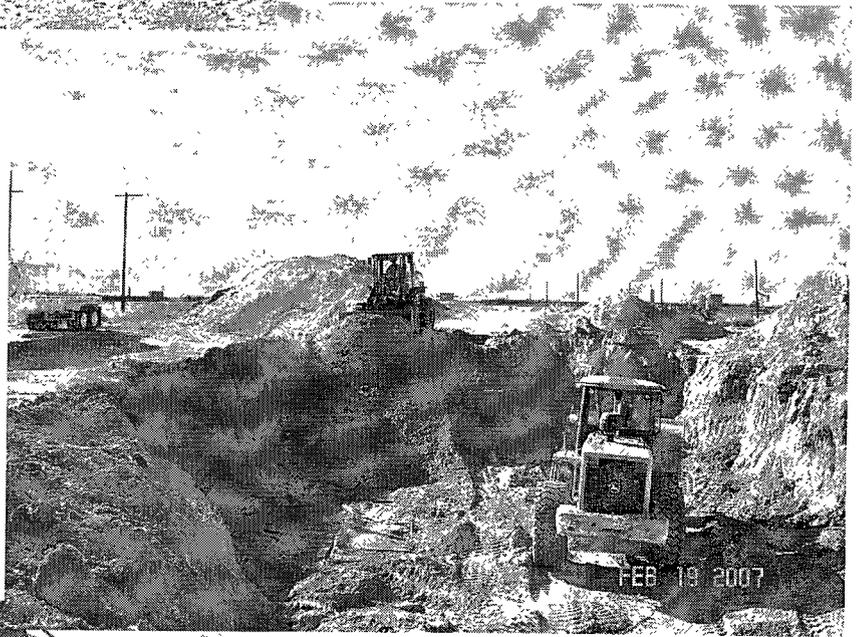
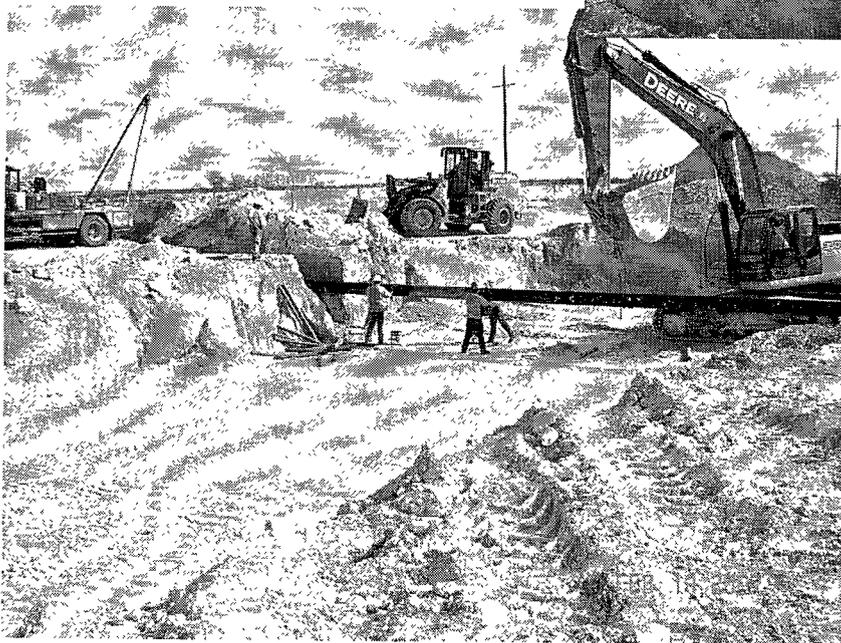
Placing backfill lift  
over plastic liner

Placing 12" conduit  
pipe across road @ 6'

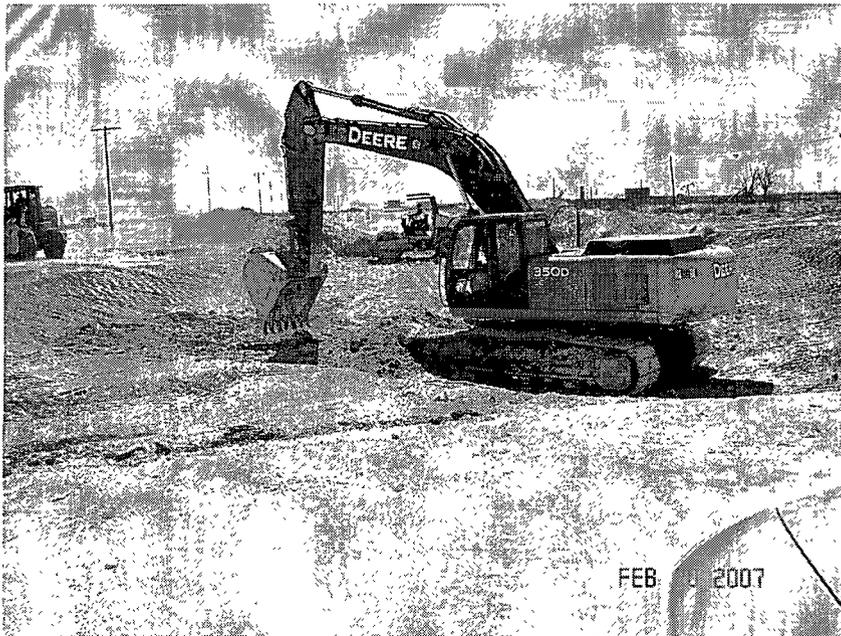
Placing final backfill layer into the right-of-way

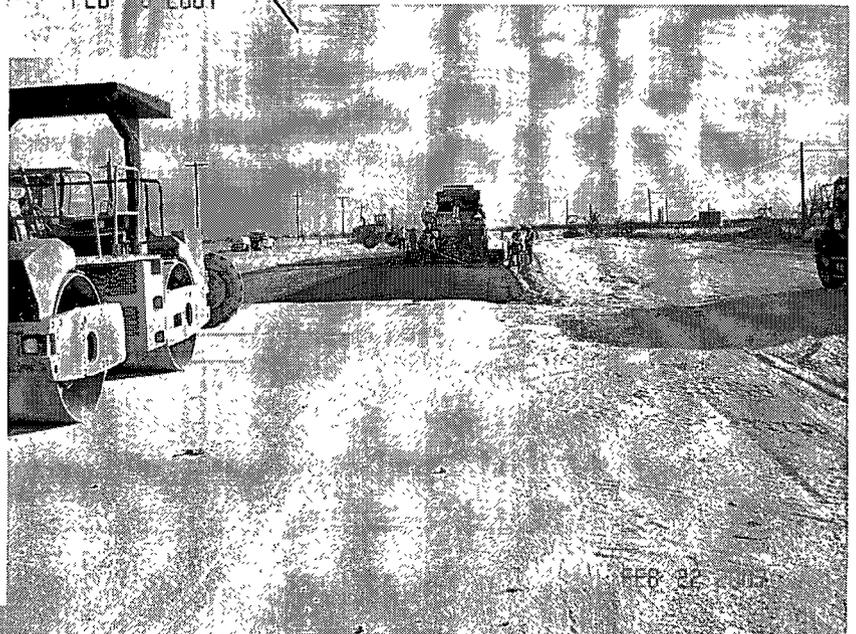
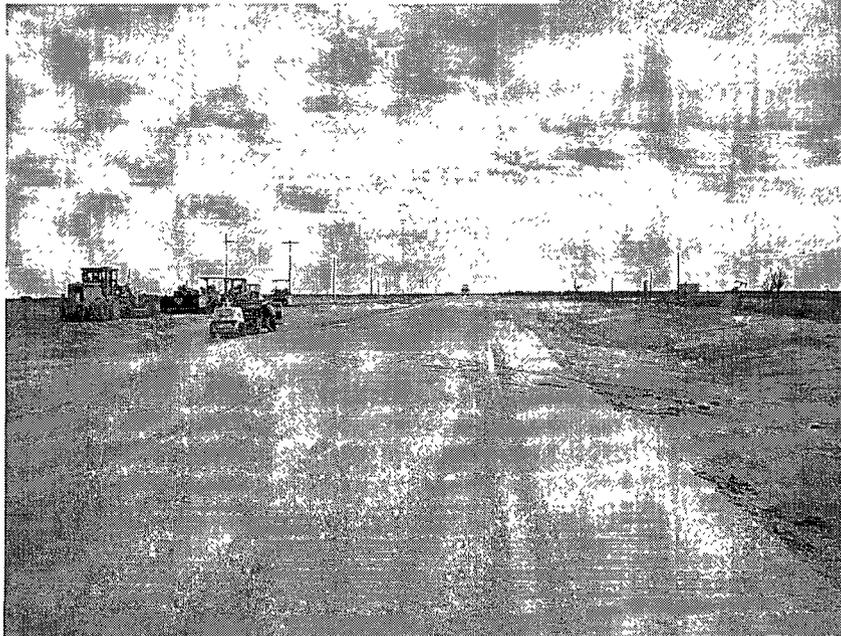
The remainder of the excavation was backfilled, compacted and certified on Tuesday, 2/20/07. At this point Hungry Horse, LLC retreated from the site, allowing Armstrong Construction and NMDOT to complete the final paving phase of the project. 143-ft of pavement and shoulder area was replaced. NM Hwy 8 was re-opened to traffic at 4:55 PM, Thursday, 2/22/07.

Armstrong Construction paving the location

Road completed and open to traffic at 4:55 PM
