LOCKHART A 17 BATTERY C141 CLOSURE REPORT

API 30-025-06638

NMOCD RP #1344

December 06, 2007

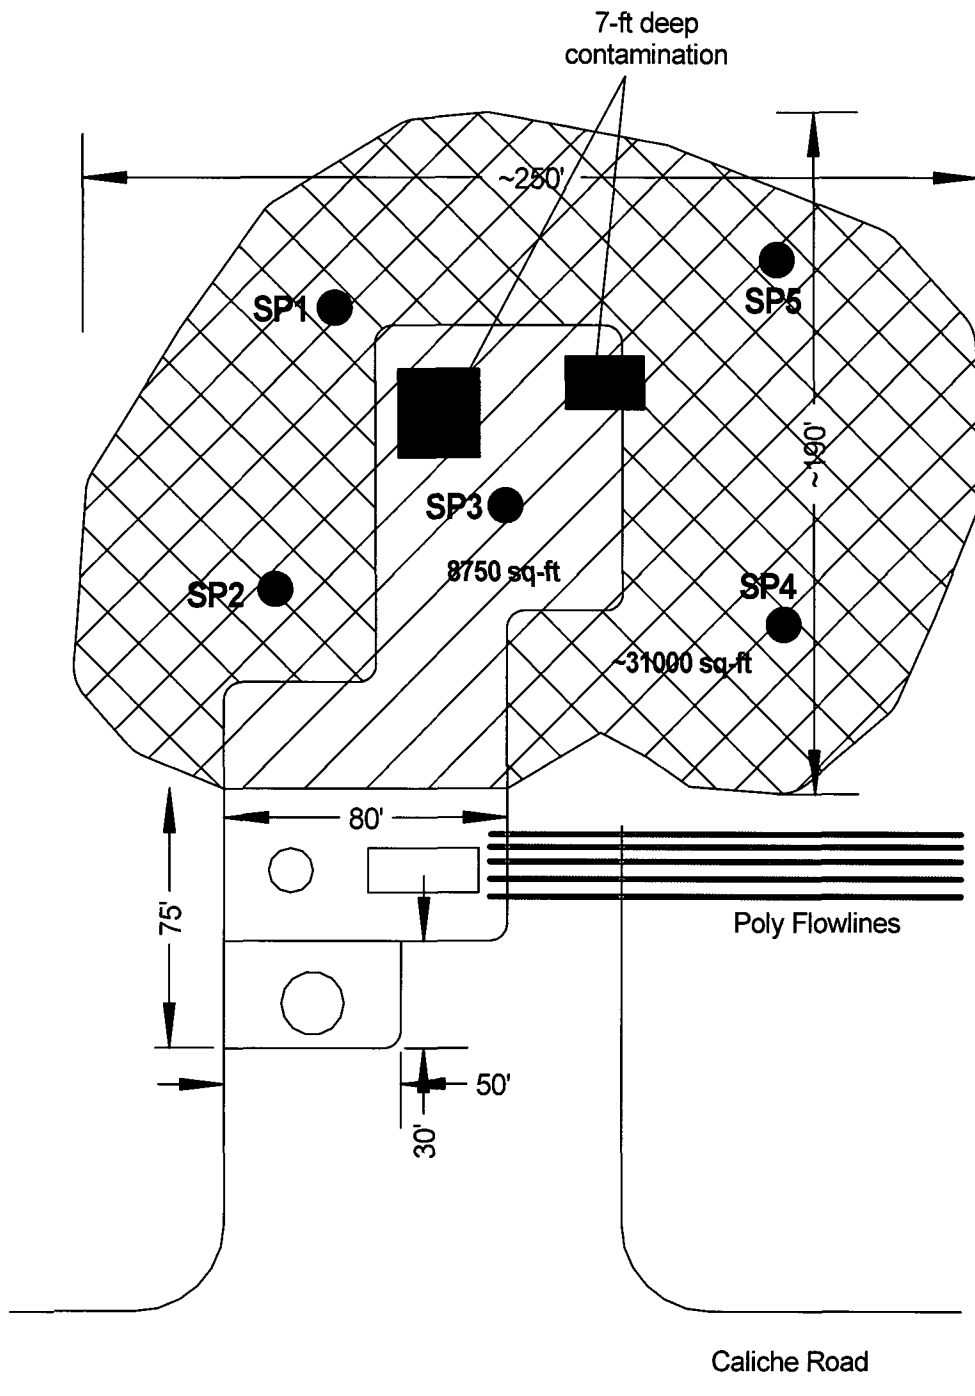
Plate 5

The primary Contaminants of Concern (COCs) were petroleum hydrocarbons and total chlorides resulting from the total release of storage tank and flow line contents. The contaminated area was ~8,750-ft² within the battery containment area and ~31,000-ft² beyond on the N, W and S sides.

Release Impacted Areas

Abandoned
Battery Area

Beyond Battery
Area

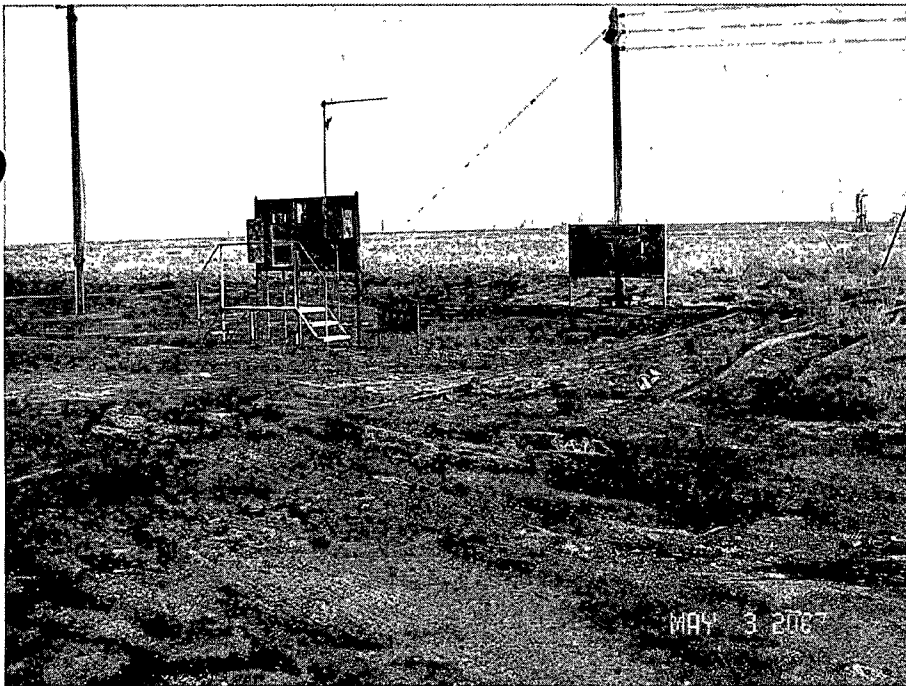
Morning after the fire

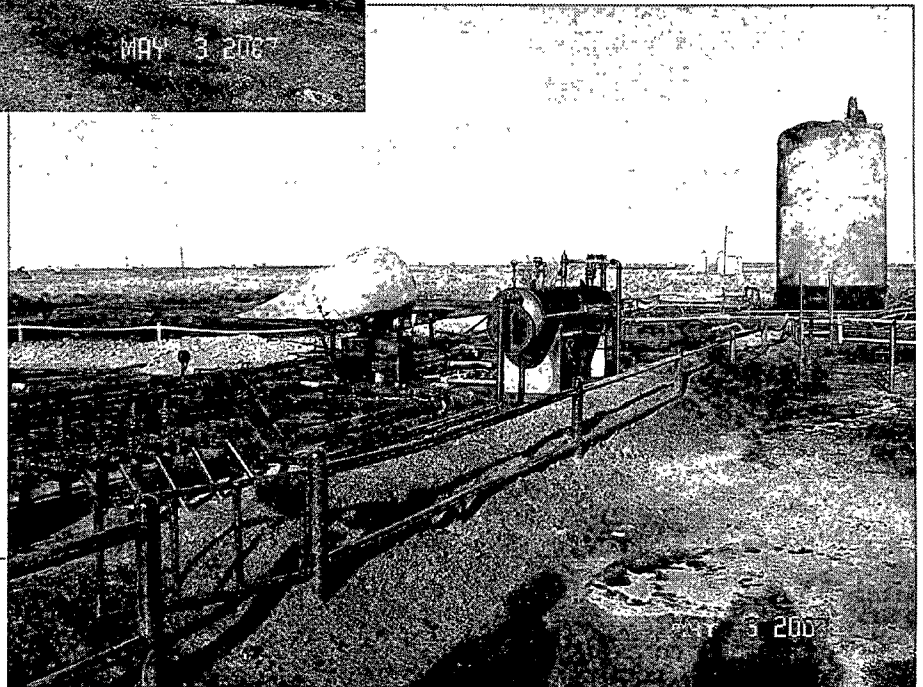
Morning after the fire

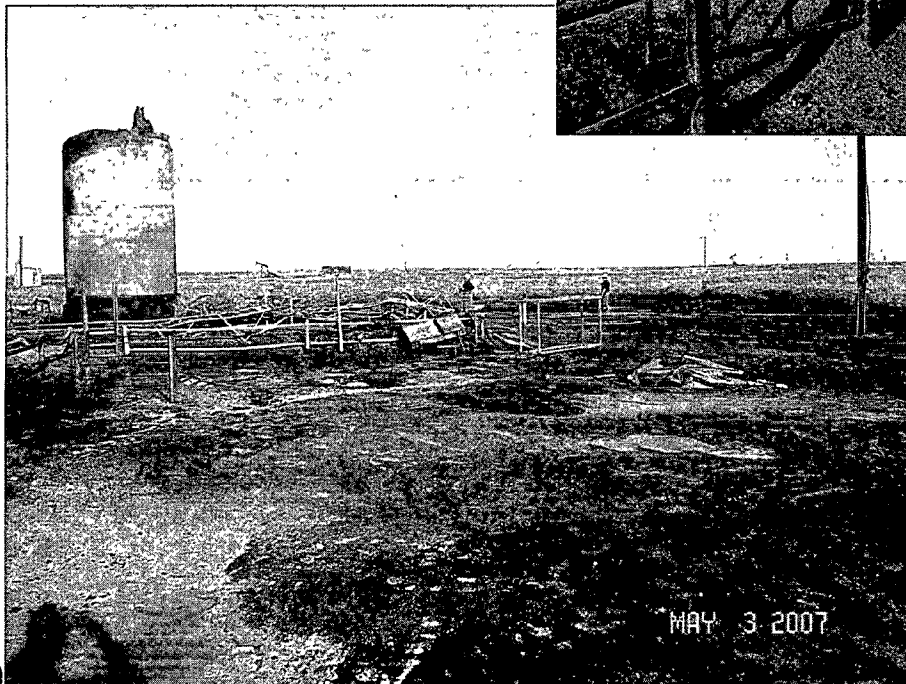
Morning after the fire

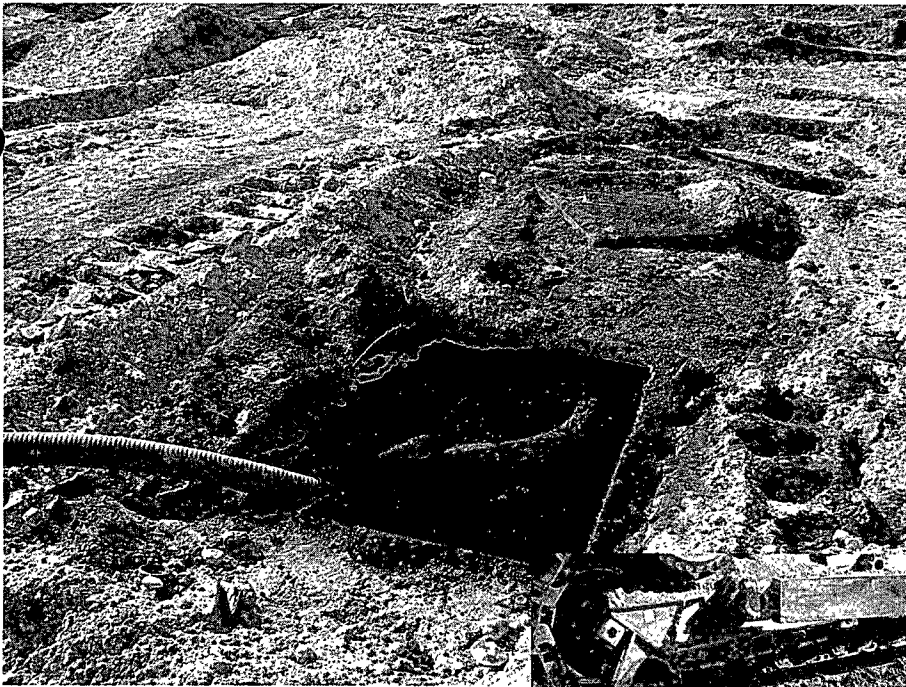
Oil being removed from sump
discovered 9/25/07 AM

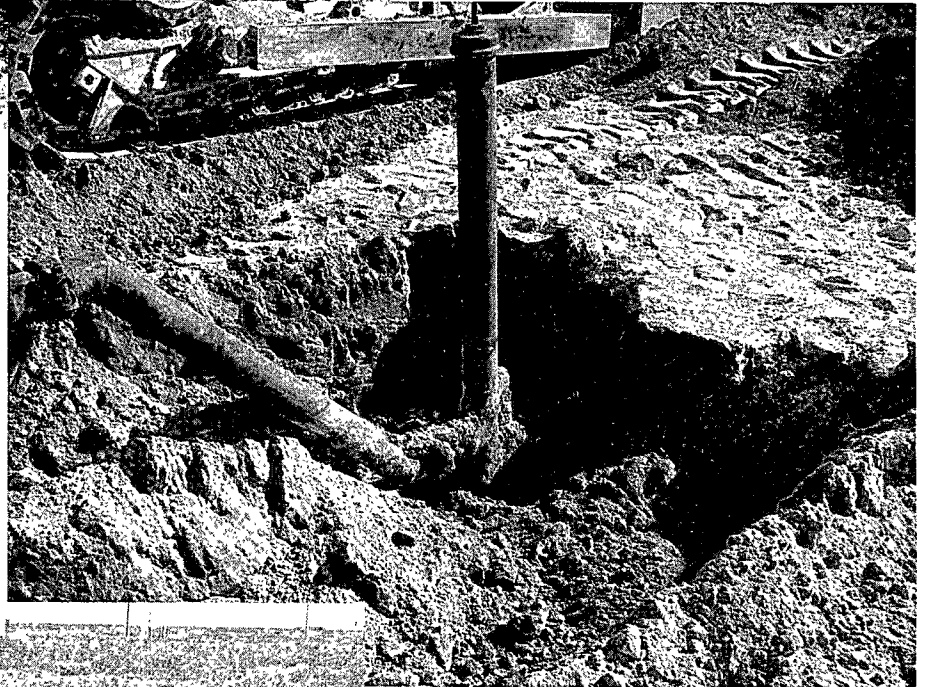
Riser near oil sump exposed.
Pipes were eventually removed.

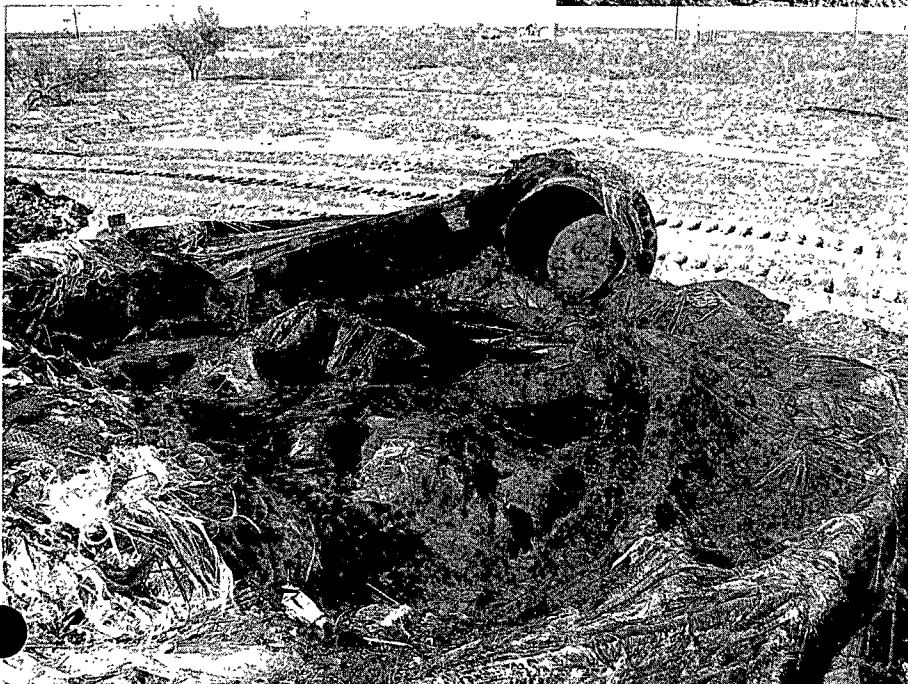
Residual oil in bottom of burned
fiberglass tank. Liquid oil was
removed by vacuum truck.

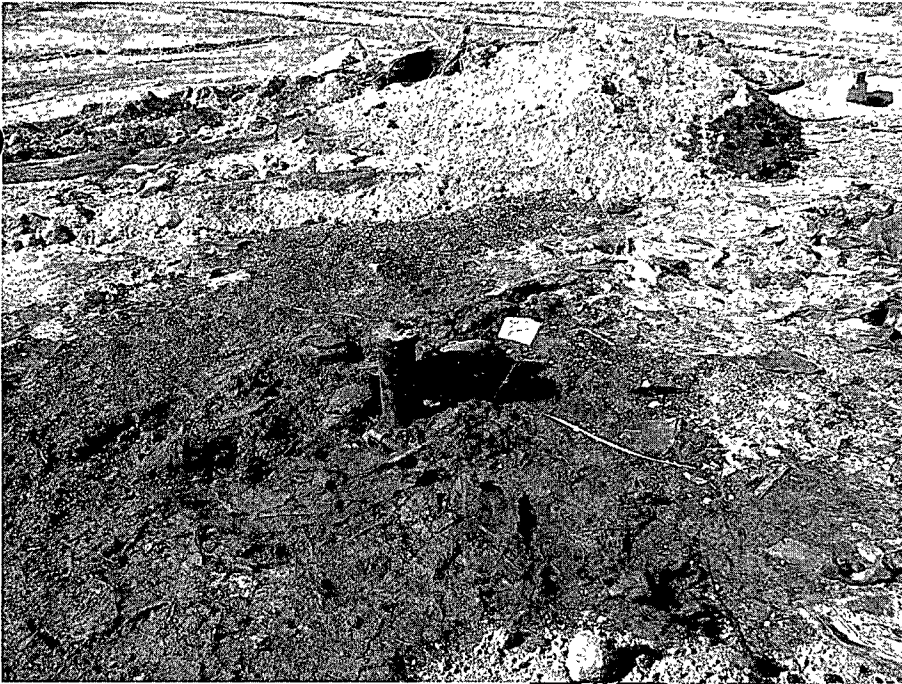
Oil contaminated soil in
previous storage tank area

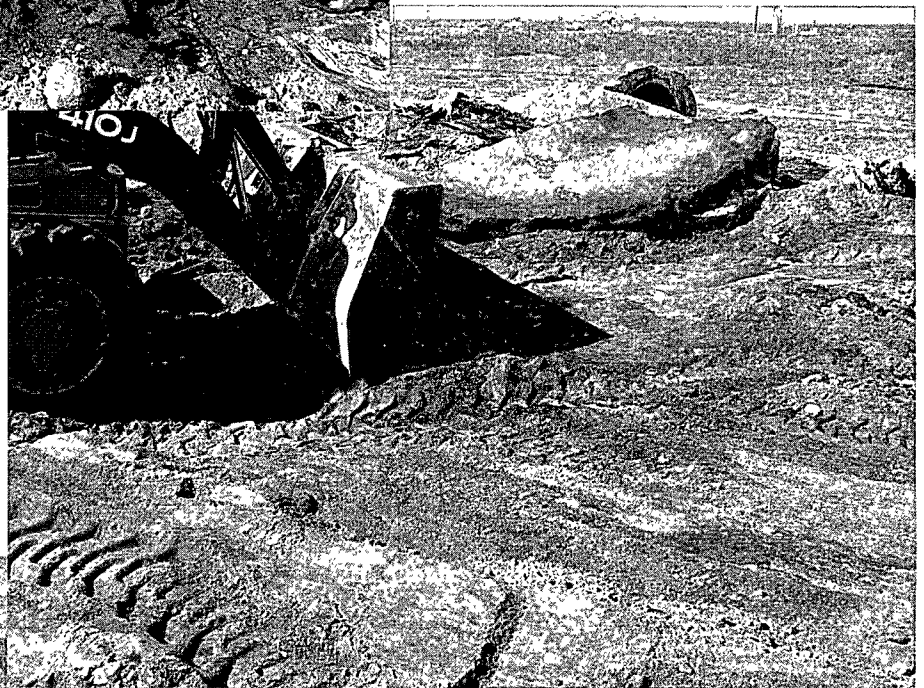
Removing tank pads and
exposing contamination.

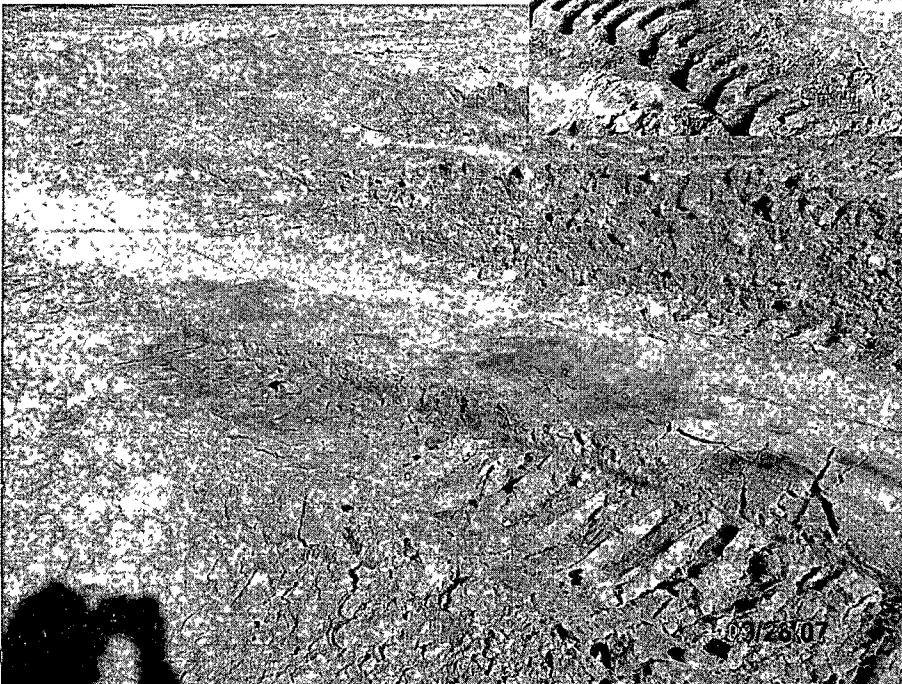
Exposed oil/produced water
contamination

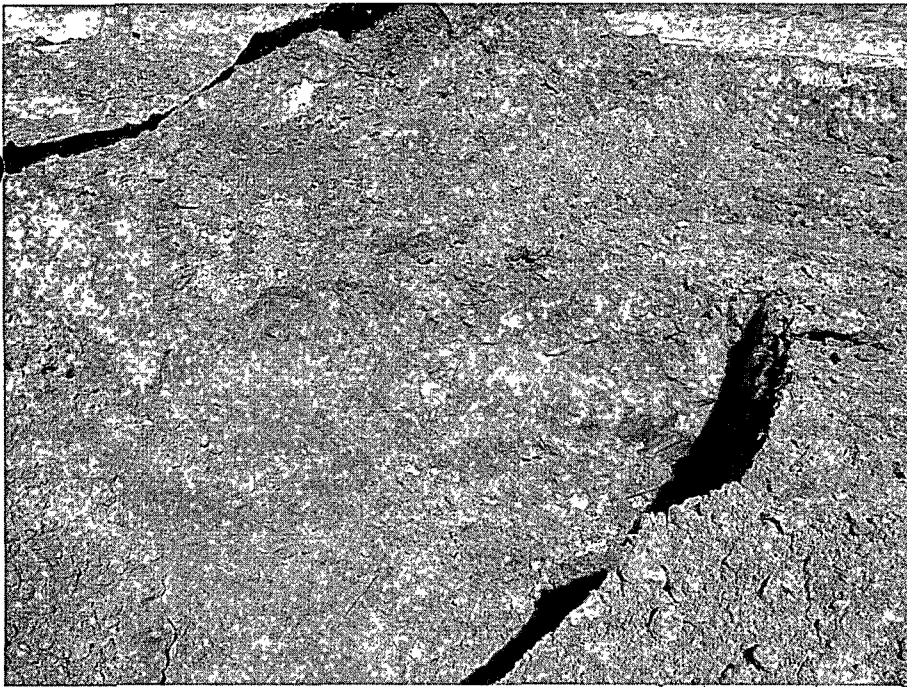
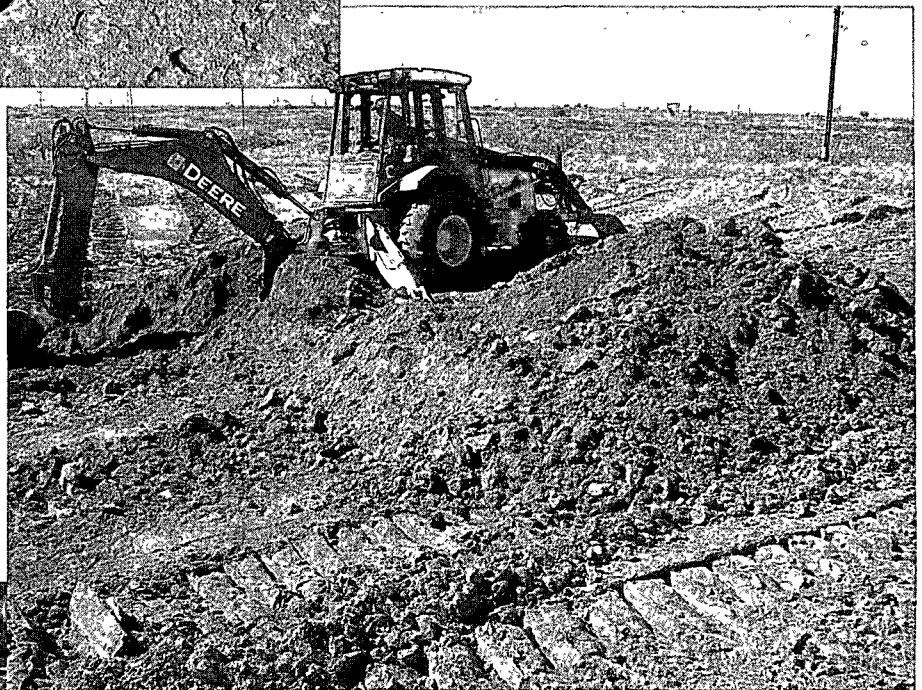
Excavating contaminated area

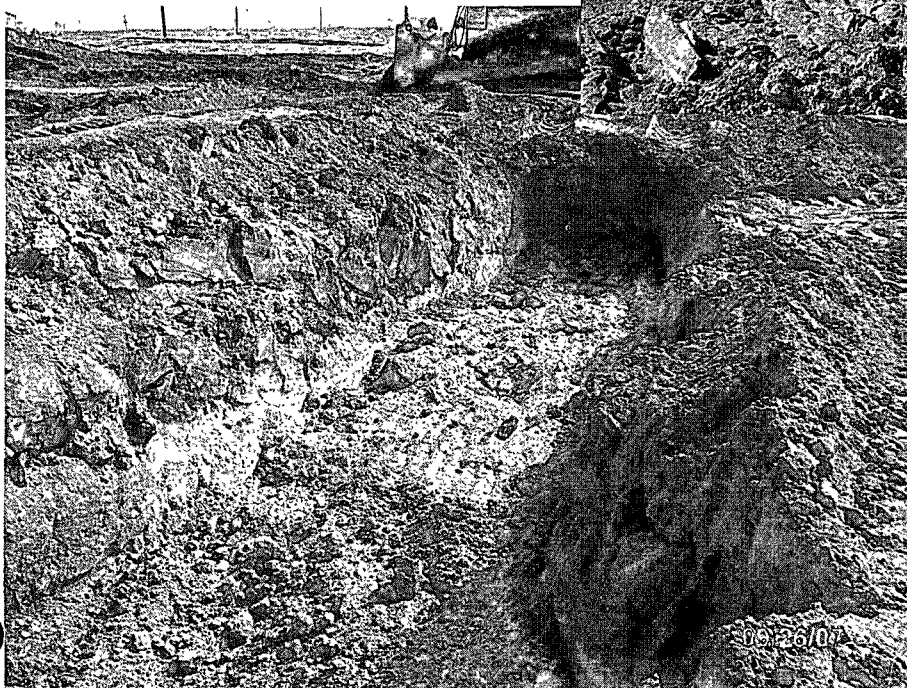
Contamination removed;
bottom was sampled for TPH
and chlorides.

The excavated surface was sampled at the center point and the 4 compass point corners (SP1 – SP5). Analyses of these samples resulted in TPH concentrations in the range 140-ppm to 660-ppm; BTEX concentrations <0.02-ppm; and total chloride concentrations <65-ppm.

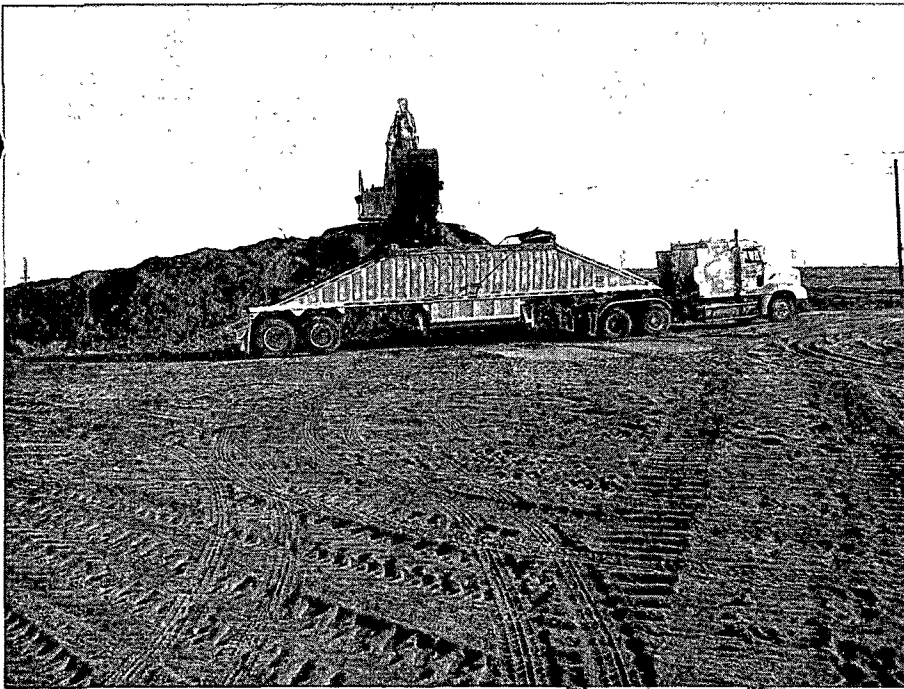
Removing blended stockpile
from location

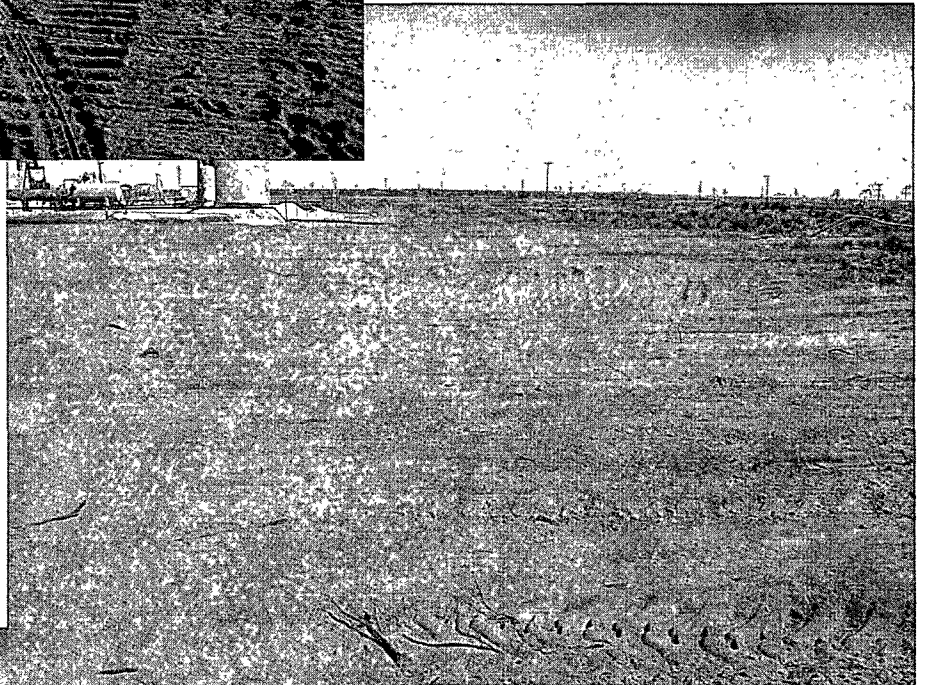
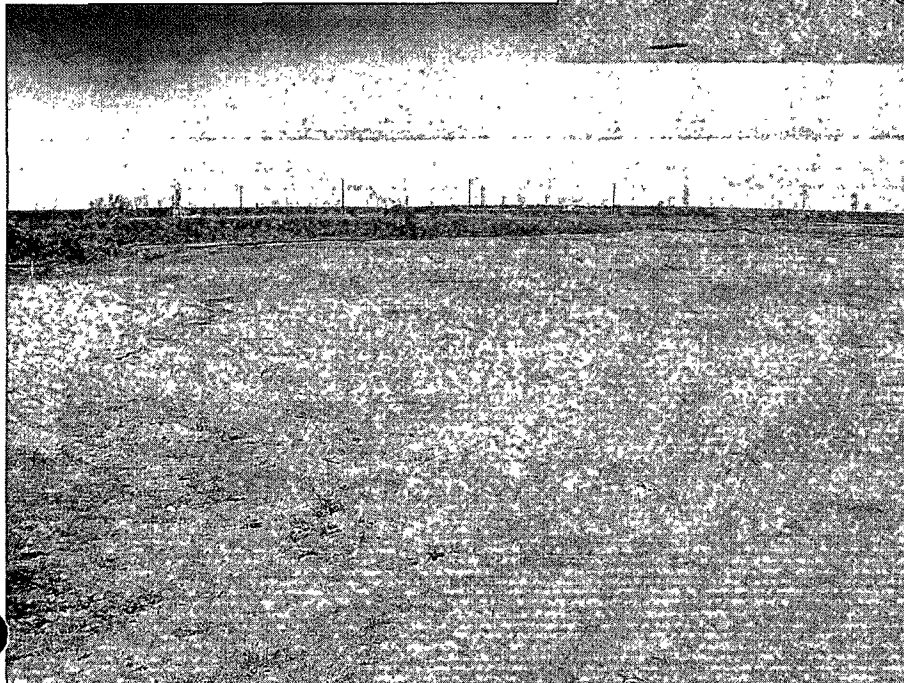
Remediated area after blending
and contouring. Area will be
seeded in April-08.

In preparation for the planned March-08 seeding of the location, the north side of the location (showing higher TPH concentrations) was excavated an additional 2-ft and pushed over on top of the south side. This process was repeated with the south side being pushed to the north side. This twice blended soil was then spread over the entire location to the surrounding contour and grade. A summary table of all soil analyses conducted during this remediation project is displayed below:
