**RICE OPERATING COMPANY
JUNCTION BOX FINAL REPORT**

SWD SYSTEM	JUNCTION	UNIT	SECTION	TOWNSHIP	RANGE	COUNTY	BOX DIMENSIONS - FEET		
							Length	Width	Depth
Vacuum	jct. C-31-3	C	31	17S	35E	Lea	no box--System Abandonment

Vacuum jet. C-31-3

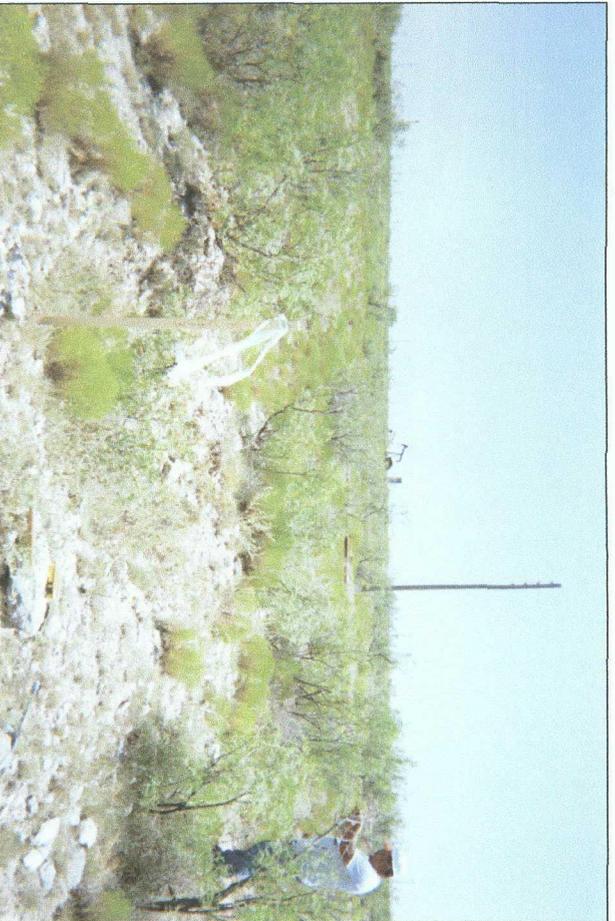
box site prior to excavation; flagged stake in foreground 6/30/2005

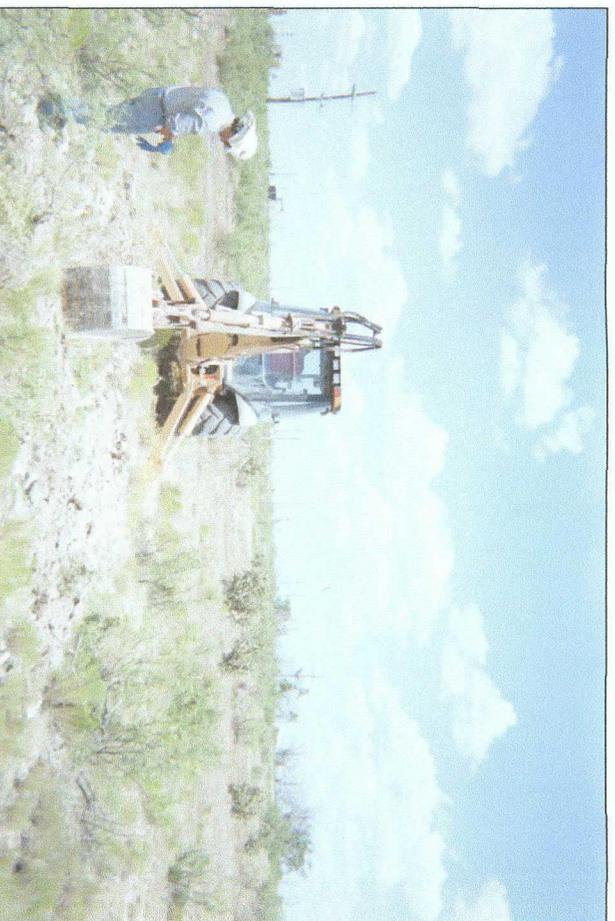
beginning delineation trench 7/19/2005

General Description of Remedial Action: This junction box was addressed as part of the Vacuum SWD System Abandonment. After the box was removed, a delineation trench was made at the junction using a backhoe to collect soil samples every vertical foot of depth.

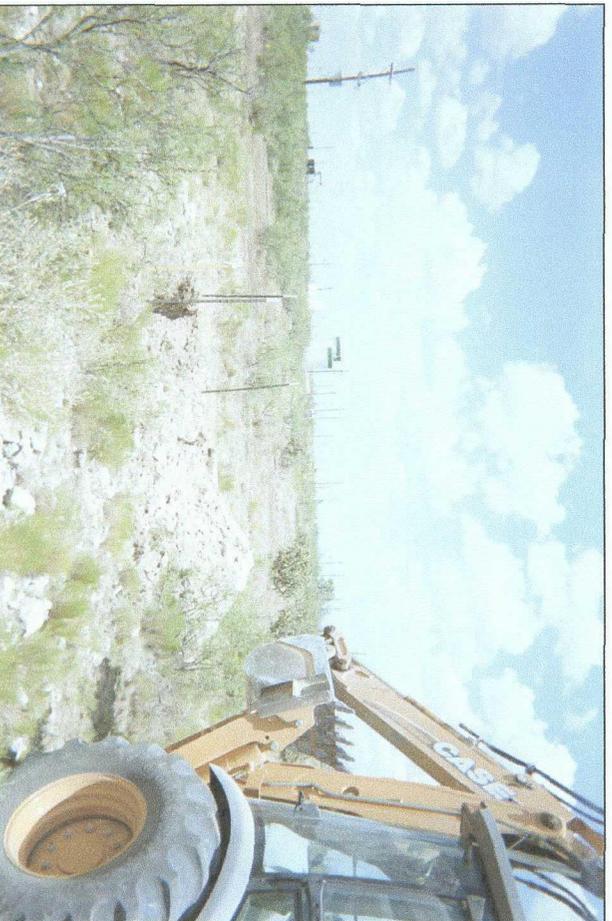
delineation trench prior to backfill

Field tests for chloride and VOCs were conducted on each sample and both constituents were only detected in very low concentrations. A grab sample from the bottom of the trench (7 ft) was sent to a commercial laboratory for confirmation of the field tests. TPH was not present within the lab's detection limits, meeting OCD guidelines. The excavated soil was blended on site and then backfilled into the trench and contoured to the surrounding terrain. On 3/21/2006 the disturbed surface was seeded with a blend of native vegetation and is expected to return to productive capacity at a normal rate.

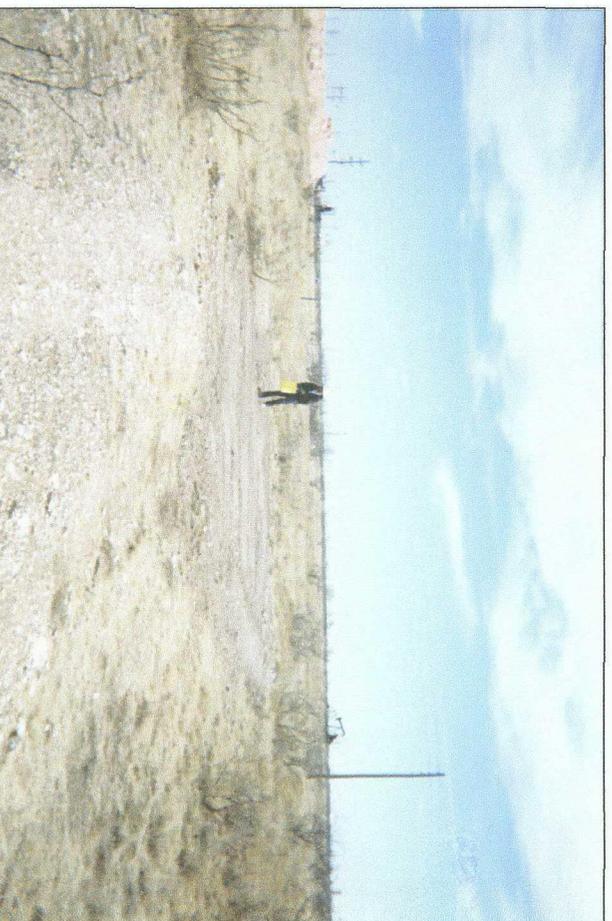
seeding disturbed area at backfilled site 3/21/2006
