# Final Report

RICE OPERATING COMPANY  
JUNCTION BOX FINAL REPORT

## Vacuum BP American Prod. St. 'A' EOL

Unit 'M', Section 22, T17S, R35E

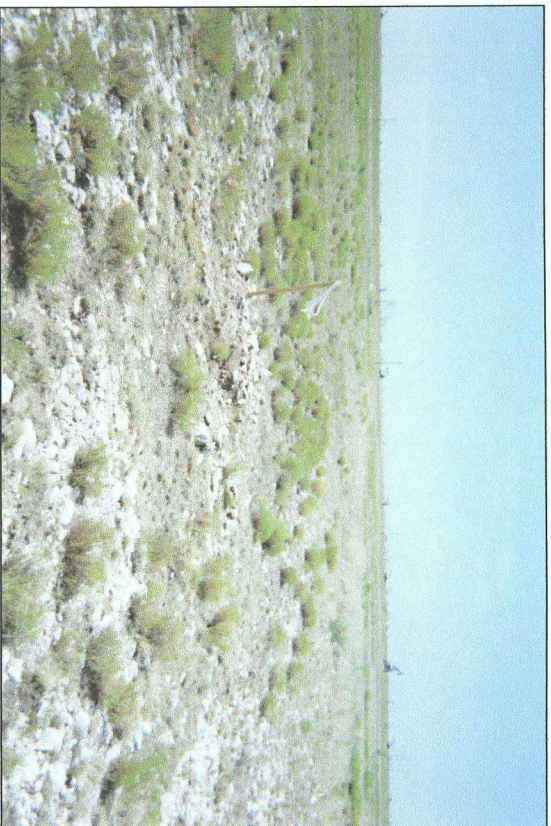
former junction box site flagged before excavation 7/11/2005

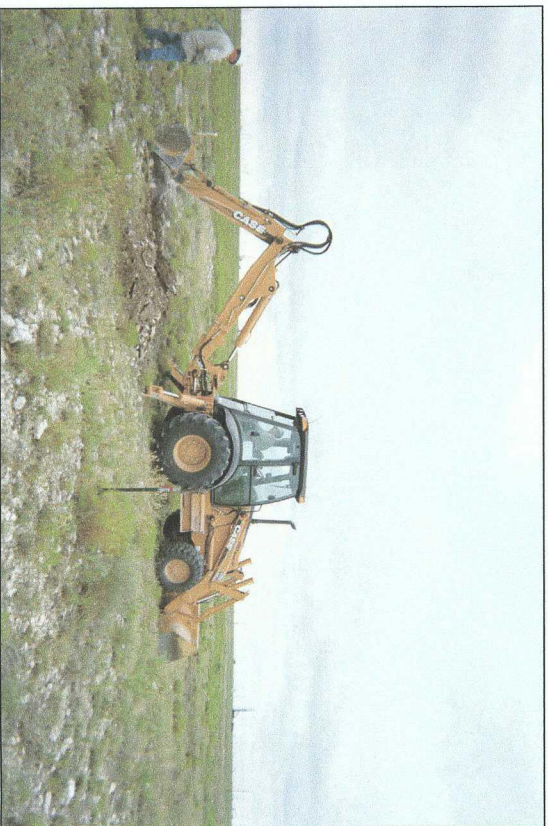
delineation trench at former box site 7/29/2005

part of the Vacuum SWD System Abandonment. After the box was removed, a backhoe was used to produce a delineation trench at the former junction as soil samples were collected at regular depth intervals to 7 ft BGS. Chloride field tests were conducted on each of the samples and yielded very low concentrations. PID screenings were also conducted on the samples and these concentrations were also very low. Soil samples did not exhibit any physical indications of adverse impact. The excavated soil was blended on site and then backfilled into the trench and leveled to the surrounding terrain. The disturbed surface was seeded with a blend of native vegetation and is expected to return to productive capacity at a normal rate. Since the Vacuum SWD System has been abandoned, a junction box is no longer required here.

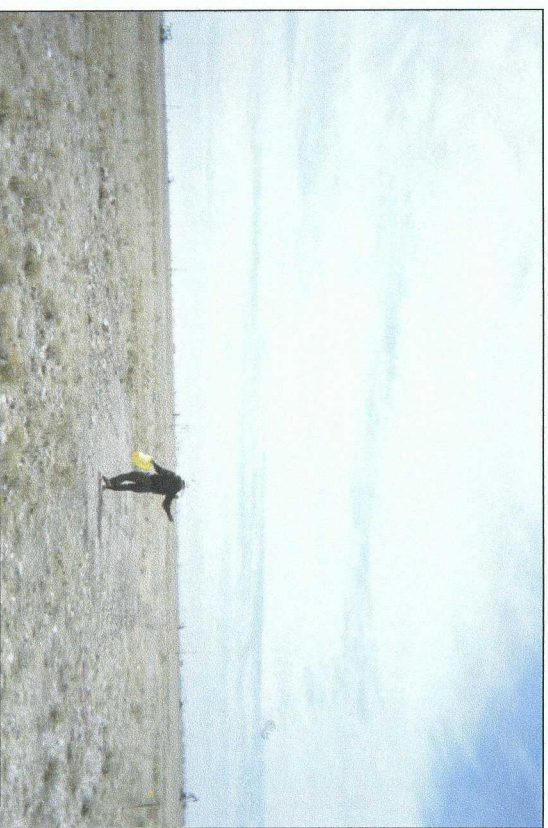
seeding disturbed area after backfilling trench 3/21/2006
