RICE OPERATING COMPANY
JUNCTION BOX **DISCLOSURE*** REPORT

SWD SYSTEM	JUNCTION	UNIT	SECTION	TOWNSHIP	RANGE	COUNTY	BOX DIMENSIONS - FEET		
BD	jct. P-30	P	30	21S	37E	Lea	Length	Width	Depth
							moved 30 ft south

BD jct. P-30

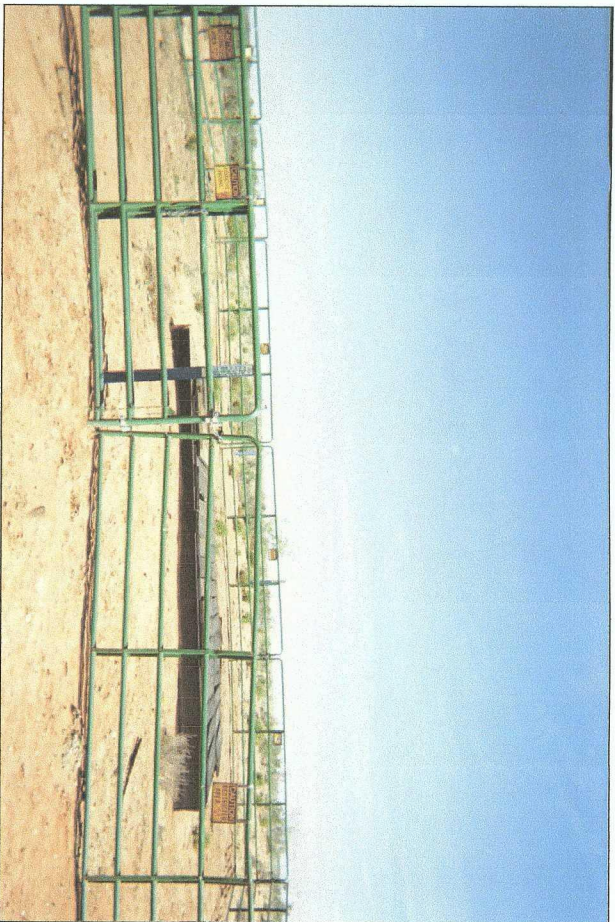
4/30/2003

undisturbed junction box

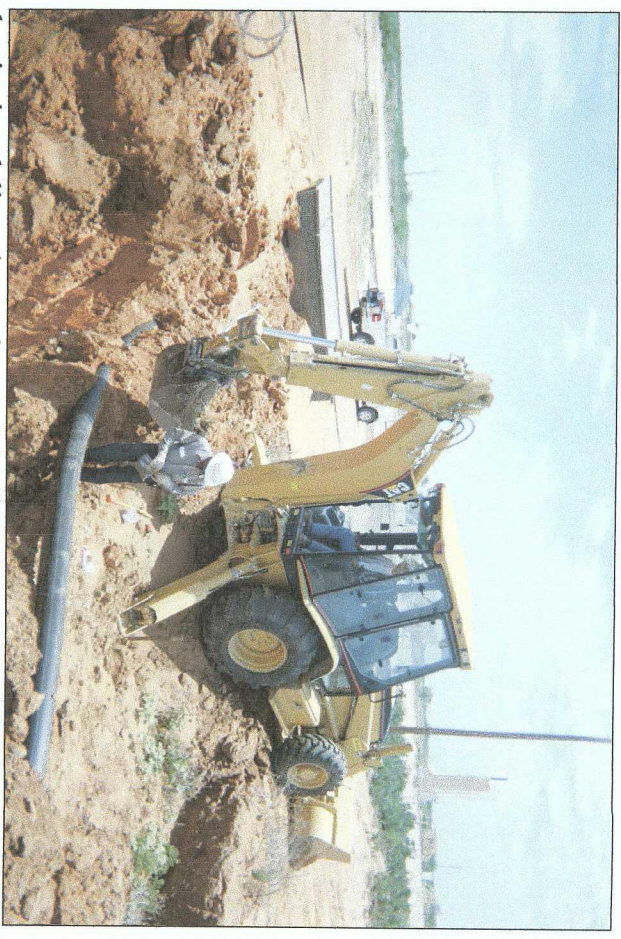
June 2006

beginning delineation at former box site (new box also shown)

This junction box was addressed with the pipeline replacement/upgrade program. This old junction box was replaced with a new, watertight box 30 ft south of the former. After the lumber was removed from the old box, the site was delineated using a backhoe while soil samples were collected at regular intervals creating a 30 x 30 x 12-ft-deep excavation. Chloride field tests and PID detections were measured on each soil sample. Trends of decline were not established with the chloride concentrations and PID detections yielded elevated concentrations, especially at the bottom of the excavation. Composite samples were collected for laboratory analysis and the excavated soil was blended on site and then backfilled to 6 ft BGS. At 6 ft, a clay barrier was installed and the remaining excavated soil was backfilled on top and contoured to the surrounding surface to divert rainwater. An identification plate was placed on the surface to mark the location of the former jct. box for future environmental considerations and the presence of clay below. NMOCD was notified of potential groundwater impact at this site on 10/13/2006.

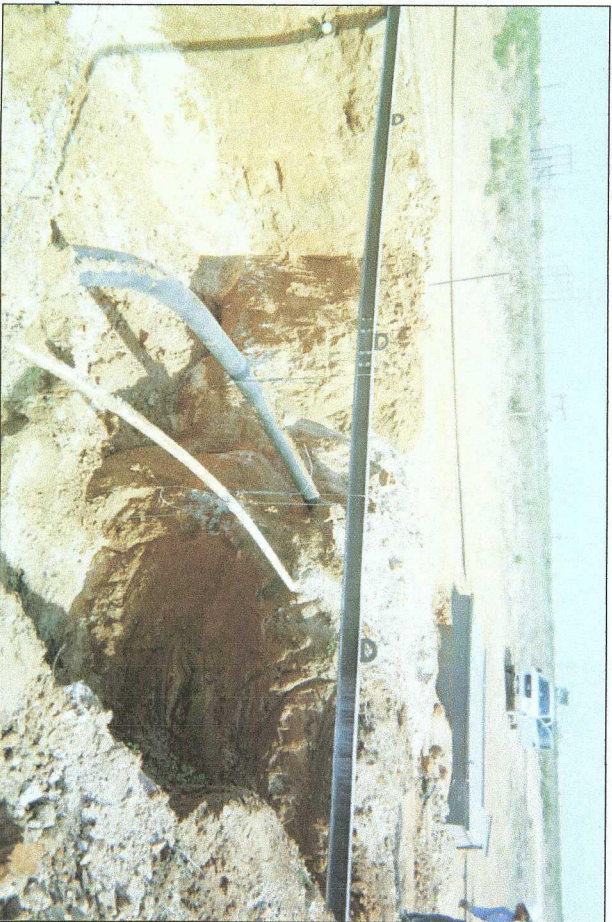
30 x 30 x 12-ft-deep excavation

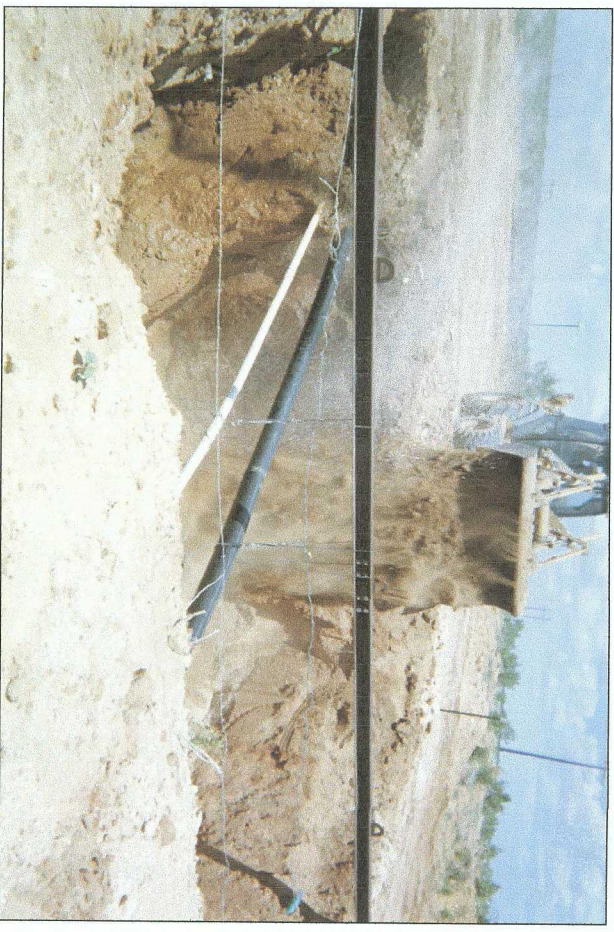
backfilling excavation

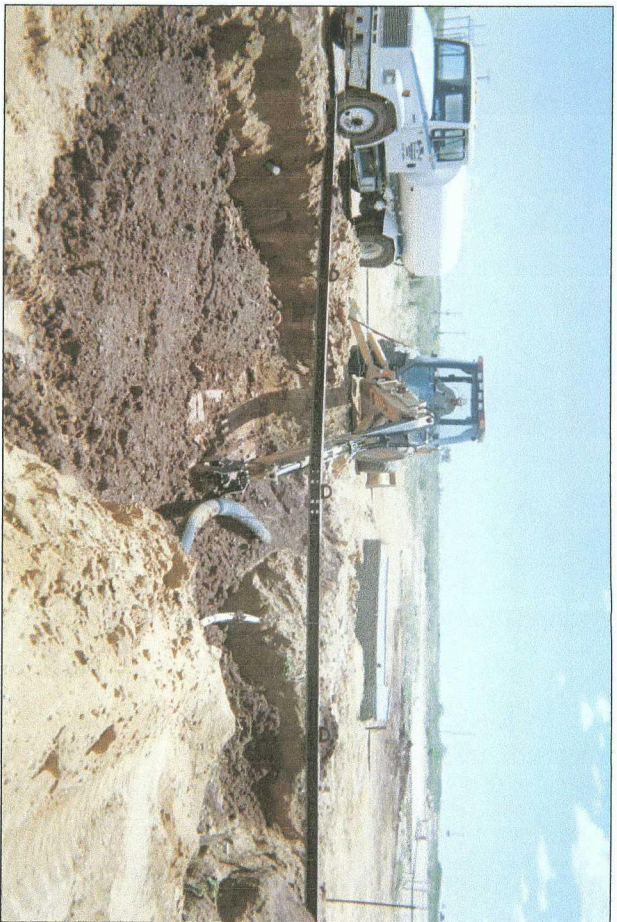
installing clay at 6 ft

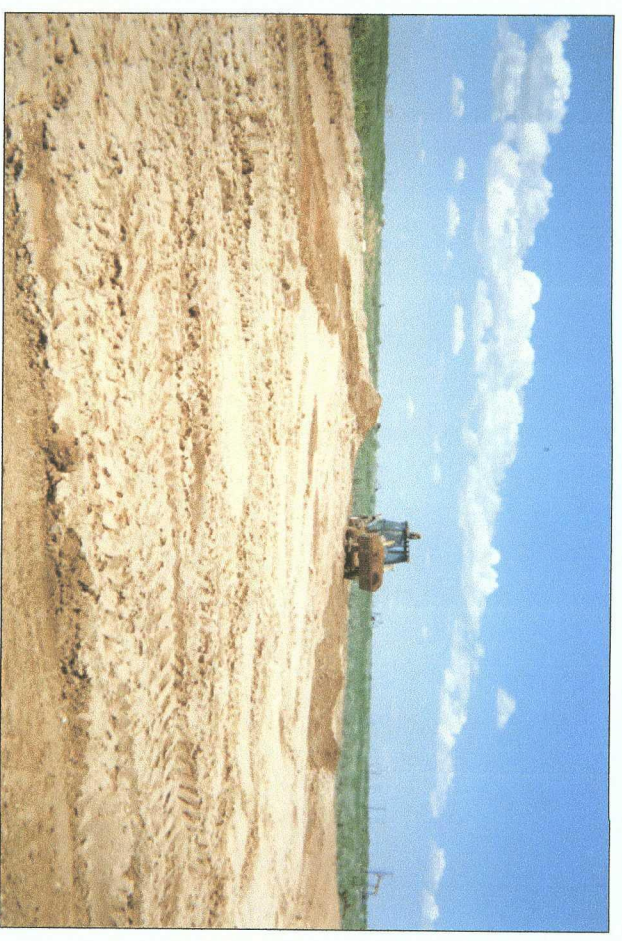
8/24/2006

completing backfill

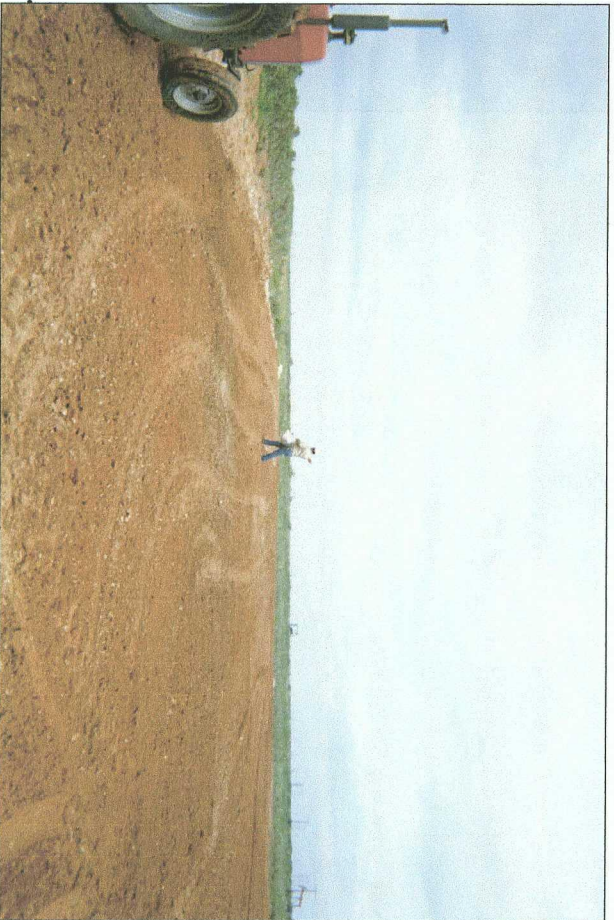
9/7/2006

seeding disturbed surface

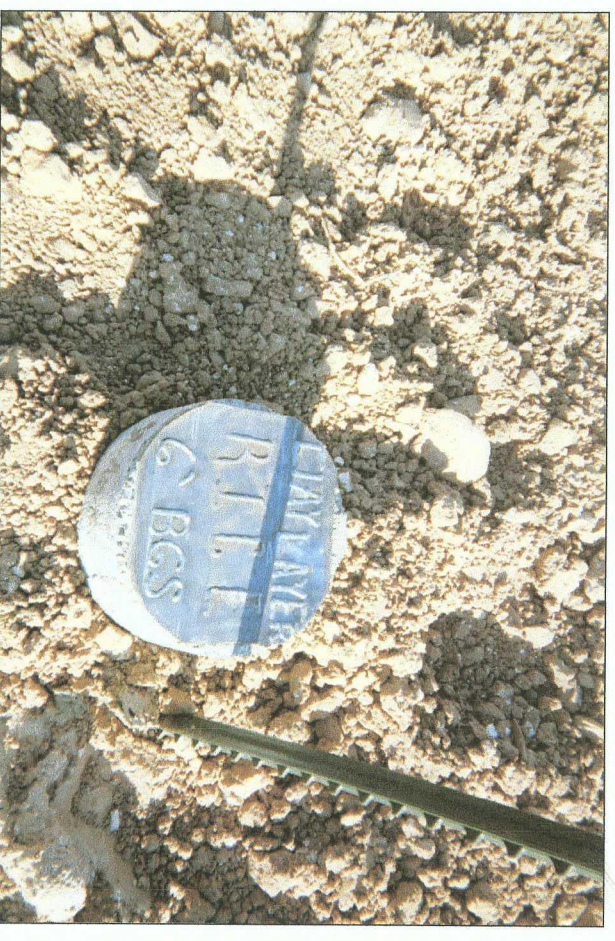
clay identification plate
