**GW - 5**

# **MONITORING REPORTS**

Table 1  
MW-03 LNAPL Recovery Summary  
Targa Midstream Services, L.P., Eunice Plant

This message is submitted to the New Mexico Oil Conservation Division (OCD) environmental bureau on behalf of Targa Midstream Services L.P. (Targa) by Larson & Associates, Inc. (LAI) to provide an update to determine the source for light non-aqueous phase liquid (condensate) discovered in monitoring wells MW-3 and MW-22 near the southeast corner of the Eunice Gas Plant (Facility). On October 13, 2010, Facility personnel discovered a leaking union on a 2-inch scrubber dump line after exposing lines, fittings and valves at a junction about 60 feet north of MW-22. The line was buried about 4 feet below ground and soil surrounding the union was stained and wet with hydrocarbons consistent with condensate. The line was isolated to control the release. Facility personnel will excavate additional soil from the area to make necessary repairs and place contaminated soil on plastic until disposal is arranged. A plan will be submitted to the OCD in Santa Fe to delineate the vertical and lateral extent of the release. Product recovery in wells MW-3 and MW-22 will continu

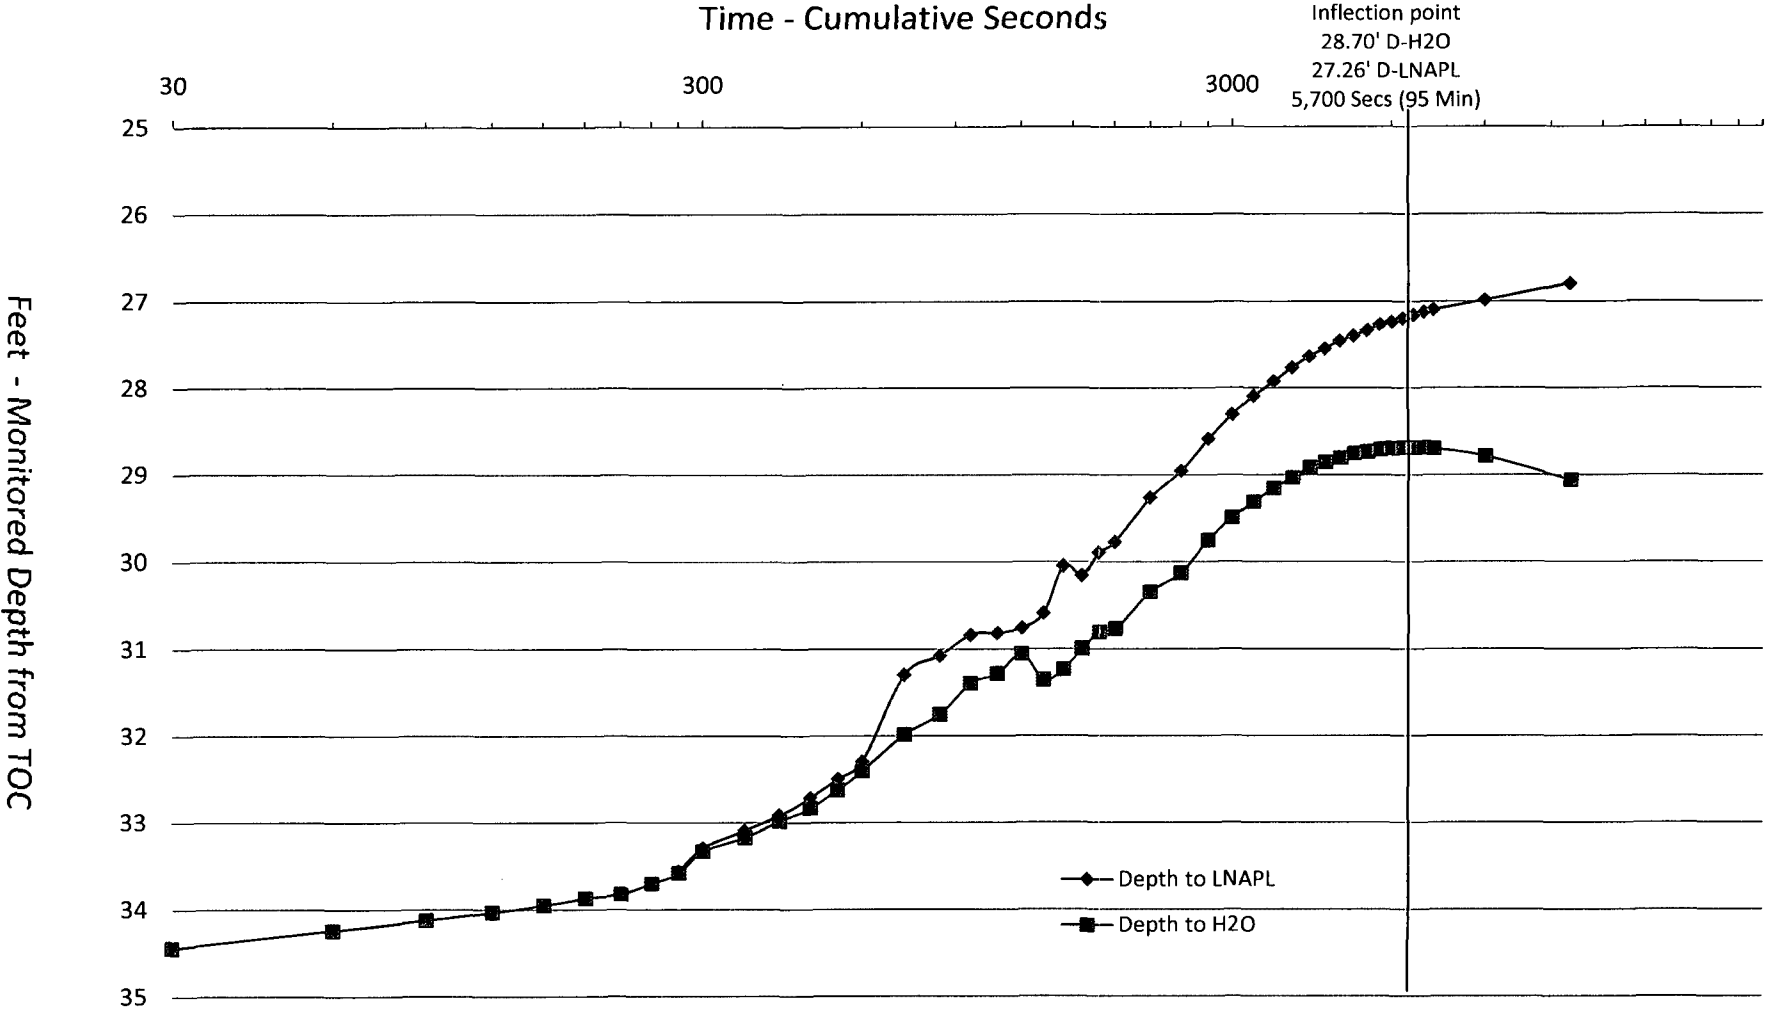
MW-03 LNAPL Recovery Test  
October 21, 2009

Obs. No.	Time Sec	Depth to LNAPL	Depth to H <sub>2</sub> O
1	30		34.44
2	60		34.24
3	90		34.12
4	120		34.03
5	150		33.95
6	180		33.87
7	210		33.82
8	240		33.70
9	270	33.56	33.58
10	300	33.29	33.33
11	360	33.09	33.17
12	420	32.91	32.98
13	480	32.71	32.83
14	540	32.49	32.62
15	600	32.29	32.40
16	720	31.29	31.98
17	840	31.07	31.75
18	960	30.83	31.39
19	1080	30.81	31.28
20	1200	30.75	31.05
21	1320	30.58	31.35
22	1440	30.04	31.23
23	1560	30.15	30.99
24	1680	29.89	30.80
25	1800	29.77	30.76
26	2100	29.26	30.34
27	2400	28.95	30.12
28	2700	28.58	29.75
29	3000	28.30	29.49
30	3300	28.09	29.31
31	3600	27.92	29.15
32	3900	27.76	29.03
33	4200	27.63	28.91
34	4500	27.54	28.85
35	4800	27.45	28.80
36	5100	27.39	28.75
37	5400	27.33	28.73
38	5700	27.26	28.70
39	6000	27.23	28.69
40	6300	27.19	28.68
41	6600	27.15	28.68
42	6900	27.12	28.68
43	7200	27.09	28.69
44	9000	26.98	28.78
45	13020	26.79	29.06

Static D-LNAPL	Static D-H2O	Corrected D-GW
26.22	31.28	27.64
