Release Notification and Corrective Action

STATE O #12 WELL C141 CLOSURE REPORT

API 30-025-05368

NMOCD RP #1602

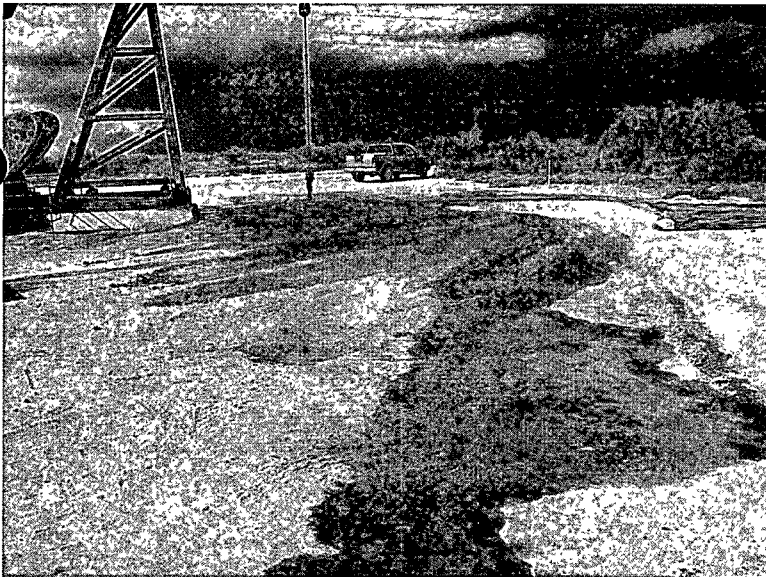
Day of release – 9-27-07 –
around 3:40 PM – SE
corner of pad

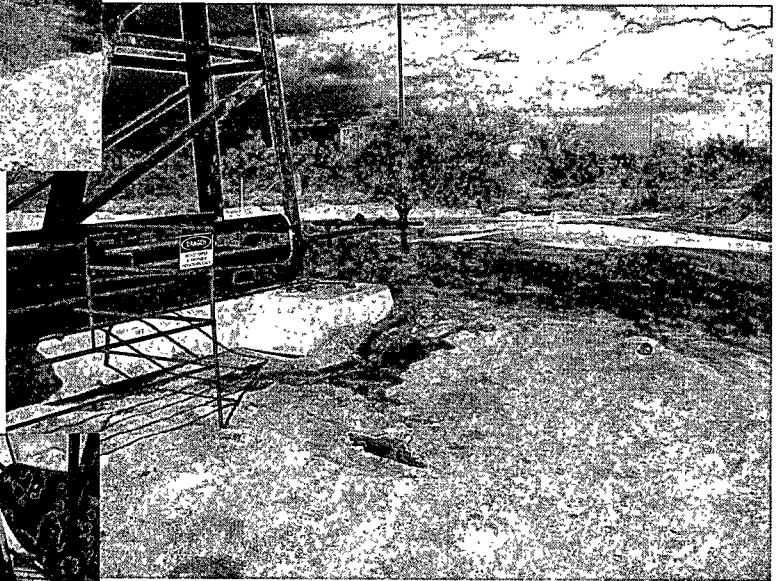
Day of release – 9-27-07 –
around 3:40 PM – south
side of pad

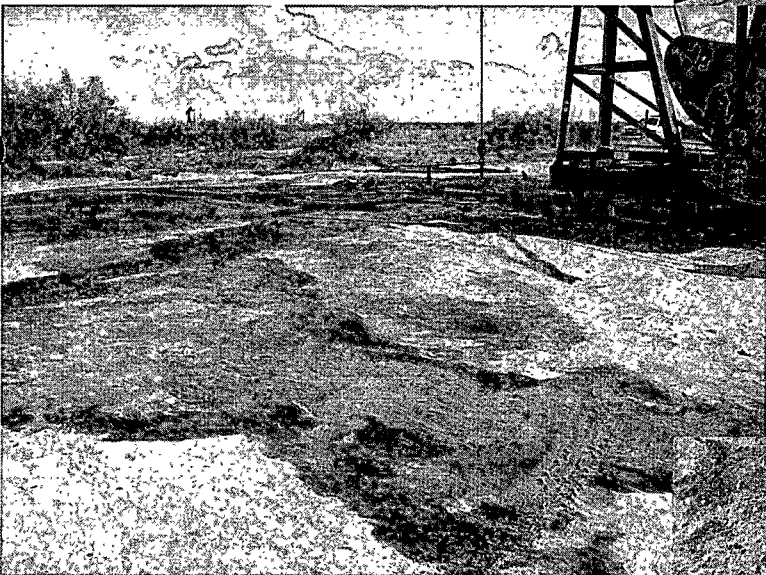
Day of release – 9-27-07 – around
3:40 PM – north side of pad

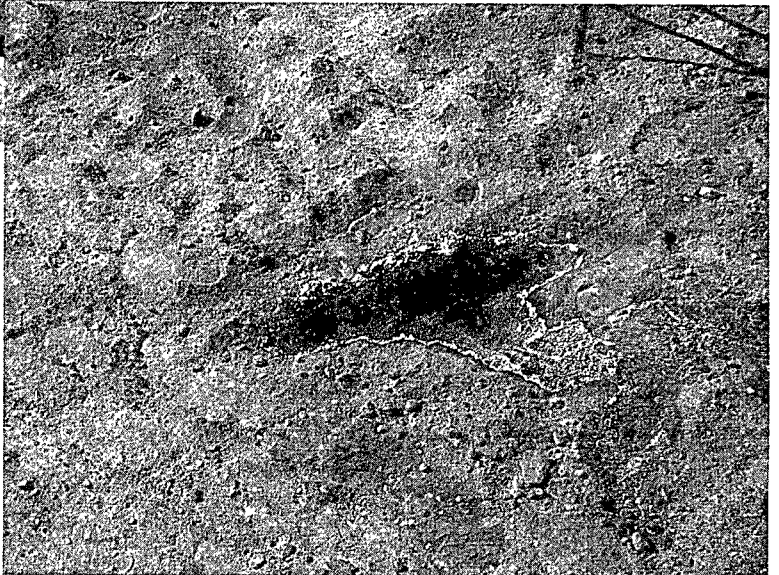
Note salt crystallization
from release

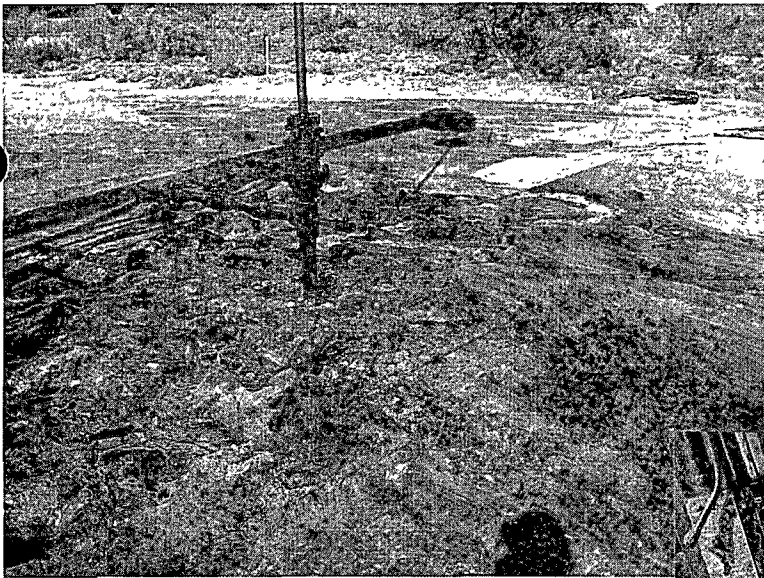
Stuffing box blew out spraying oil into air and onto location.

Day of release – 9-27-07 –
around 3:40 PM – immediate to
well head.

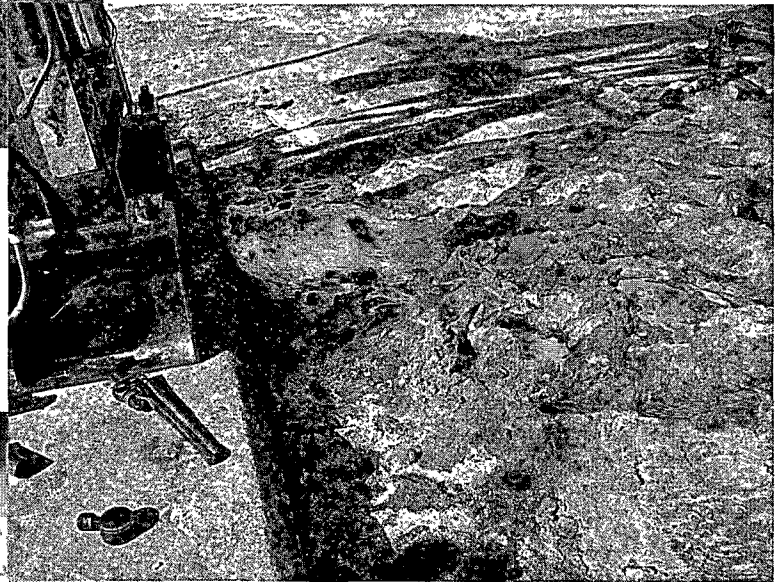
Day of release – 9-27-07 – around
3:40 PM – immediate to well head.

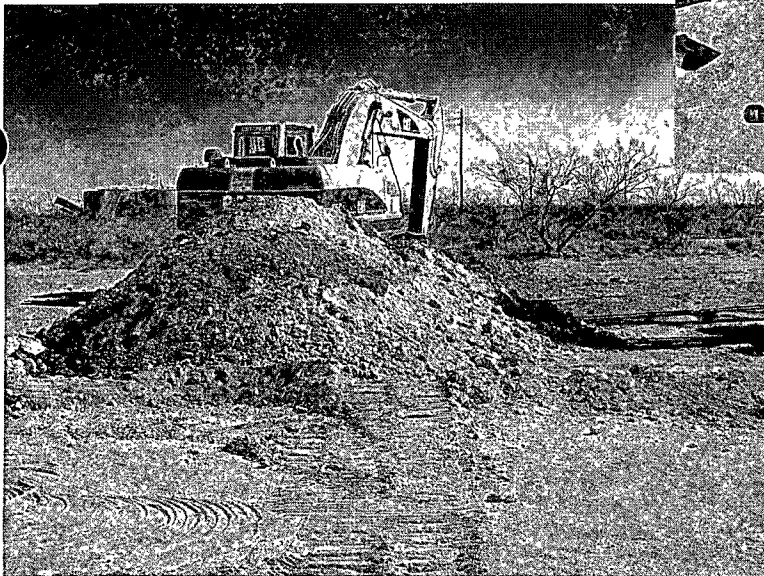
2-6-08 – commencing
excavation of north side.

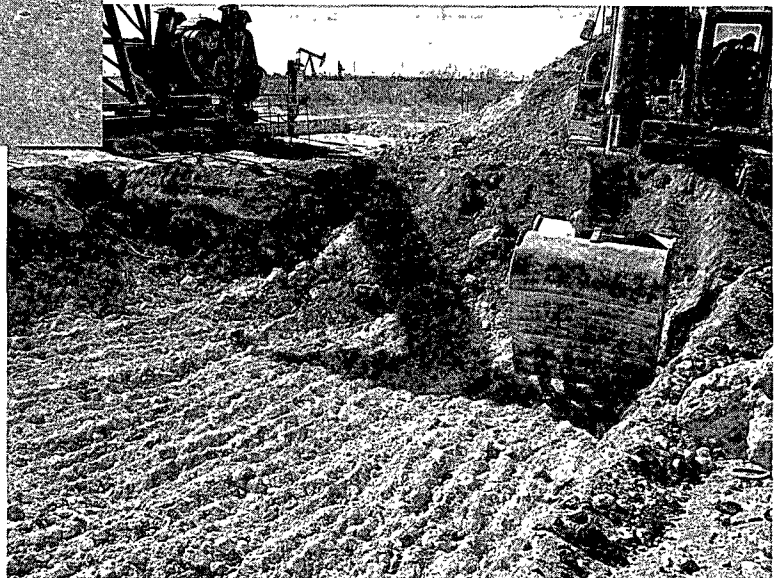
2-6-08 – continuing
excavation of north side.

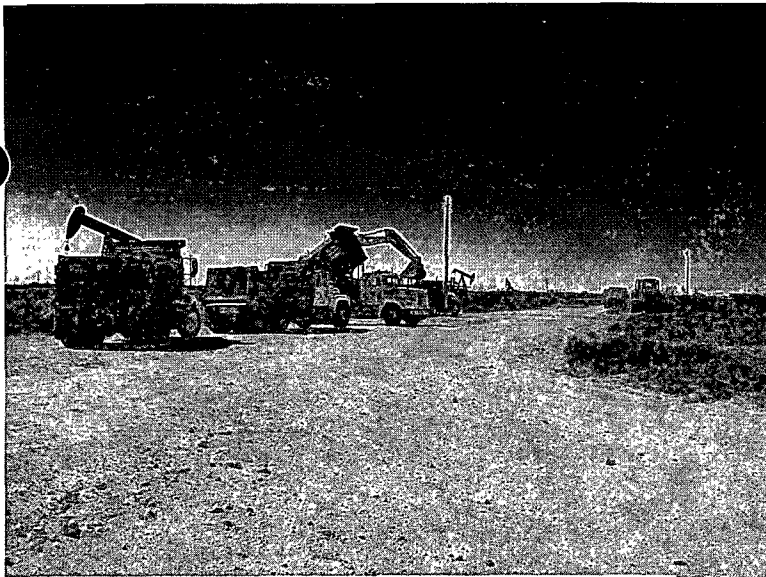
2-7-08 – Hauling contaminated soil to J-Dan LF west of Lovington.

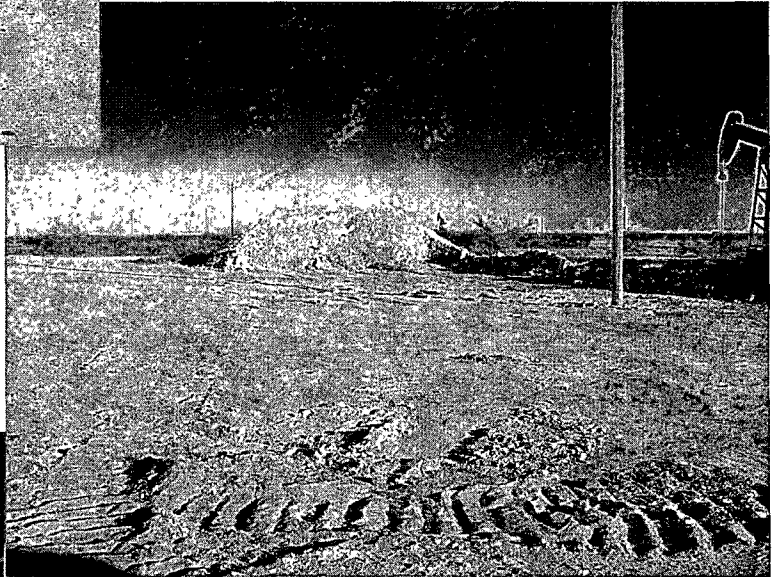
2-7-08 – Stockpiling clean caliche obtained from Danny Watson at the Landfarm location

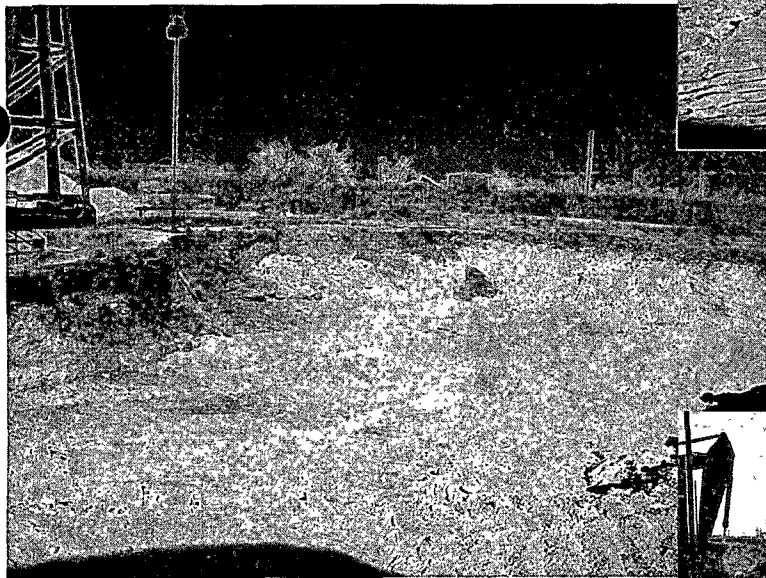
2-8-08 - South side excavated to 6-ft.

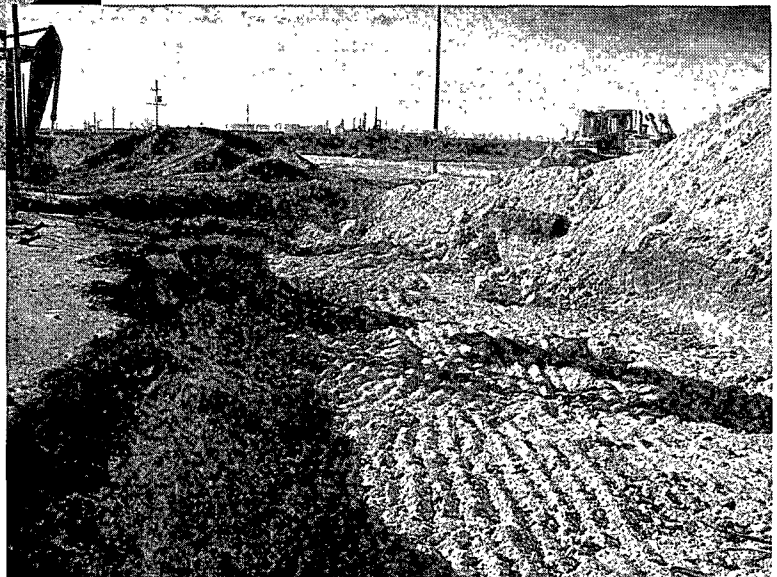
2-8-08 North side excavated to 6-ft.

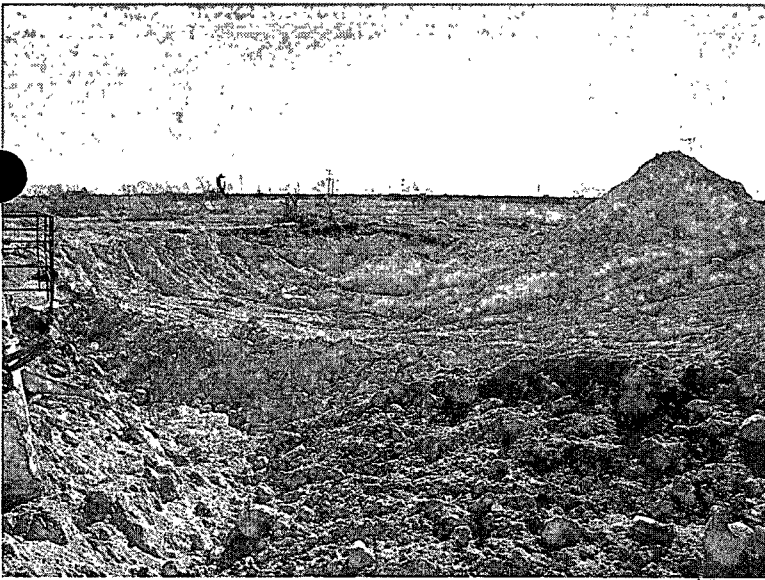
2-13-08 – Moving some stockpiled caliche to south side to make room for sidewall excavation on north side.

Excavating contaminated area at NW corner of north excavation.

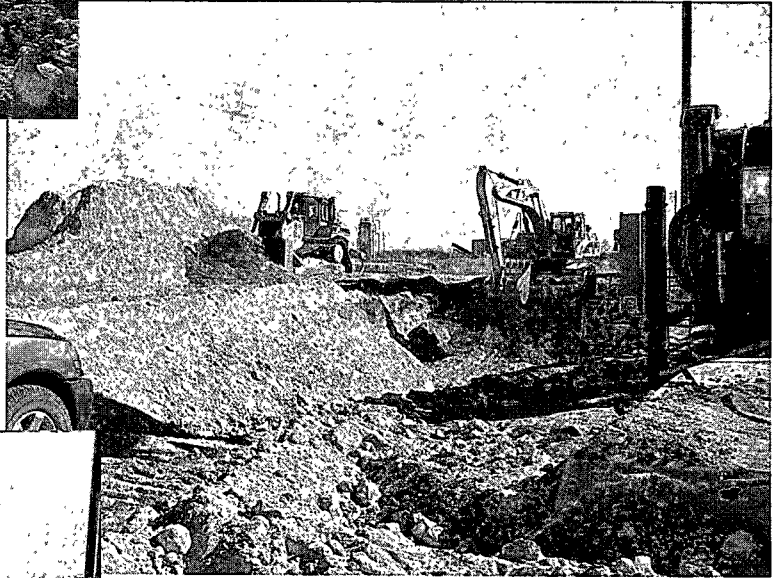
NW corner and W wall extended.

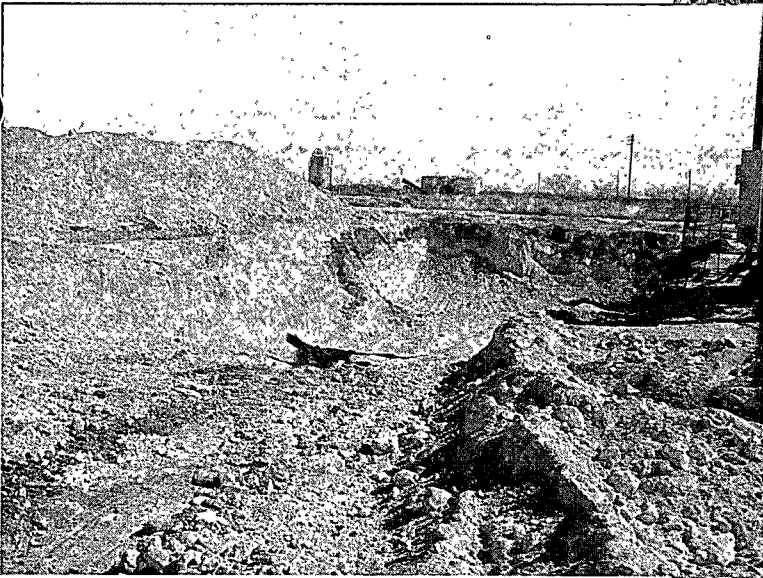
Excavation was backfilled after the caliche was blended with the material removed from the west side of the excavated area.

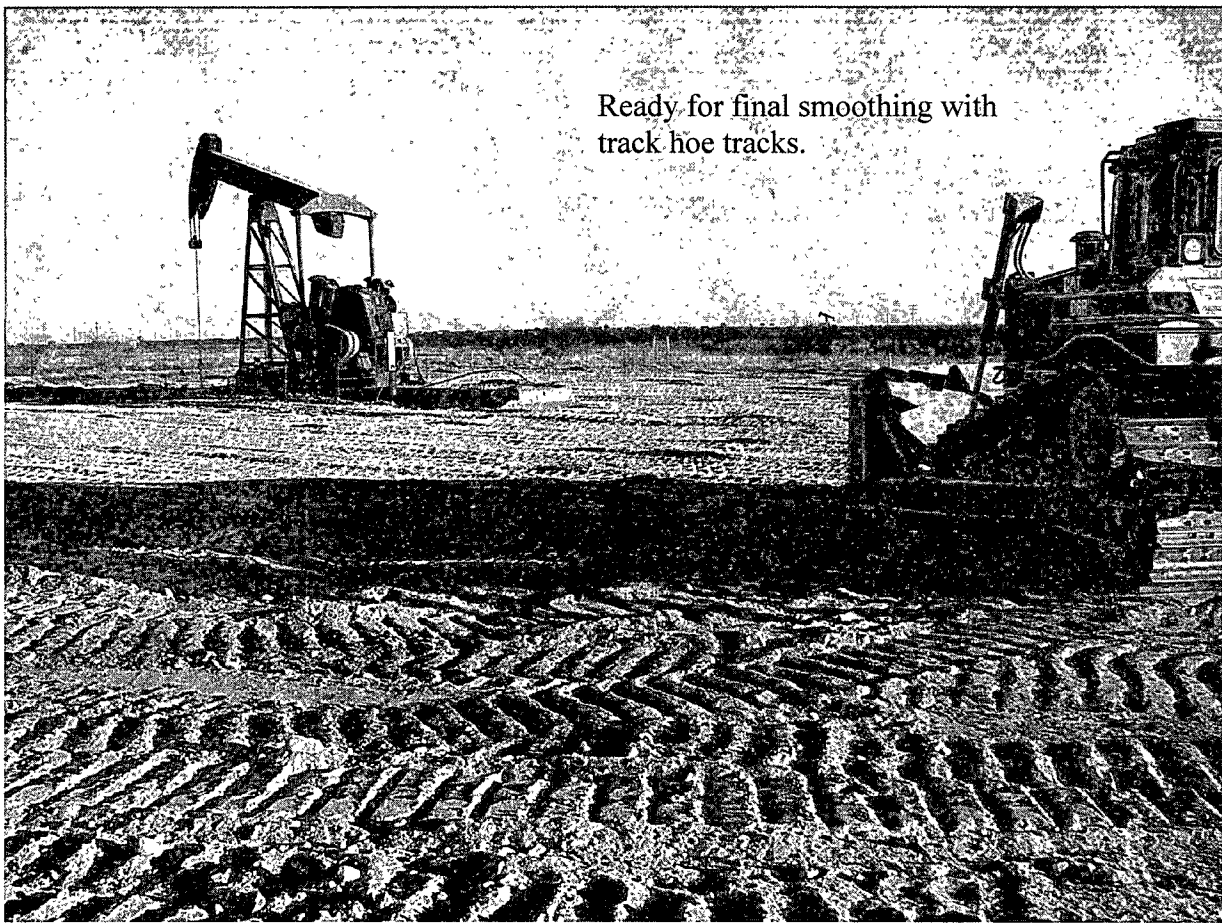
Ready for final smoothing with
track hoe tracks.

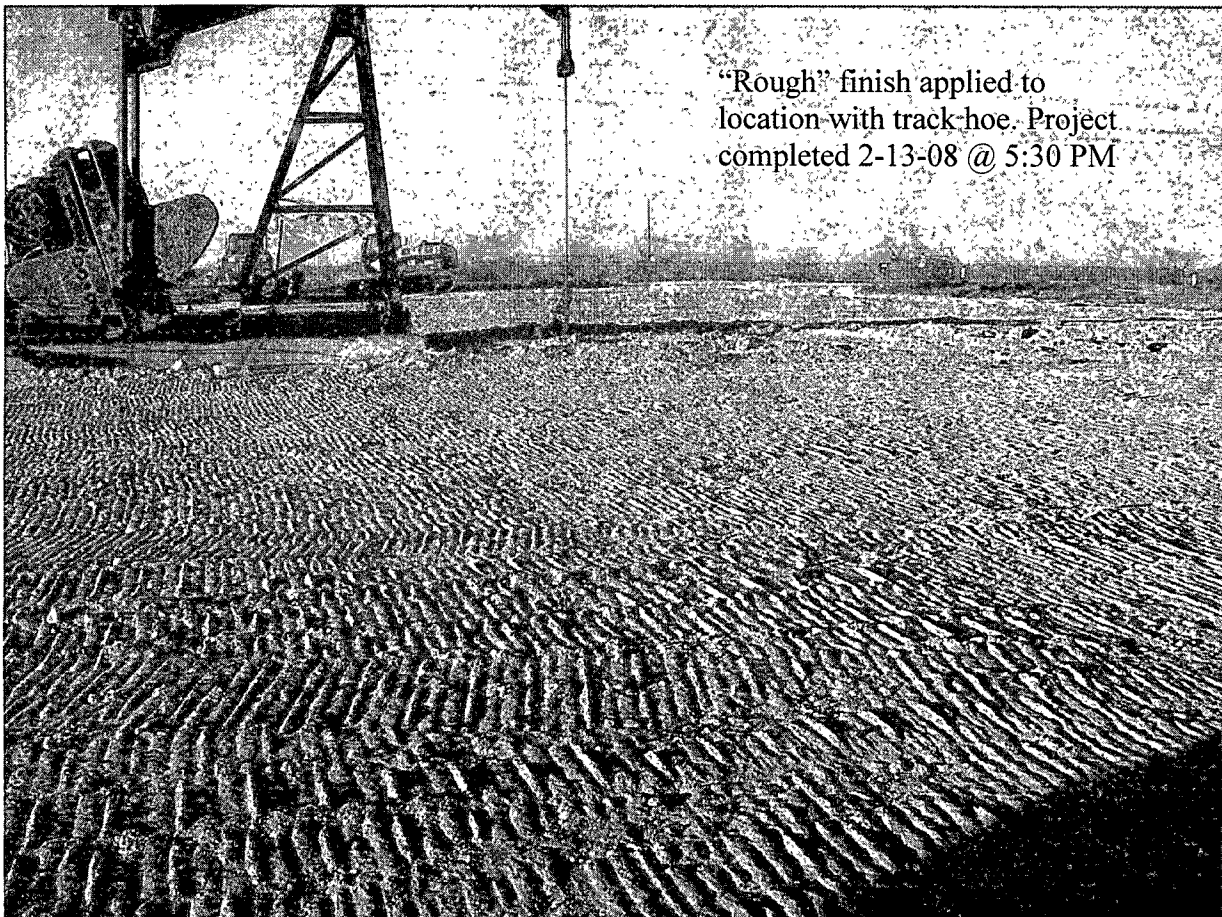
"Rough" finish applied to
location with track hoe. Project
completed 2-13-08 @ 5:30 PM
