**Pit or Below-Grade Tank Registration or Closure**

# Closure Report

**Rattletrap #1**  
**API # 30-025-38373**  
**Lea County, NM**

Re: B C Operating – Rattletrap #1  
UL 'H' Sec. 18 T16S R32E Lea County, NM  
API # 30-025-38373

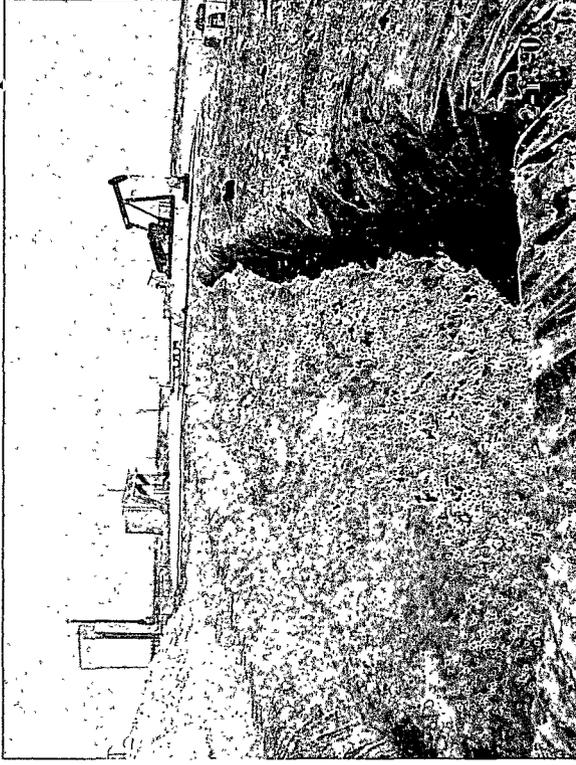
Burial pit full of drilling mud.
