Pit or Below-Grade Tank Registration or Closure

Closure Report

East Saunders Unit #1

Re: Pride Energy -- East Saunders Unit #1
UL 'F' Sec. 12 T14S R34E Lea County, NM
API # 30-025-01871

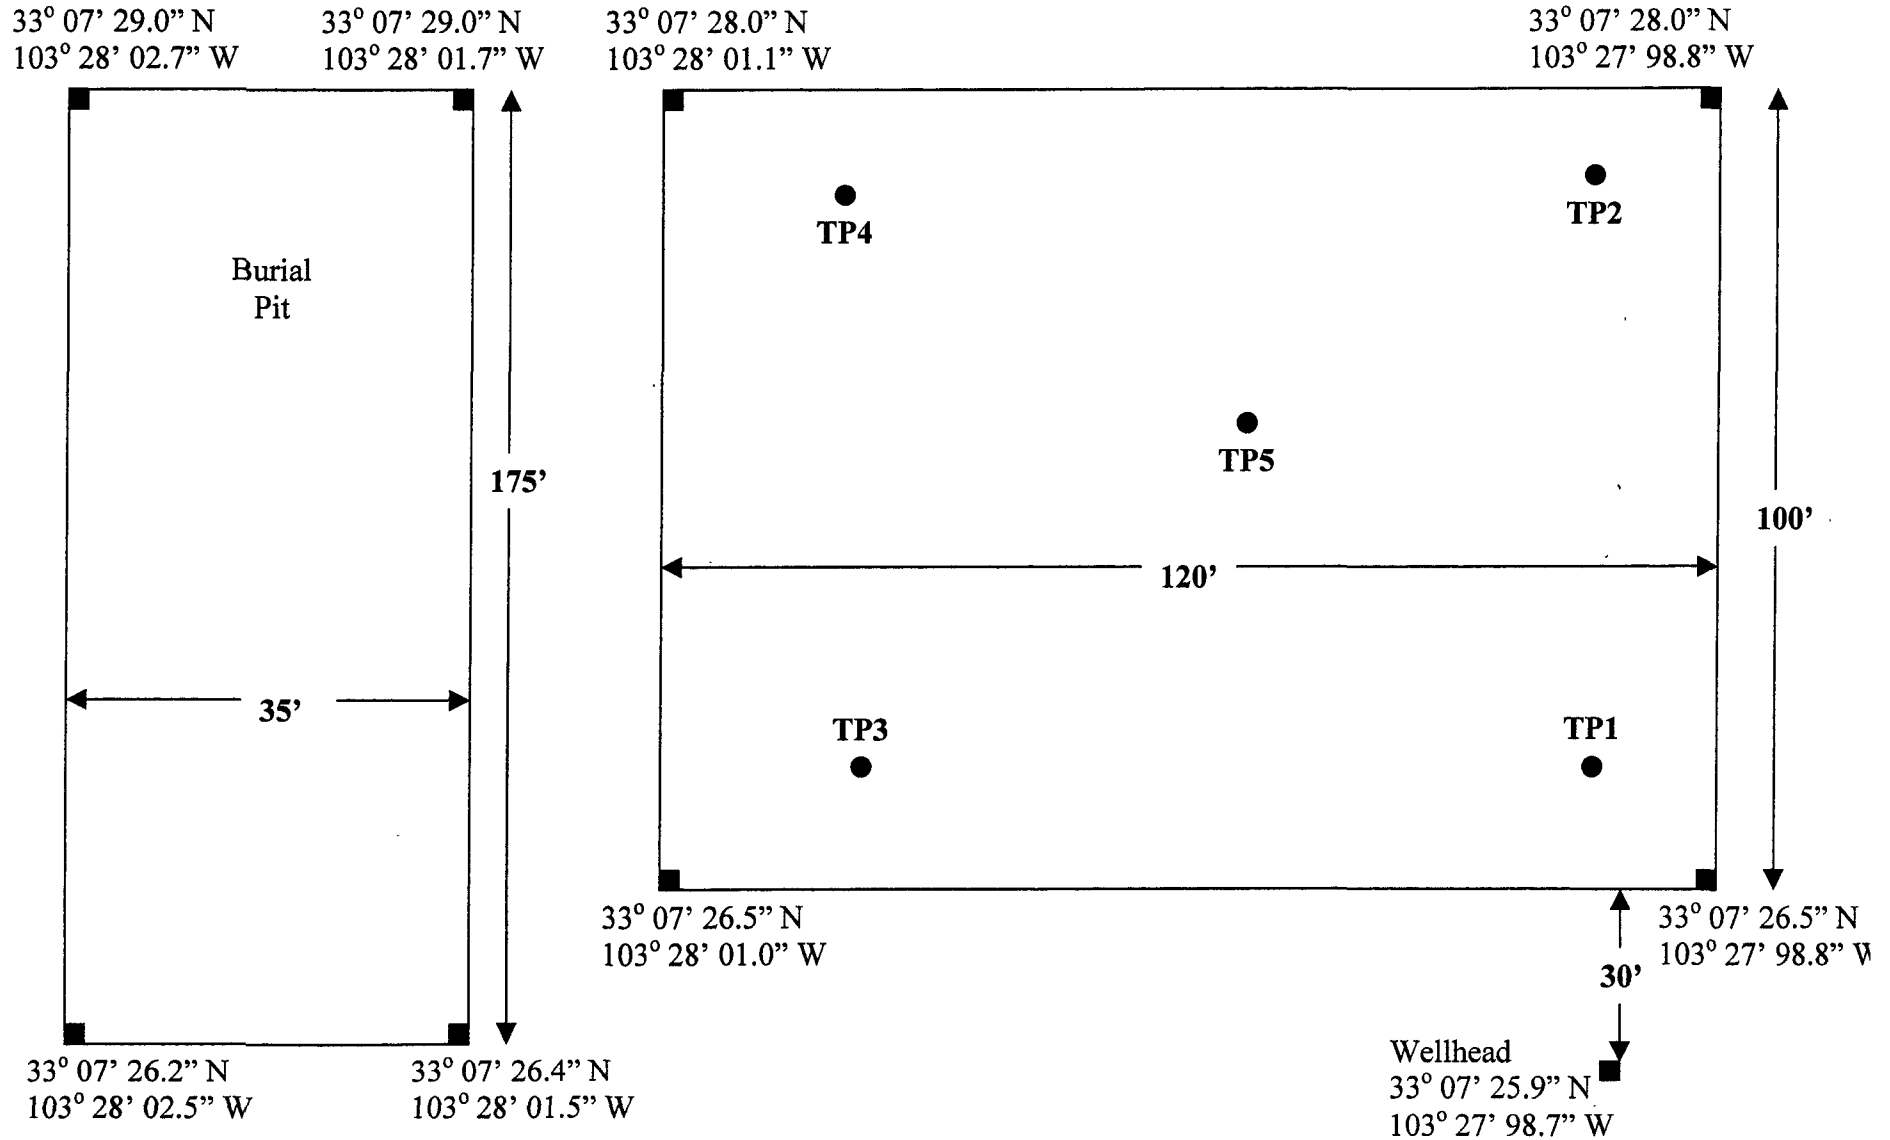
Pride Energy

East Saunders Unit #1

UL 'F' Sec. 12 T14S R34E

Lea County, NM

N

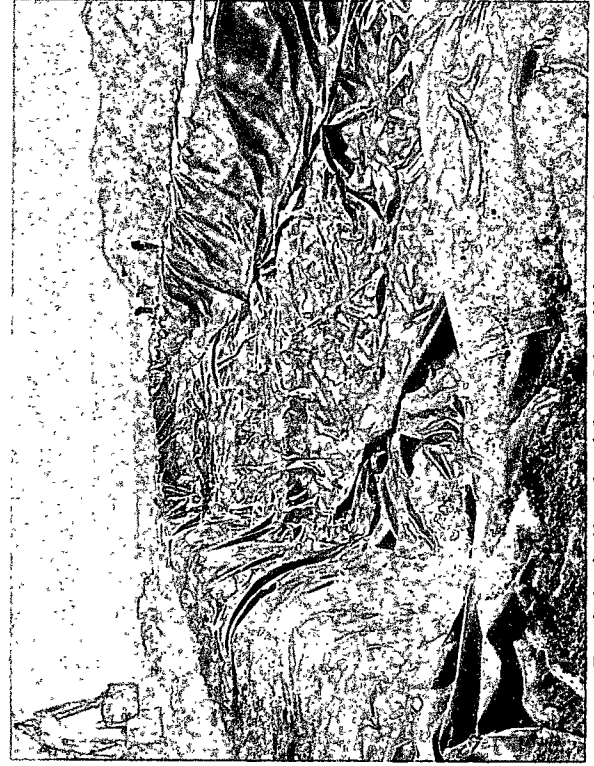
Burial pit lined with a 20 mil impervious liner.

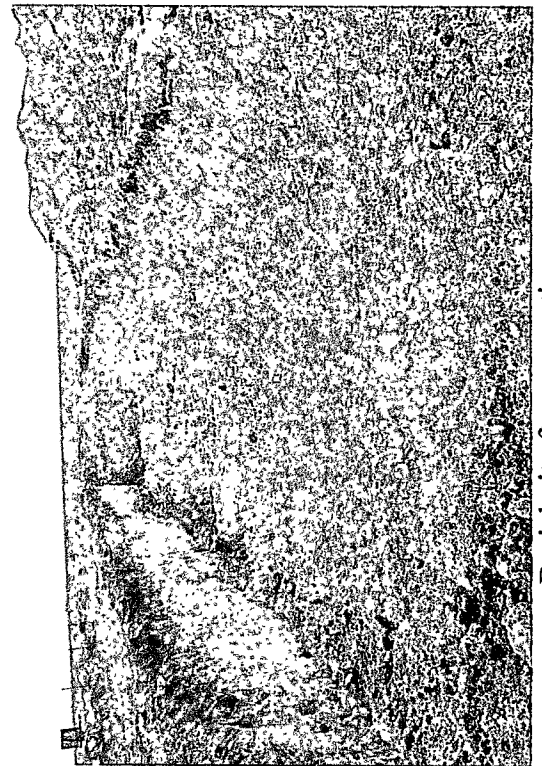
Burial pit after excavation.

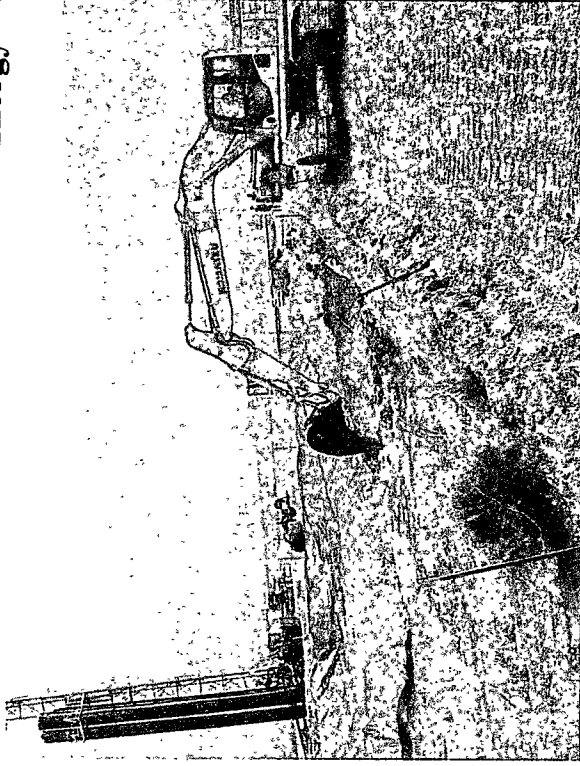
Mixing mud with Elke Environmental Solidification Product.

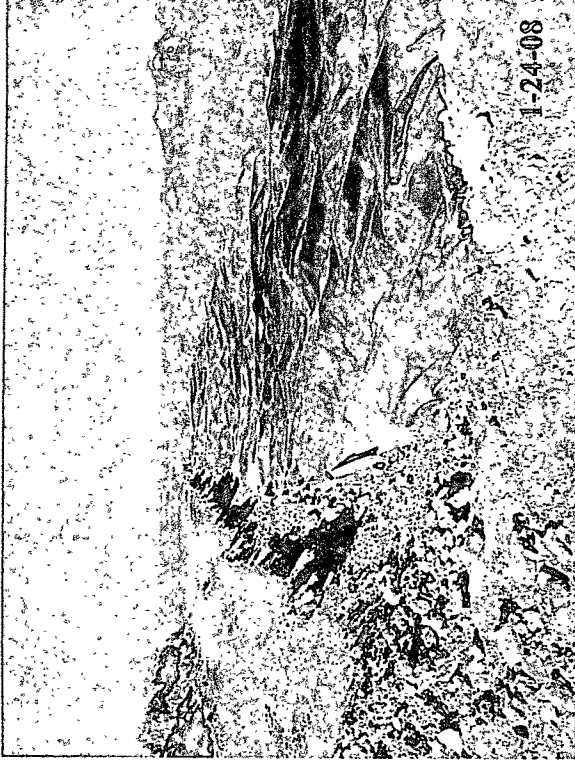
Burial pit capped with a 20 mil impervious liner.

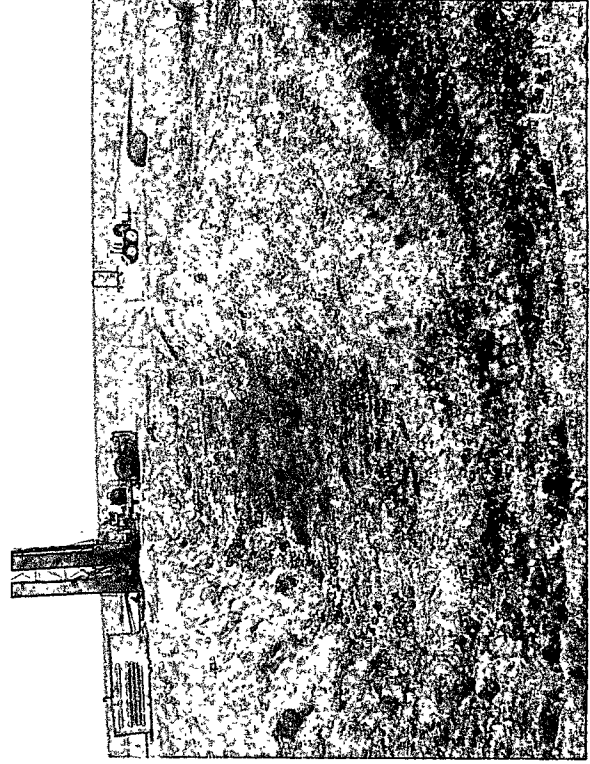
Drilling pit after mud and liner have been removed.

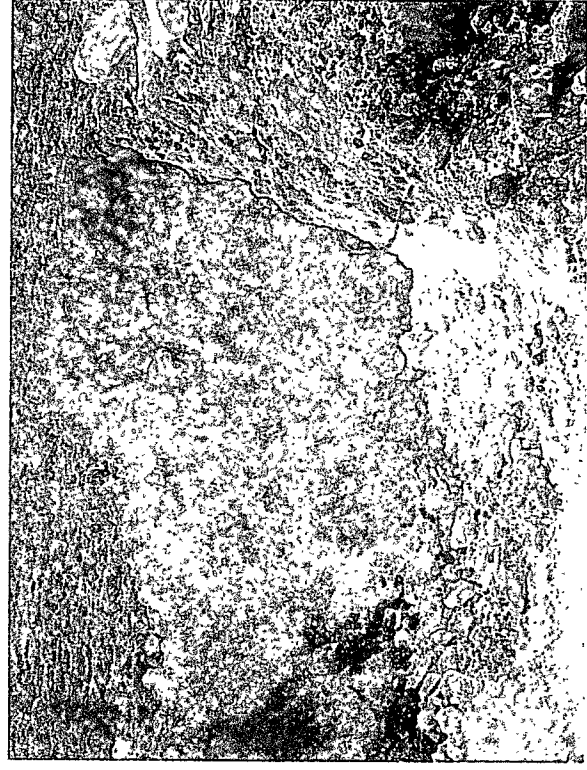
Delineation trench excavated by a trackhoe.

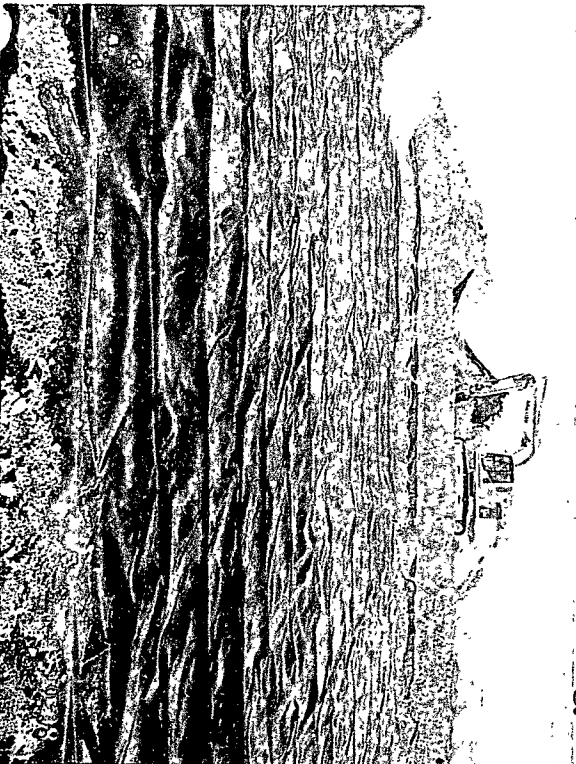
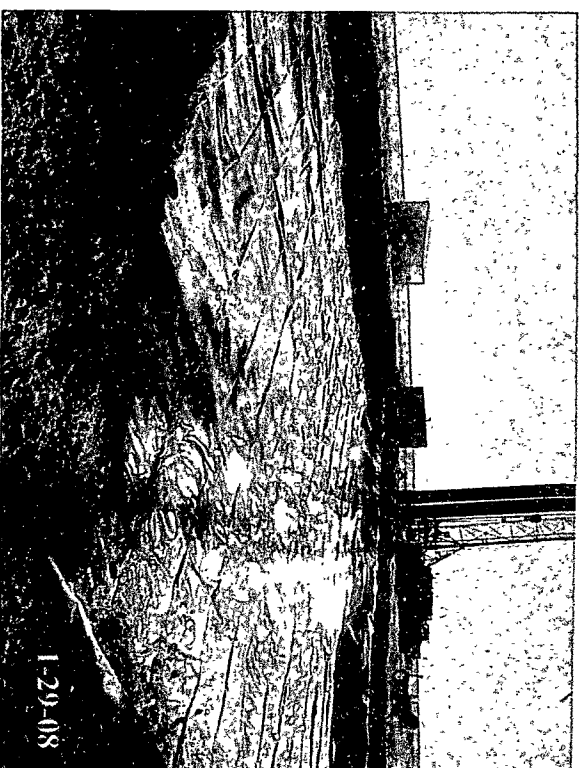
Drilling pit capped with a 40 mil impervious liner.

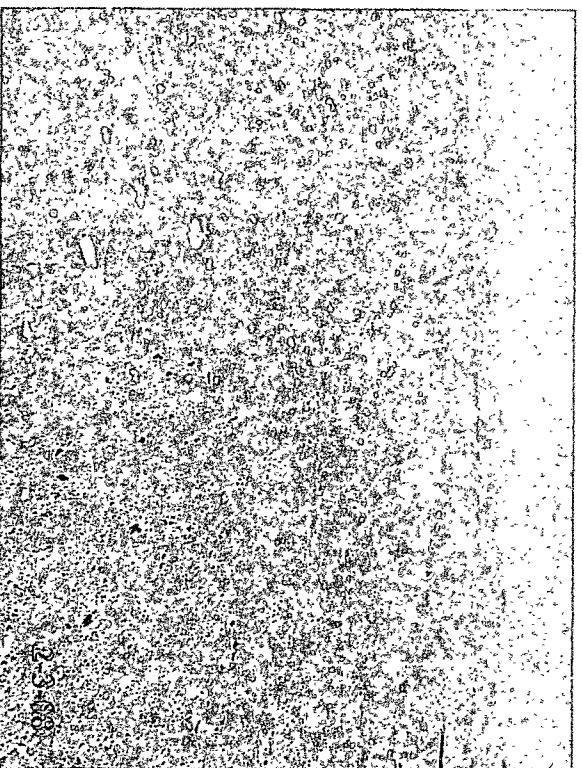
Drilling pit after backfill and contouring.
