**BW - 8**

**QUARTERLY  
MONITORING  
REPORTS**

Re: Salty Dog Brine Station - Second Quarterly Groundwater Monitoring and O&M Report

**Second Quarterly Groundwater  
Monitoring and O&M Report  
Salty Dog Brine Station  
Lea County, New Mexico**

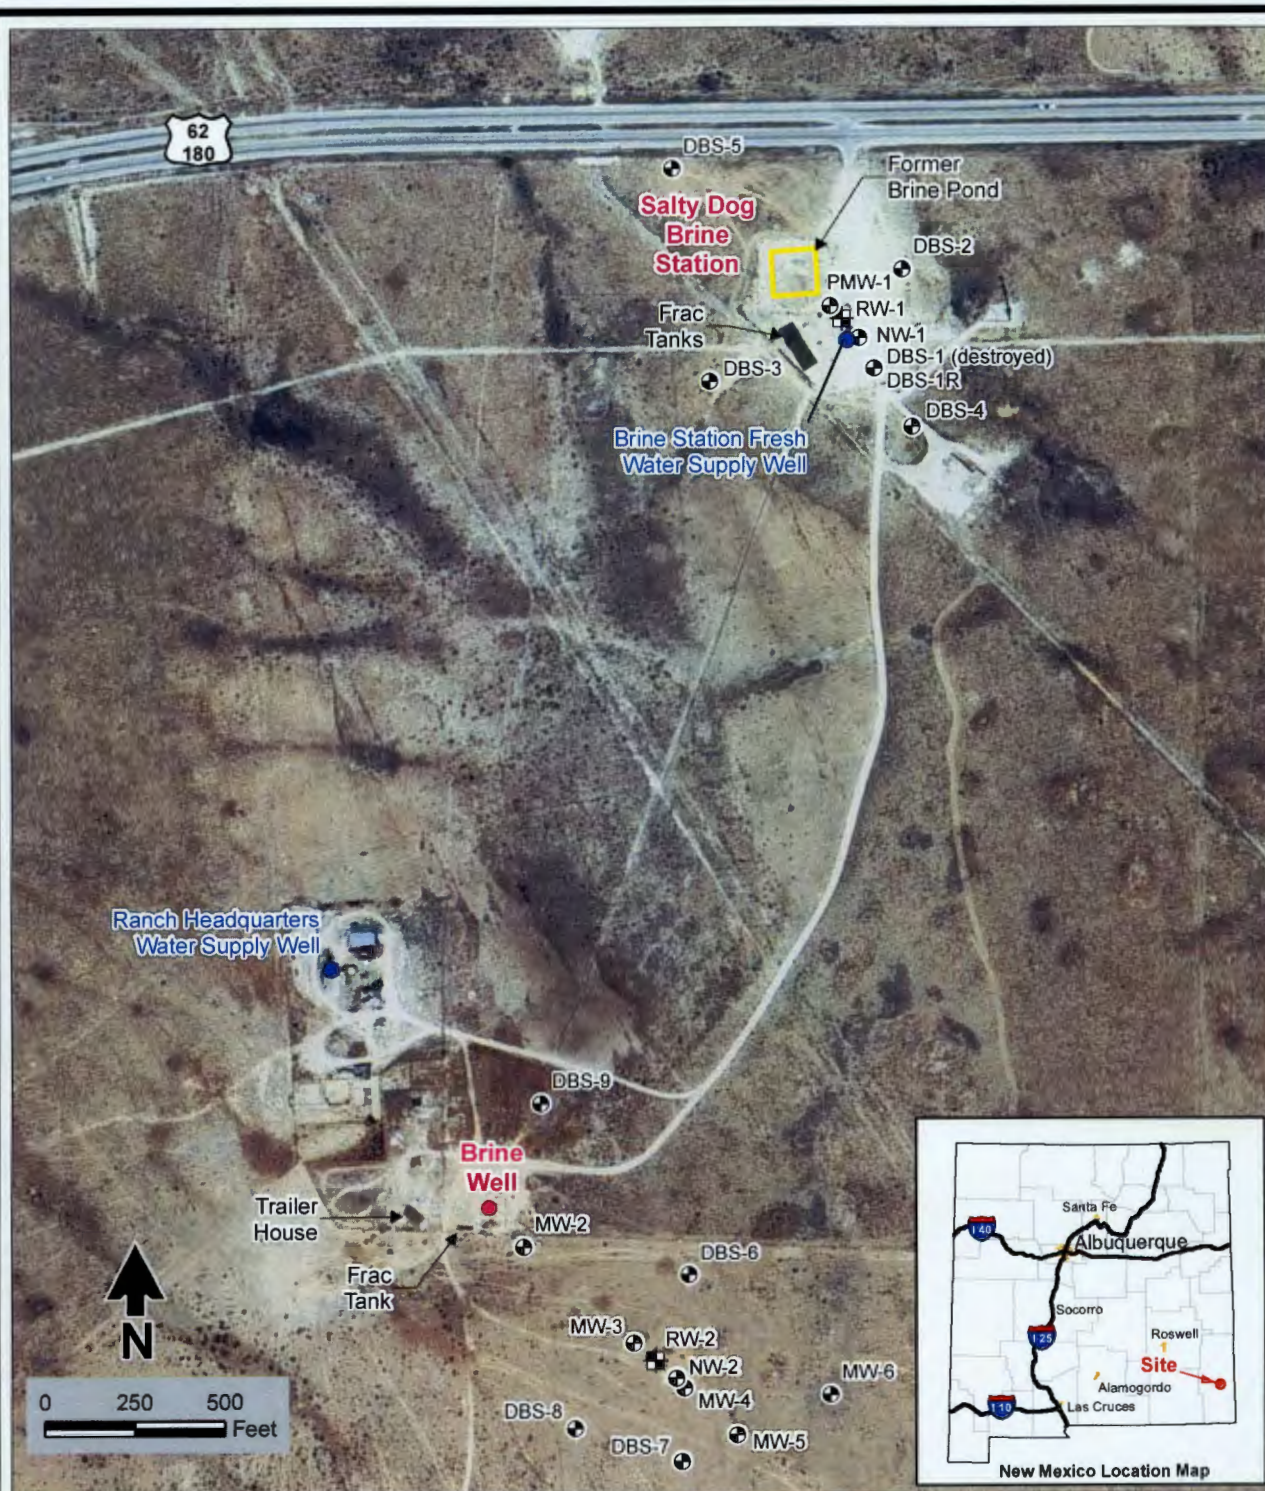
Figure 1

The site is comprised of a northern portion where the brine pond was located prior to closure in October 2008 and a southern portion where the brine well is located. The brine pond area and the brine well area are separated by approximately 2,500 feet, joined by a dirt road. Since the closure of the brine pond, a number of frac tanks have been stationed in the northern portion of the site to serve as storage for brine that is produced for resale. A concrete truck loading pad is located near the frac tanks. The brine well is currently not operational and attempts are being made to redrill the well and restore brine production. Six monitor wells (PMW-1, DBS-1R, and DBS-2 through DBS-5), one nested well (NW-1), and one recovery well (RW-1) are located in the former brine pond area. Nine monitor wells (MW-2 through MW-6, DBS-6 through DBS-9), one nested well (NW-2), and one recovery well (RW-2) are located in the brine well area (Figure 1).

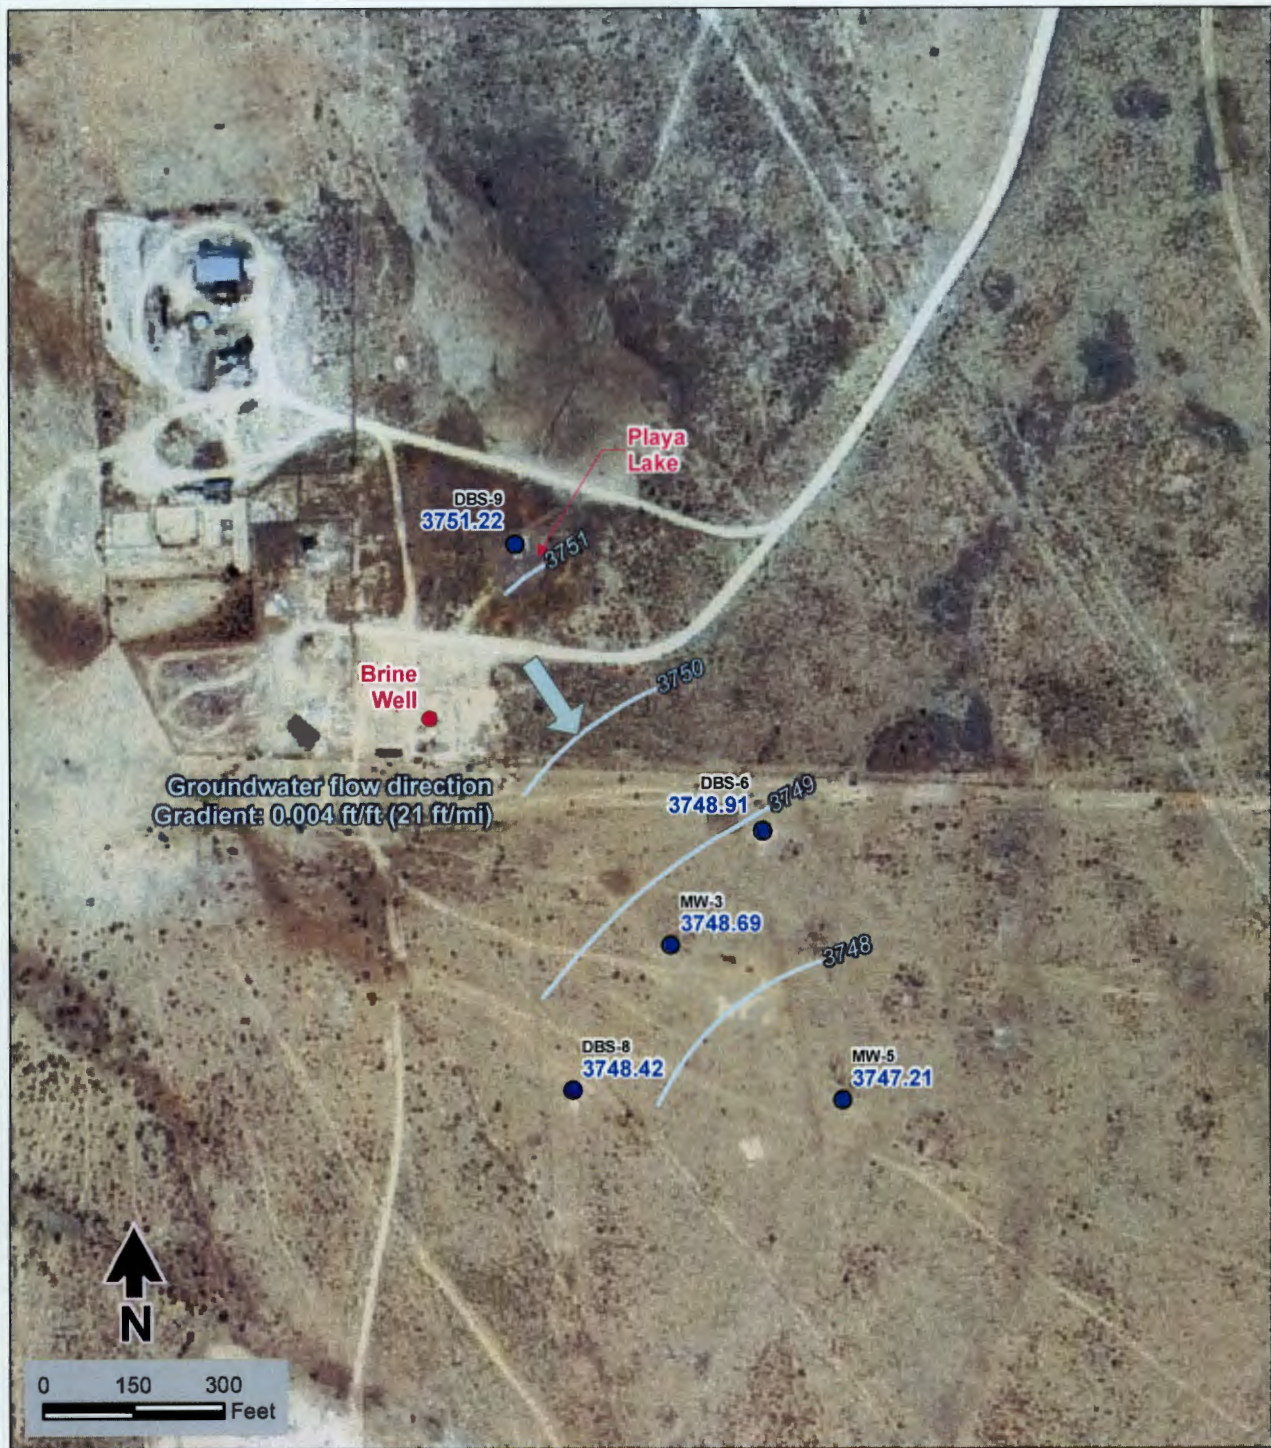
Figure 3

The direction of groundwater flow beneath the brine well area remains to the southeast; the gradient remained unchanged at approximately 0.004 ft/ft (Figure 3). The pump in recovery well RW-2 went down in December 2012, and was removed for replacement. No groundwater was extracted from December through the June 2013 monitoring event. The gradient remained unchanged since the last monitoring and O&M event in September 2012 indicating that pumping at the former rate was having little to no effect on drawdown in the brine well area.

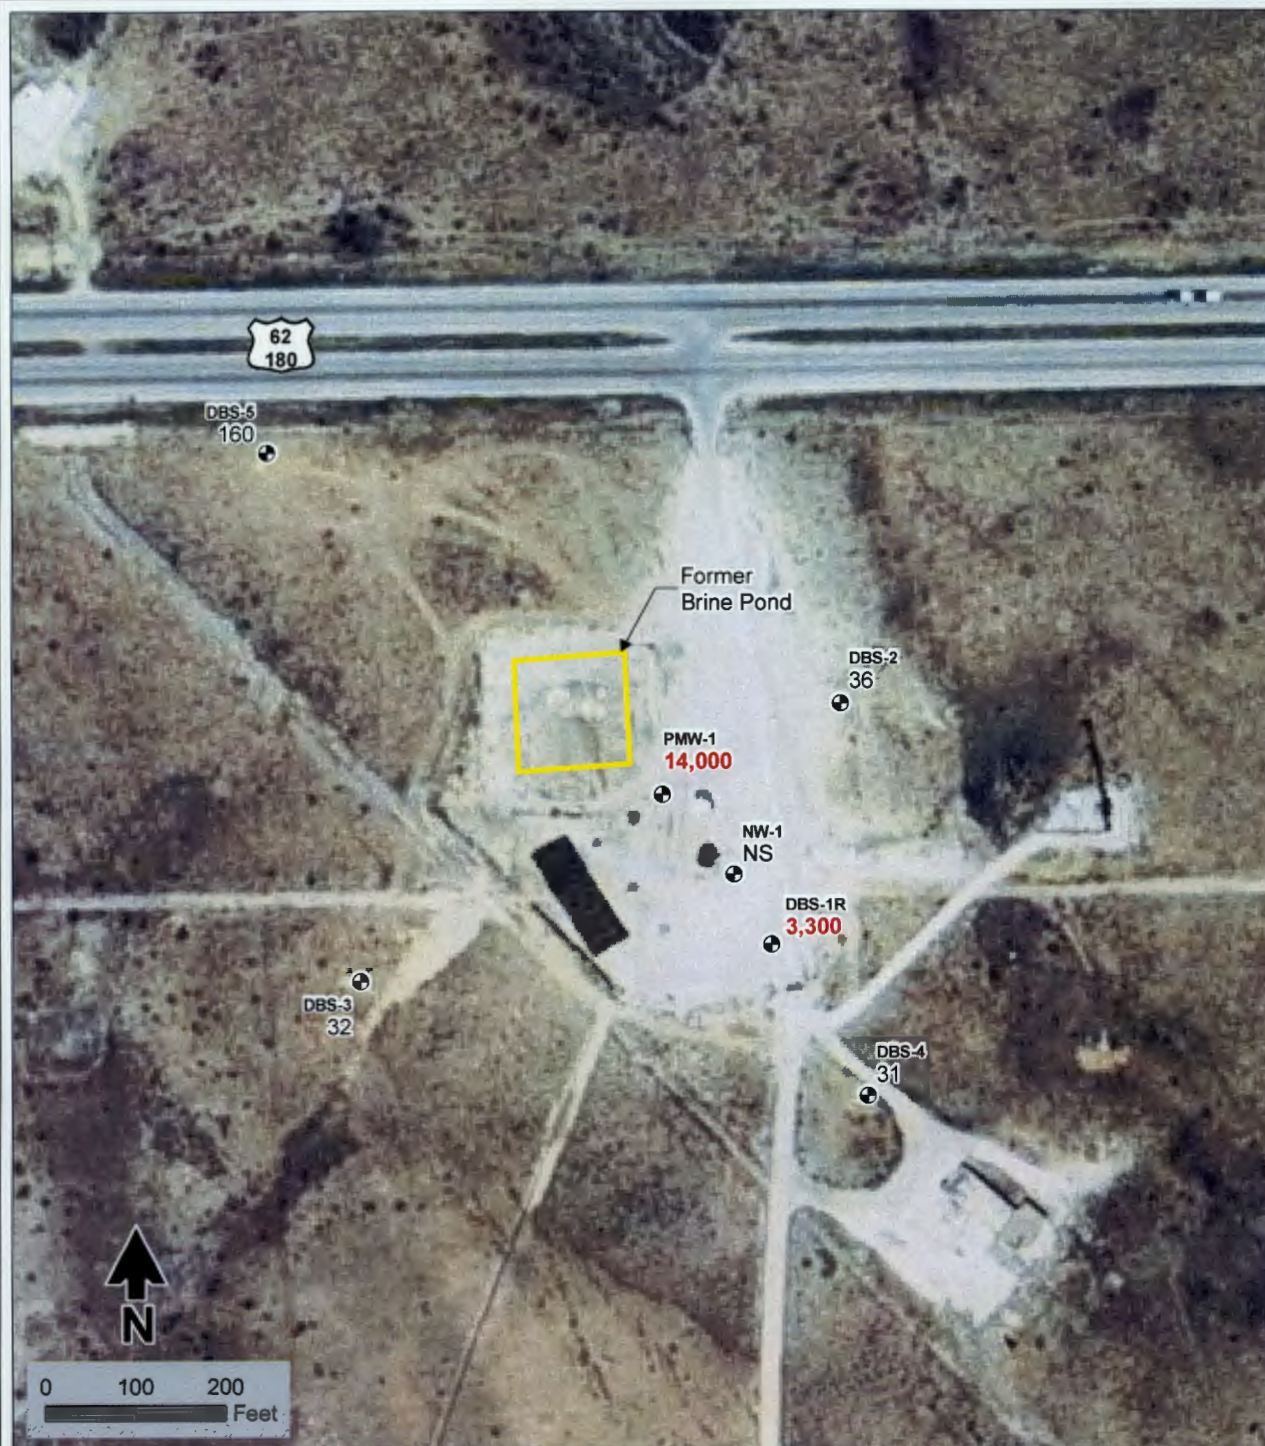
Figure 4

chloride concentration was observed in DBS-1R (3,200 to 3,300 mg/L). Decreases were observed in DBS-2 (44 to 36 mg/L), DBS-3 (34 to 32 mg/L), and DBS-4 (32 to 31 mg/L). Chloride concentrations remained unchanged in DBS-5 (160 mg/L), and PMW-1 (14,000 mg/L). Two of the six wells (DBS-1R and PMW-1) sampled in the former brine pond area contain chloride concentrations in excess of the New Mexico Water Quality Control Commission (NMWQCC) standard of 250 mg/L (Table 2).

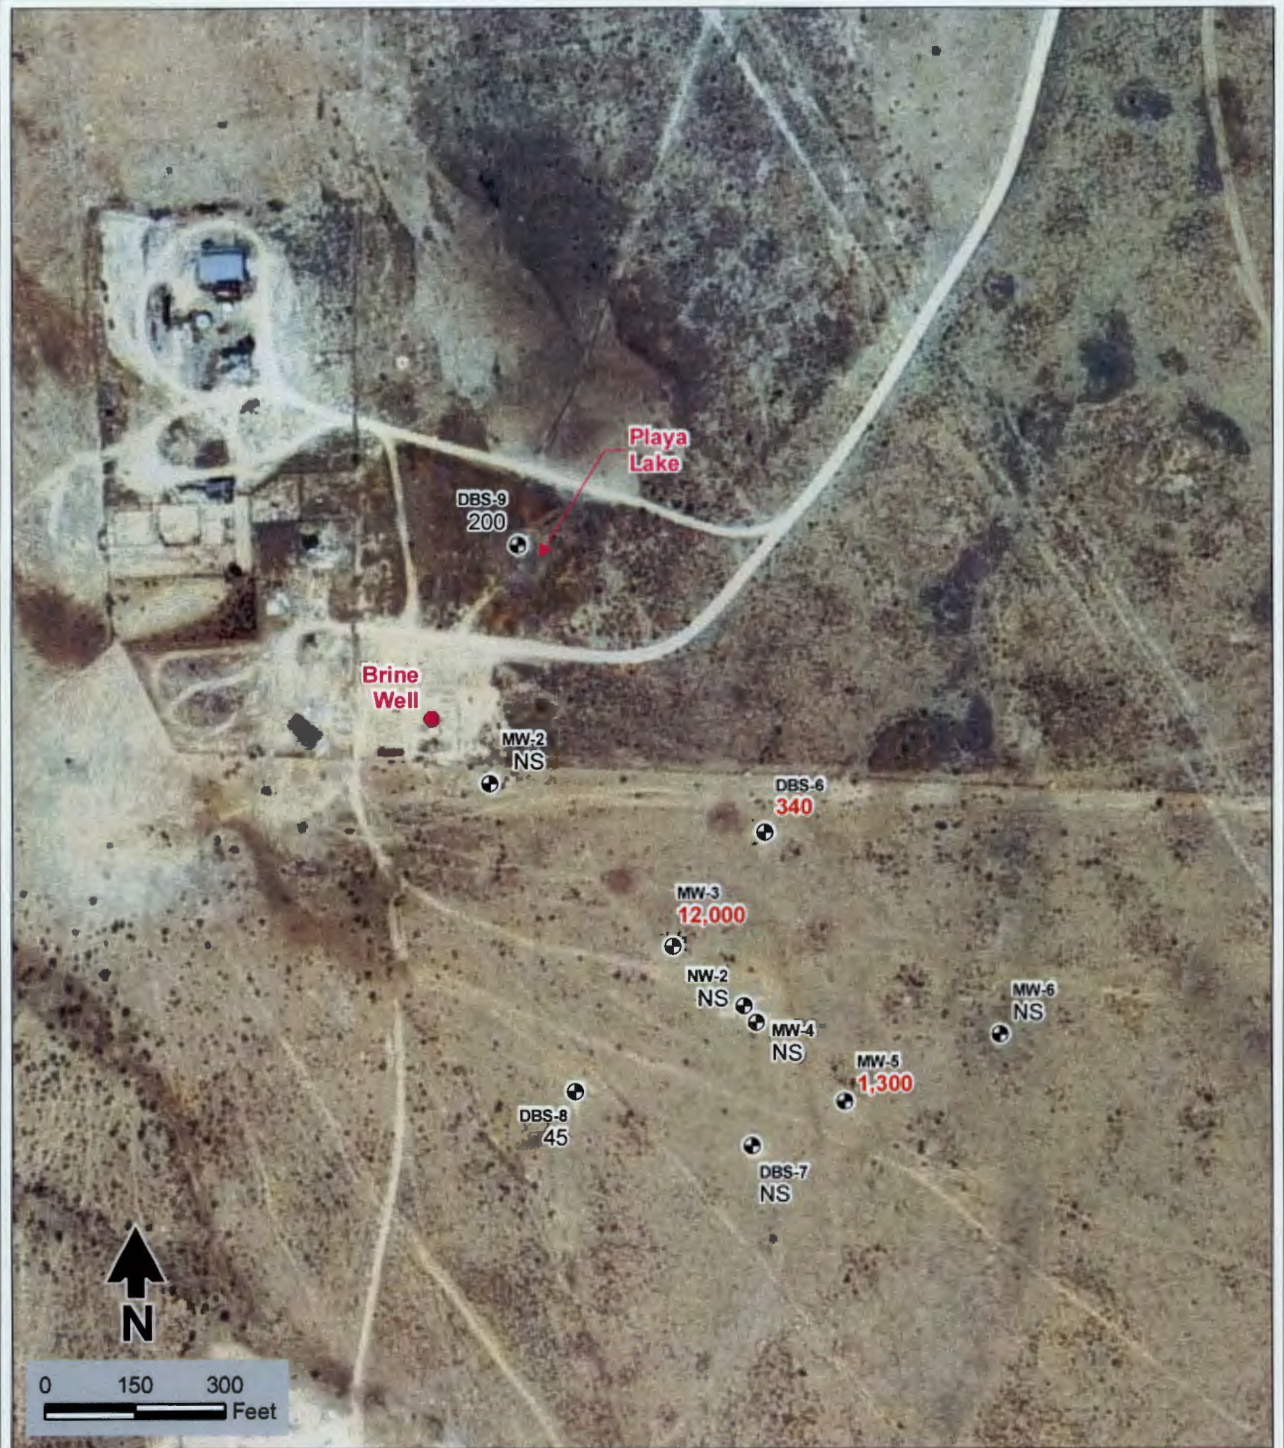
Groundwater samples submitted from the wells in the brine well area showed the following changes since the last monitoring event in September 2012. The only increase in chloride concentration was observed in DBS-8 (42 to 45 mg/L). Decreases were observed in DBS-6 (390 to 340 mg/L), MW-3 (16,000 to 12,000 mg/L), and MW-5 (1,500 to 1,300 mg/L). Three of the five wells sampled in the brine well area (MW-3, MW-5, and DBS-6) contain chloride concentrations in excess of the New Mexico Water Quality Control Commission (NMWQCC) standard of 250 mg/L (Table 2).

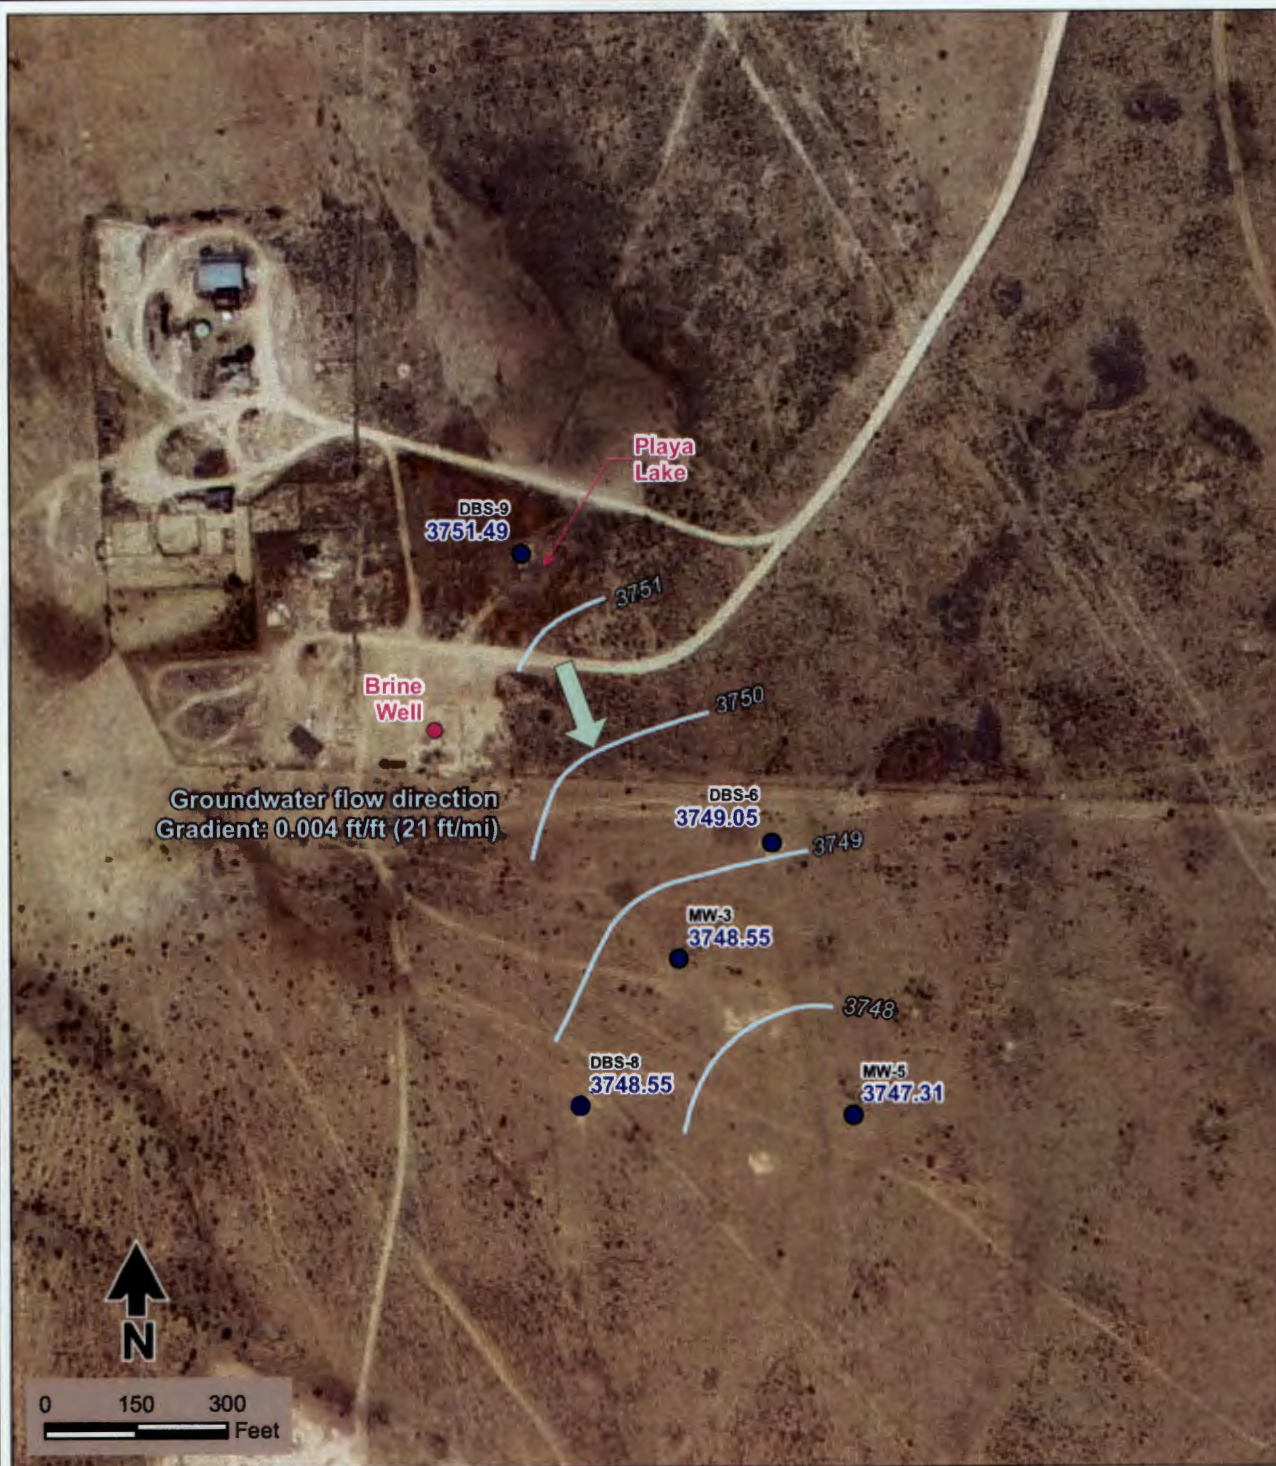
Figure 2

- MW-5 Well designation
- 3747.31 Groundwater elevation, ft msl
- Groundwater elevation (ft msl)
- Potentiometric surface elevation contour (ft msl)

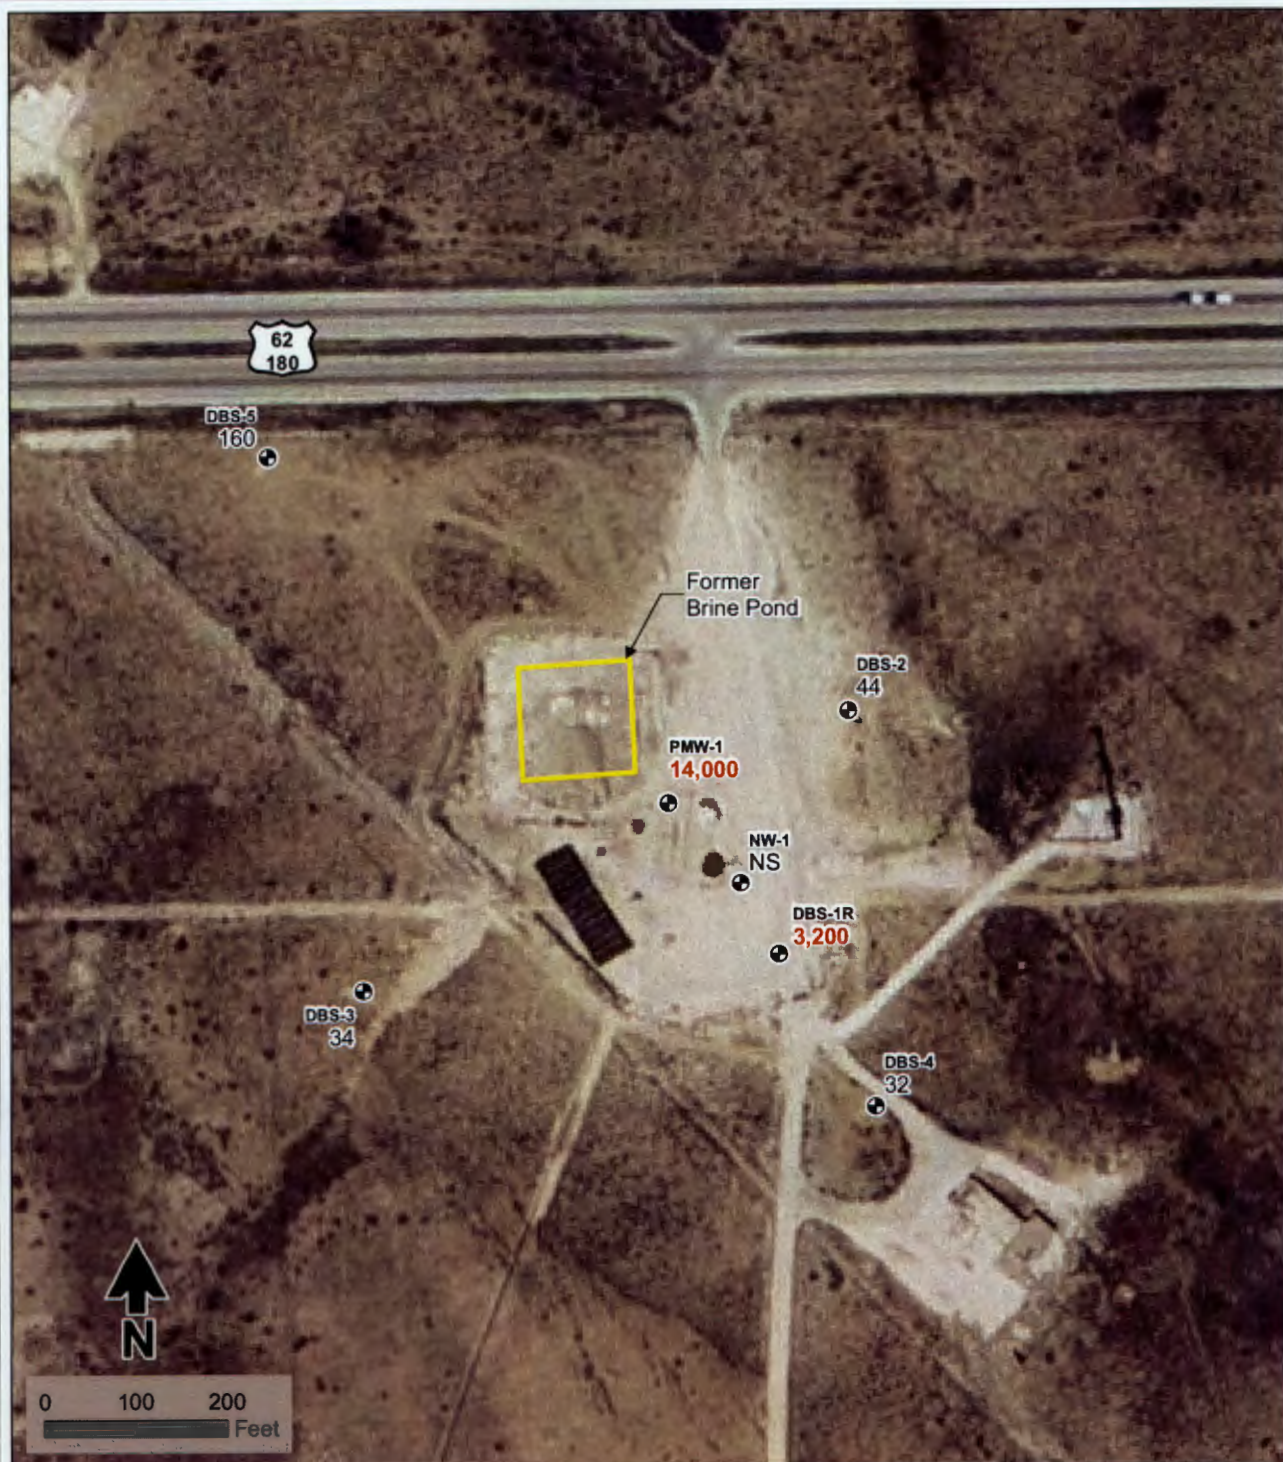
Figure 3

**SALTY DOG BRINE STATION  
Playa Lake and Brine Well Area  
Potentiometric Surface Elevations  
September 10, 2012**

- DBS-5 Well designation  
160 Chloride concentration (mg/L)  
⊕ Monitor well location

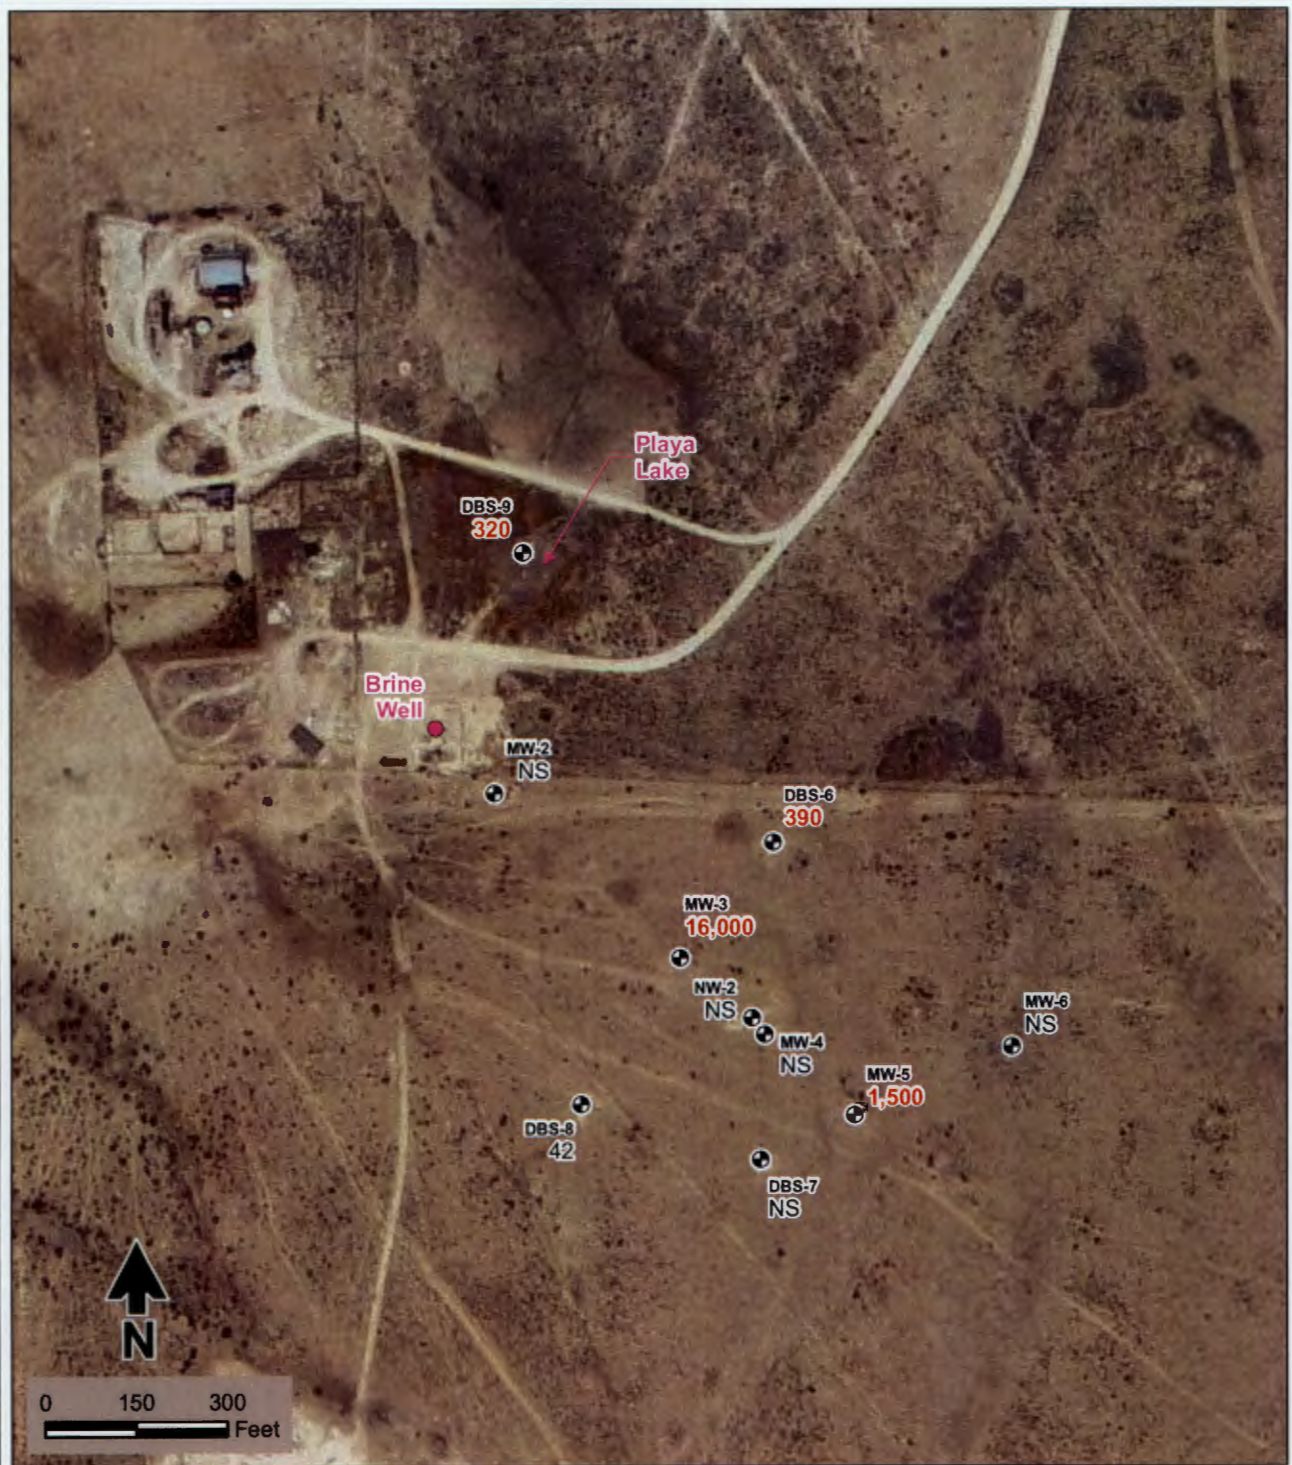
Figure 4

MW-5 Well designation  
**1,500** Chloride concentration (mg/L)

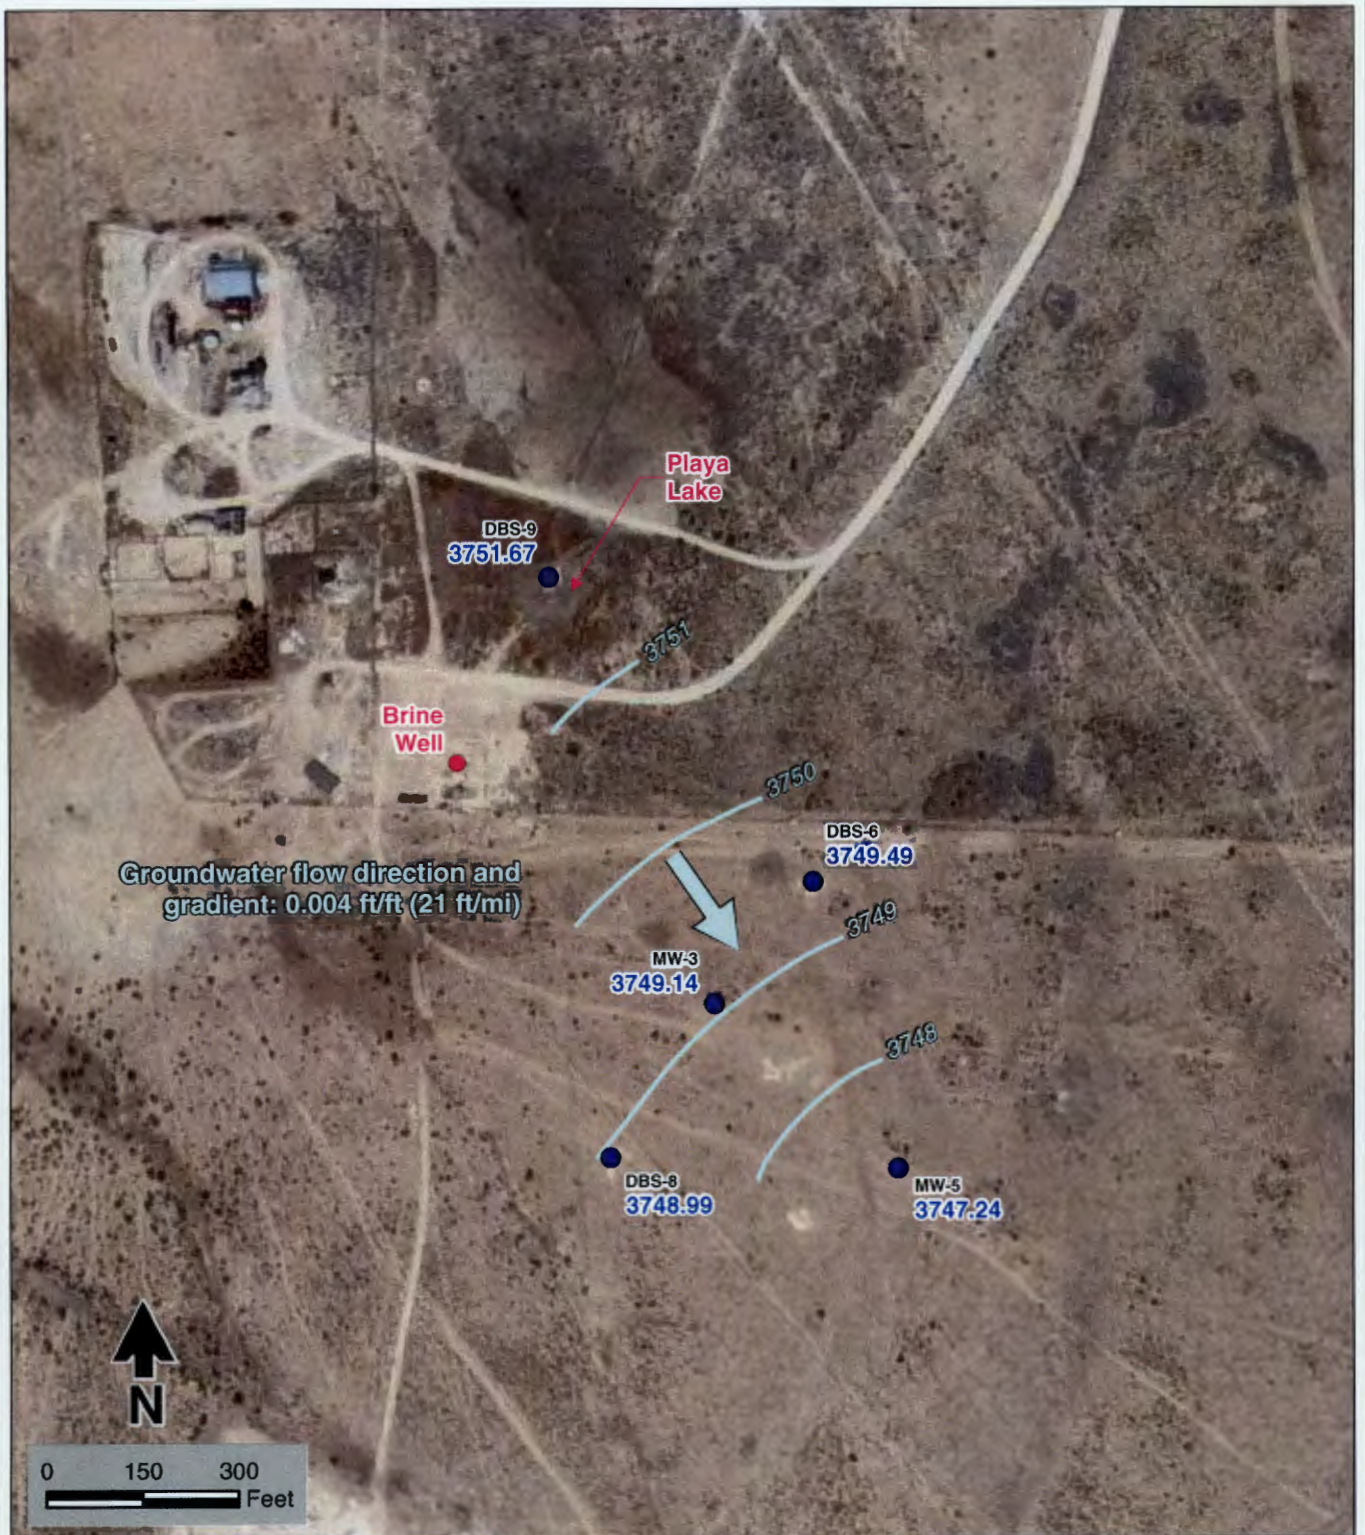
Figure 2

- MW-5 Well designation
- 3747.24 Groundwater elevation, ft msl
- Groundwater elevation (ft msl)
- Potentiometric surface elevation contour (ft msl)

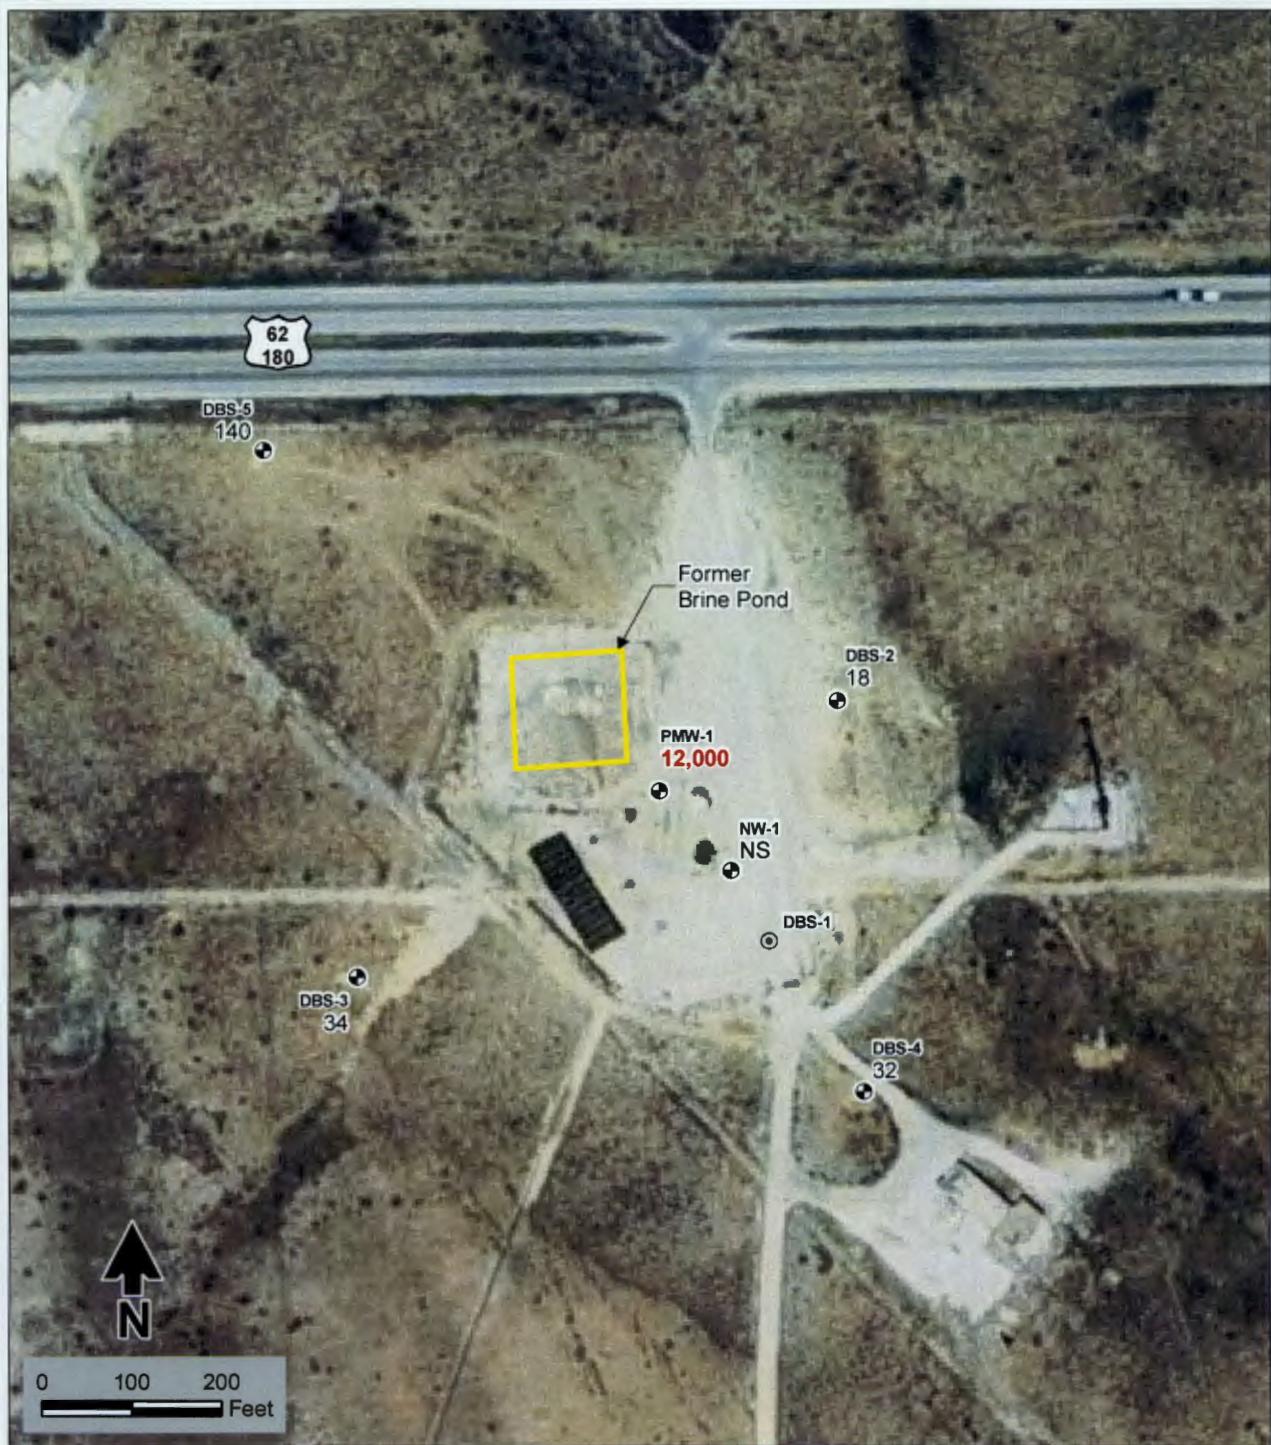
Figure 3

- DBS-5 Well designation
- 140** Chloride concentration (mg/L)
- Monitor well location
- ⊙ Well destroyed
- BOLD** indicates concentration equal to or greater than the NMWQCC standard.
- NS = Not sampled

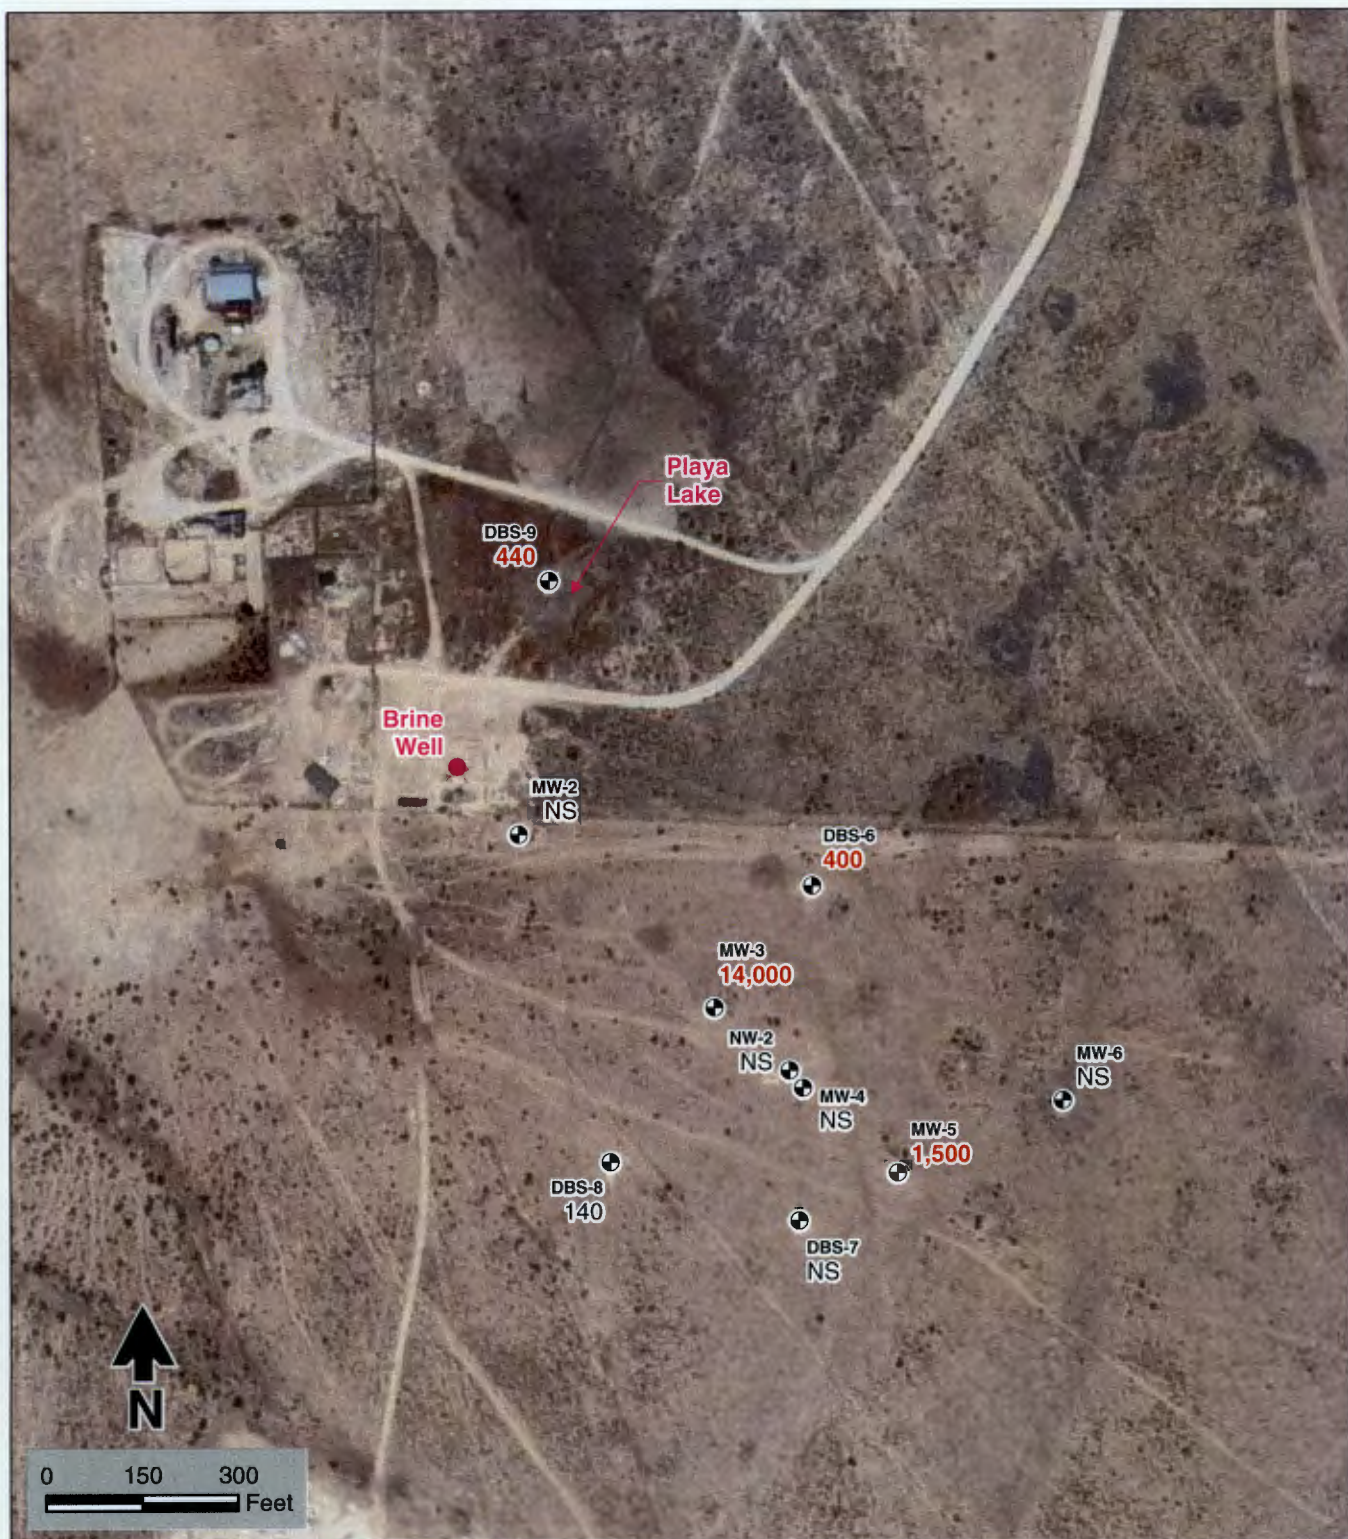
Figure 4

- MW-5 Well designation  
**1,500** Chloride concentration (mg/L)  
⊕ Monitor well location

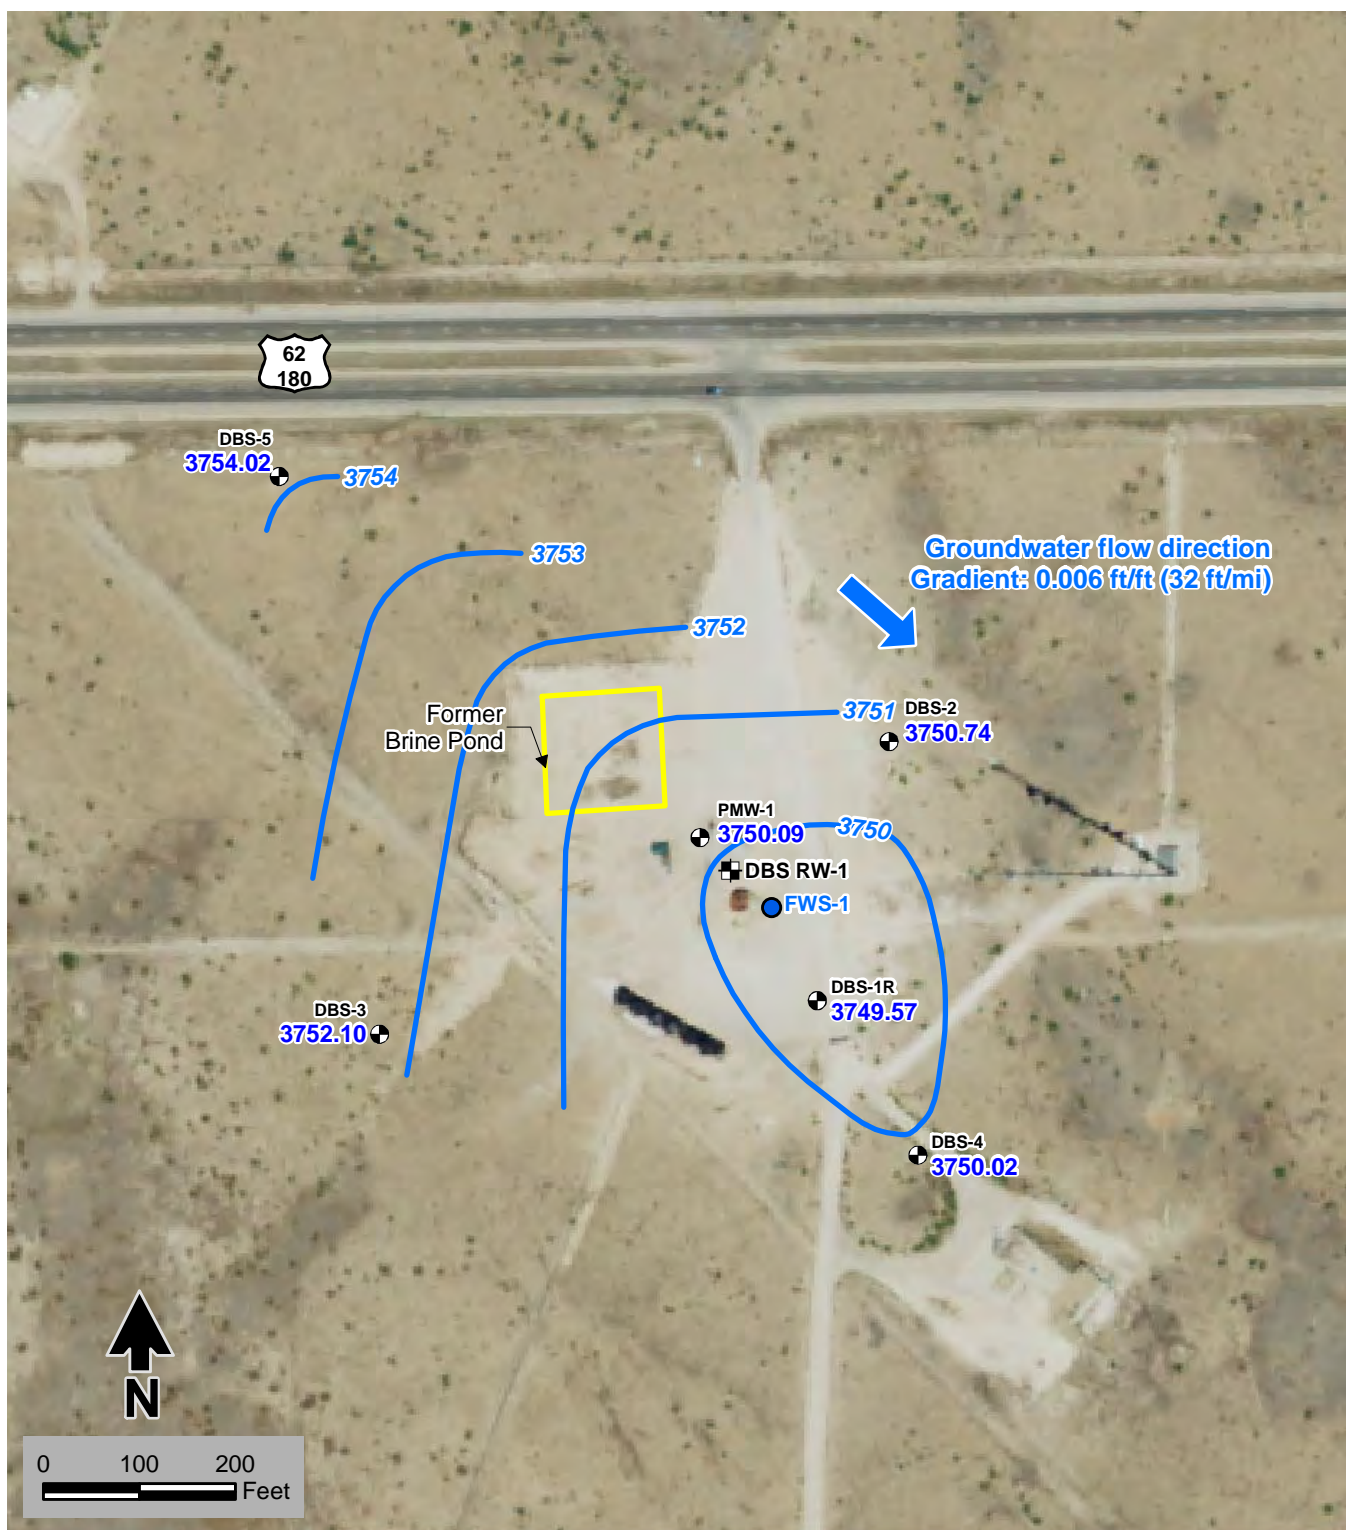
Figures 2 and 3 present potentiometric surface maps for the former brine pond area and the brine well area, respectively. The direction of groundwater flow beneath the former brine pond area remains to the southeast at a gradient of approximately 0.006 foot per foot (ft/ft) (Figure 2)—increasing slightly since the previous monitoring event. A broad cone of depression was observed in the vicinity of the fresh water supply well (FWS-1) due to increased fresh water production when depth to water level measurements were recorded. The direction of groundwater flow beneath the brine well area remains to the southeast at a gradient of approximately 0.004 ft/ft (Figure 3)—decreasing slightly relative to the previous monitoring event.
