**BW - 8**

**QUARTERLY  
MONITORING  
REPORTS**

Re: Salty Dog Brine Station - Second Quarterly Groundwater Monitoring and O&M Report

**Second Quarterly Groundwater  
Monitoring and O&M Report  
Salty Dog Brine Station  
Lea County, New Mexico**

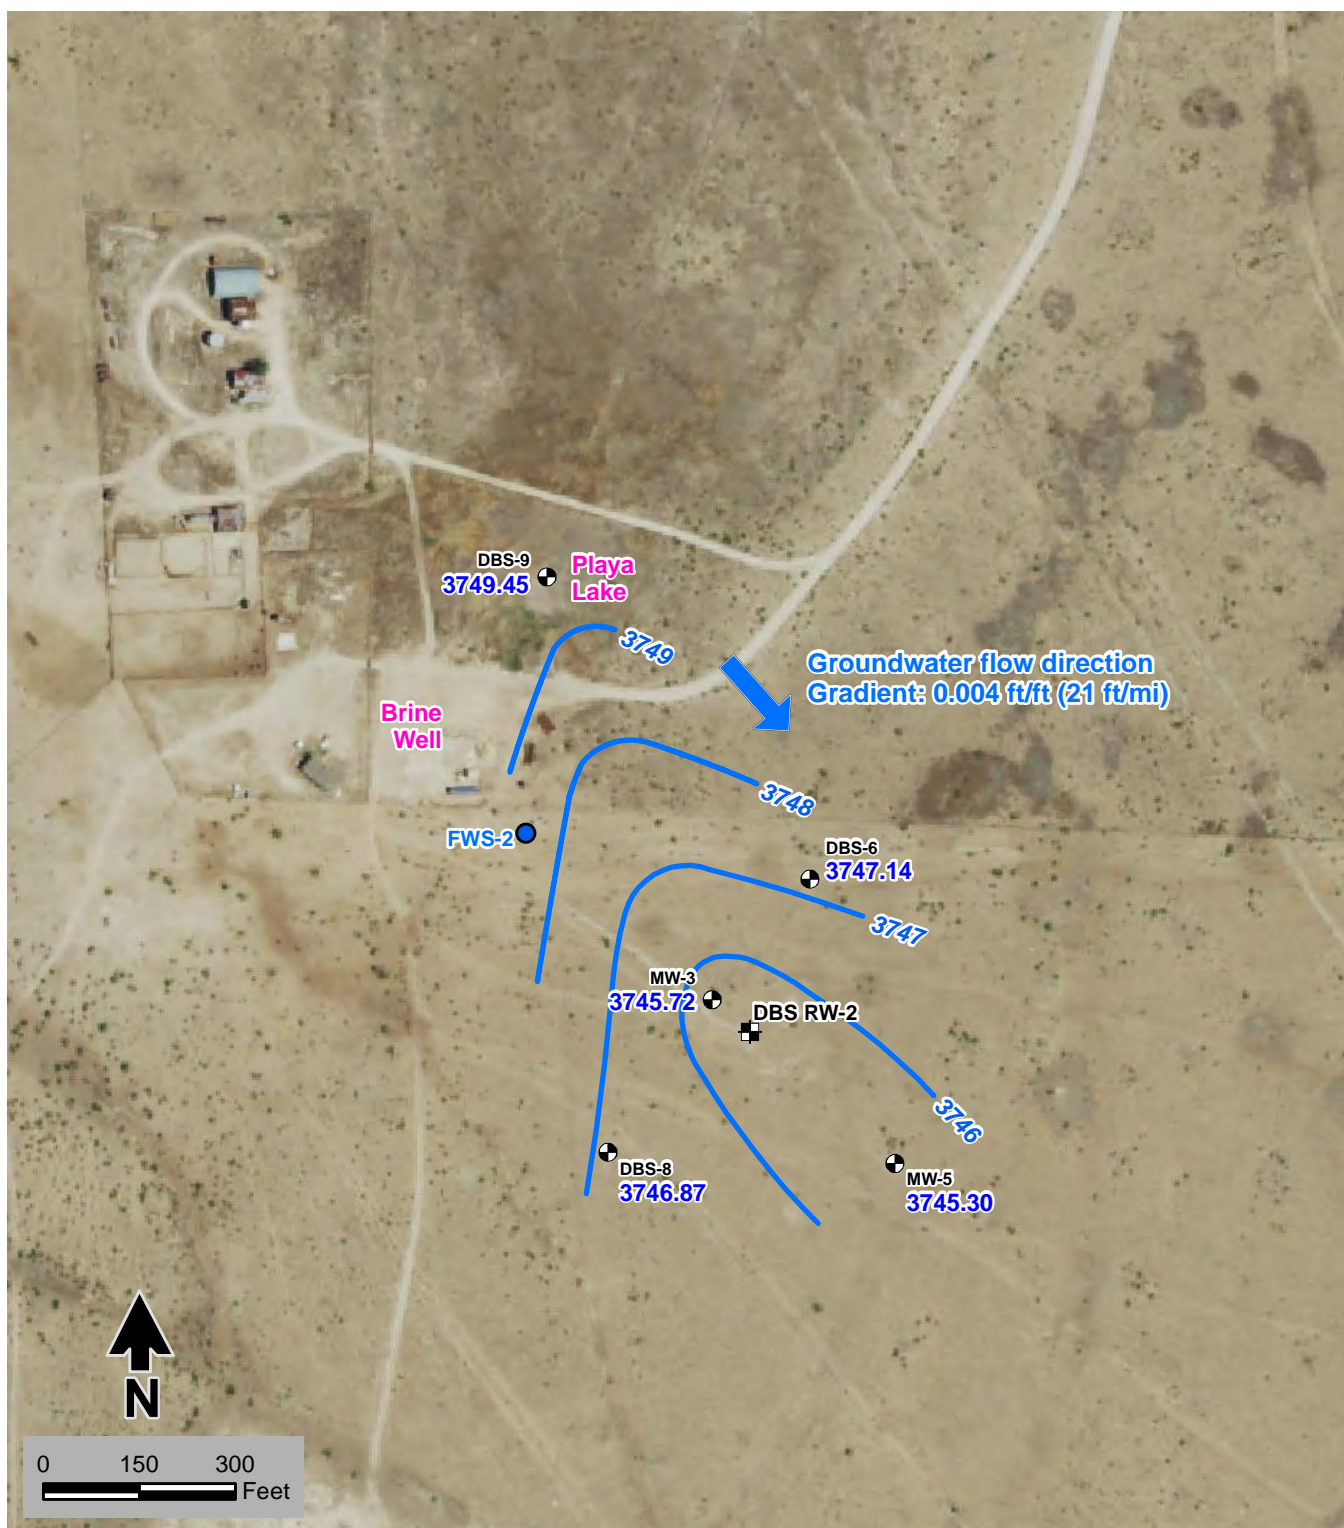
Figures 2 and 3 present potentiometric surface maps for the former brine pond area and the brine well area, respectively. The direction of groundwater flow beneath the former brine pond area remains to the southeast at a gradient of approximately 0.006 foot per foot (ft/ft) (Figure 2)—increasing slightly since the previous monitoring event. A broad cone of depression was observed in the vicinity of the fresh water supply well (FWS-1) due to increased fresh water production when depth to water level measurements were recorded. The direction of groundwater flow beneath the brine well area remains to the southeast at a gradient of approximately 0.004 ft/ft (Figure 3)—decreasing slightly relative to the previous monitoring event.

The average pumping rate at RW-2 during this reporting period was approximately 6 gpm. A cone of depression was not observed during this monitoring event (Figure 3), although RW-2 was pumping at the time water level measurements were recorded.

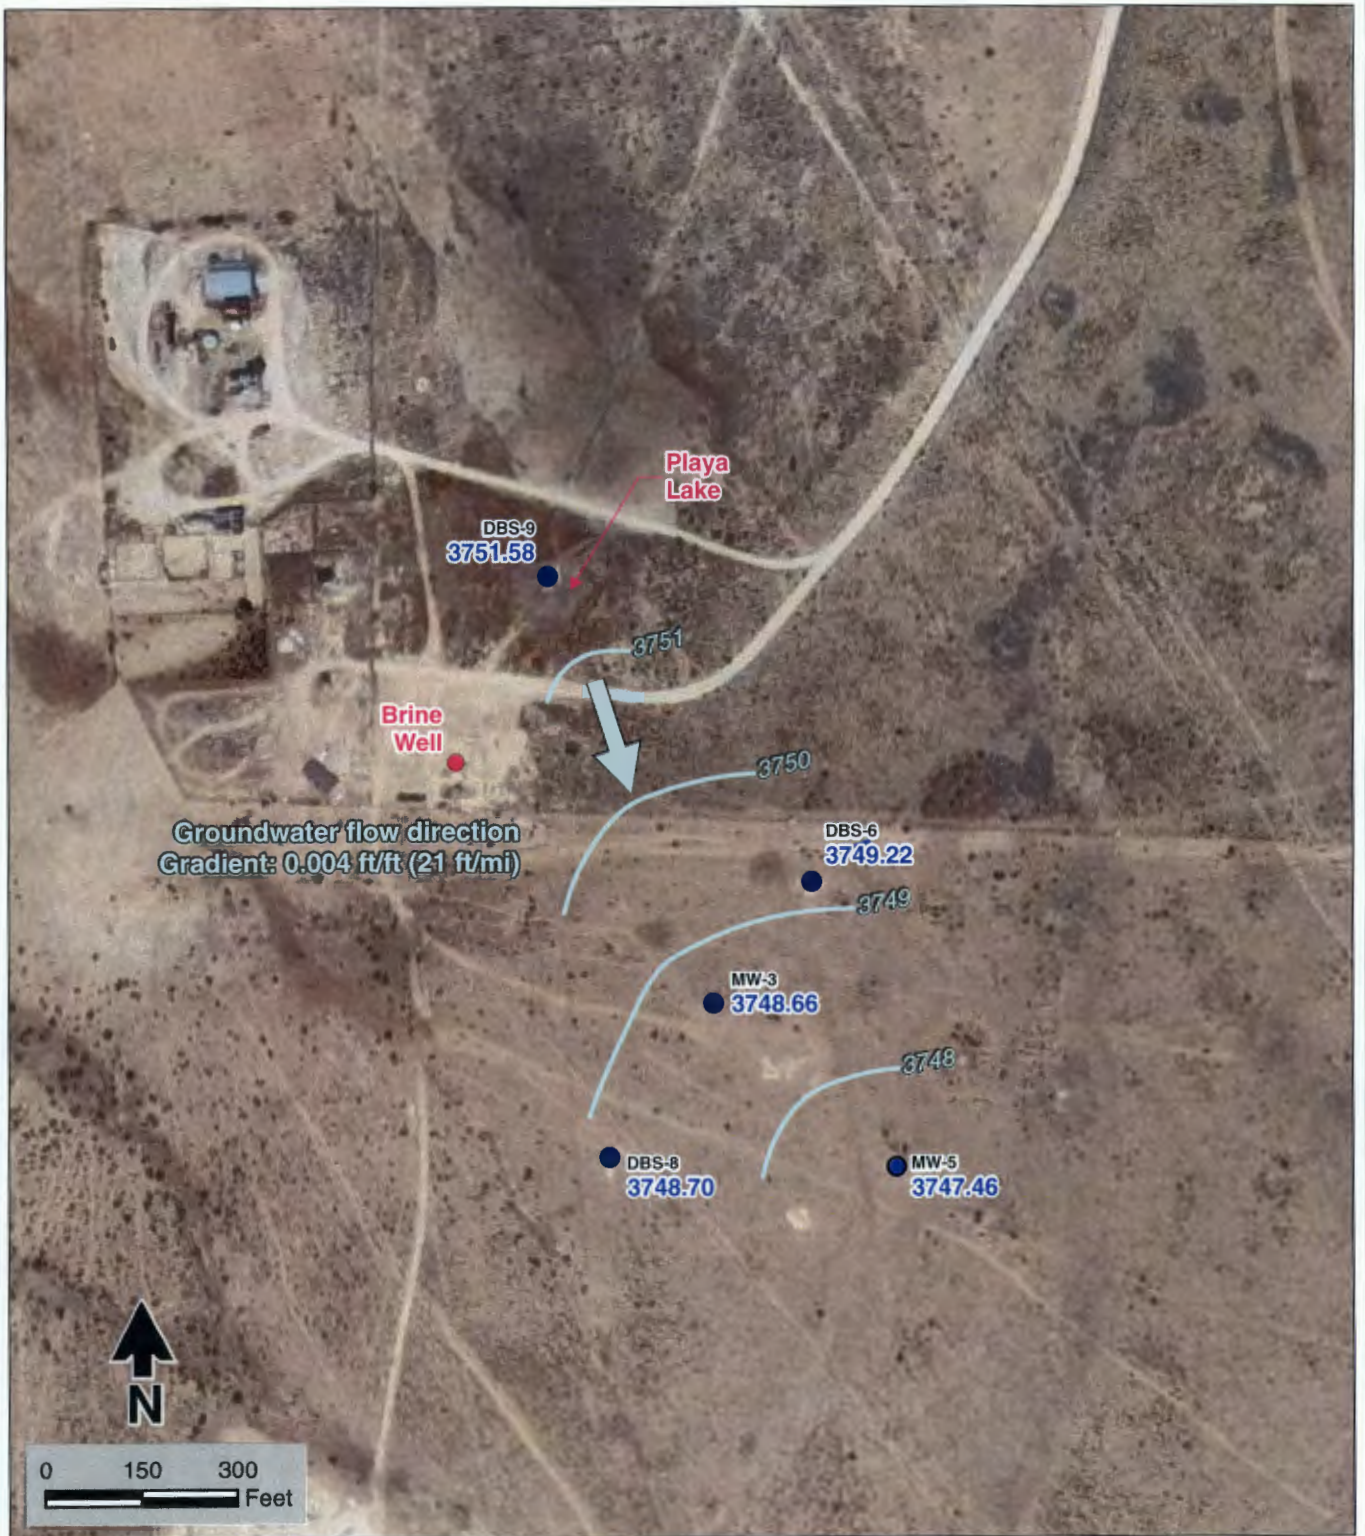
Figure 2

- MW-5** Well designation
- 3747.46** Groundwater elevation, ft msl
- Groundwater elevation (ft msl)
- Potentiometric surface elevation contour (ft msl)

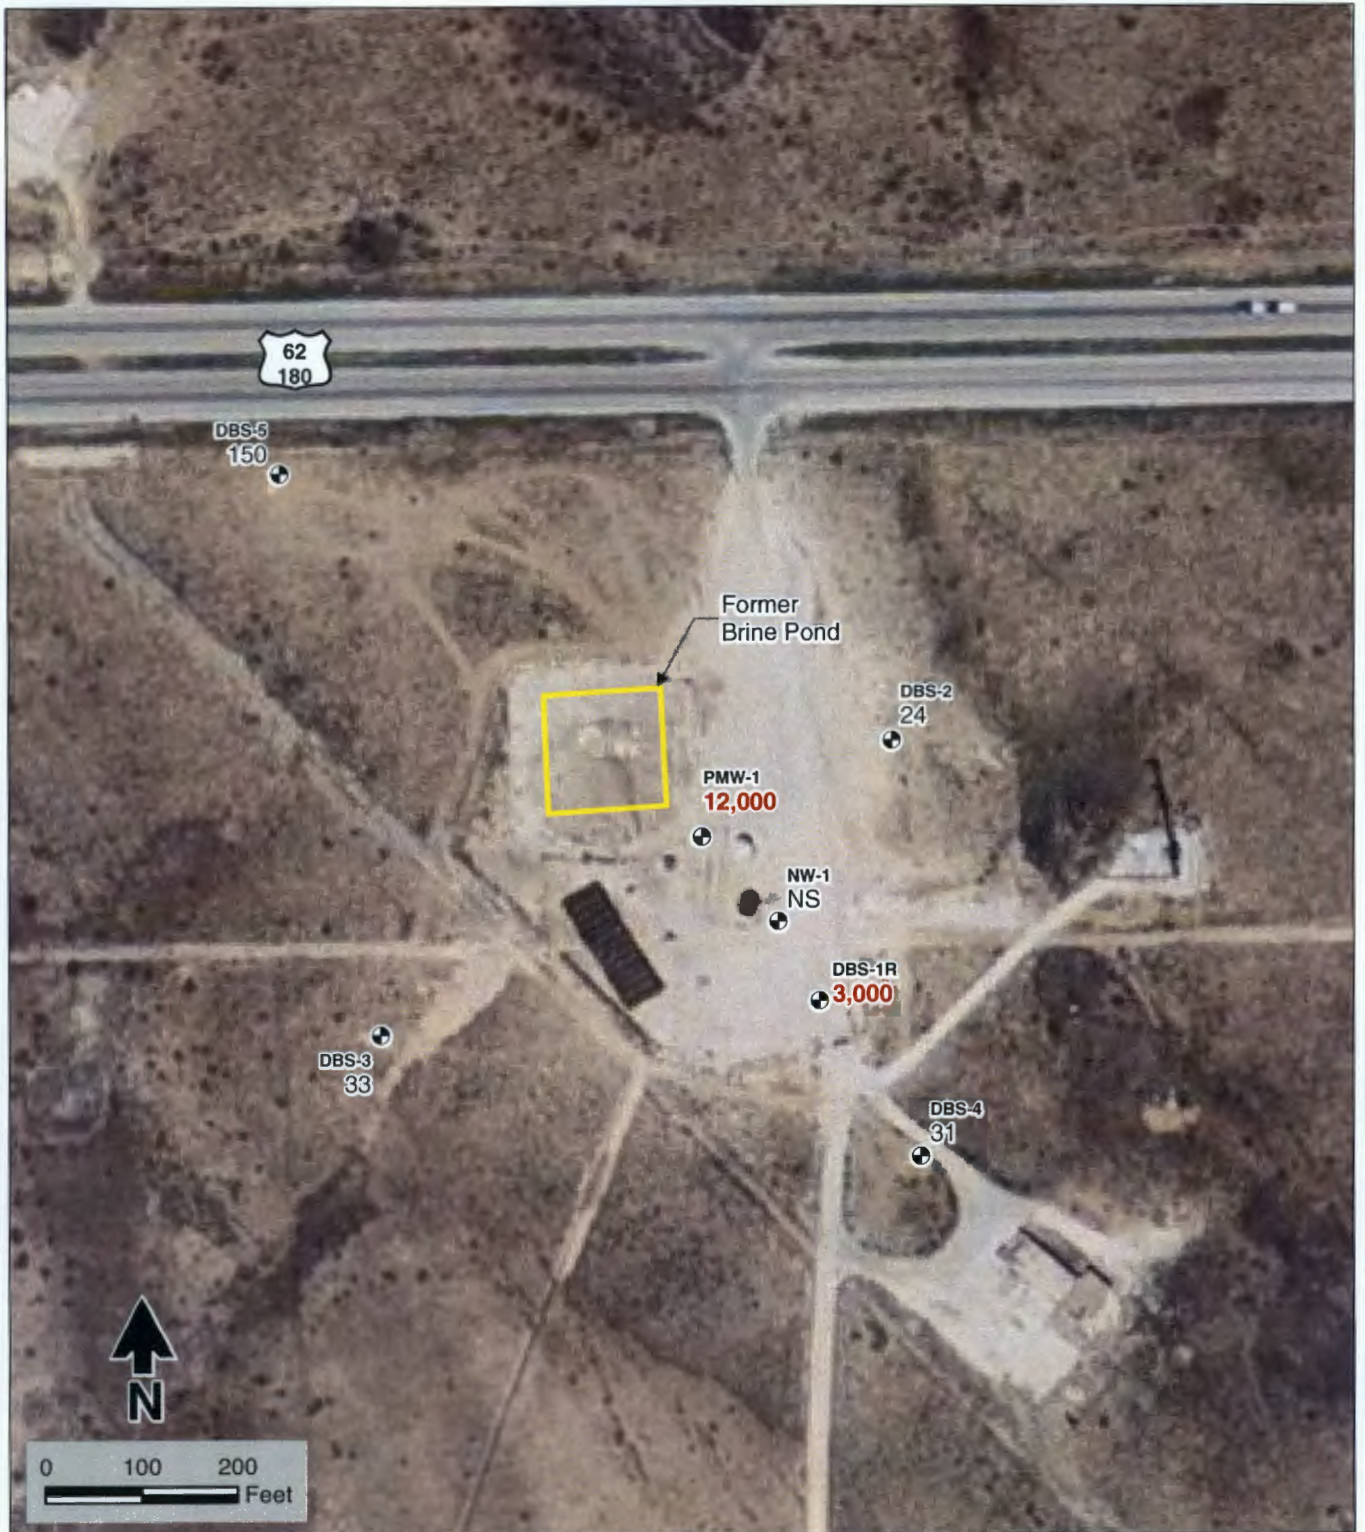
Figure 3

- DBS-5 Well designation  
 150 Chloride concentration (mg/L)  
 ● Monitor well location

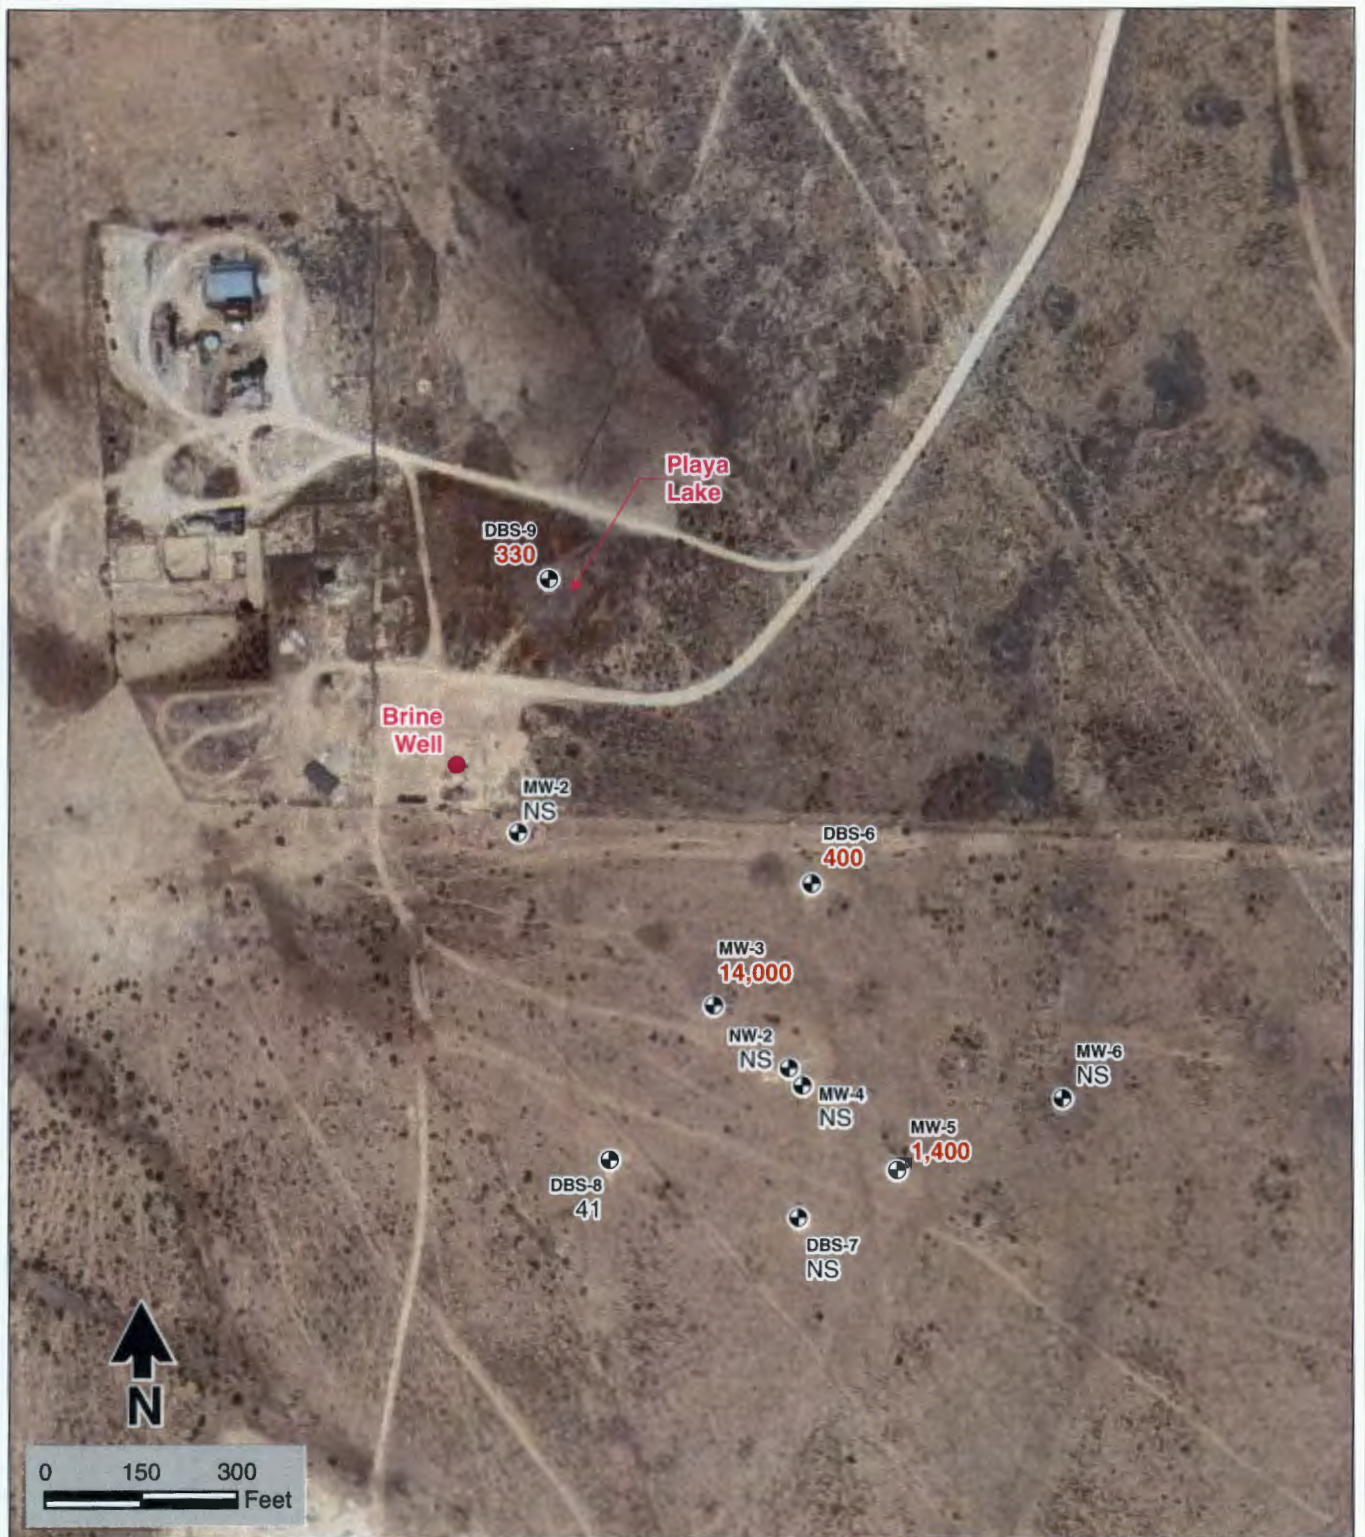
Figure 4

- MW-5 Well designation  
**1,400** Chloride concentration (mg/L)  
⊕ Monitor well location  
**BOLD** indicates concentration equal to or greater than the NMWQCC standard.  
NS = Not sampled

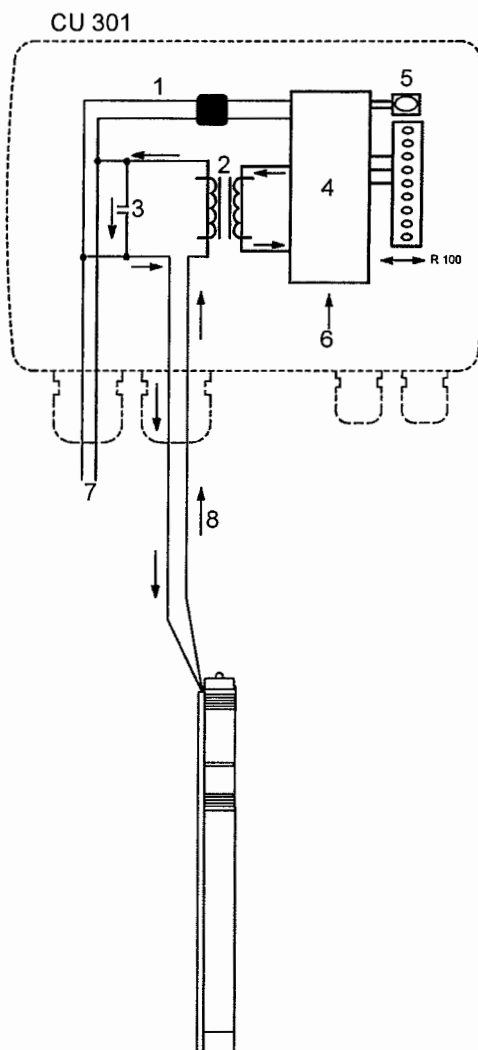
Fig. 2 Principle of mains borne signalling

Pos.	Description
1	Supply to the electronics
2	Signal coils
3	Capacitor
4	Electronics for the control of the communication
5	On/Off button
6	Sensor signal
7	Mains supply
8	Communication signals

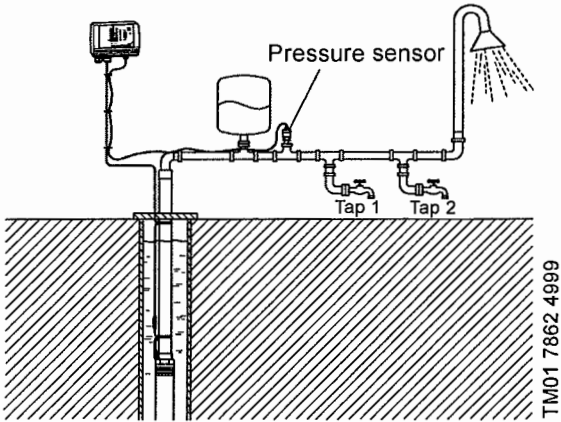
Fig. 7 Pressure sensor position

In fig. 7, tap 1 is placed close to the pressure sensor. Therefore, the pressure will be kept nearly constant at tap 1, as the friction loss is small. At the shower and tap 2, the friction loss is greater. This, of course, depends on the piping.

Pressure losses often cause inconvenience to the user. The CU 301 keeps the pressure constant in the place where the pressure sensor is positioned, see fig. 7.

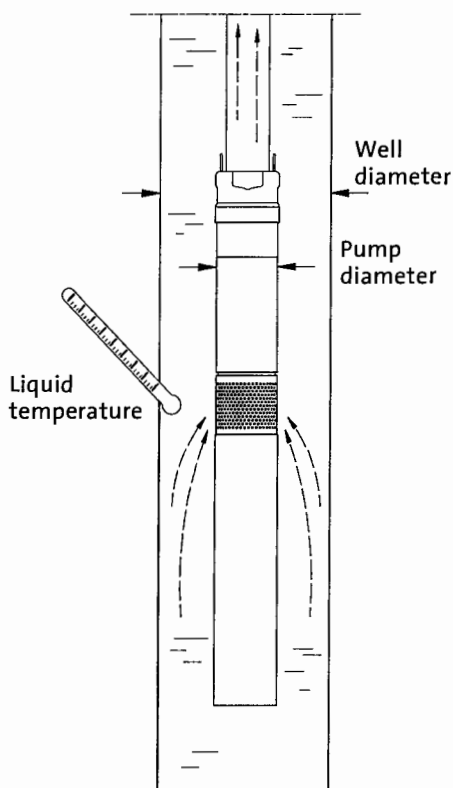
Fig. 1 Pump installed in well

**Note:** The well diameter must be at least 3 inches. If there is a risk that the motor will be covered with sediment, it is recommended the pump be placed in a flow sleeve. The motor should always be installed above the well screen.

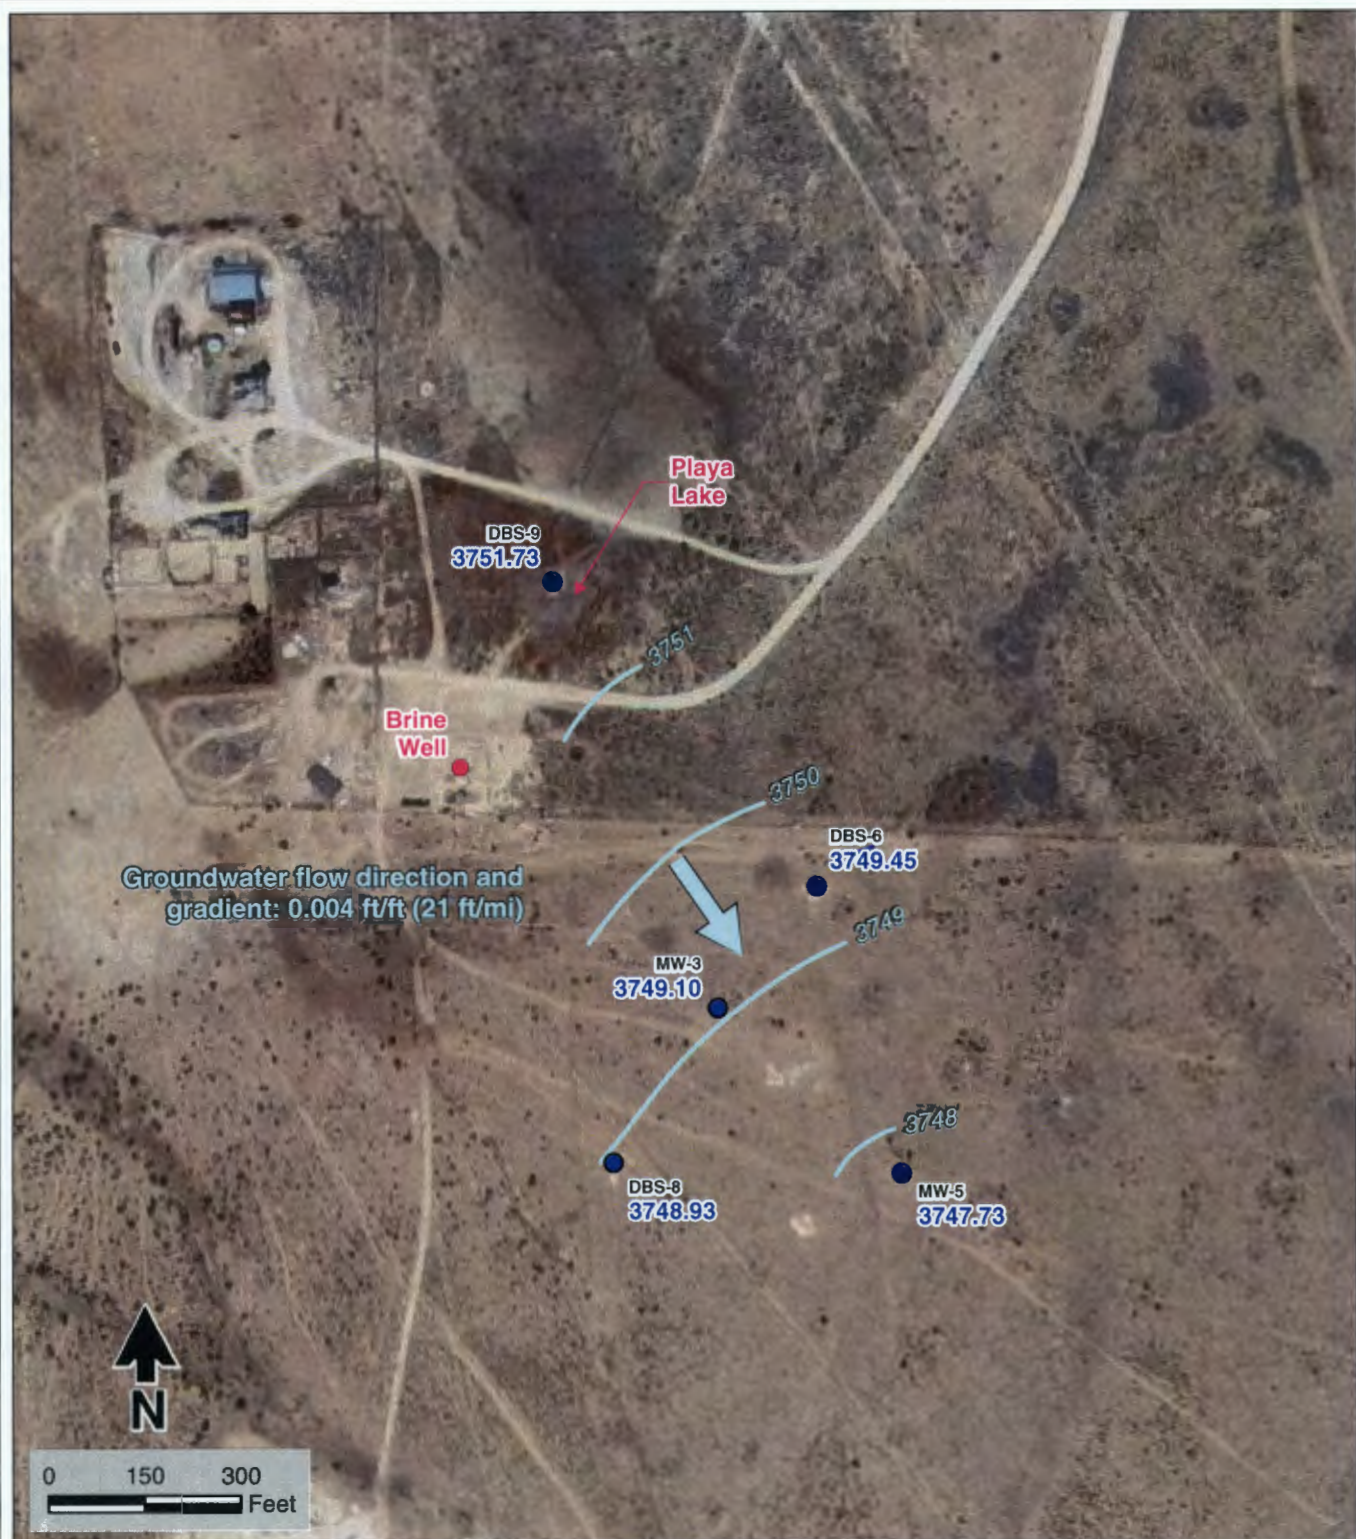
- MW-5 Well designation
- 3747.73 Groundwater elevation, ft msl
- Groundwater elevation (ft msl)
- Potentiometric surface elevation contour (ft msl)

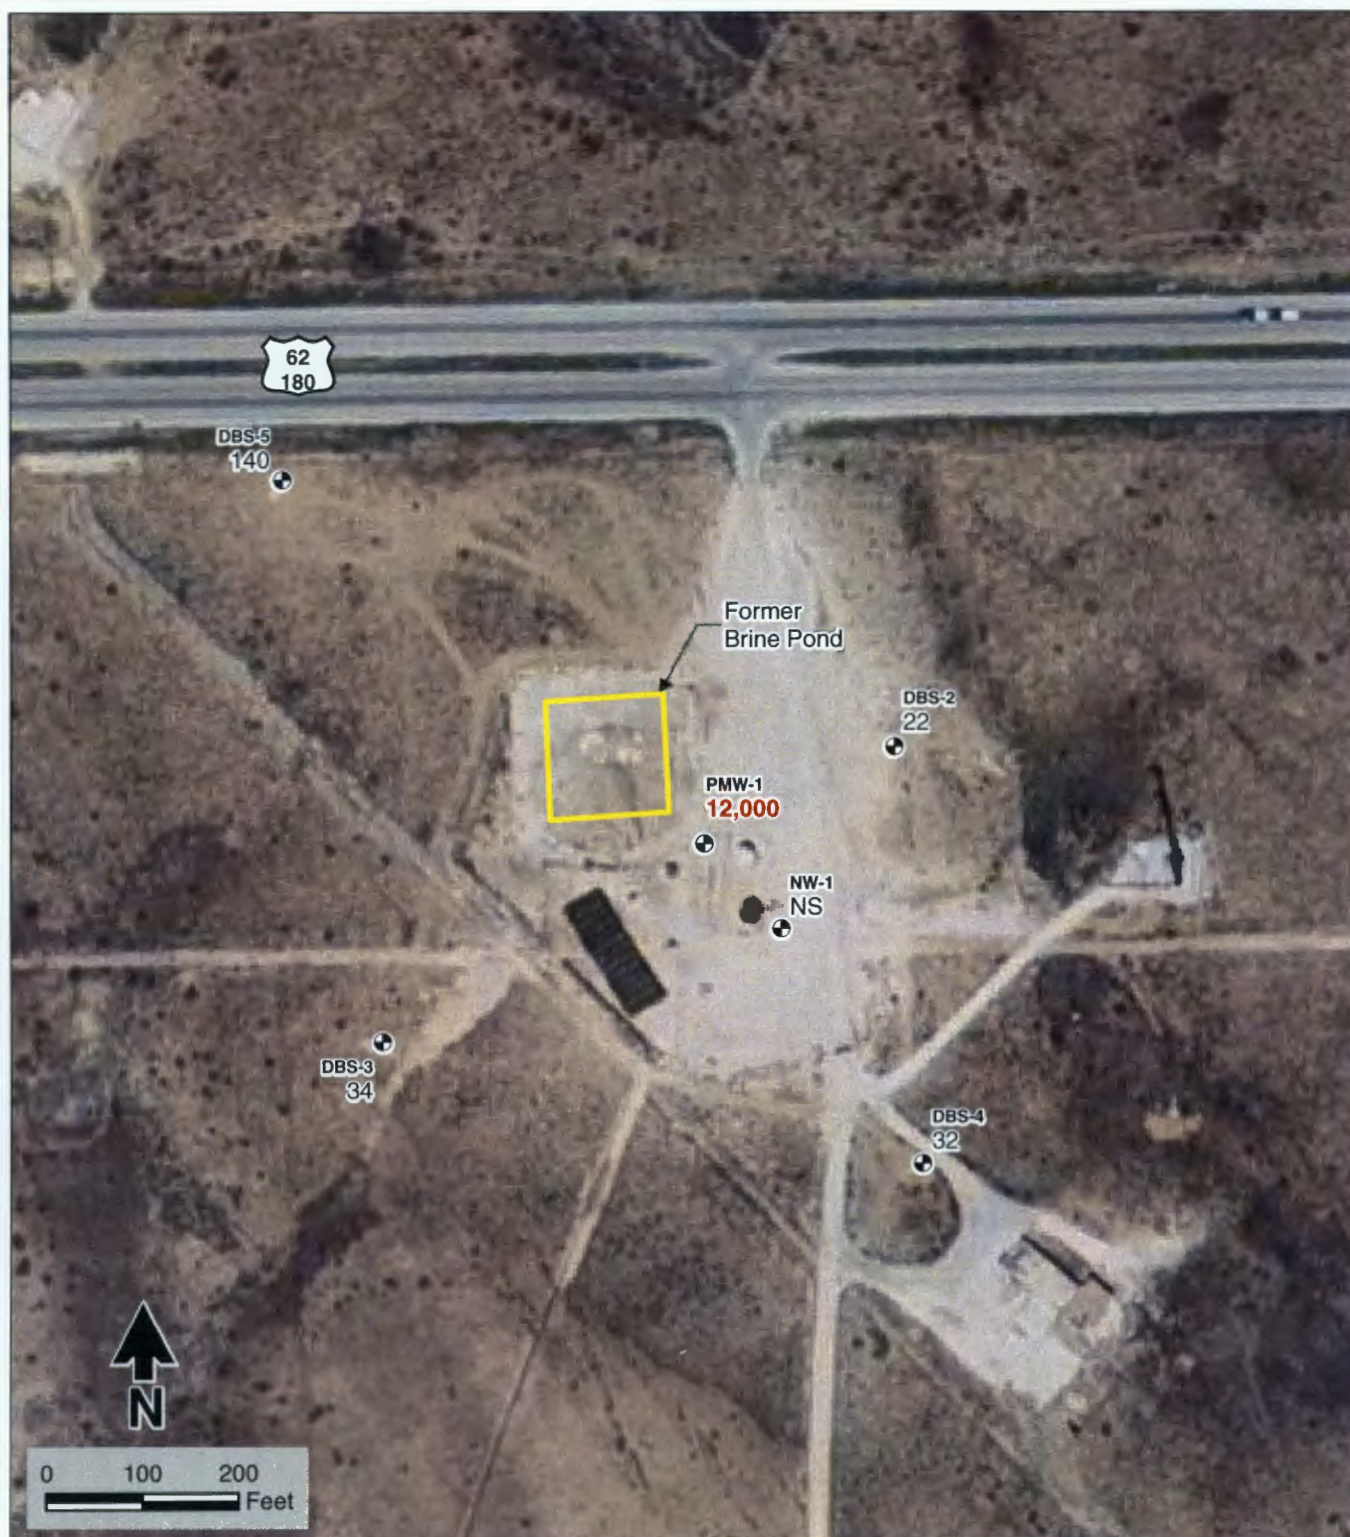
Figure 3

- DBS-5 Well designation  
**140** Chloride concentration (mg/L)  
● Monitor well location

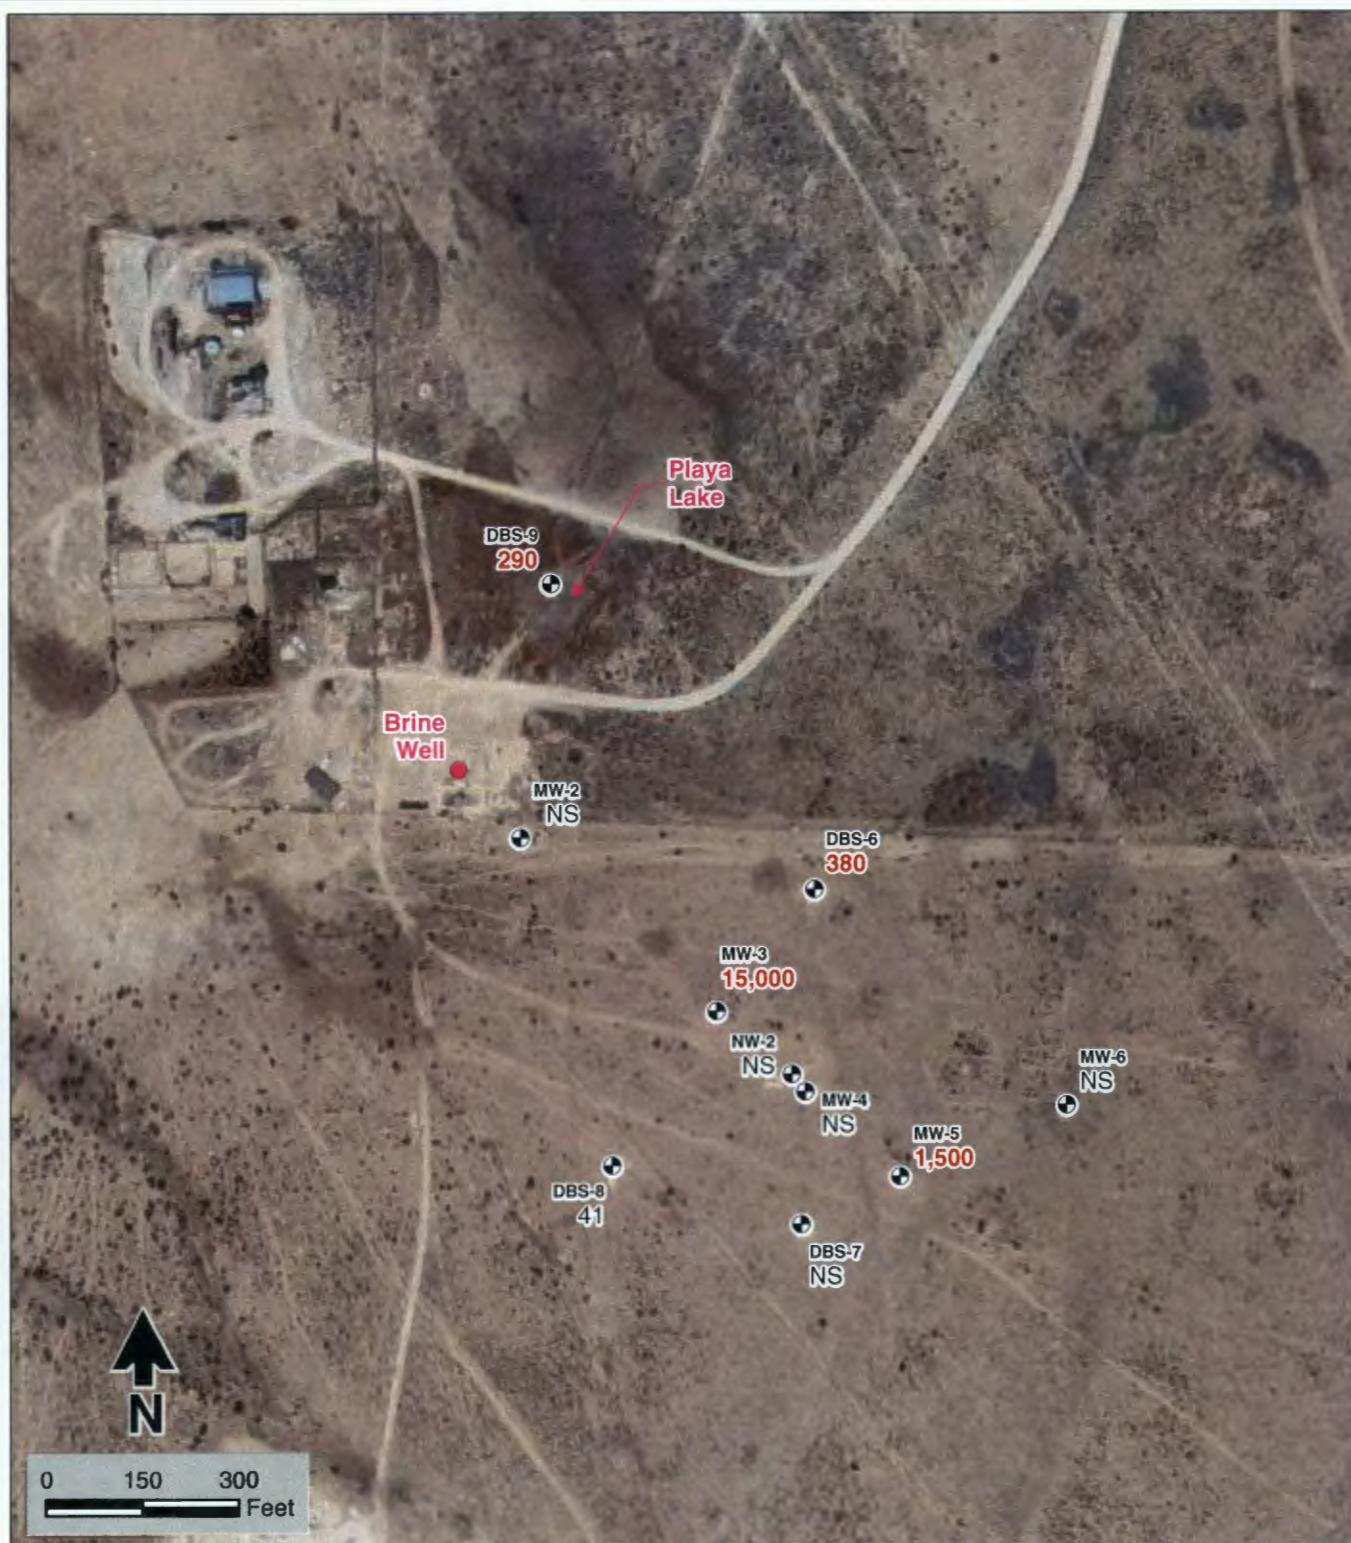
Figure 4

- MW-5 Well designation
- 1,500** Chloride concentration (mg/L)
- ⊕ Monitor well location
